**SITE IMPROVEMENTS**  
**MILE POST 5.45**  
**HAWAII BELT ROAD DRAINAGE IMPROVEMENTS**  
Project No. 19GHJ-01-05M  
Scale: 1"=10' Date: Apr 14, 2006

**SITE IMPROVEMENTS**  
**MILE POST 5.58**  
**HAWAII BELT ROAD DRAINAGE IMPROVEMENTS**  
Project No. 19GHJ-01-05M  
Scale: 1"=10' Date: Apr 14, 2006

STATE OF HAWAII  
DEPARTMENT OF TRANSPORTATION  
HIGHWAYS DIVISION  
**SITE IMPROVEMENTS**  
**MILE POST 19.36**  
**HAWAII BELT ROAD DRAINAGE IMPROVEMENTS**  
Project No. 19GHJ-01-05M  
Scale: As Shown Date: Apr 14, 2006

**SITE IMPROVEMENTS**  
**MILE POST 39.00**  
**HAWAII BELT ROAD DRAINAGE**  
**IMPROVEMENTS**

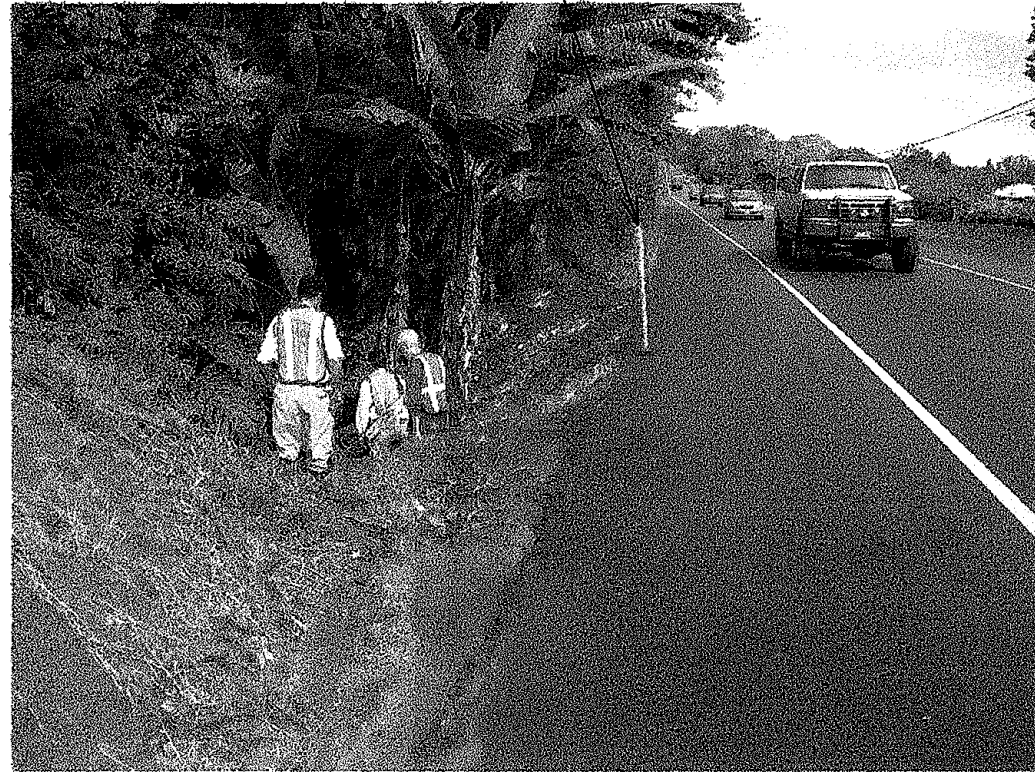
Roadway marker along inlet (mauka) side of culvert

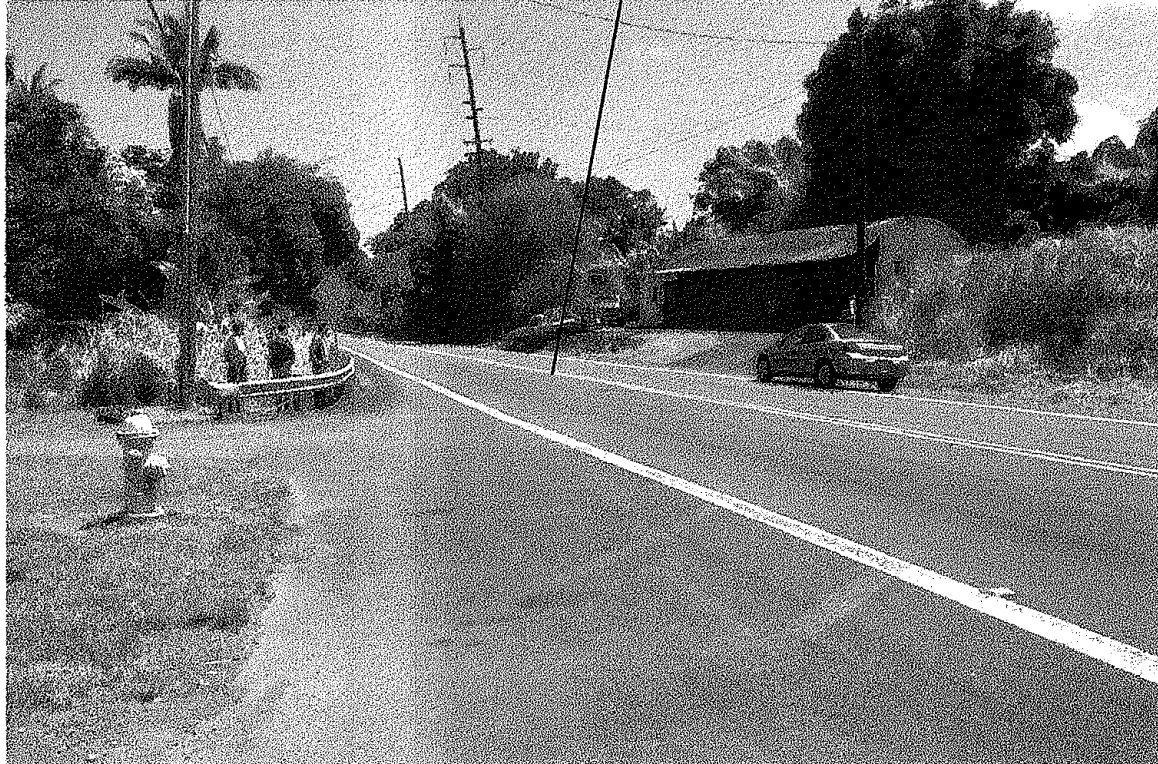
Photo 1

Approx location of new box culvert alignment across roadway

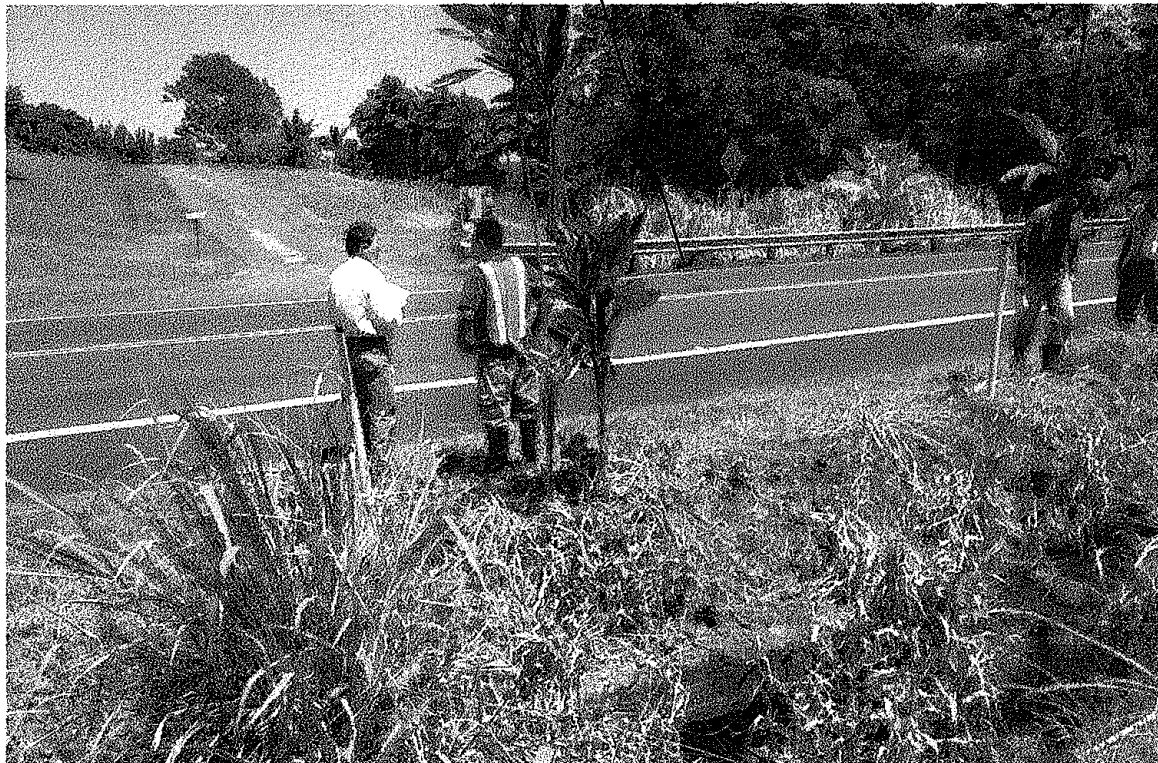
Photo 2

Approx location of exist outlet

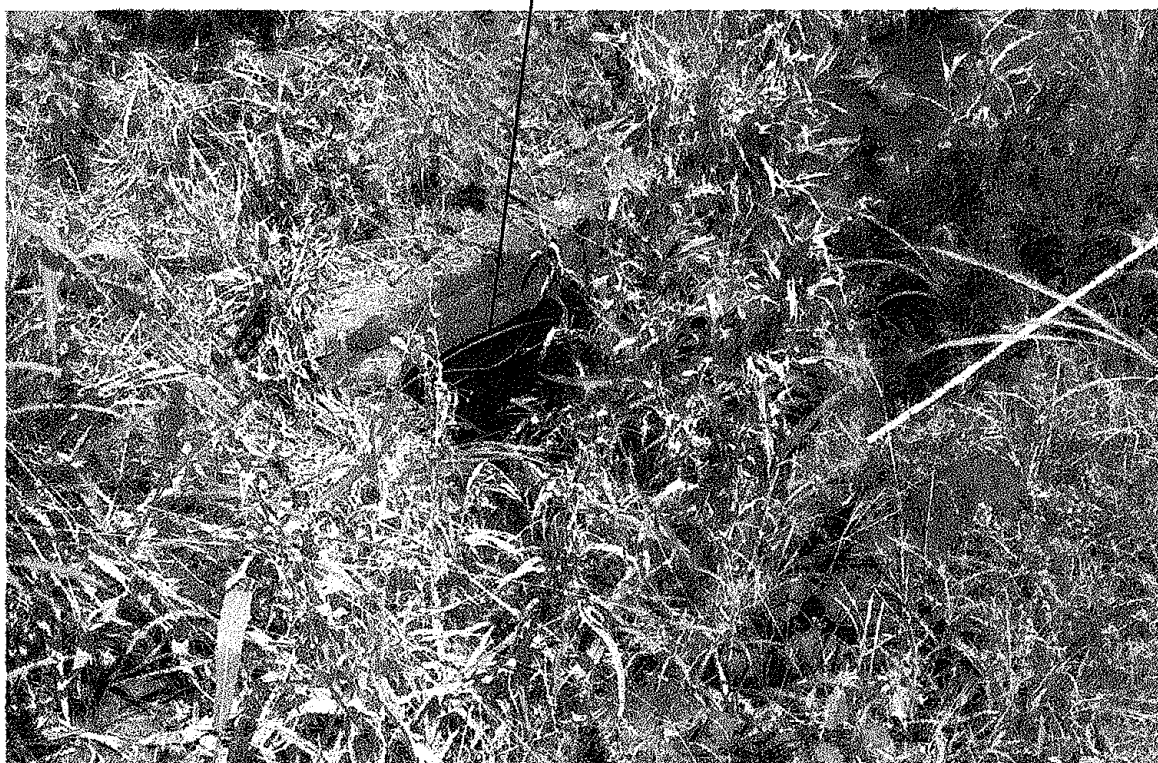
Photo 3

Exist inlet
