## **Asbestos, Lead, Arsenic and Waste Characterization Survey Report**

**Saddle Road Maintenance Baseyard  
Vicinity of Mauna Kea State Park  
District of Hamakua, Island of Hawaii  
TMK: 4-4-016:003**

**Saddle Road Maintenance Baseyard  
New Maintenance Facility**

**Date of Report: June 27, 2013**

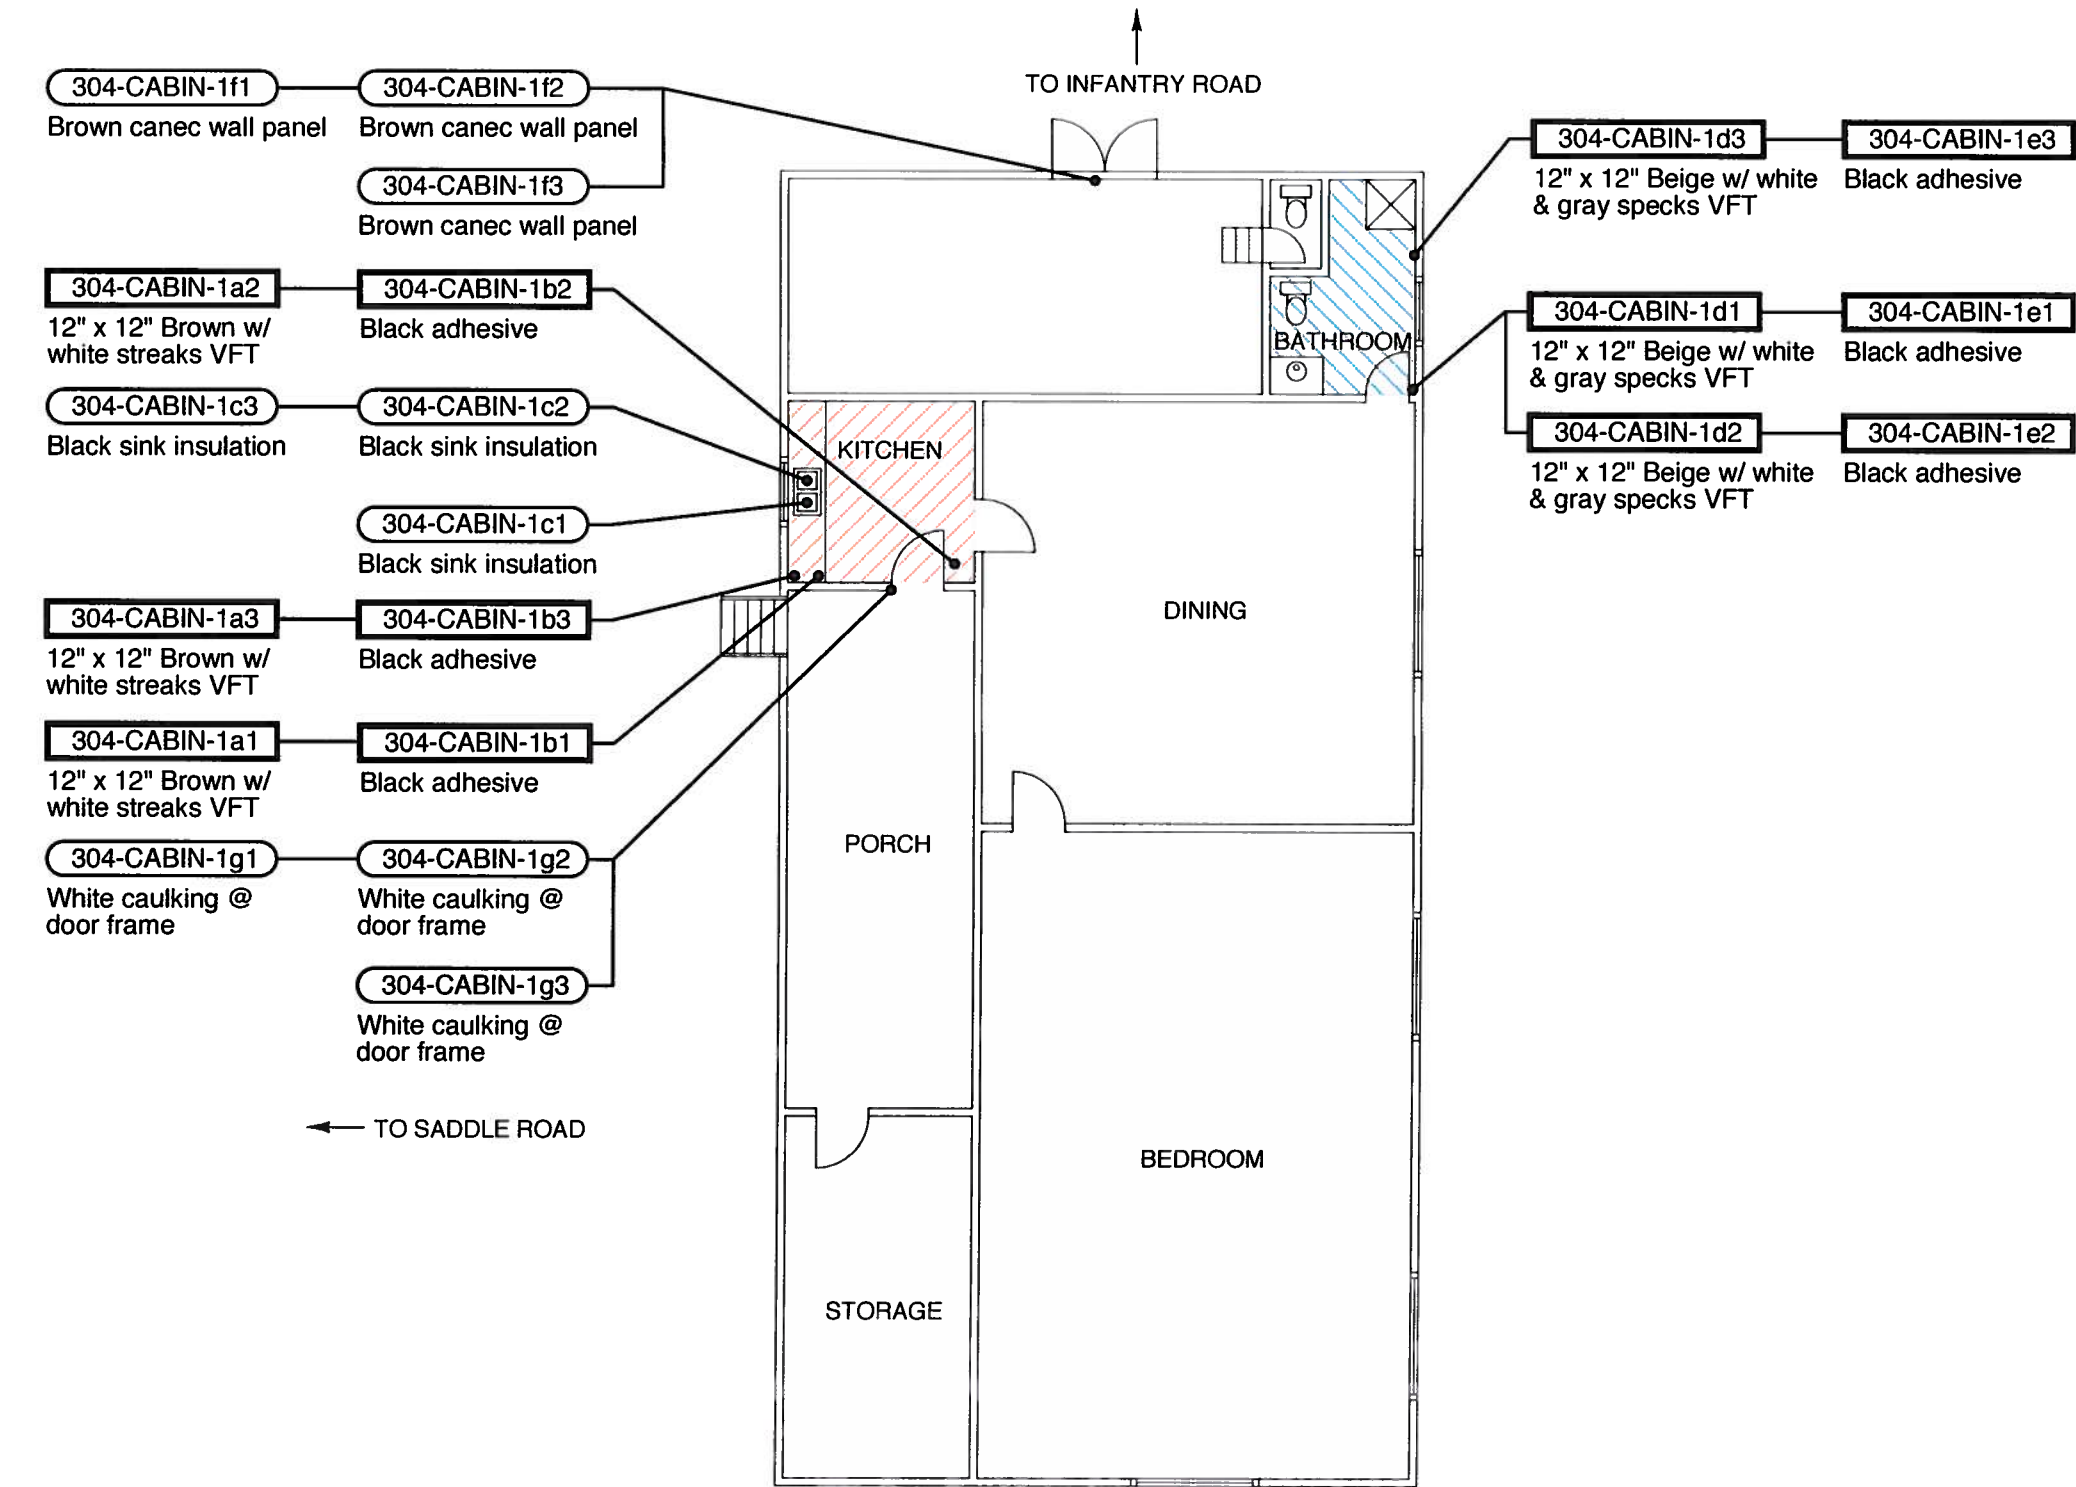
SADDLE ROAD MAINTENANCE BASE YARD  
CABIN - FLOOR PLAN  
NOT TO SCALE

| Material Description | Quantity | Material Location | Condition;<br>Friable/Non<br>Friable |
|---|---|---|---|
| <b>12" x 12" brown w/<br/>white streaks vinyl<br/>floor tile and black<br/>adhesive</b> | ± 60 sf | throughout the kitchen of the cabin | no damage;<br>non-friable |
| <b>12" x 12" beige w/<br/>white and gray<br/>specks sheet vinyl<br/>flooring and black<br/>adhesive</b> | ± 70 sf | throughout the bathroom of the cabin | no damage;<br>non-friable |
