Modified
Phase I Environmental Site Assessment

**Lihue Airport (LIH)
3901 Mokulele Loop
Lihue, Hawaii 96766**

**Engineering Branch – AIR-EM
State of Hawaii Department of Transportation Airports Division
400 Rodgers Boulevard, Suite 700
Honolulu, Hawaii 96819-1880**

Project No. 117019:DO-36/120037:DO-15

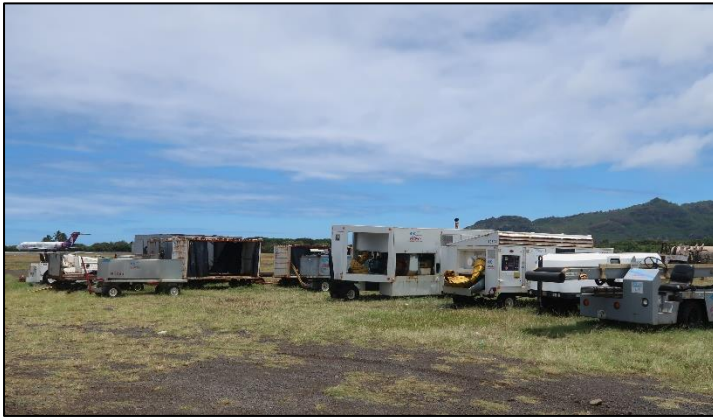
Photo 01: Containers and out-of-use luggage carts – Runway Area.

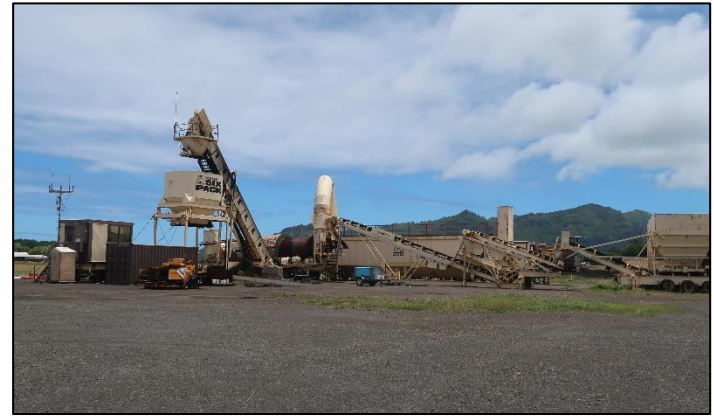
Photo 02: Support facility for asphalt milling – Runway Area.

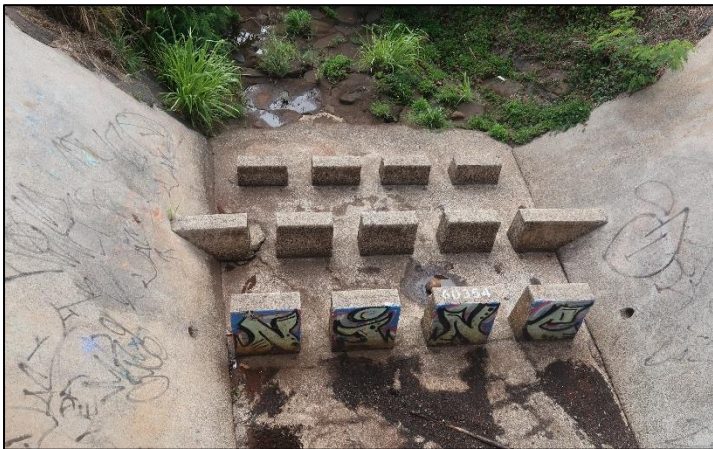
Photo 03: Stormwater canal discharge point – Runway Area.

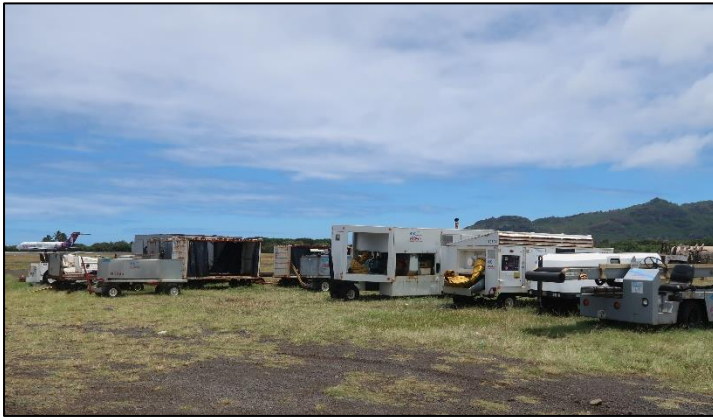
Photo 01: Containers and out-of-use luggage carts – Runway Area.

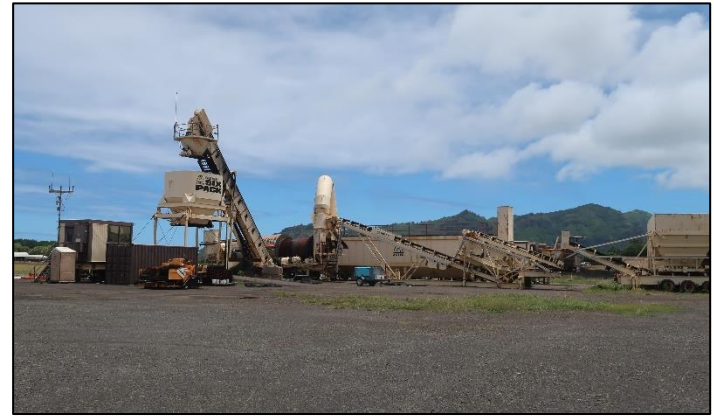
Photo 02: Support facility for asphalt milling – Runway Area.

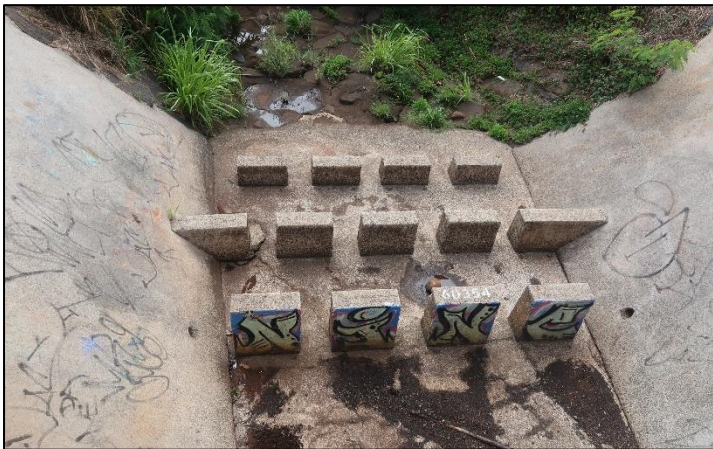
Photo 03: Stormwater canal discharge point – Runway Area.
