Photos of Bridge Spall Repairs for Solicitation B23002876
Minor Bridge Repairs at Various Locations, Part 1
Project No. HWY-K-02-23M

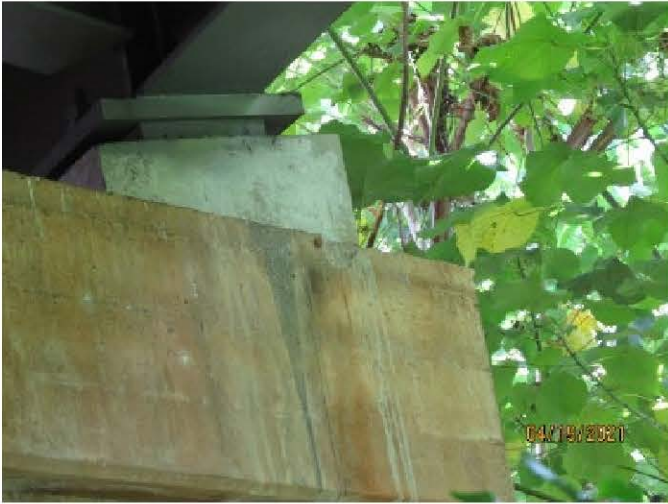
1. Nawiliwili Stream (Lihue Mill) Bridge (Inbound)

1'-0" Long Spall in Top edge of Pilecap.
Type 3 Spall Repair (a=9", b=9").
*Overhead

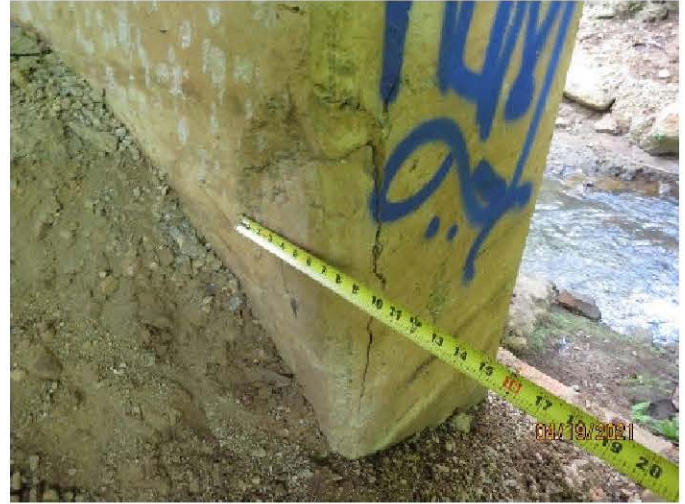
2'-0" Long Spall in Downstream Nose of Pier
at Bottom. Type 3 Spall Repair (a=12", b=12").
*At your feet

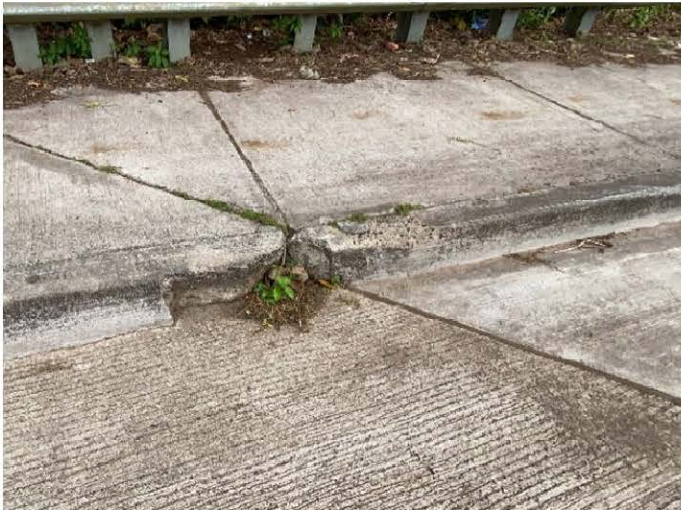
4'-0" Long Spall in Curb at Joint.
Type 3 Spall Repair (a=9", b=6"). Provide
Expansion Separation at Joint.
*At your feet

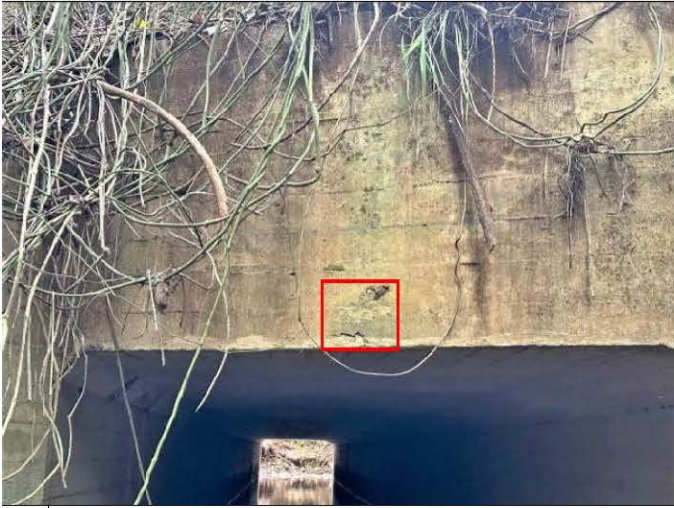
2. Hoinakaunalehua Stream Bridge

3 S.F. Spall in Bottom of Upstream Headwall,
Type 1 Repair
*Overhead

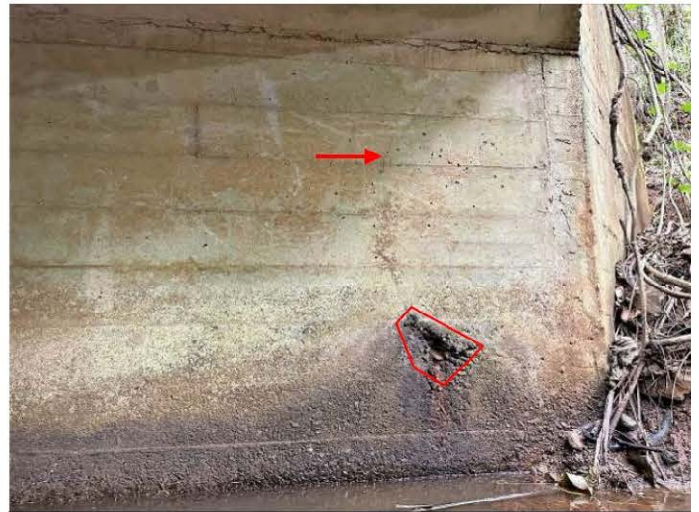
2 S.F. Spall in Bottom of Upstream Headwall,
Type 1 Repair
* Vertical

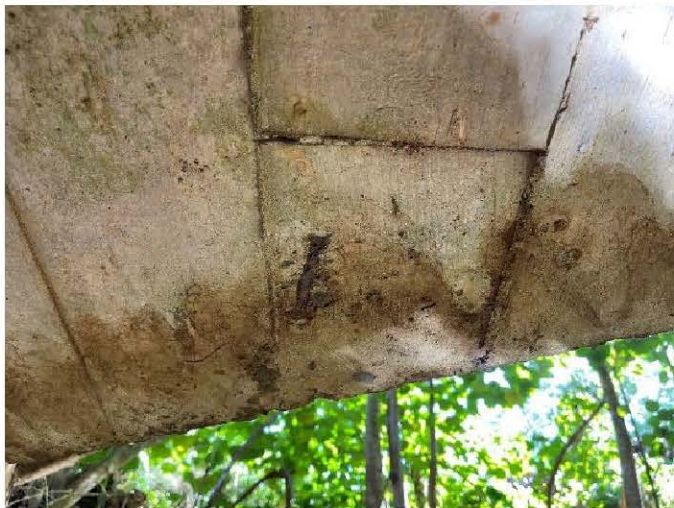
2 S.F. Spall in Soffit of Downstream Headwall,
Type 1 Repair
*Overhead

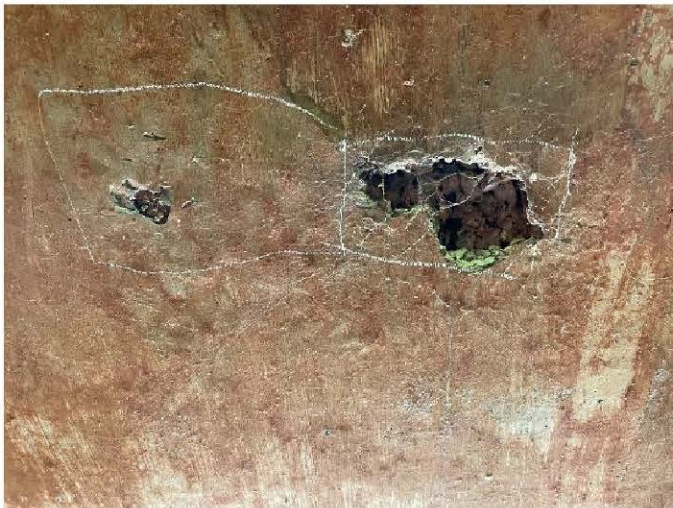
3. Unnamed Stream (5-Cell) Culvert

2 S.F. Spall in Soffit (Cell #4), Type 1 Repair
*Overhead

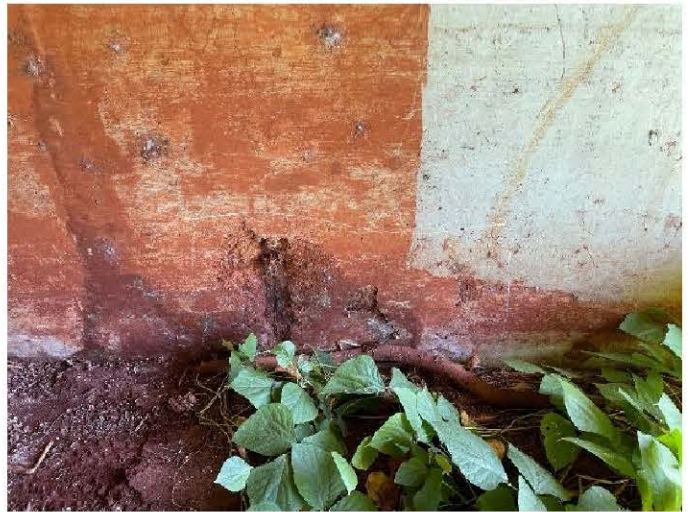
2 S.F. Spall at Bottom of Culvert Wall
(Cell #4), Type 1 Repair
*At your feet

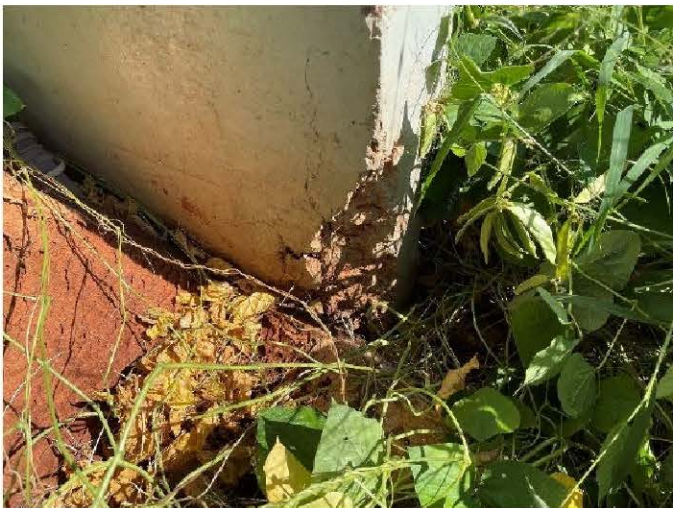
2 L.F. Spall in Leading Edge of Wall (Cell #4),
Type 2 Repair (a=12", b=9")
*At your feet

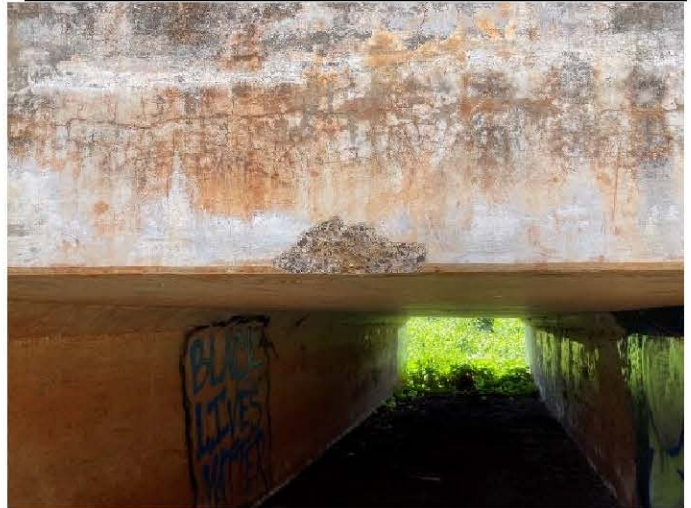
Spall in Bottom Edge of Headwall (Cell #2),
Type 3 Spall Repair (a=12", b=6", length=12")
*Overhead

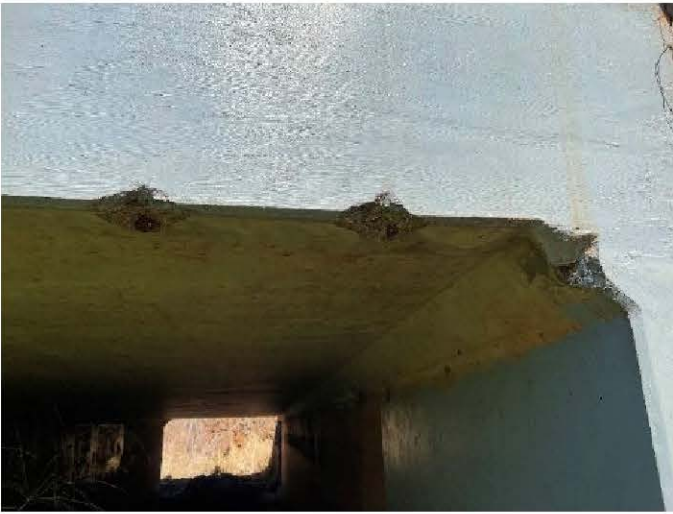
(3) Spalls in Bottom Edge of Headwall
(Cell #1), Type 3 Spall Repair
(a=12", b=6", length=12", each)
*Overhead

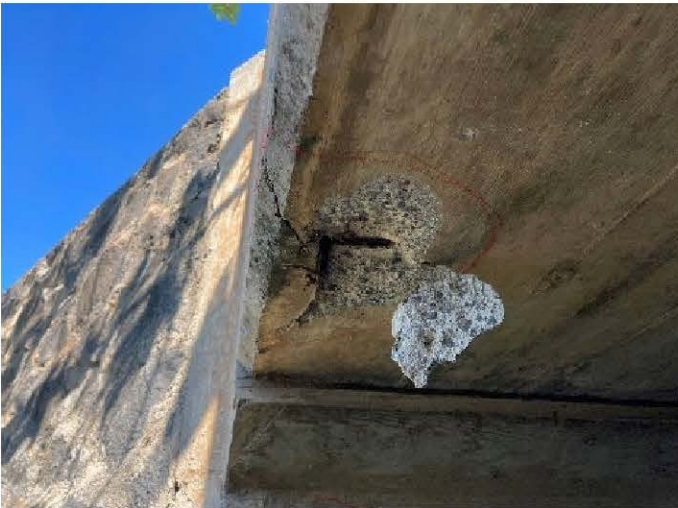
4. Kekaha Channel No.1 Culvert

3 S.F. Spall in Soffit (Polihale Cell)
Type 1 Repair
*Overhead

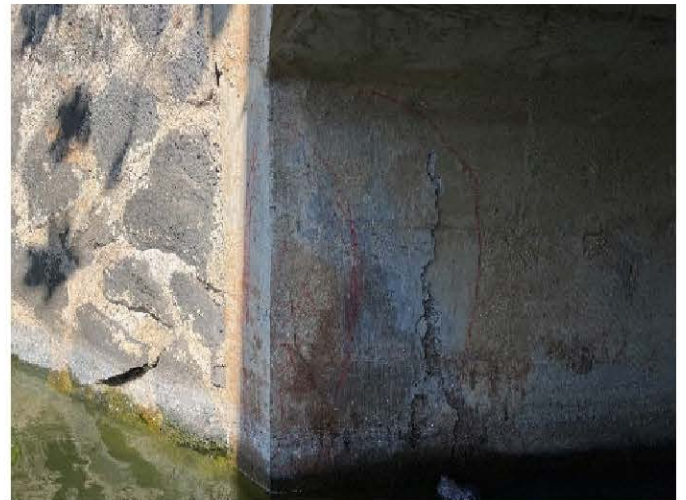
12 S.F. Spall in Wall (Polihale Cell)
Type 1 Repair
*At your feet

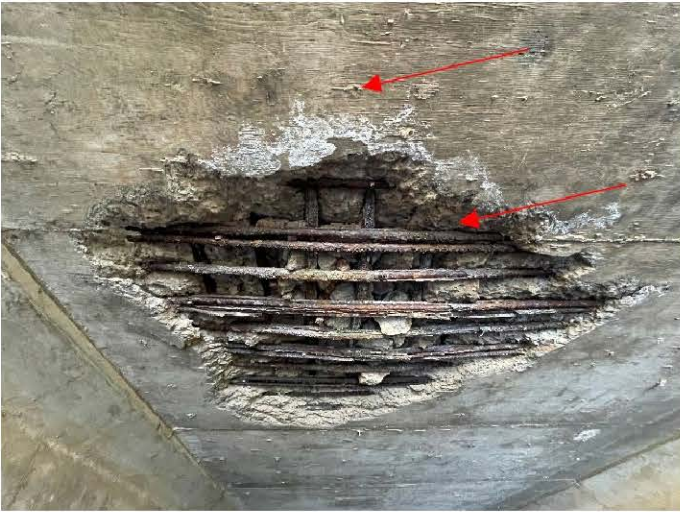
60 S.F. Spall in Soffit (Polihale Cell)
*Overhead

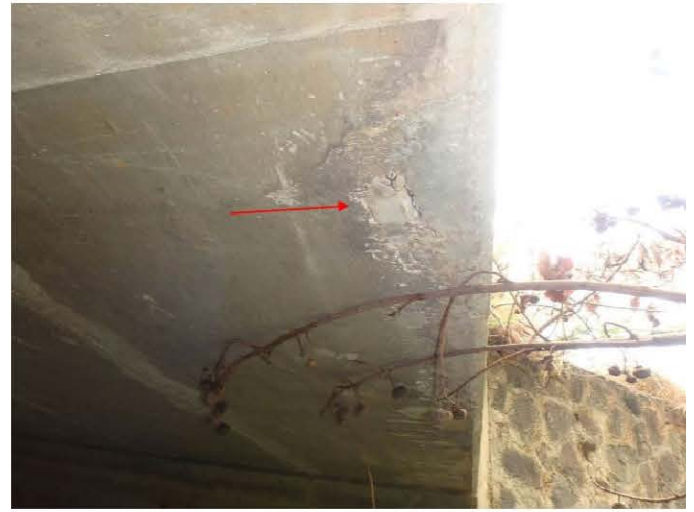
8 S.F. Spall in Headwall (Polihale Cell),
Type 1 Repair
*Overhead

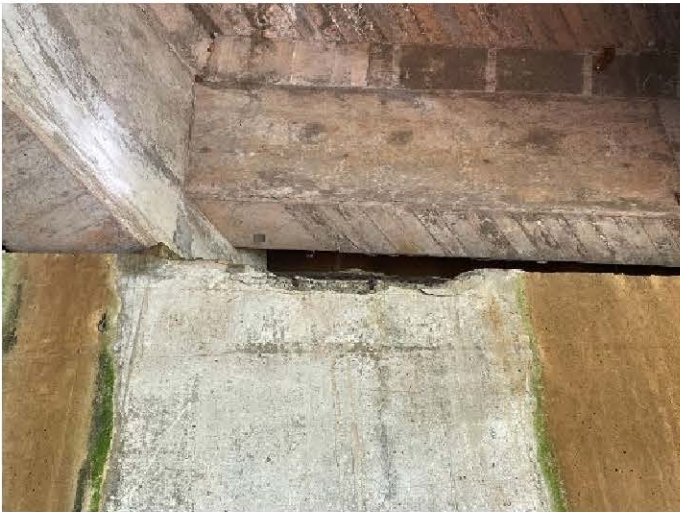
5. Papaa Stream Bridge

4 S.F. Spall at Top of Abutment Wall Between
Girders 2 and 3, Type 3 Repair
*Overhead
