ROUTINE (PERIODIC) BRIDGE INSPECTION REPORT

NUAAILUA STREAM BRIDGE
BRIDGE NO. 009003600501540
MAUI, HAWAII

State of Hawaii
Department of Transportation
Highways Division

Nagamine Okawa Engineers Inc.
1003 Bishop Street
Suite 2025
Honolulu, Hawaii 96813
Telephone: (808) 536-2626

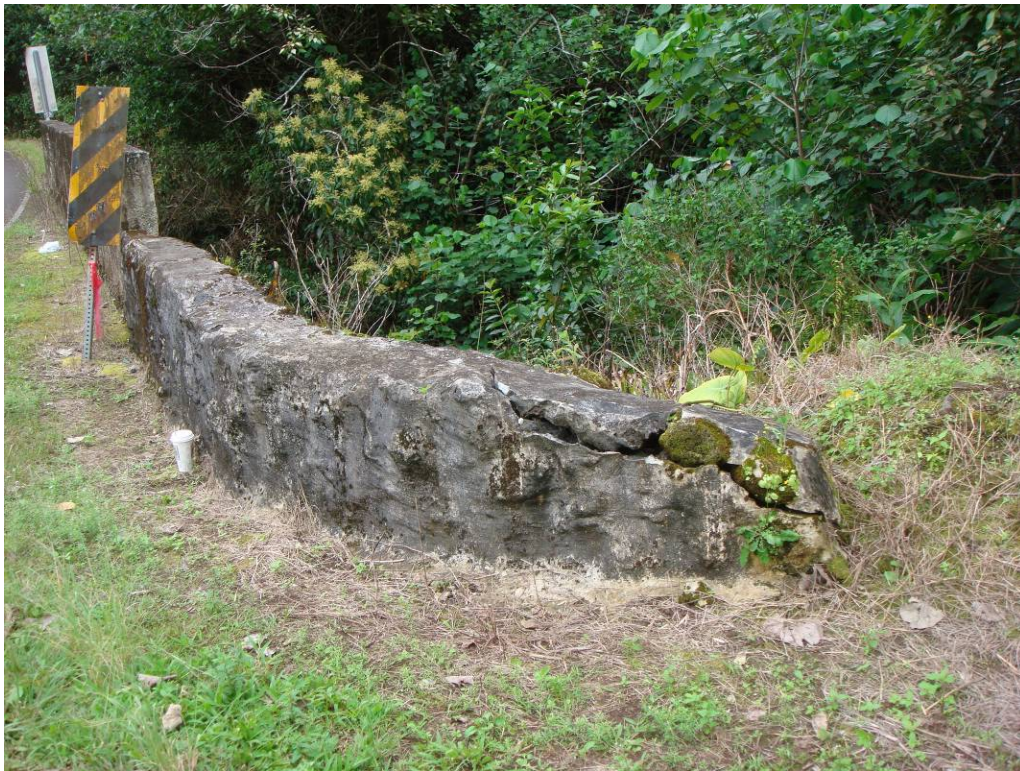
PHOTO 3 UPSTREAM / KAHULUI CRM WALL WITH COLLISION DAMAGE

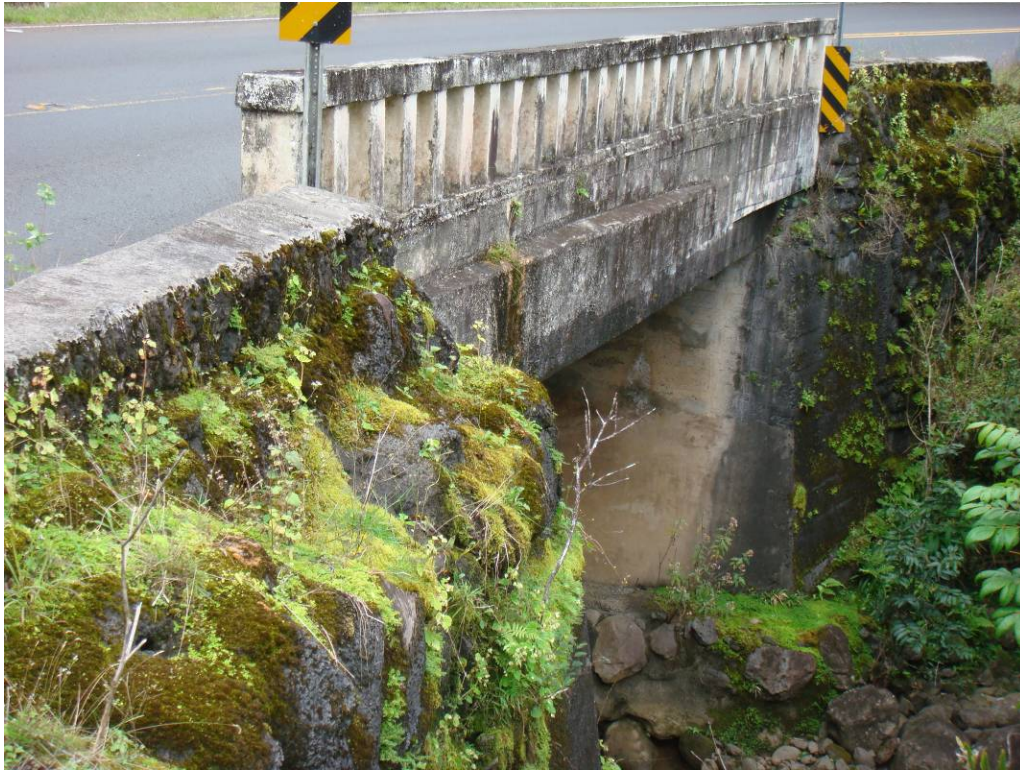
Condition Rating		Remarks
36	TRAFFIC SAFETY FEATURES	Indicate if feature meets currently acceptable standards. 0 - No 1 - Yes N - Not Applicable
1.	Bridge Railings	0
2.	Transitions	0
3.	Approach Guardrail	0
4.	Approach Guardrail Ends	0
		RM-4 signs are damaged at the Kahului approach.

**PHOTO 11 BACKSIDE DOWNSTREAM RAILING ELEVATION. NOTE: DAMAGED RM-4 SIGN
AT THE KAHULUI END OF RAILING**

- List all work done to this bridge since the last inspection including cost.
a) Repaved A.C. overlay
- Indicate proposed and/or recommended improvements including estimated cost.
a) Install guardrail transitions, approach guardrails, and end treatments to meet current acceptable standards (Cost Est. = \$50,000).
b) Upgrade railing and parapet to meet current acceptable standards (Cost Est. = \$120,000).
c) Repair cracks, delaminations, and spalls in girders (Cost Est. = \$50,000).
d) Clear vegetation from bridge and upstream of channel (Maintenance Item).
e) Repair Kahului approach RM-4 signs (Maintenance Item).
- List any existing temporary conditions.

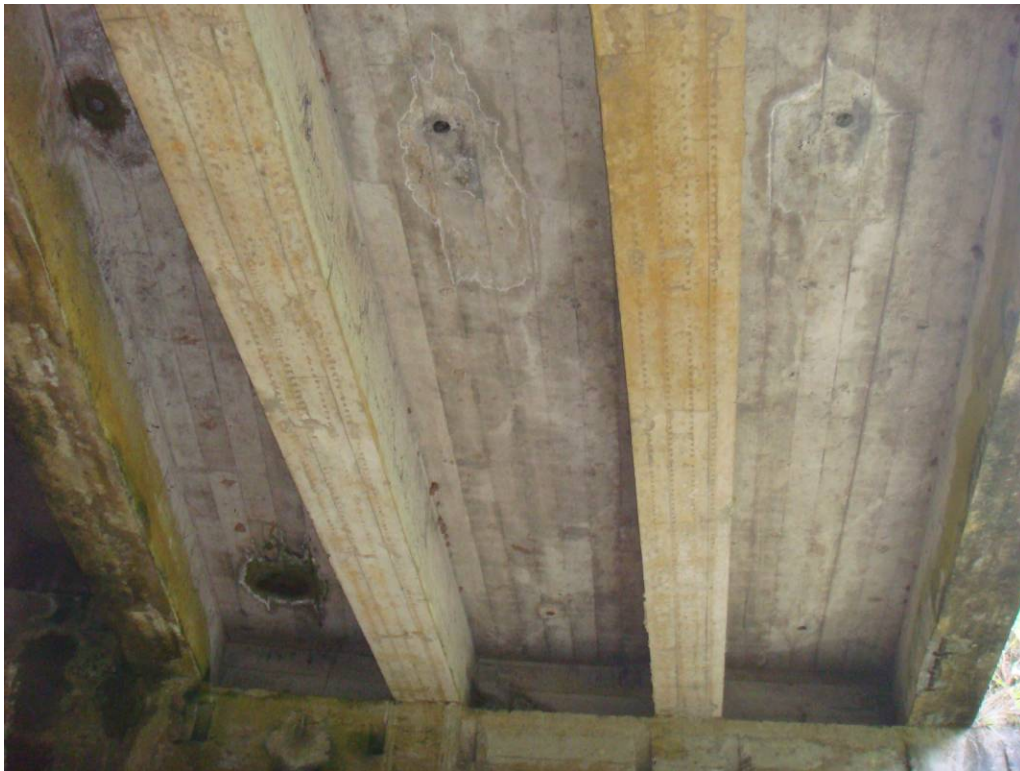
PHOTO 14 DOWNSTREAM HALF OF SOFFIT LOOKING TOWARD KAHULUI WITH EFFLORESCENCE AND WATER STAINS. NOTE: DECK DRAINS HAVE BEEN PAVED OVER

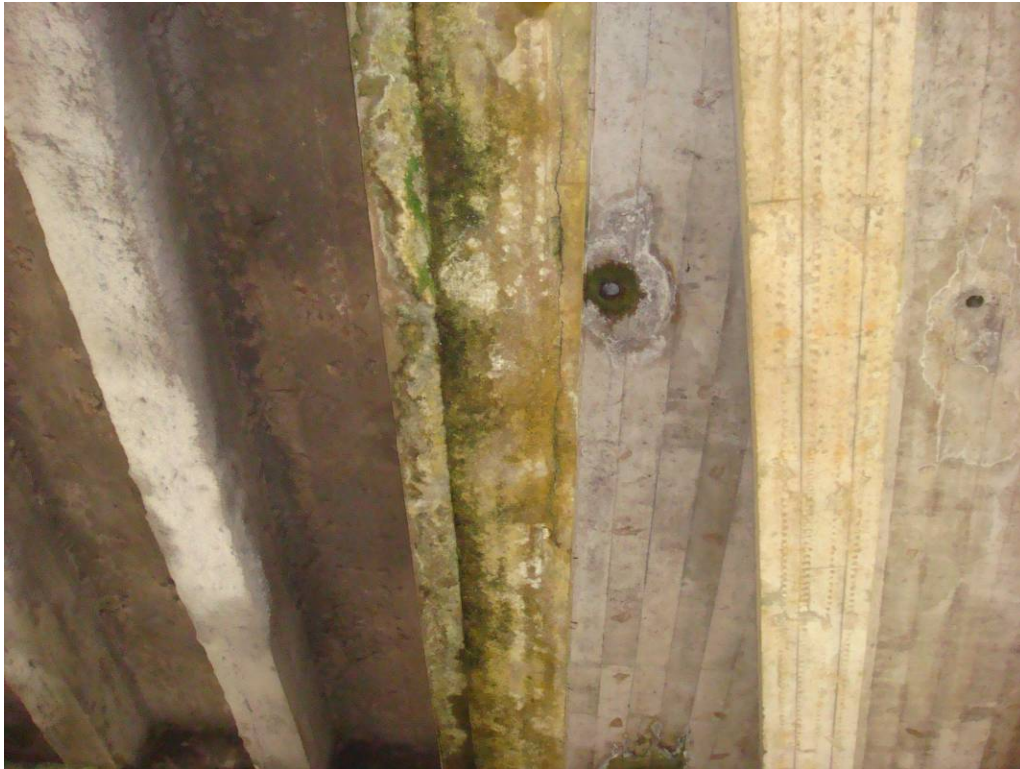
PHOTO 15 DELAMINATION AND HAIRLINE CRACK (8' LONG) IN BOTTOM OF GIRDER G5 NEAR HANA ABUTMENT

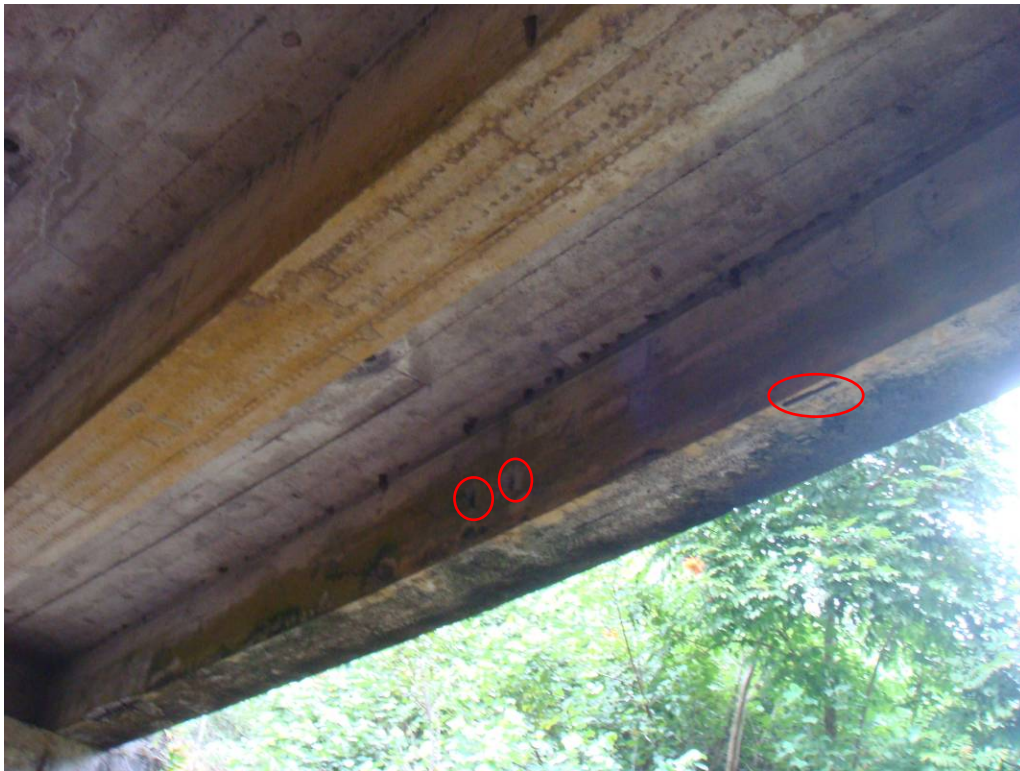
PHOTO 16 OVERALL VIEW OF GIRDER G8 LOOKING DOWNSTREAM WITH SEVERAL SMALL SPALLS WITH EXPOSED REBAR AND DELAMINATION THROUGHOUT THE UPSTREAM FACE

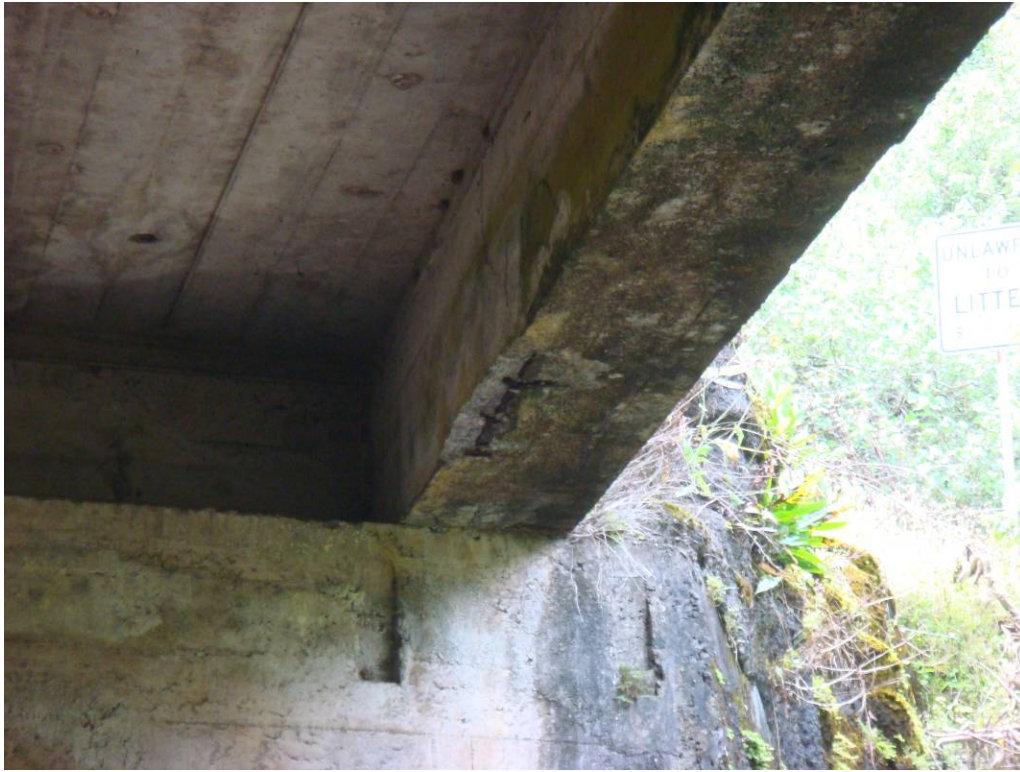
**PHOTO 17 CLOSE UP OF LARGE SPALL WITH EXPOSED REBAR IN BOTTOM OF GIRDER
G8 NEAR KAHULUI ABUTMENT**

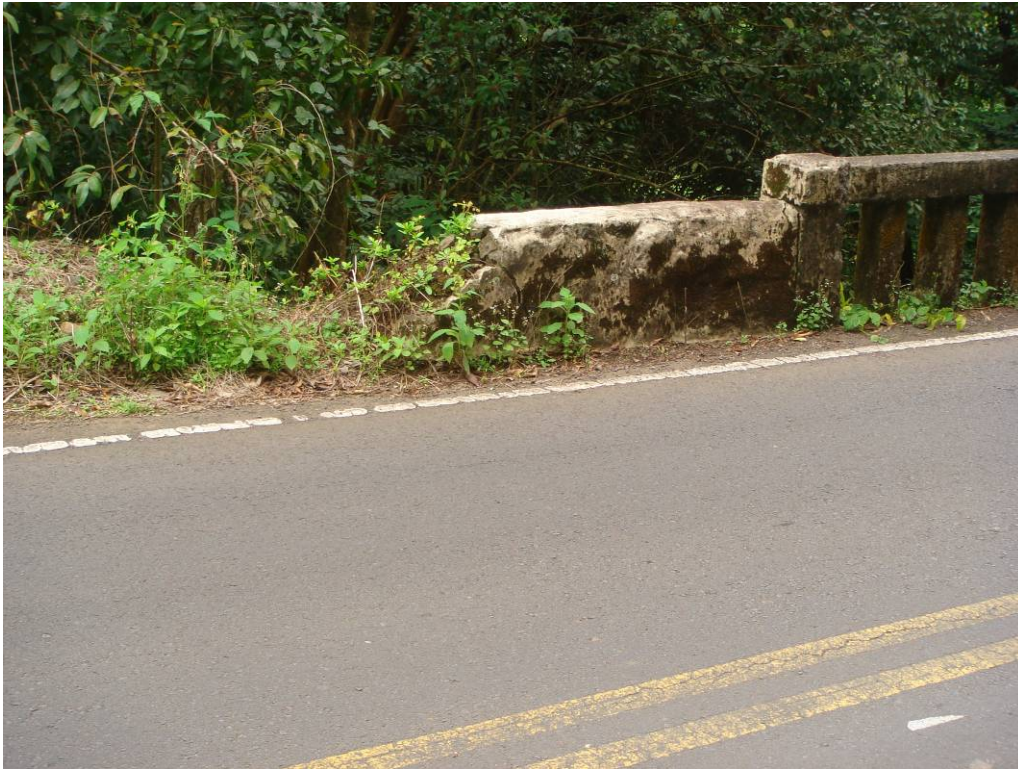
PHOTO 5 DAMAGE TO END OF DOWNSTREAM KAHULUI CRM WALL

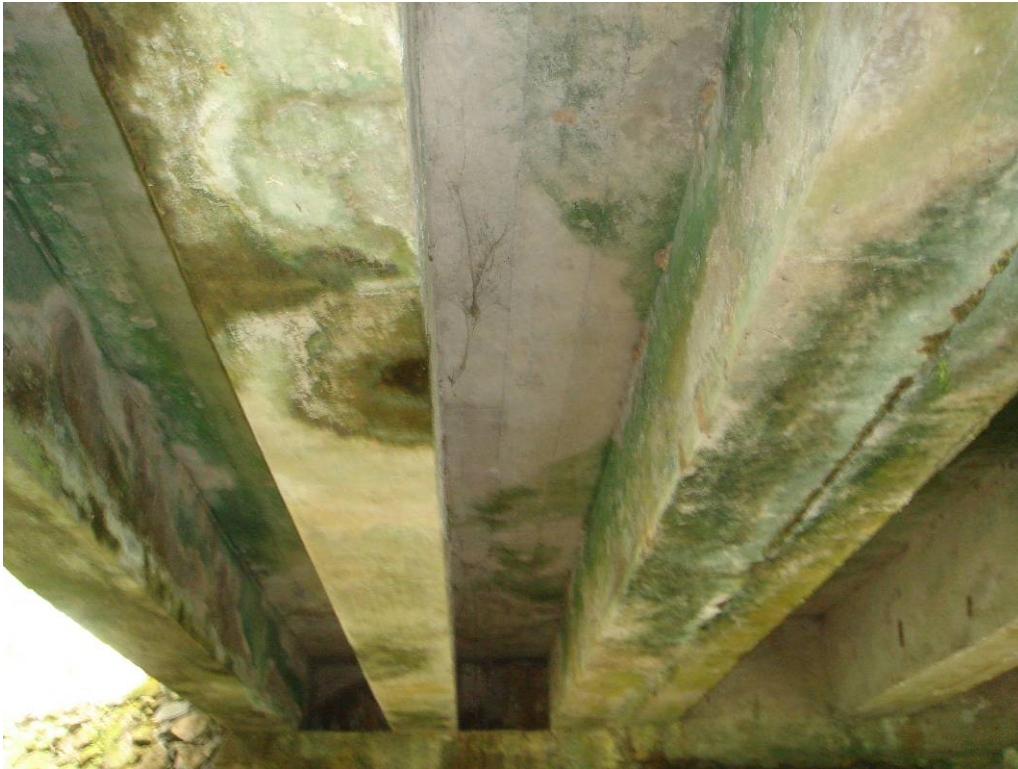
PHOTO 13 UPSTREAM HALF OF SOFFIT LOOKING TOWARD KAHULUI WITH EFFLORESCENCE AND MOSS. DELAMINATION IN GIRDER G4 NEAR HANA ABUTMENT AND VERTICAL CRACKS.

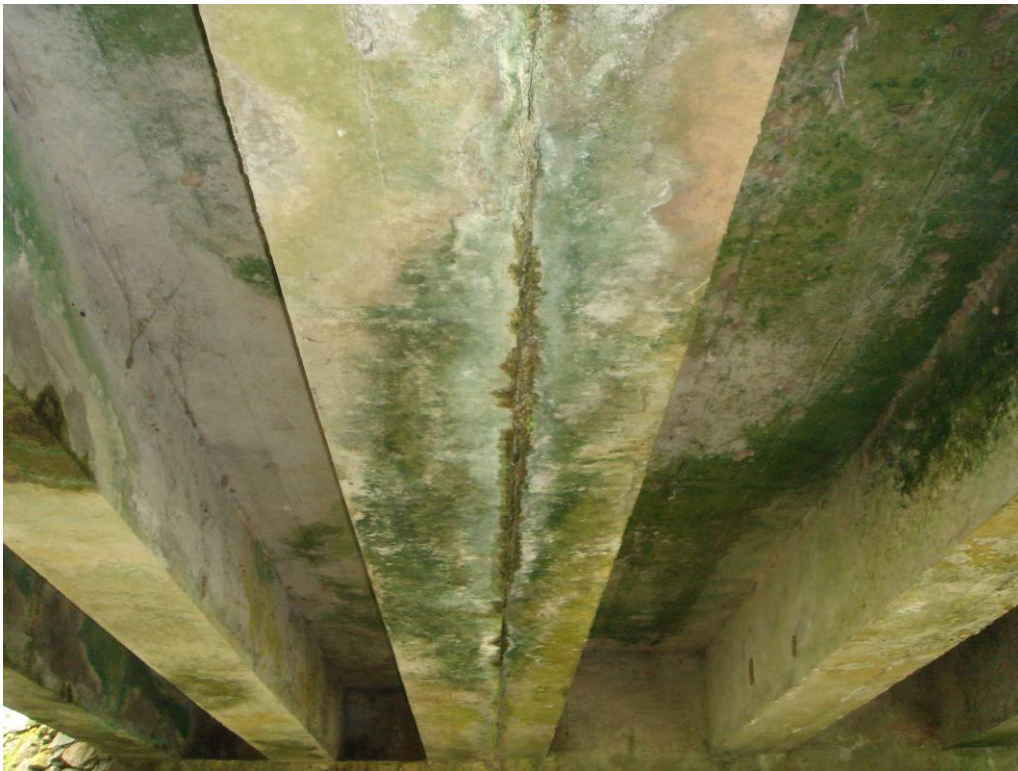
PHOTO 14 JOINT LEAKAGE IN SOFFIT LOOKING TOWARD KAHULUI WITH EFFLORESCENCE AND MOSS

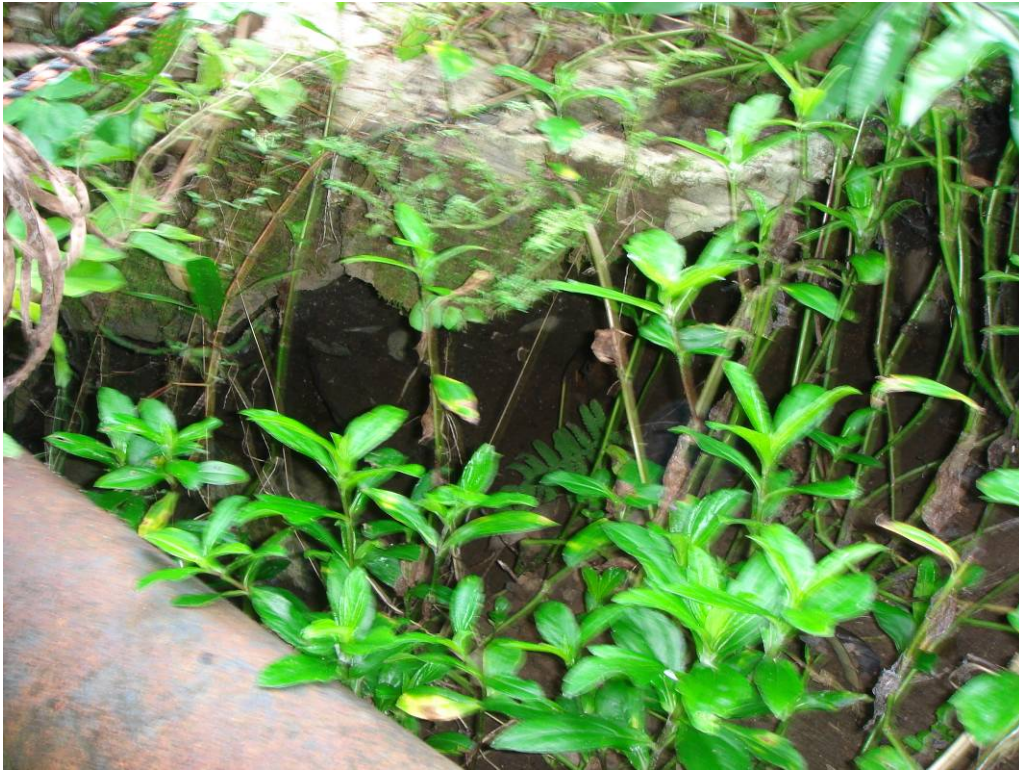
PHOTO 25 EROSION 2'x3' AT BASE OF KAHULUI CRM WALL

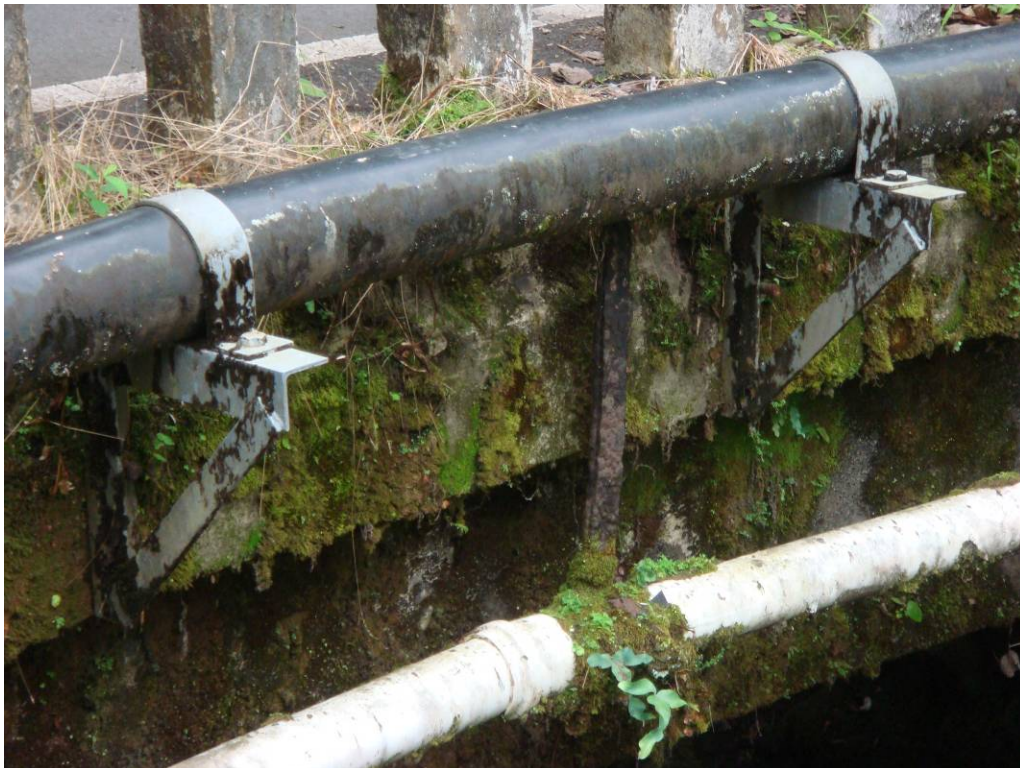
PHOTO 14 SUPPORTS FOR PVC PIPELINE ARE CORRODED ON THE DOWNSTREAM SIDE OF BRIDGE (SEE PHOTO 13)

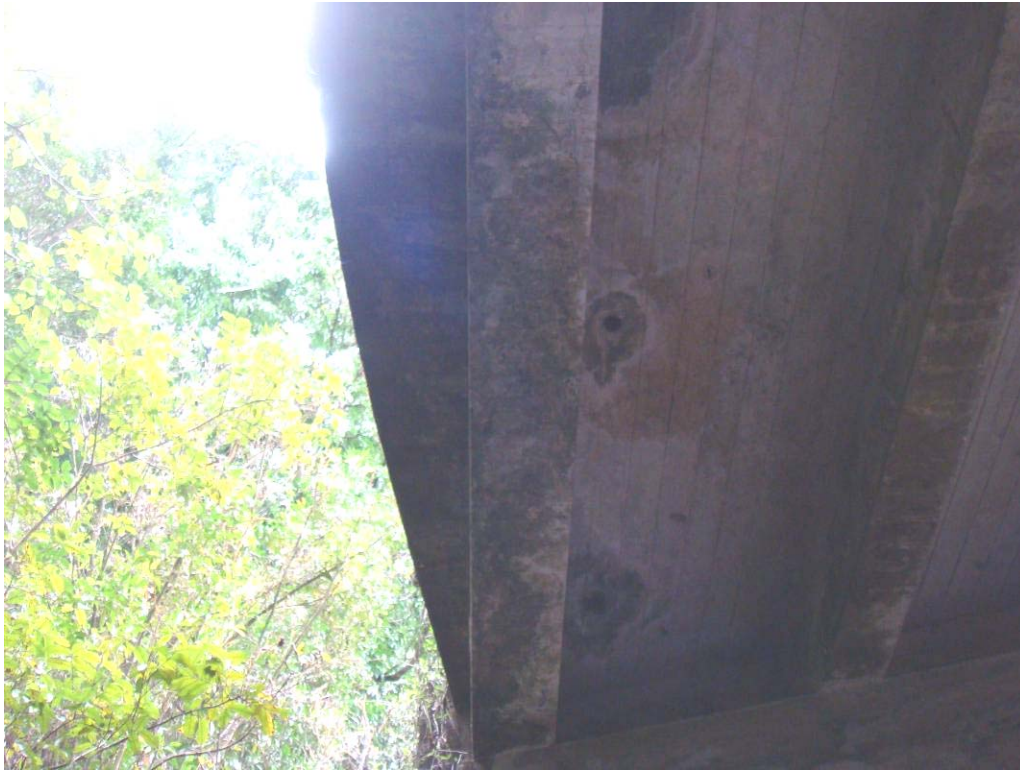
PHOTO 17 HAIRLINE LONGITUDINAL CRACK ALONG BOTTOM OF GIRDER G1

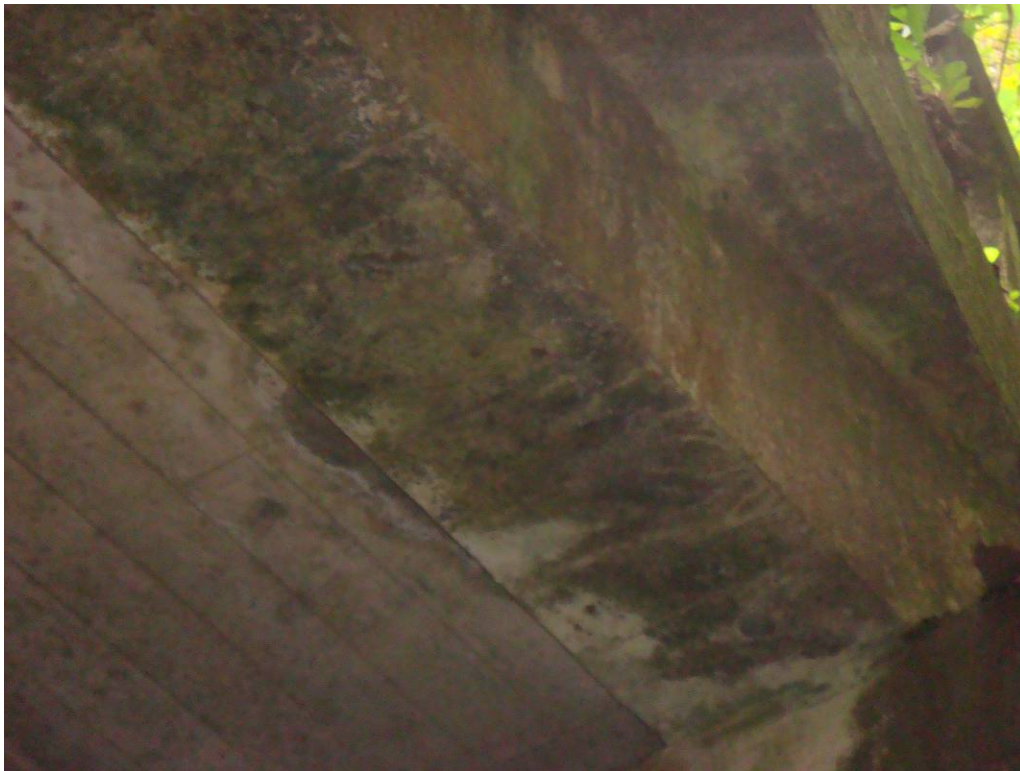
PHOTO 18 SMALL SPALL WITH EXPOSED REBAR IN BOTTOM OF GIRDER G1 NEAR HANA ABUTMENT

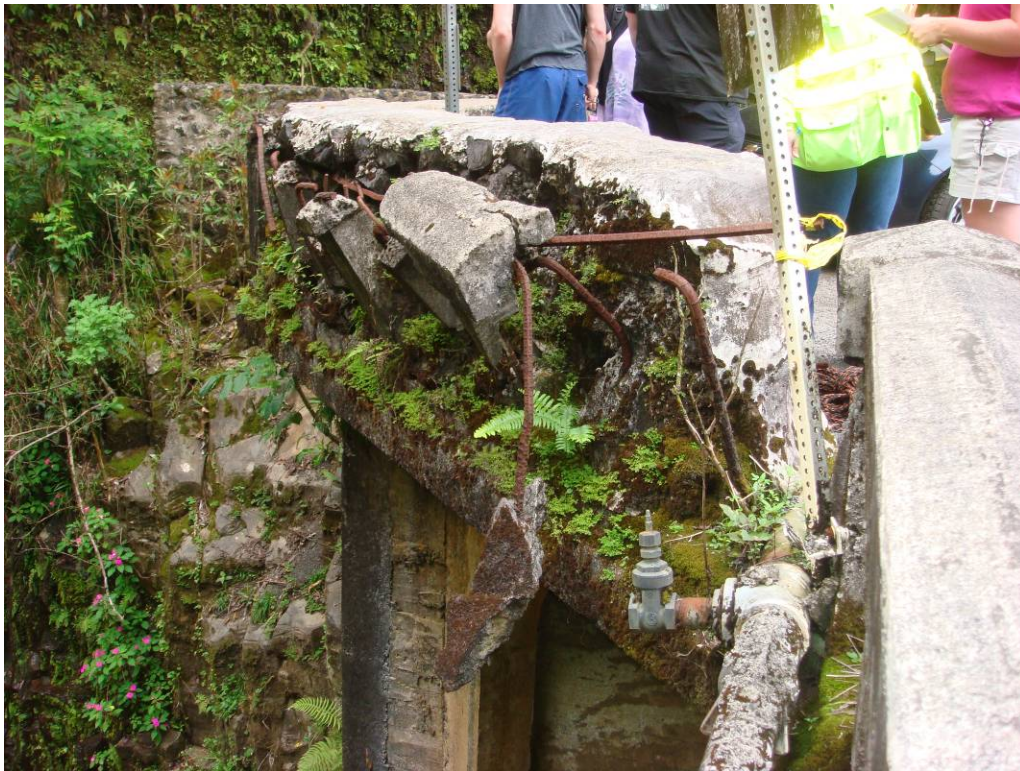
PHOTO 4 COLLISION DAMAGE WITH EXPOSED REBAR AT FORMER CONCRETE BRIDGE RAILING AT UPSTREAM / KAHULUI SIDE

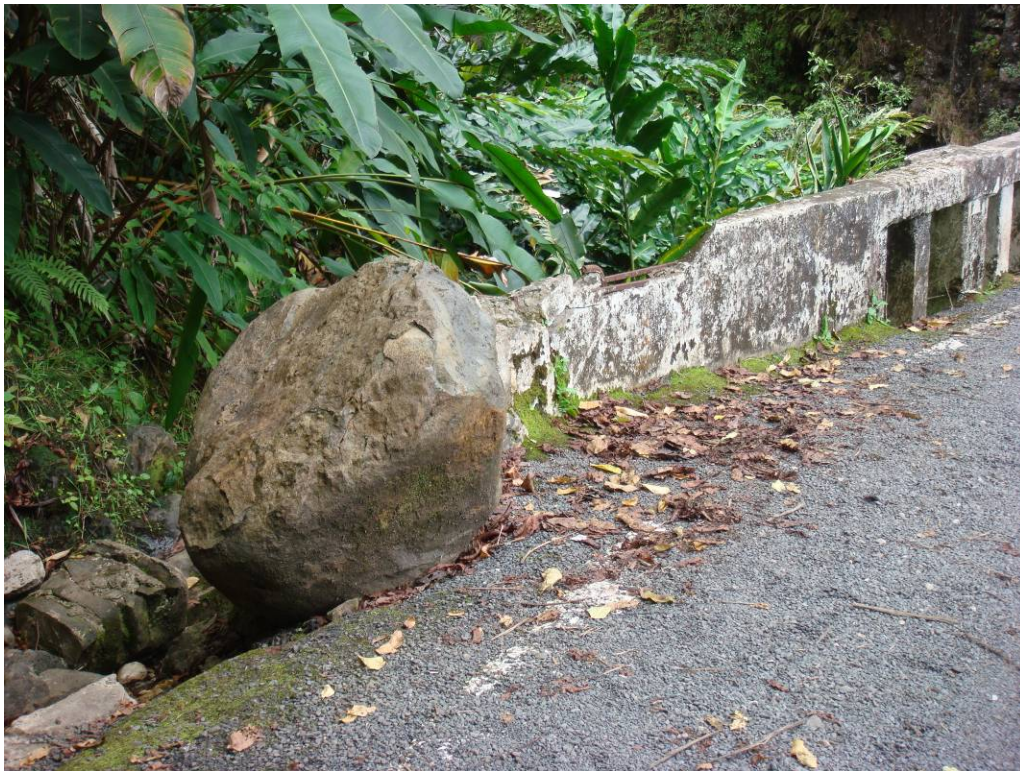
PHOTO 6 UPSTREAM / HANA CONCRETE PARAPET WITH COLLISION DAMAGE AND EXPOSED REBAR. NOTE: PARAPET HEIGHT VARIES DUE TO COLLISION DAMAGE

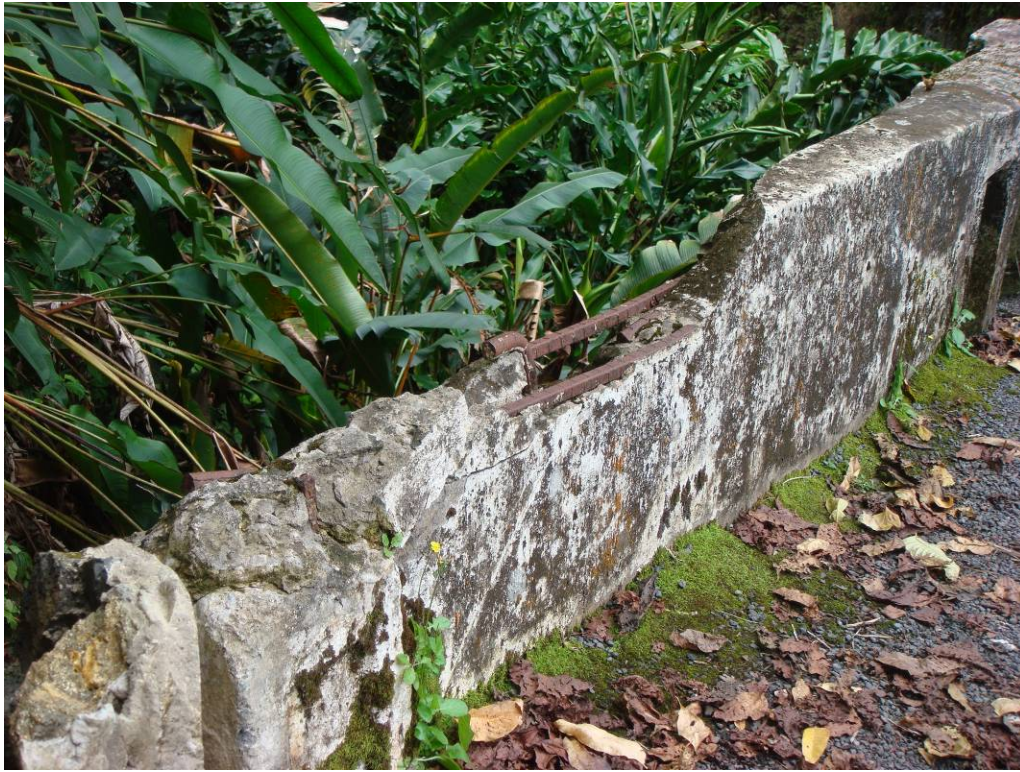
PHOTO 7 CLOSE UP OF COLLISION DAMAGE AT UPSTREAM / HANA CONCRETE PARAPET

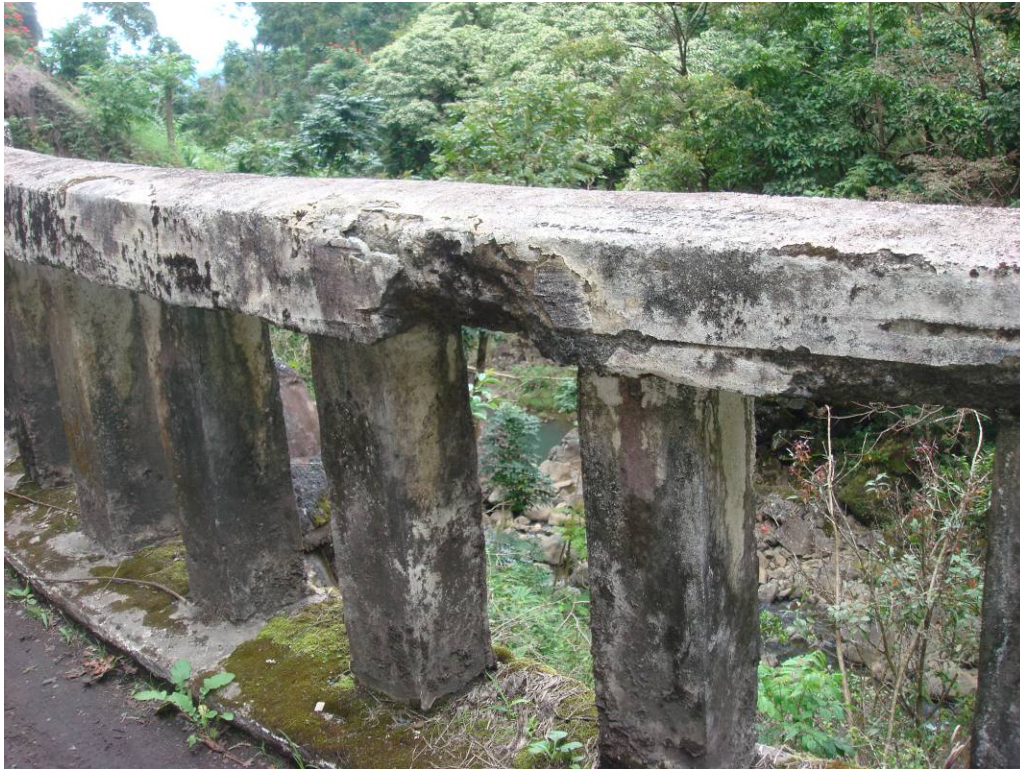
PHOTO 13 CLOSE UP OF SPALL WITH EXPOSED REBAR IN DOWNSTREAM RAILING CAP

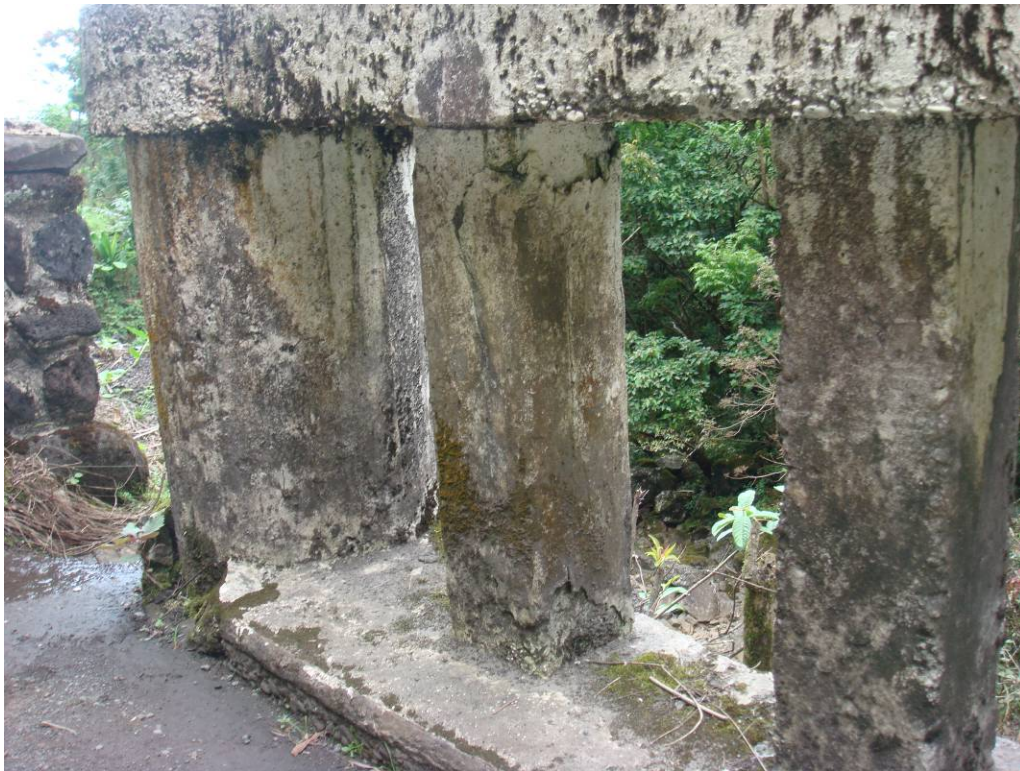
PHOTO 14 DELAMINATION ON SECOND PICKET AT DOWNSTREAM / KAHULUI RAILING

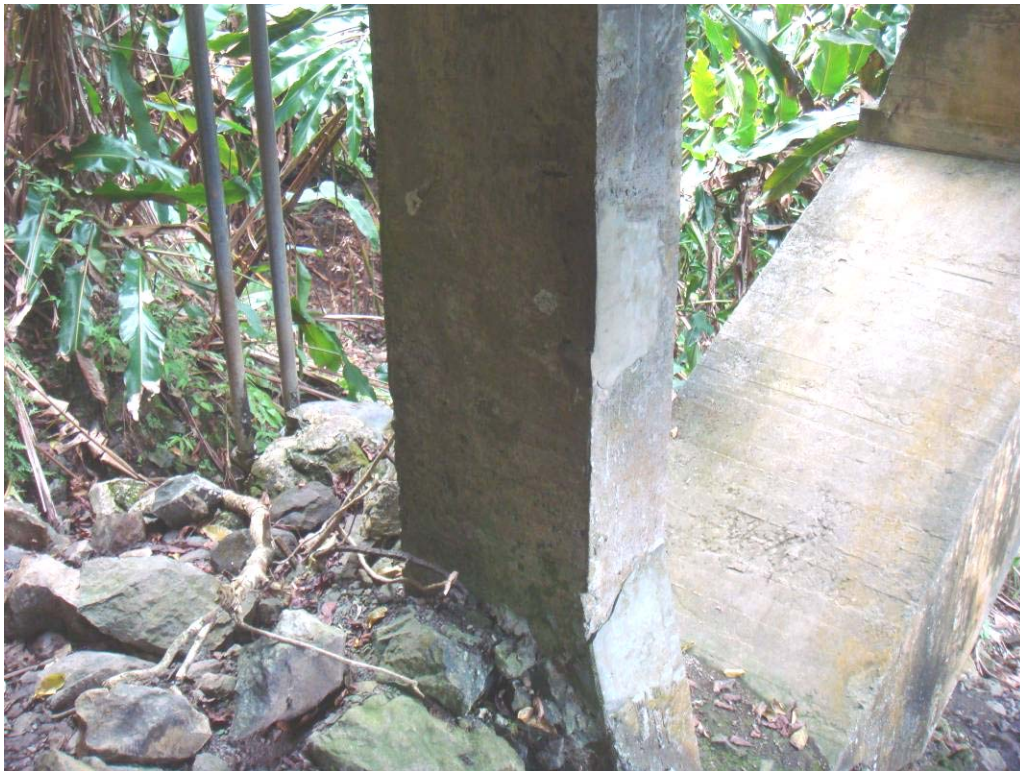
PHOTO 28 SMALL SPALL WITH EXPOSED REBAR ON HANA FACE OF UPSTREAM SPANDREL COLUMN IN SPANDREL BENT 1.

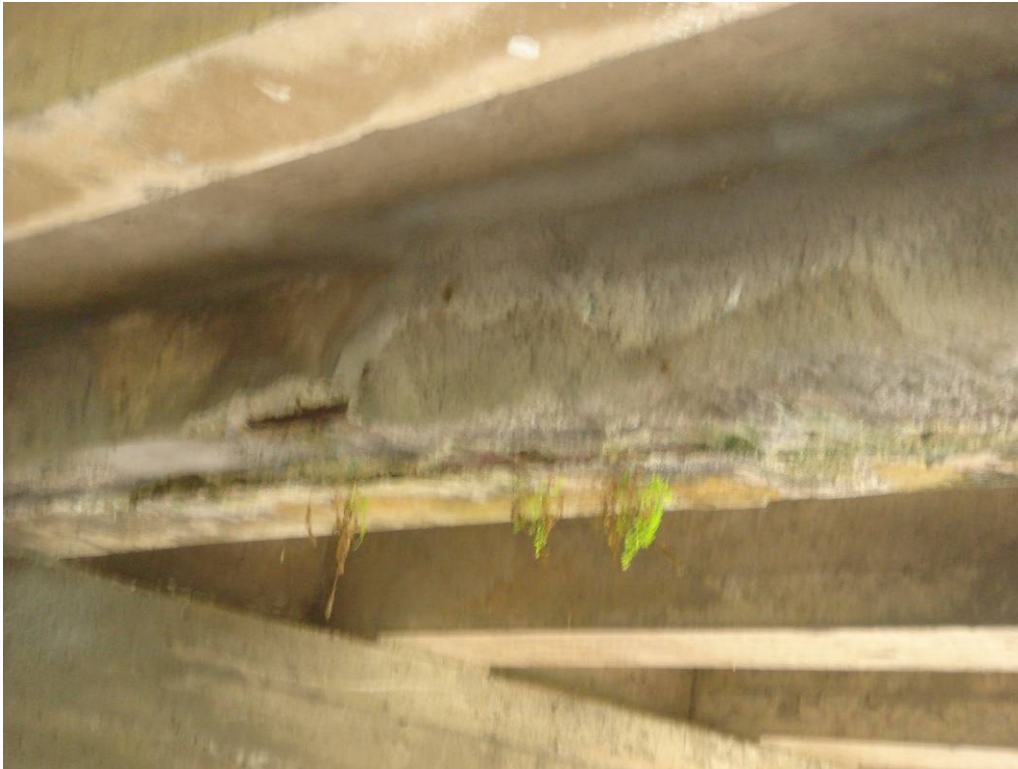
PHOTO 19 SPALL WITH EXPOSED REBAR AND UNSOUND PATCH IN GIRDER G4

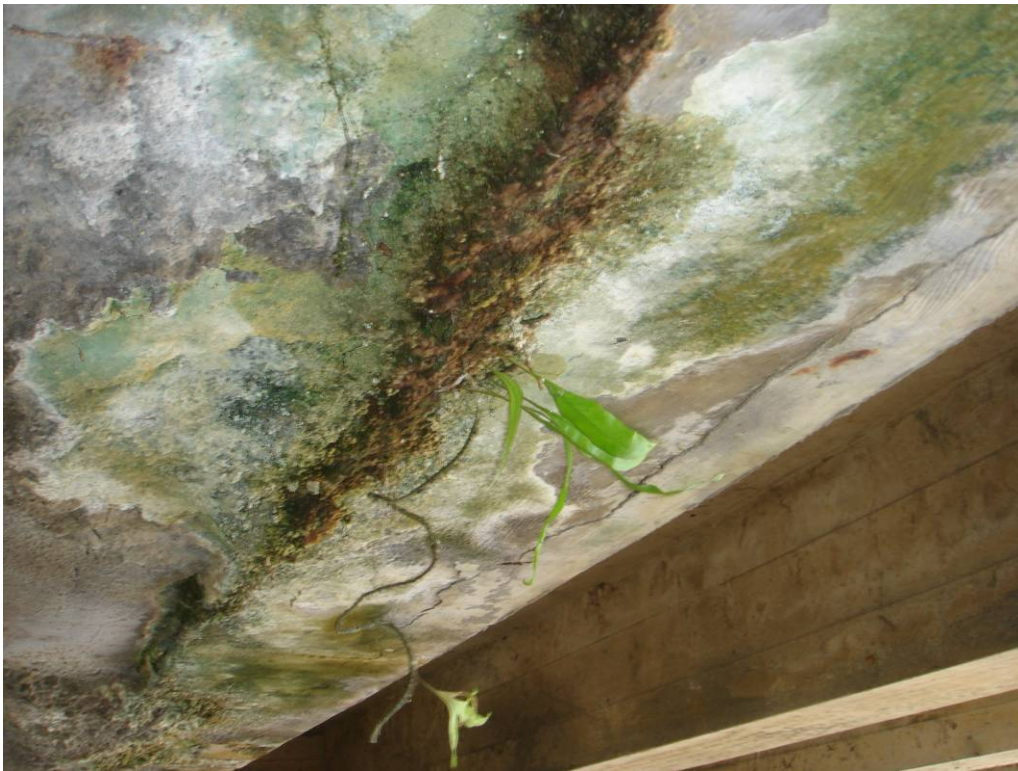
PHOTO 20 DELAMINATION AND VEGETATION GROWING IN GIRDERS G4 AND G5

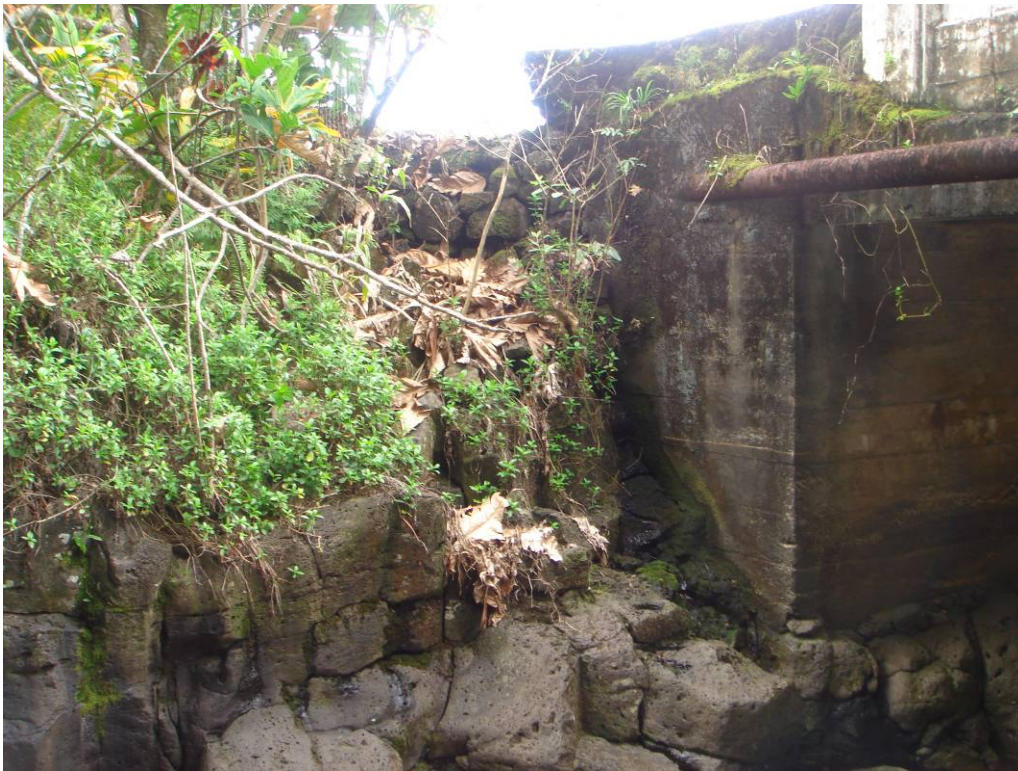
PHOTO 26 LOOSE ROCKS IN UPSTREAM KAHULUI CRM WALL

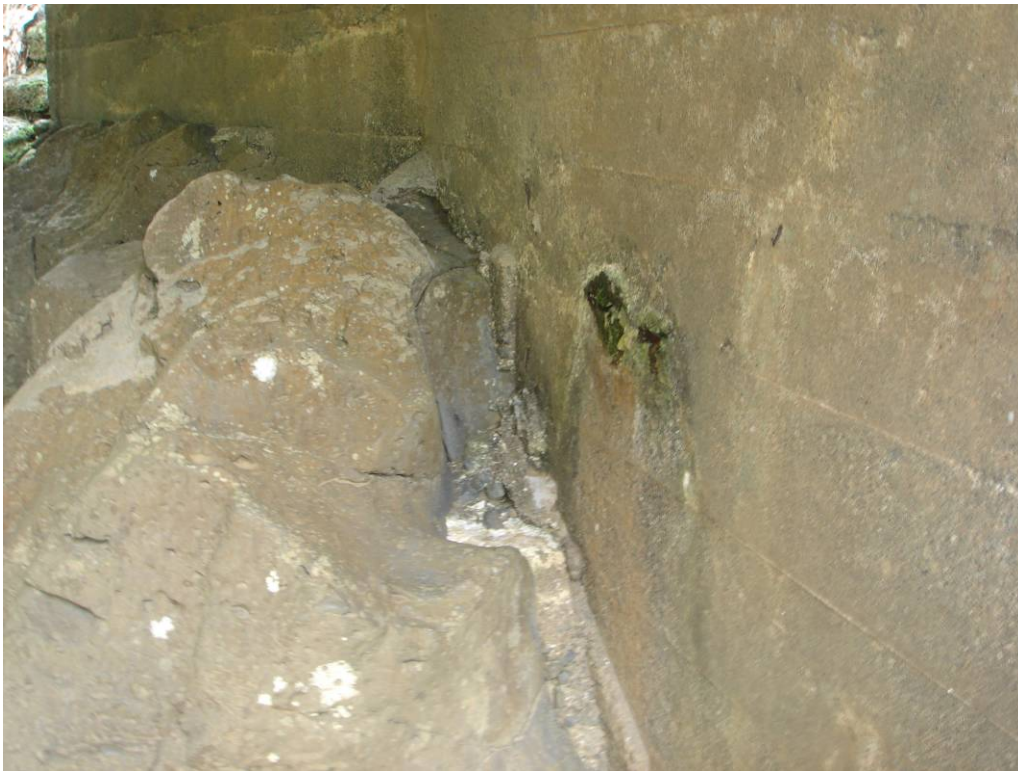
PHOTO 30 SPALL IN KAHULUI ABUTMENT UNDER GIRDERS G4 AND G5
