**TARGETED HAZARDOUS MATERIAL SURVEY REPORT  
FOR  
HAWAII DEPARTMENT OF TRANSPORTATION AIRPORTS DIVISION  
DANIEL K. INOUE INTERNATIONAL AIRPORT  
1ST, 2ND, AND 3RD LEVEL ROADWAY REHABILITATION  
300 RODGERS BLVD.  
HONOLULU, ISLAND OF OAHU 96819**

**MNA PROJECT 2866\_2**

**AUGUST 23, 2021**

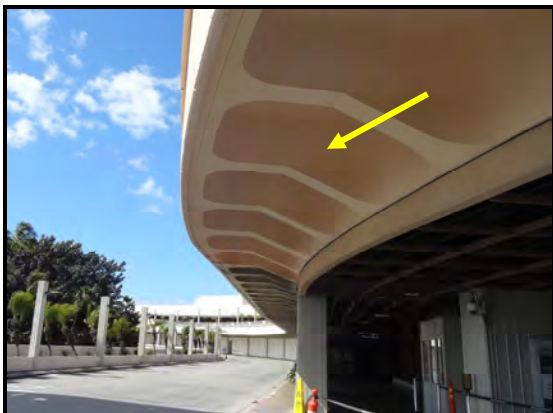
HM ID: 1  
Floor 2

Light pink paint on concrete eave.

**2866-P1A: 56 mg/kg**

**2866-P1B: 49 mg/kg**

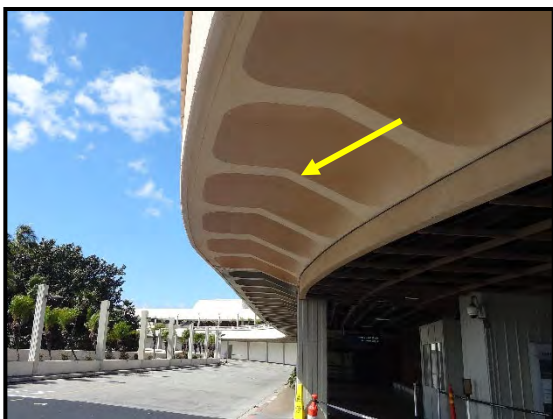
HM ID: 2  
Floor 2

Light pink textured paint with gray skim coat on concrete eave.

2866-A1C-Texture paint: ND

2866-A1C-Skim coat: <0.1% Chrysotile

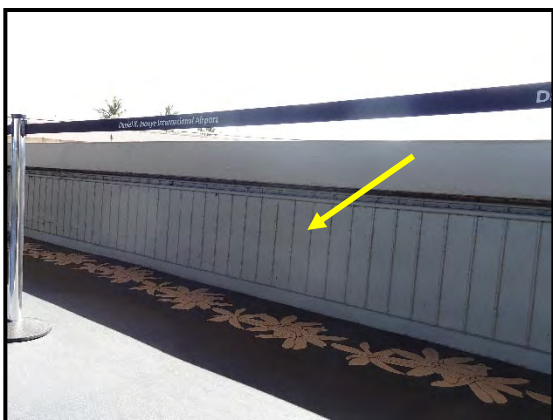
HM ID: 3  
Floor 2

Beige paint on concrete wall.

**2866-P2A: 40 mg/kg**

**2866-P2B: 550 mg/kg**

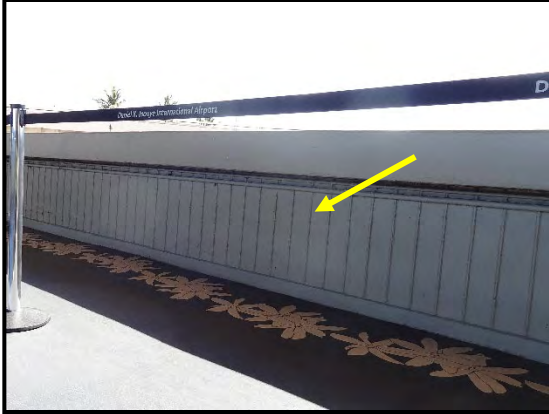
HM ID: 4  
Floor 2

Beige textured paint with gray skim coat on concrete wall.

2866-A2C-Texture paint: ND

2866-A2C-Skim coat: ND

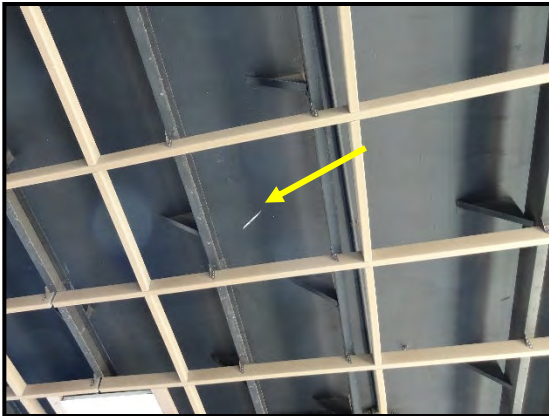
HM ID: 5  
Floor 2

Black paint on concrete ceiling.

2866-P3A: <40 mg/kg

2866-P3B: <40 mg/kg

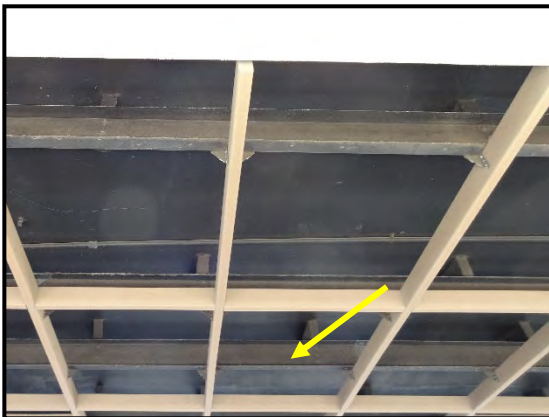
HM ID: 6  
Floor 2

Black paint on metal trim.

2866-P4A: <40 mg/kg

2866-P4B: <40 mg/kg

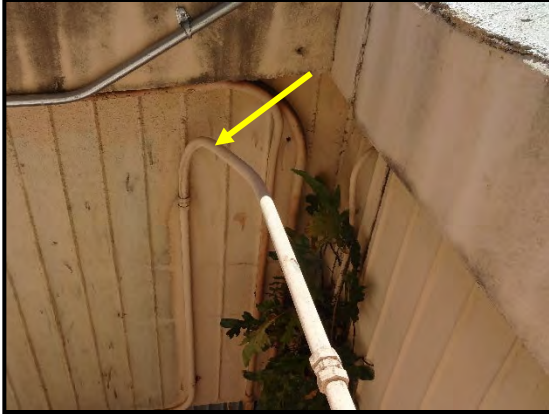
HM ID: 7  
Floor 2

Light pink paint on metal conduit.

**2866-P5A: 79 mg/kg**

**2866-P5B: 190 mg/kg**

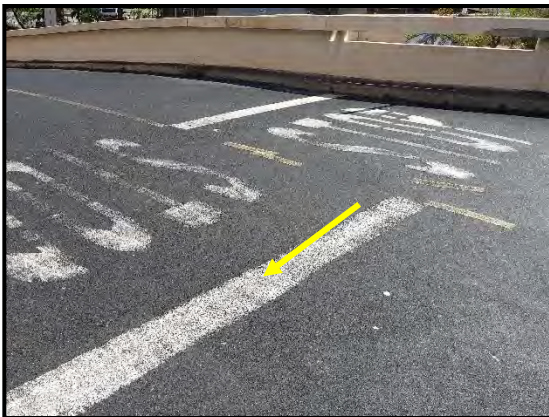
HM ID: 8  
Floor 2

White paint on asphalt roadway.

**2866-P6A: <40 mg/kg**

**2866-P6B: <40 mg/kg**

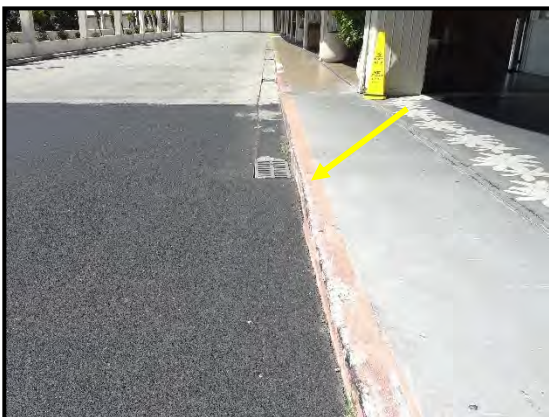
HM ID: 9  
Floor 2

Red paint on concrete curb.

**2866-P7A: <40 mg/kg**

**2866-P7B: 4,200 mg/kg**

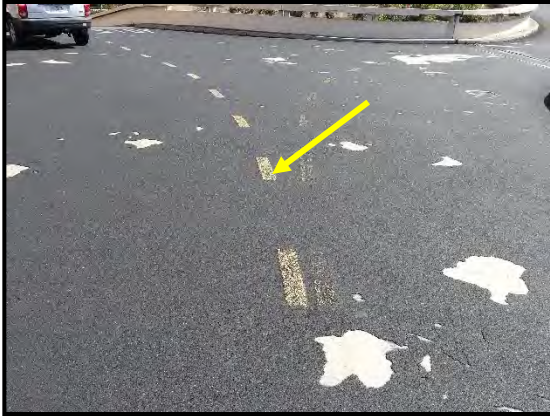
HM ID: 10  
Floor 2

Yellow paint on asphalt roadway.

**2866-P8A: 550 mg/kg**

**2866-P8B: <40 mg/kg**

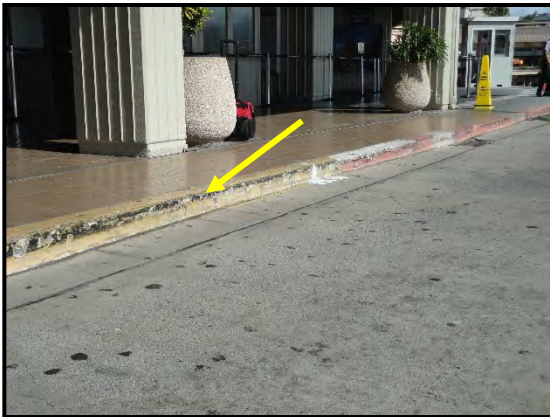
HM ID: 11  
Floor 2

Yellow paint on concrete curb.

**2866-P9A: 27,000 mg/kg**

**2866-P9B: 38,000 mg/kg**

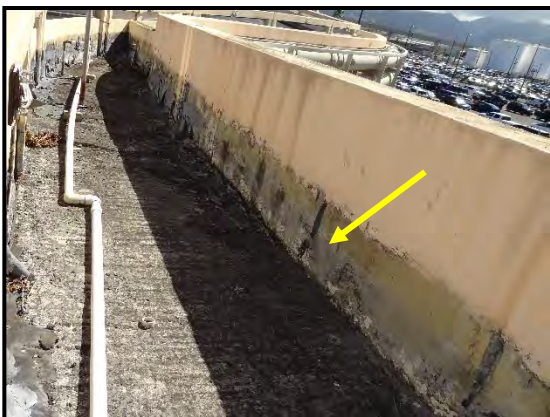
HM ID: 12  
Floor 2

Black coating and silver paint on concrete wall.

**2866-A3B-Coating: 5% Chrysotile**

2866-A3C: Stop positive

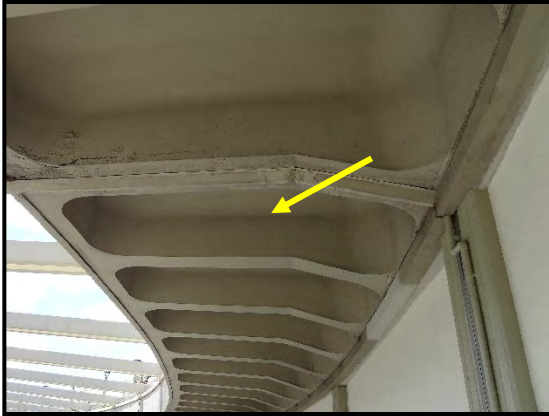
HM ID: 13  
Floor 2

Beige textured paint on concrete eave.

2866-P10A: <40 mg/kg

2866-P10B: <40 mg/kg

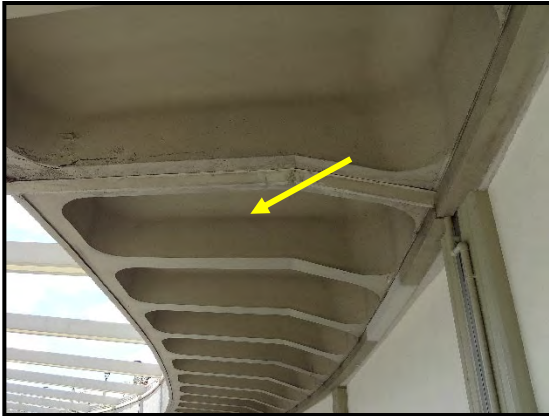
HM ID: 14  
Floor 2

Beige textured paint with skim coat and plaster  
on concrete eave.

2866-A4C-Skim coat: ND

2866-A4C-Plaster: ND

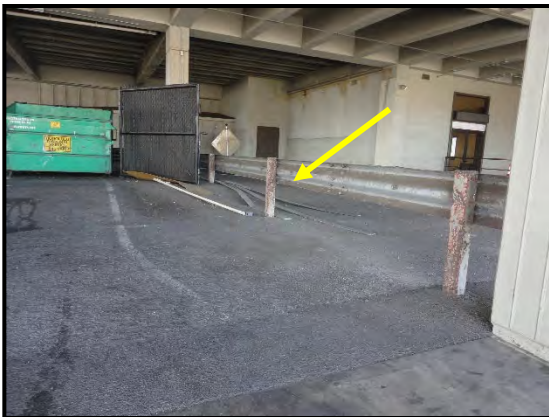
HM ID: 15  
Floor 2

Silver paint on metal guardrail.

**2866-P11A: 130,000 mg/kg**

**2866-P11B: 110,000 mg/kg**

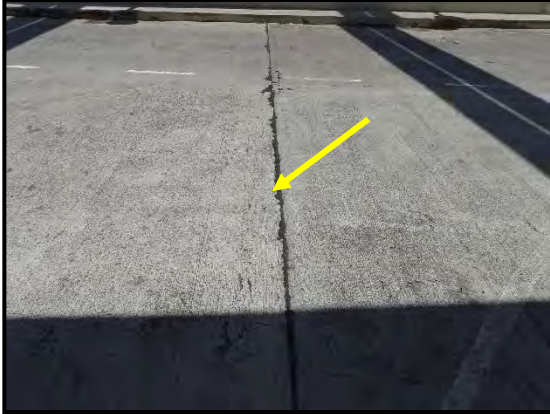
HM ID: 19  
Floor 2

Black expansion joint on concrete roadway.

2866-A7B: ND

2866-A7C: ND

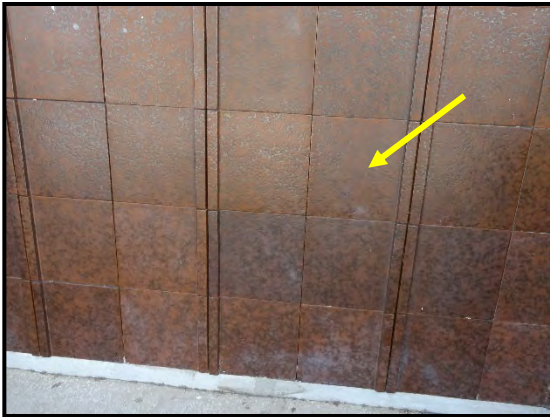
HM ID: 20  
Floor 2

Gray grout on 12" x 12" red ceramic tile wall.

2866-A8C-Mortar: ND

2866-A8C-Mastic: ND

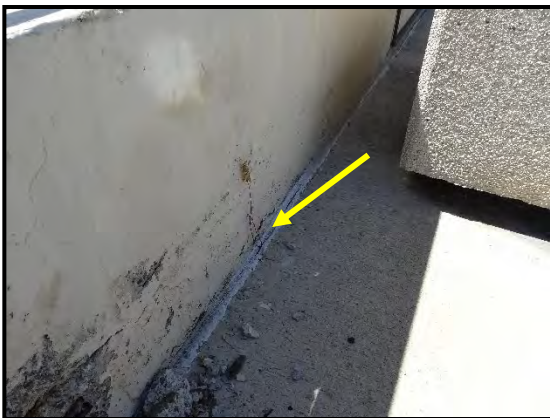
HM ID: 21  
Floor 2

Light gray caulking on concrete floor.

2866-A9C-Caulking: ND

2866-A9C-Mastic: ND

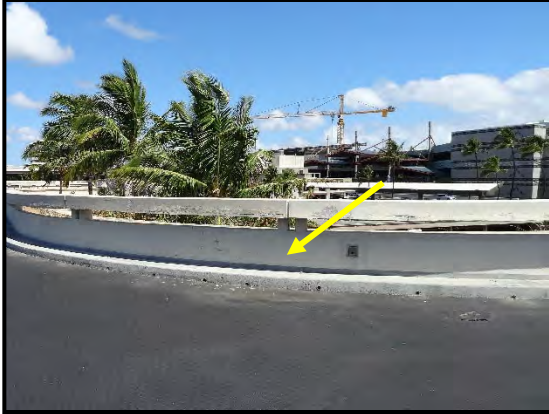
HM ID: 25  
Floor 3

Beige paint and skim coat with black mastic on concrete wall.

2866-A11C-Texture paint: ND

2866-A11C-Concrete: ND

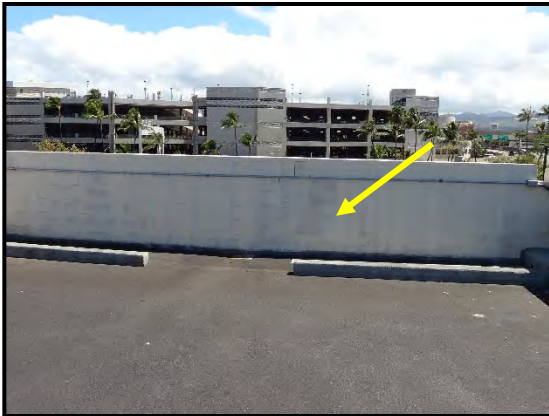
HM ID: 26  
Floor 3

Beige paint on concrete masonry unit wall.

**2866-P15A: 220 mg/kg**

**2866-P15B: 9,500 mg/kg**

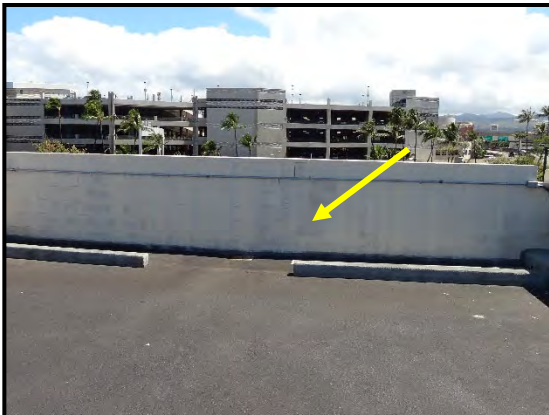
HM ID: 27  
Floor 3

Beige paint and skim coat on concrete masonry unit wall.

2866-A12B-Comp texture paint/skim coat:  
<0.1% Chrysotile

2866-A12C-Comp texture paint/skim coat:  
<0.1% Chrysotile

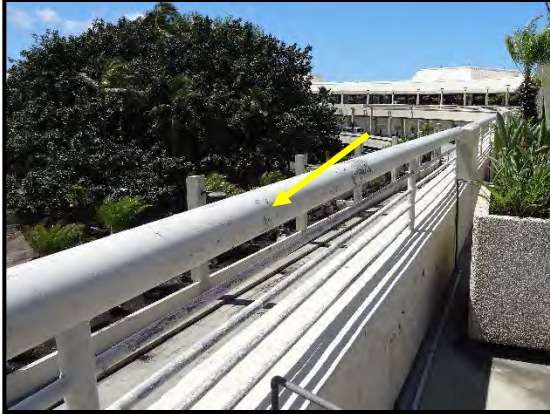
HM ID: 28  
Floor 3

Beige paint on metal handrail.

2866-P16A: <40 mg/kg

**2866-P16B: 130 mg/kg**

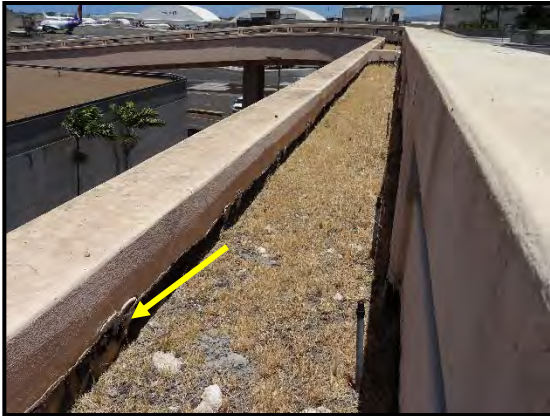
HM ID: 29  
Floor 3

Black coating and vinyl wrap with mastic on concrete wall.

2866-A13C-Concrete: ND

2866-A13C-Mastic: ND

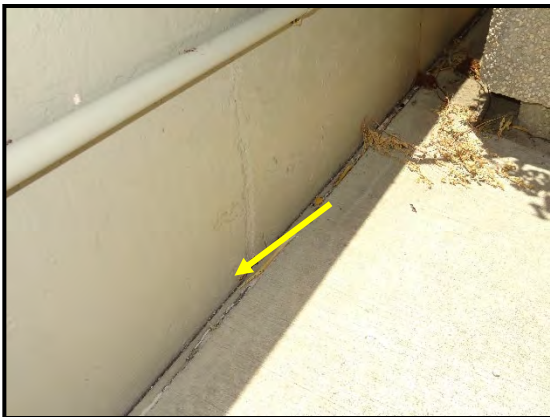
HM ID: 30  
Floor 3

Light gray caulking with mastic on concrete floor.

2866-A14B-Caulking: ND

2866-A14C: ND

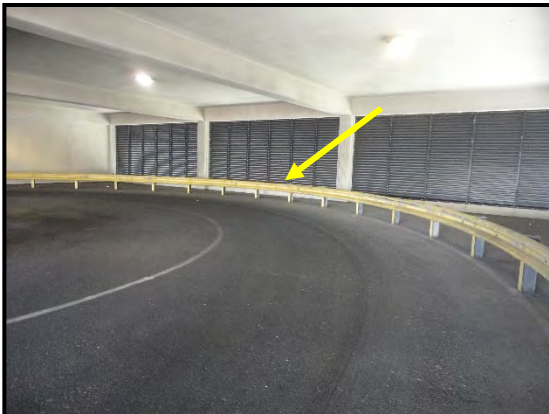
HM ID: 36  
Floor 3

Yellow paint on metal guardrail.

2866-P21A: 420 mg/kg

2866-P21B: 330 mg/kg

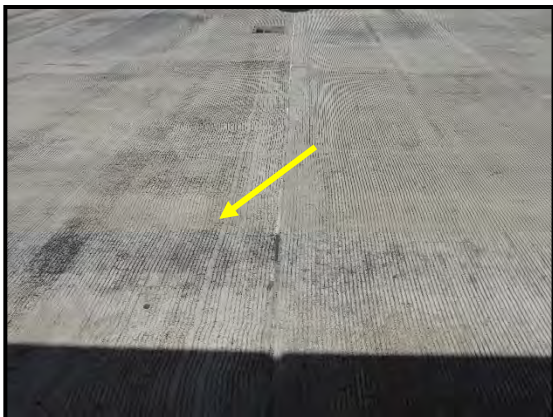
HM ID: 37  
Floor 3

Gray expansion joint with black fibrous material on concrete roadway.

Non-ACM

2866-A16A-Expansion joint: ND  
2866-A16A-Cement material: ND  
2866-A16A-Fibrous material: ND  
2866-A16B-Expansion joint: ND  
2866-A16B-Cement material: ND  
2866-A16B-Fibrous material: ND  
2866-A16C-Expansion joint: ND  
2866-A16C-Cement material: ND  
2866-A16C-Fibrous material: ND

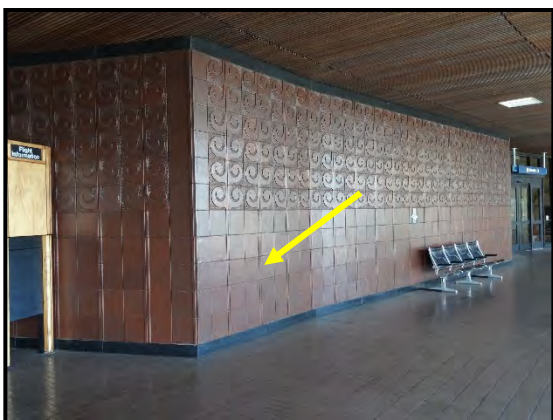
HM ID: 38  
Floor 3

Gray grout on 12" x 12" red ceramic tile wall.

Non-ACM

2866-A17A-Ceramic tile: ND  
2866-A17A-Grout: ND  
2866-A17B-Ceramic tile: ND  
2866-A17B-Grout: ND  
2866-A17C-Ceramic tile: ND  
2866-A17C-Grout: ND

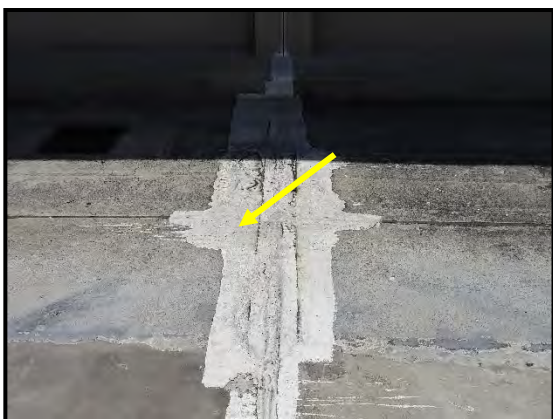
HM ID: 39  
Floor 3

White coating on concrete roadway.

Non-LCP

2866-P22A: <40 mg/kg  
2866-P22B: <40 mg/kg

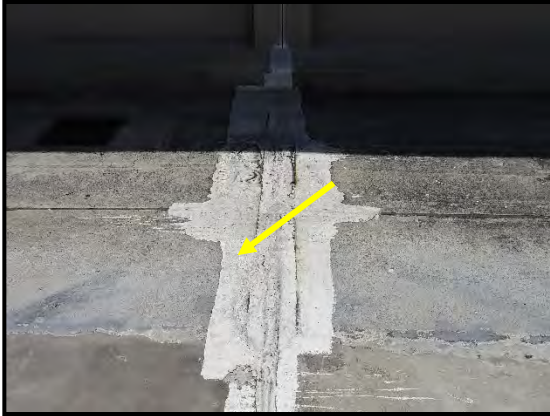
HM ID: 40  
Floor 3

White coating on concrete roadway.

Non-ACM

2866-A18A-Caulk 1: ND  
2866-A18A-Caulk 2: ND  
2866-A18B: ND  
2866-A18C: ND

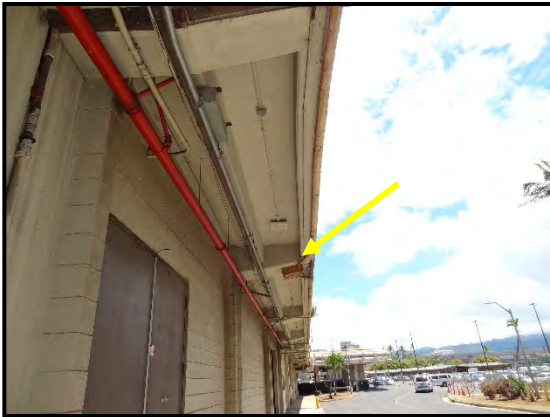
HM ID: 41  
Floor 1

Light pink paint on metal conduit.

LCP

2866-P23A: 46 mg/kg  
2866-P23B: 78 mg/kg

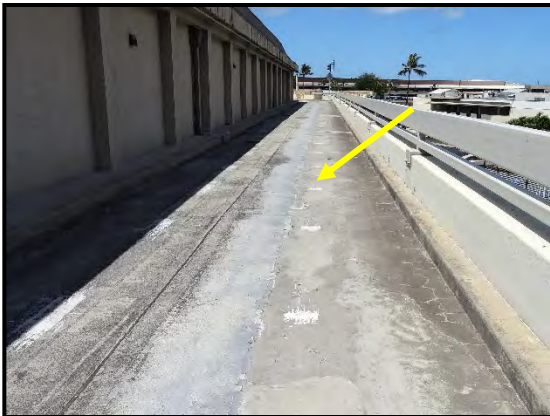
HM ID: 42  
Floor 3

Gray skim coat on concrete roadway.

Non-ACM

2866-A19A: ND  
2866-A19B: ND  
2866-A19C: ND

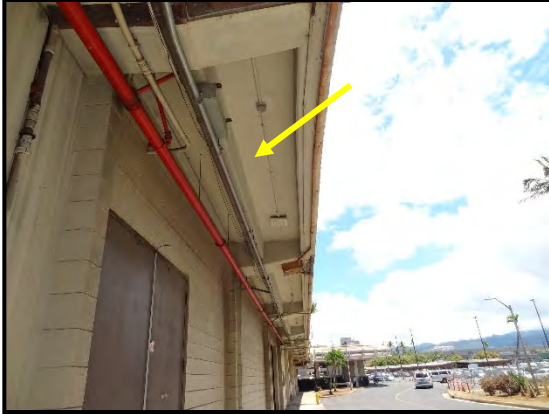
HM ID: 43  
Floor 1

Beige paint on concrete ceiling.

**2866-P24A: 82 mg/kg**

**2866-P24B: 250 mg/kg**

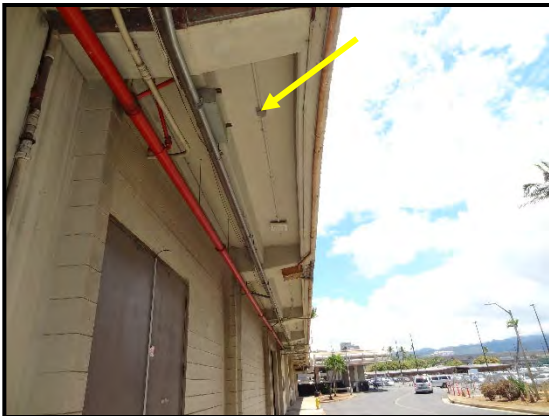
HM ID: 44  
Floor 1

Beige textured paint and skim coat on concrete ceiling.

2866-A20C-Texture paint/mastic: Stop positive

2866-A20C-Skim coat: <0.1% Chrysotile

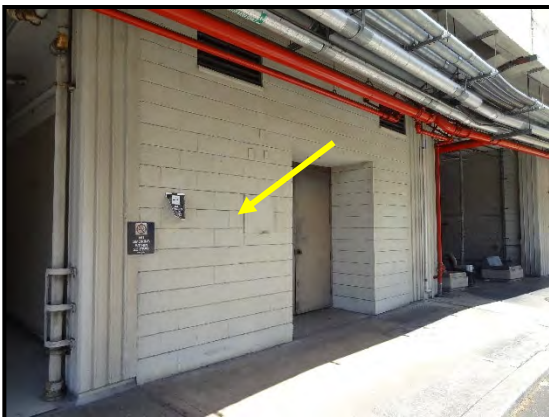
HM ID: 45  
Floor 1

Beige paint on concrete masonry unit wall.

**2866-P25A: 94 mg/kg**

**2866-P25B: 120 mg/kg**

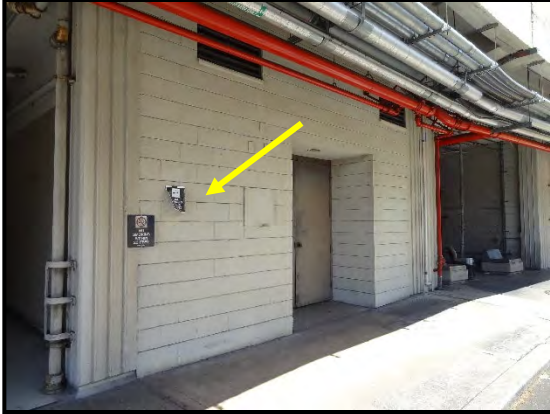
HM ID: 46  
Floor 1

Beige textured paint and skim coat on concrete masonry unit wall.

2866-A21B-Skim coat: ND

2866-A21C-Comp texture paint/skim coat: ND

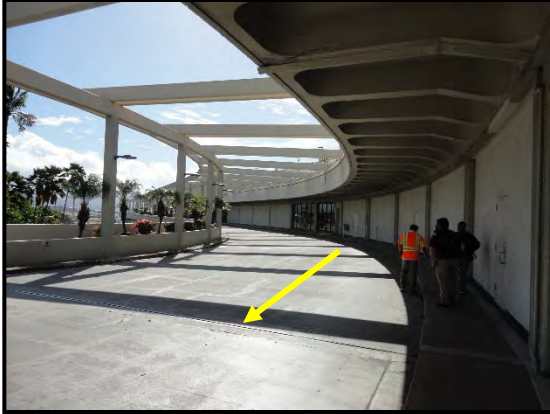
HM ID: 49  
Floor 2

Black waterproofing under concrete pavement on roadway.
