**REHABILITATION OF PALI HIGHWAY
WAOKANAKA STREET TO KAMEHAMEHA HIGHWAY
HONOLULU TO KANEOHE, OAHU, HAWAII**

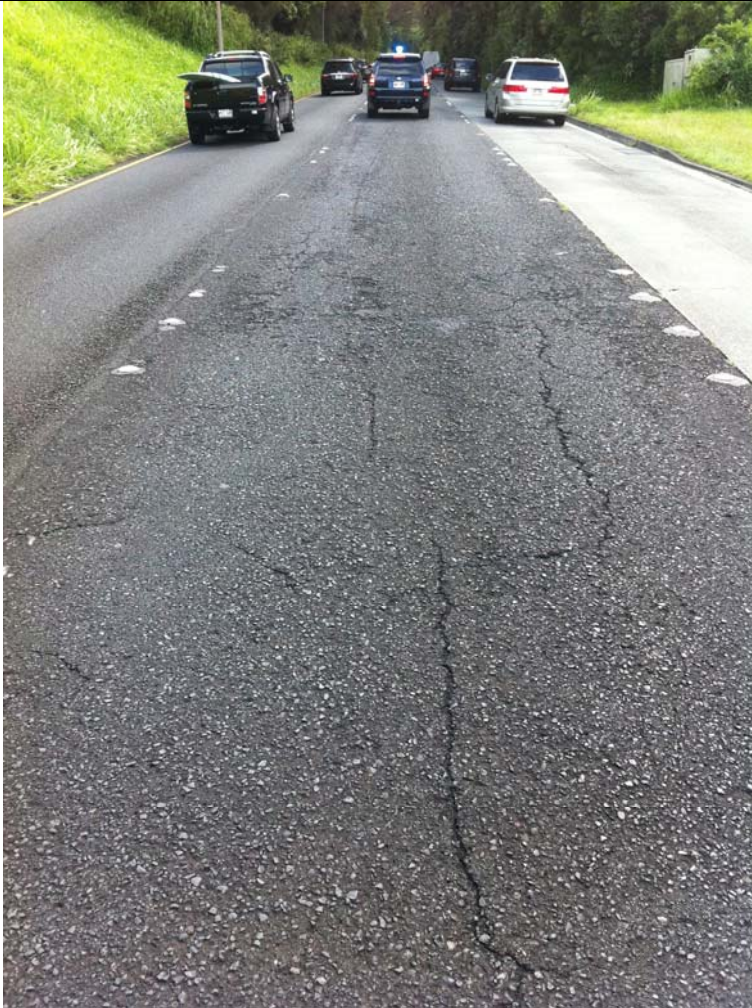
Photograph No. 1: Existing pavements with alligator cracking (fatigue) and minor block cracking.

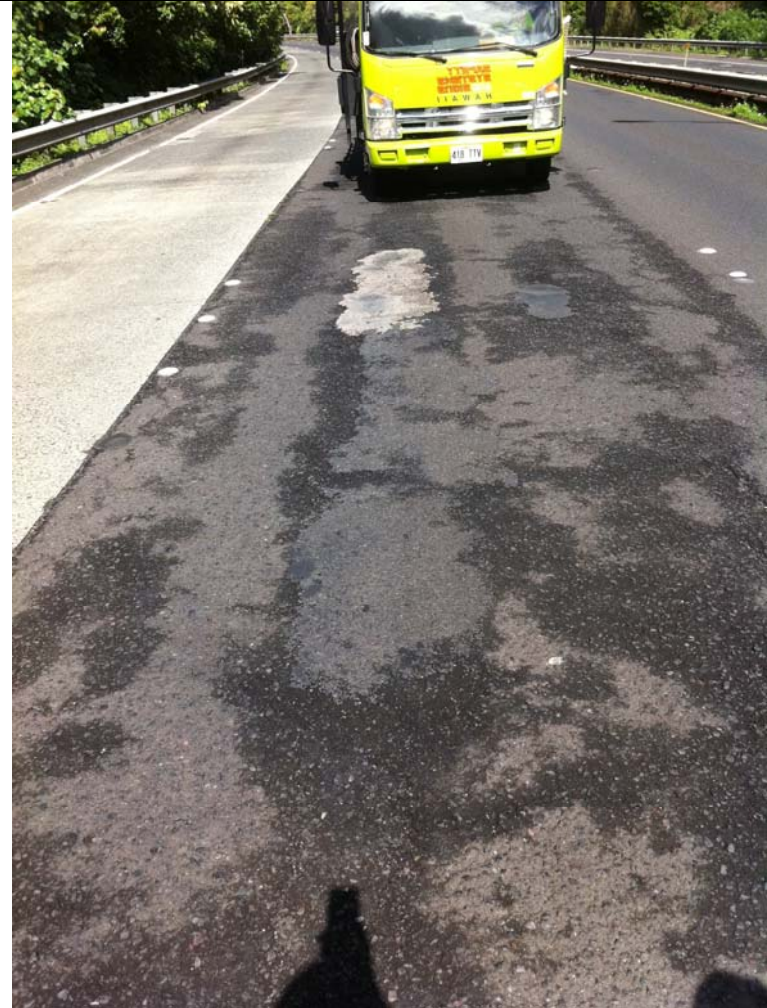
Photograph No. 2: Deteriorated pavements with asphalt and concrete patches.

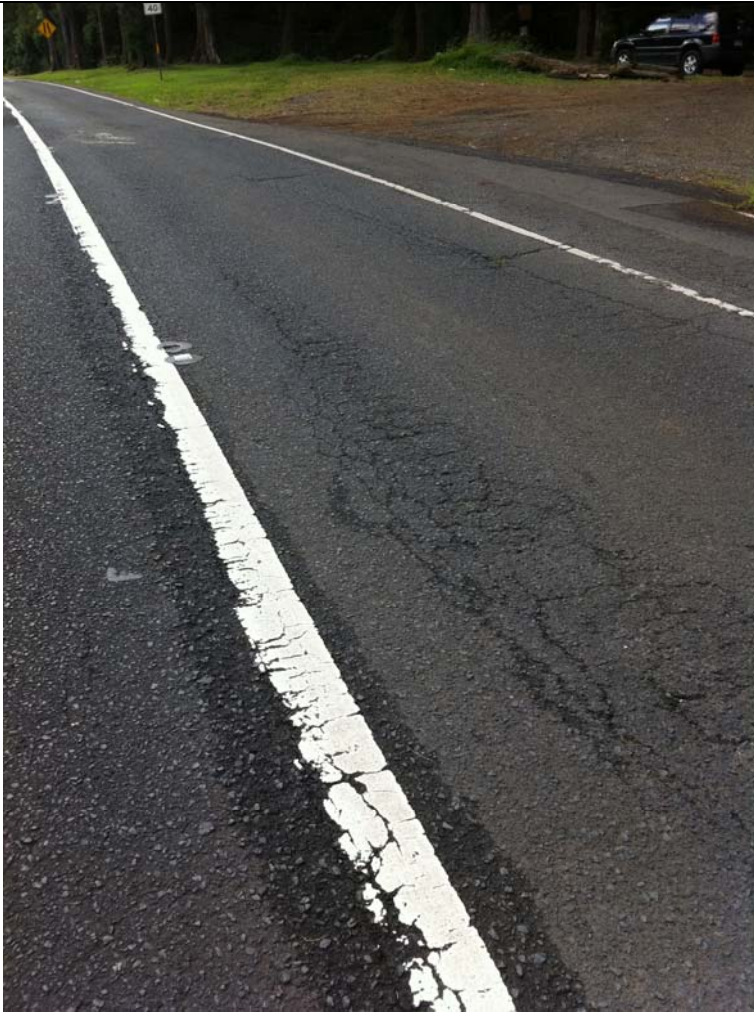
Photograph No. 3: Rutting and depression along wheel path.

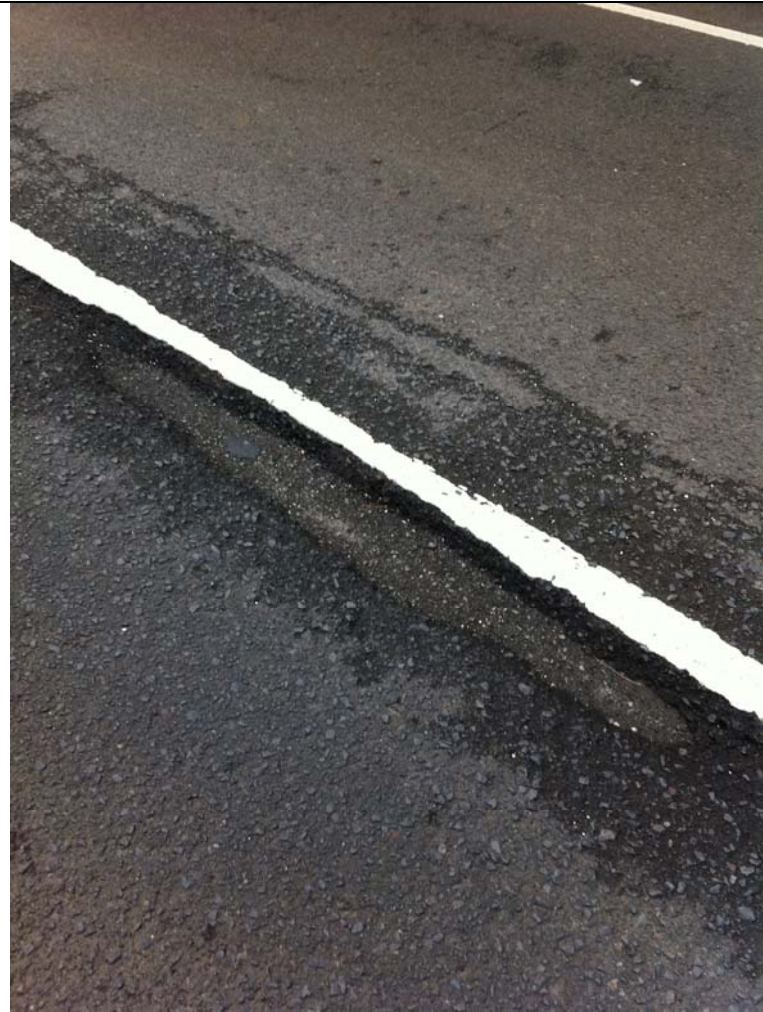
Photograph No. 4: Delamination of asphalt concrete overlay.

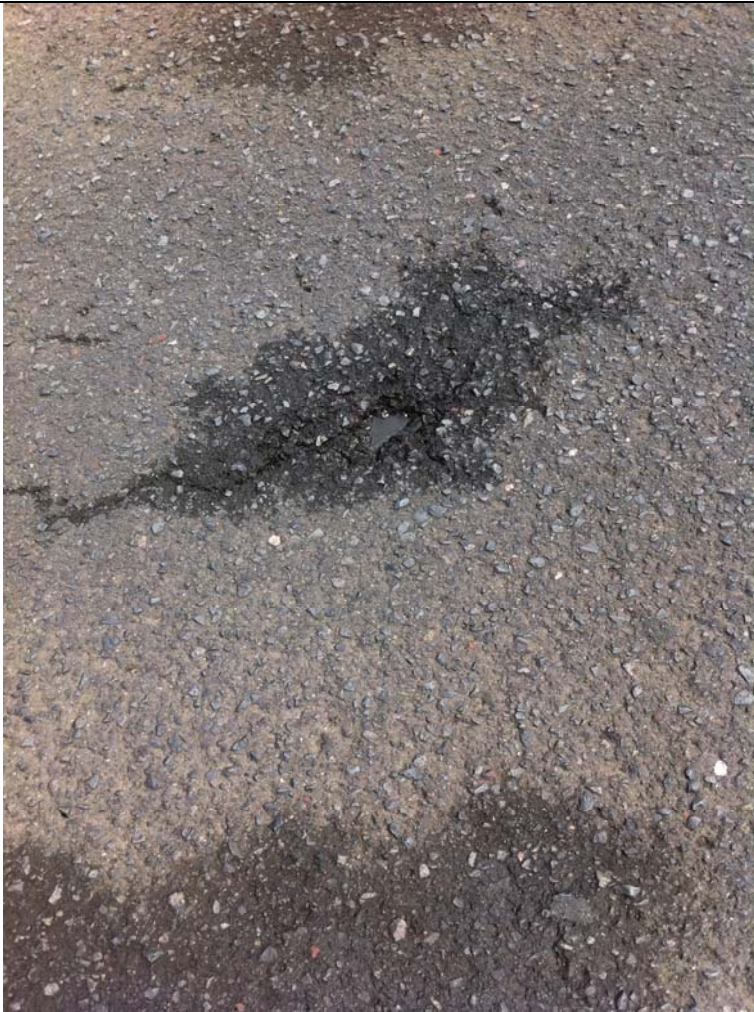
Photograph No. 5: Pothole exhibiting shallow subterranean seepage.

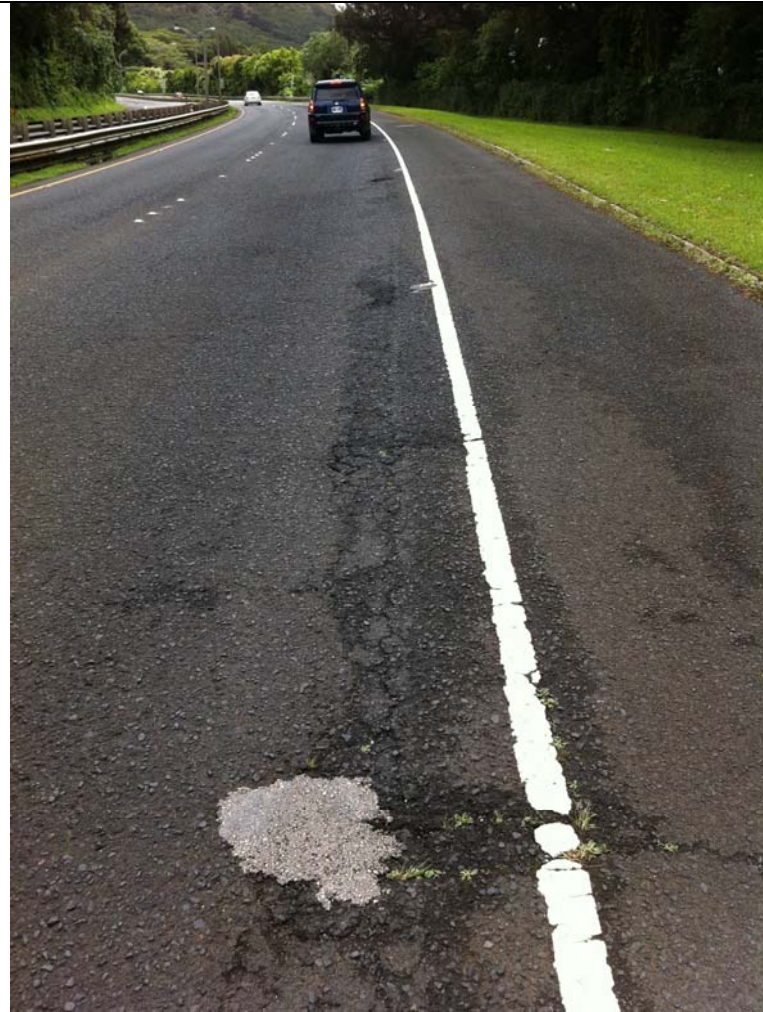
Photograph No. 6: Fatigue cracking along edge of travel lane and shoulder area.

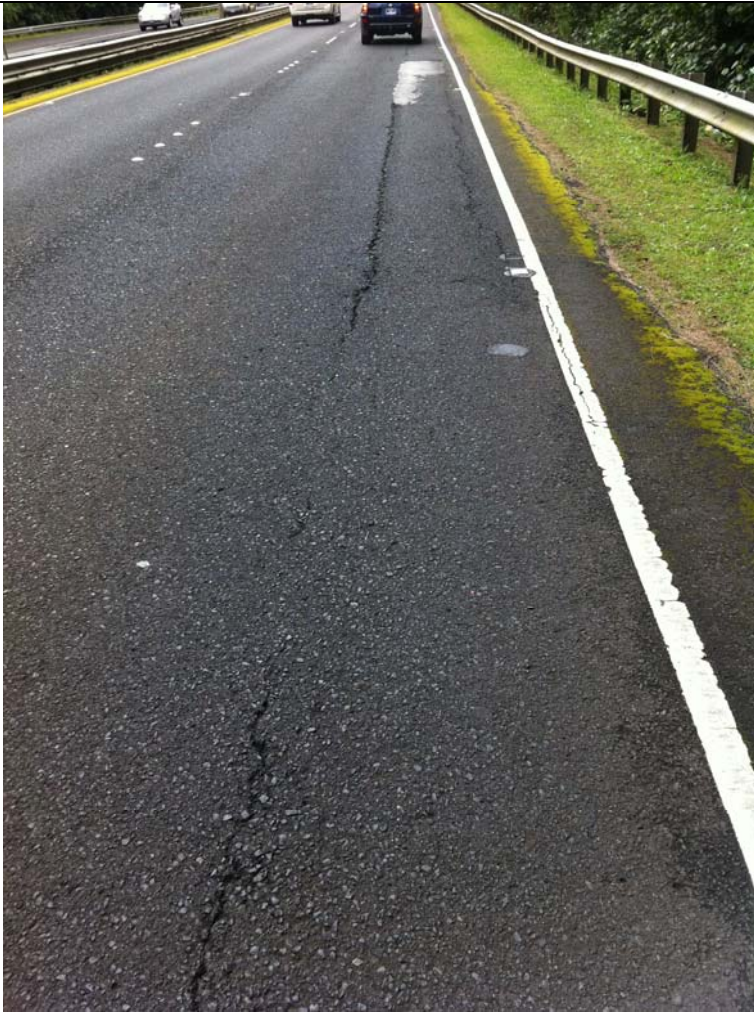
Photograph No. 7: Existing pavements exhibiting longitudinal cracking.

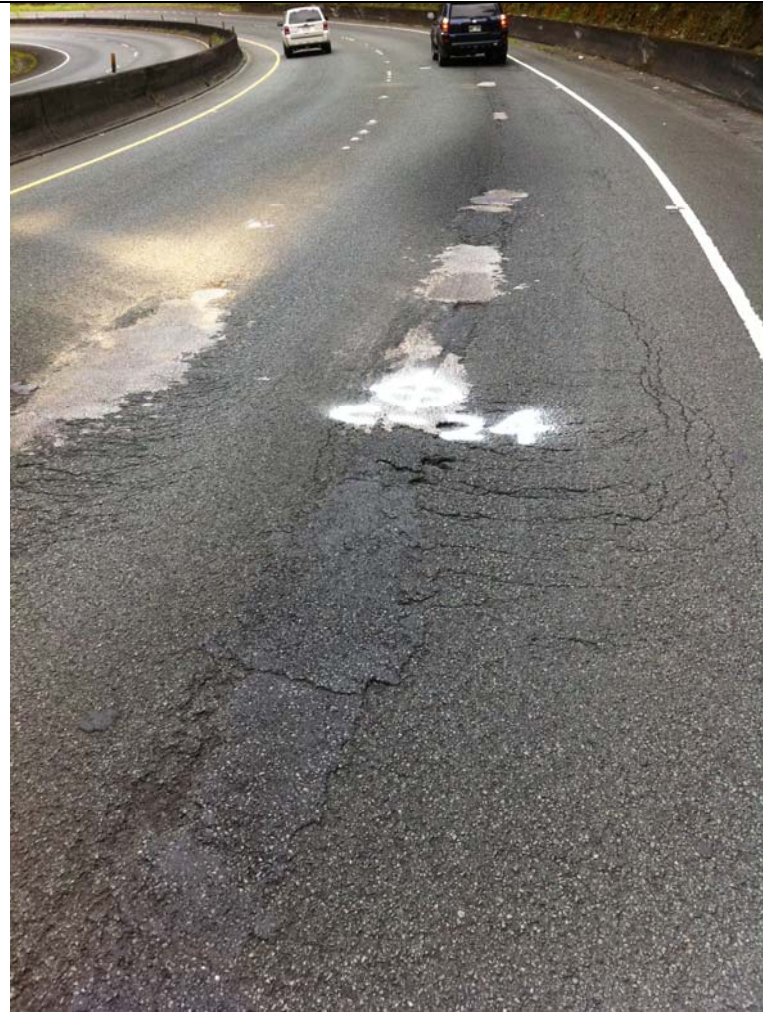
Photograph No. 8: Severely distressed pavements with rutting, shoving, and cracking.

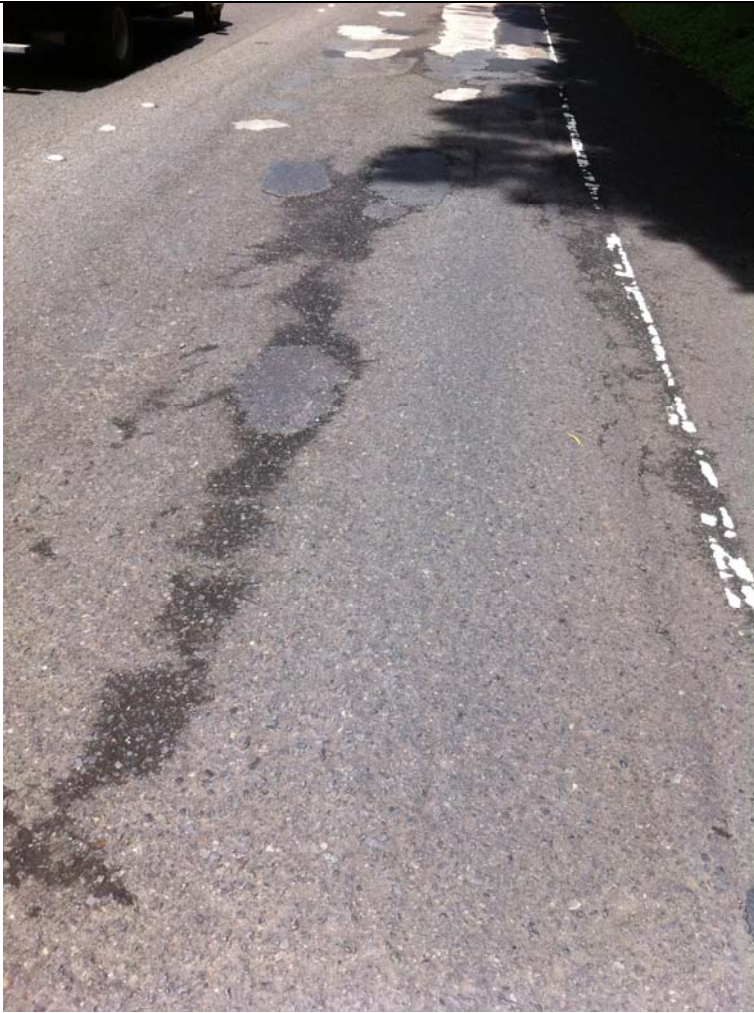
Photograph No. 9: Distressed pavements with multiple asphalt and concrete patches.

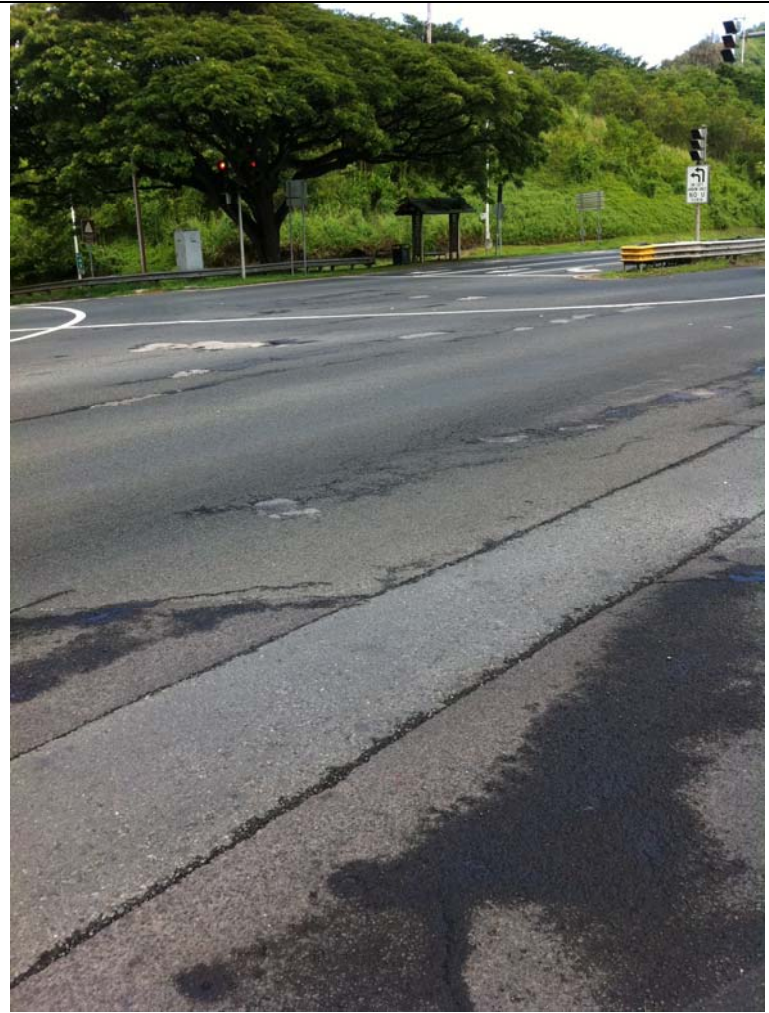
Photograph No. 7: Existing pavement condition at Pali and Kamehameha Highway Intersection.
