**PALI HIGHWAY RESURFACING
VINEYARD BOULEVARD TO WAOKANAKA STREET
PHOTOGRAPHS OF ROADWAY SURVEY**

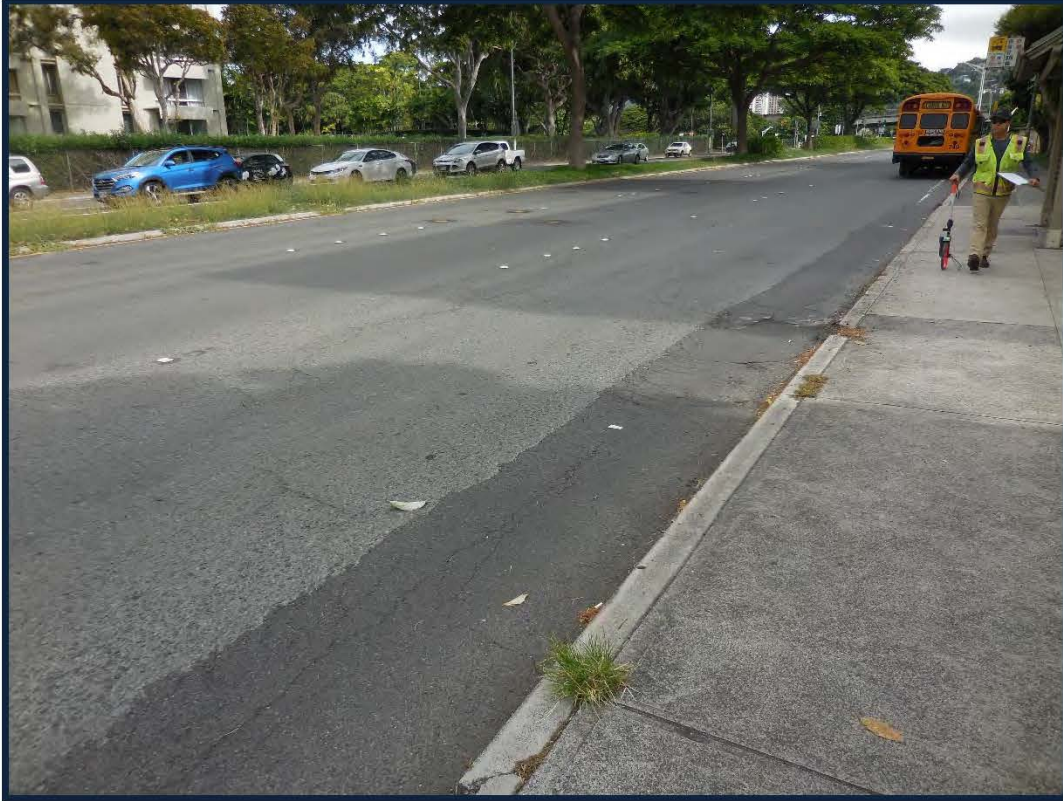
Photo No. 1: Heavy rutting under bus wheel path.

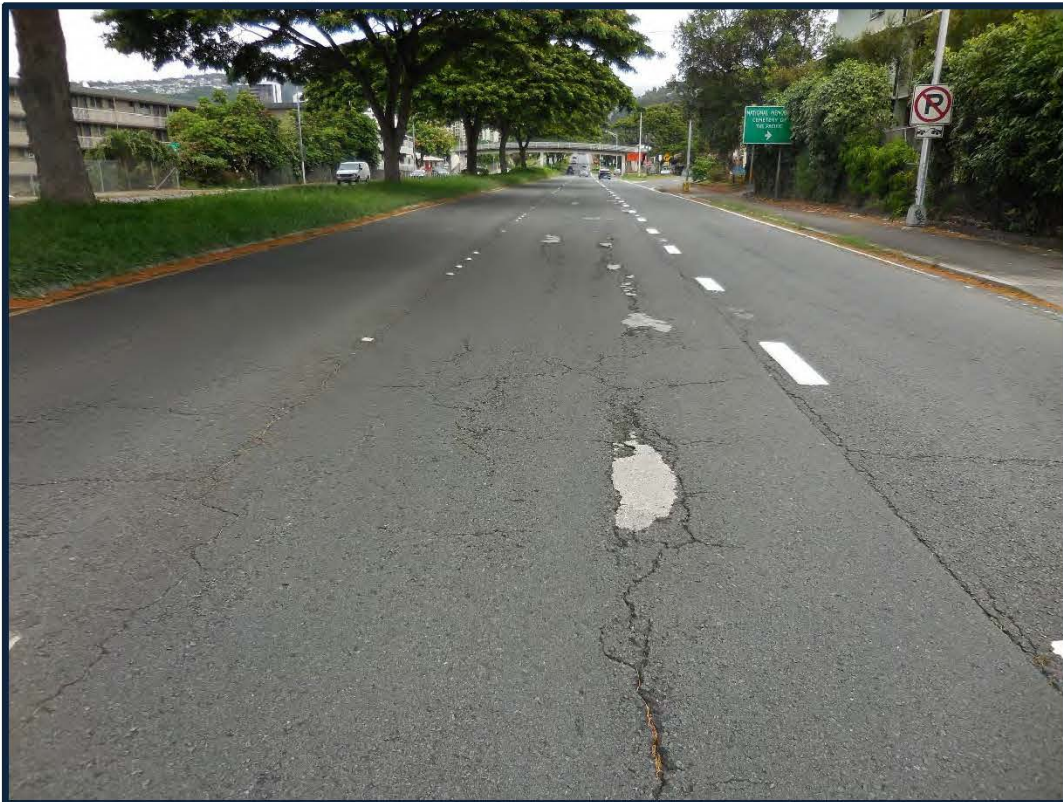
Photo No. 2: Concrete pothole patching along longitudinal cracks.

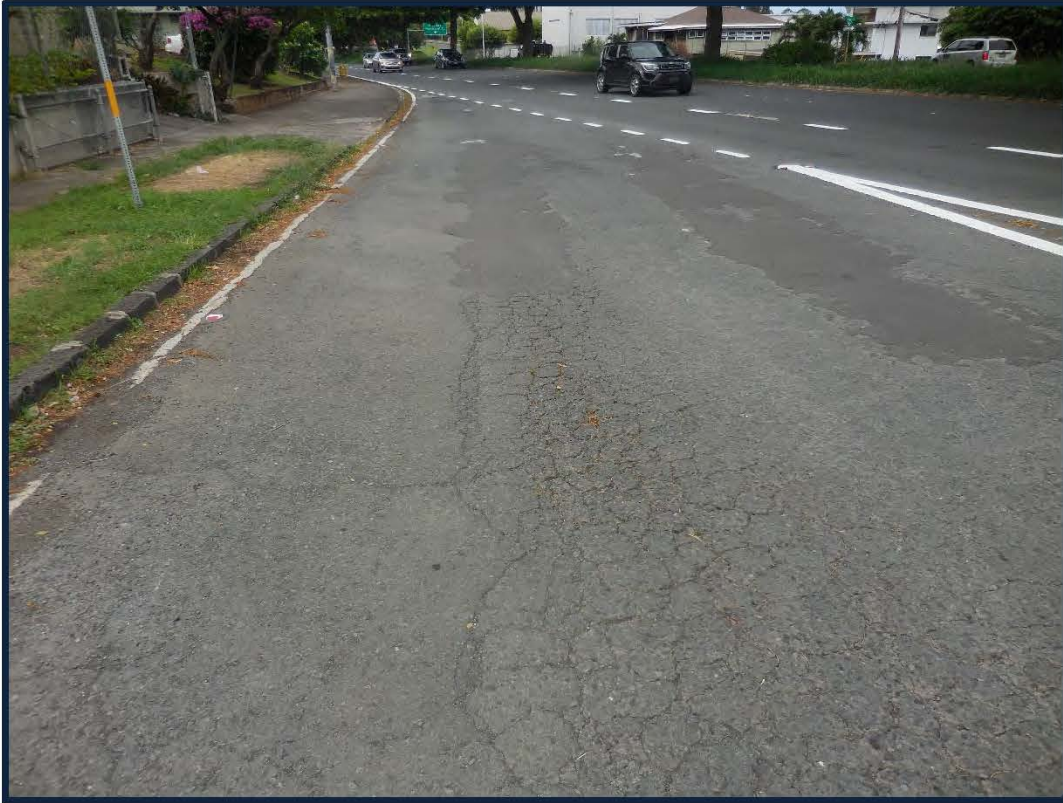
Photo No. 3: Heavy alligator cracking and asphalt concrete patches under vehicle wheel paths.

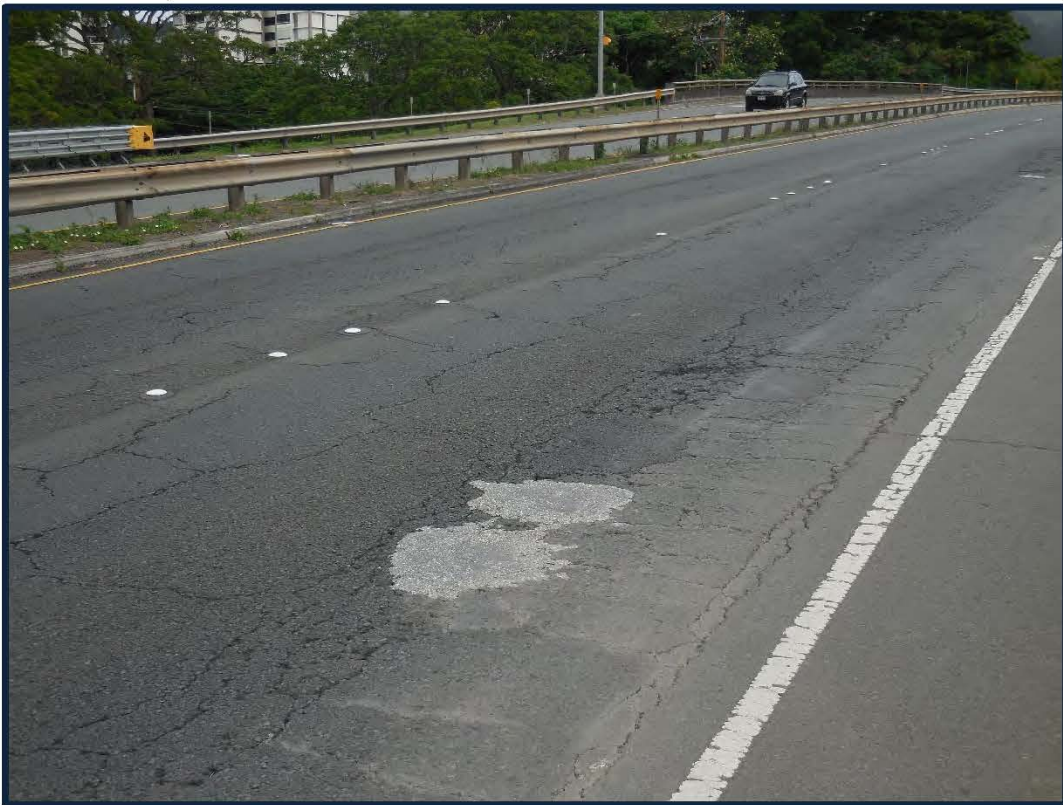
Photo No. 4: Alligator cracking, block cracking, asphalt and concrete pothole patches, and subgrade failure.

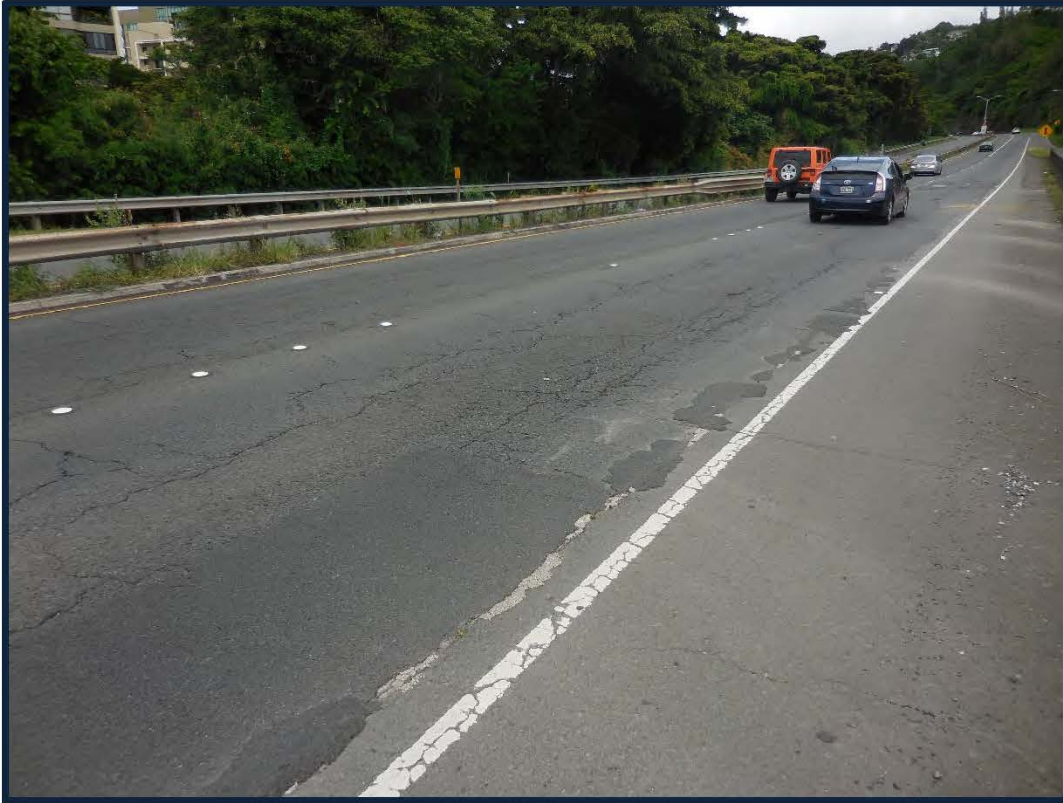
Photo No. 5: Longitudinal cracking, large asphalt and concrete patches, and subgrade failure.

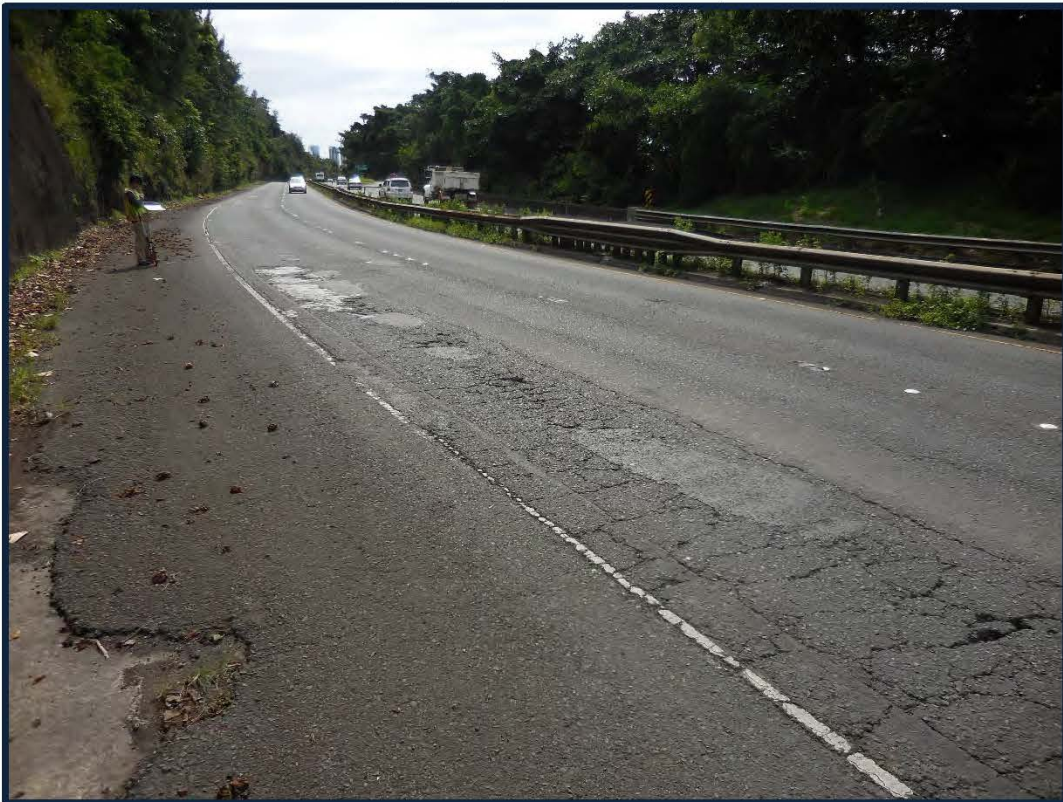
Photo No. 6: Heavy rutting, alligator cracking, and pothole patches under vehicle wheel path.

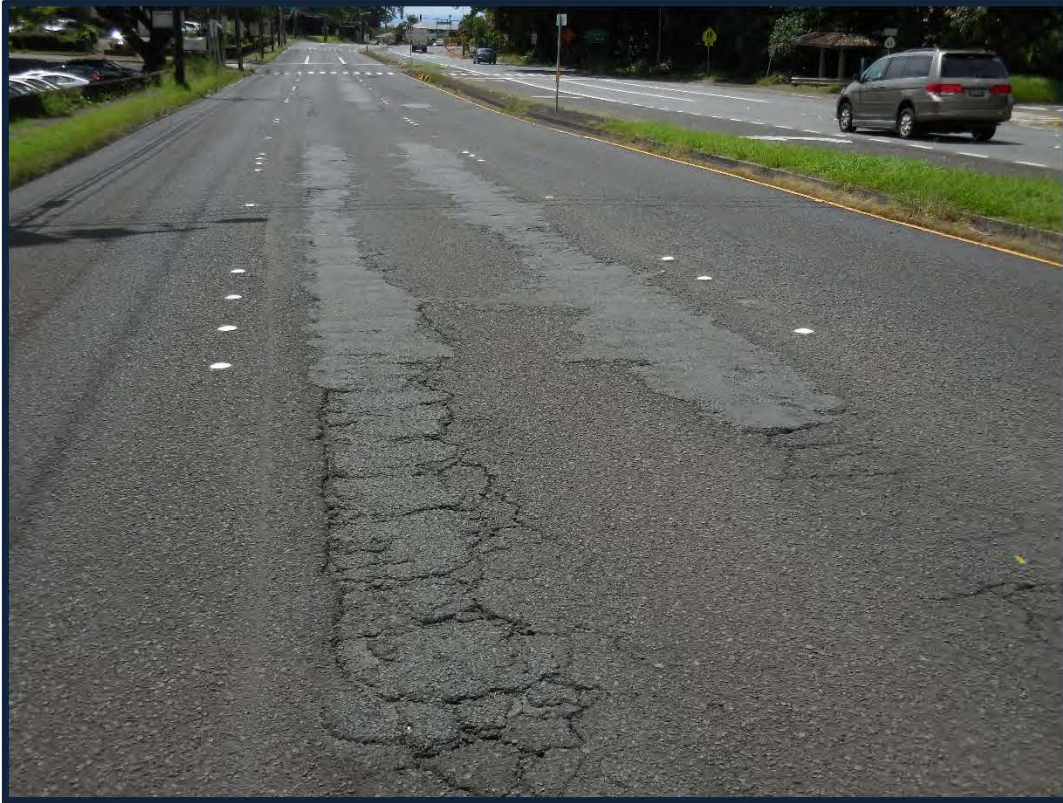
Photo No. 7: Rutting, alligator cracking, and long asphalt patches under vehicle wheel paths.

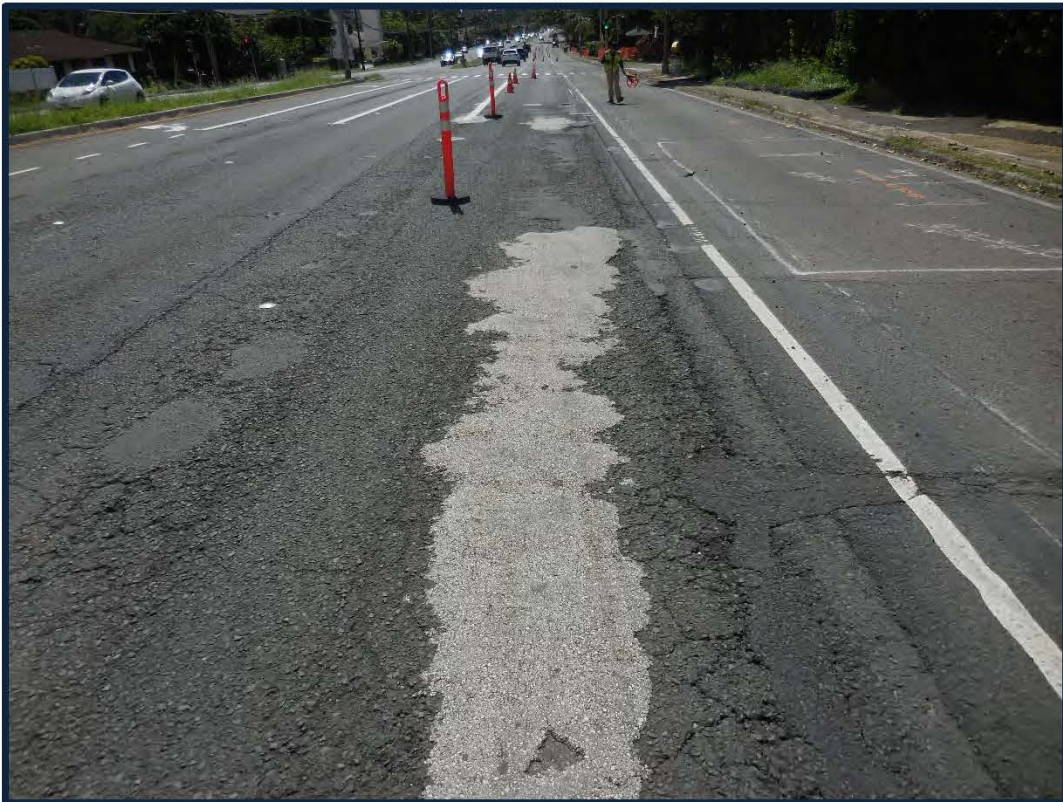
Photo No. 8: Surface raveling, alligator cracking, and large asphalt and concrete patches.
