DETAILS & SECTIONS

SAND ISLAND ACCESS ROAD

SAND ISLAND BASCULE BRIDGE

REHABILITATION

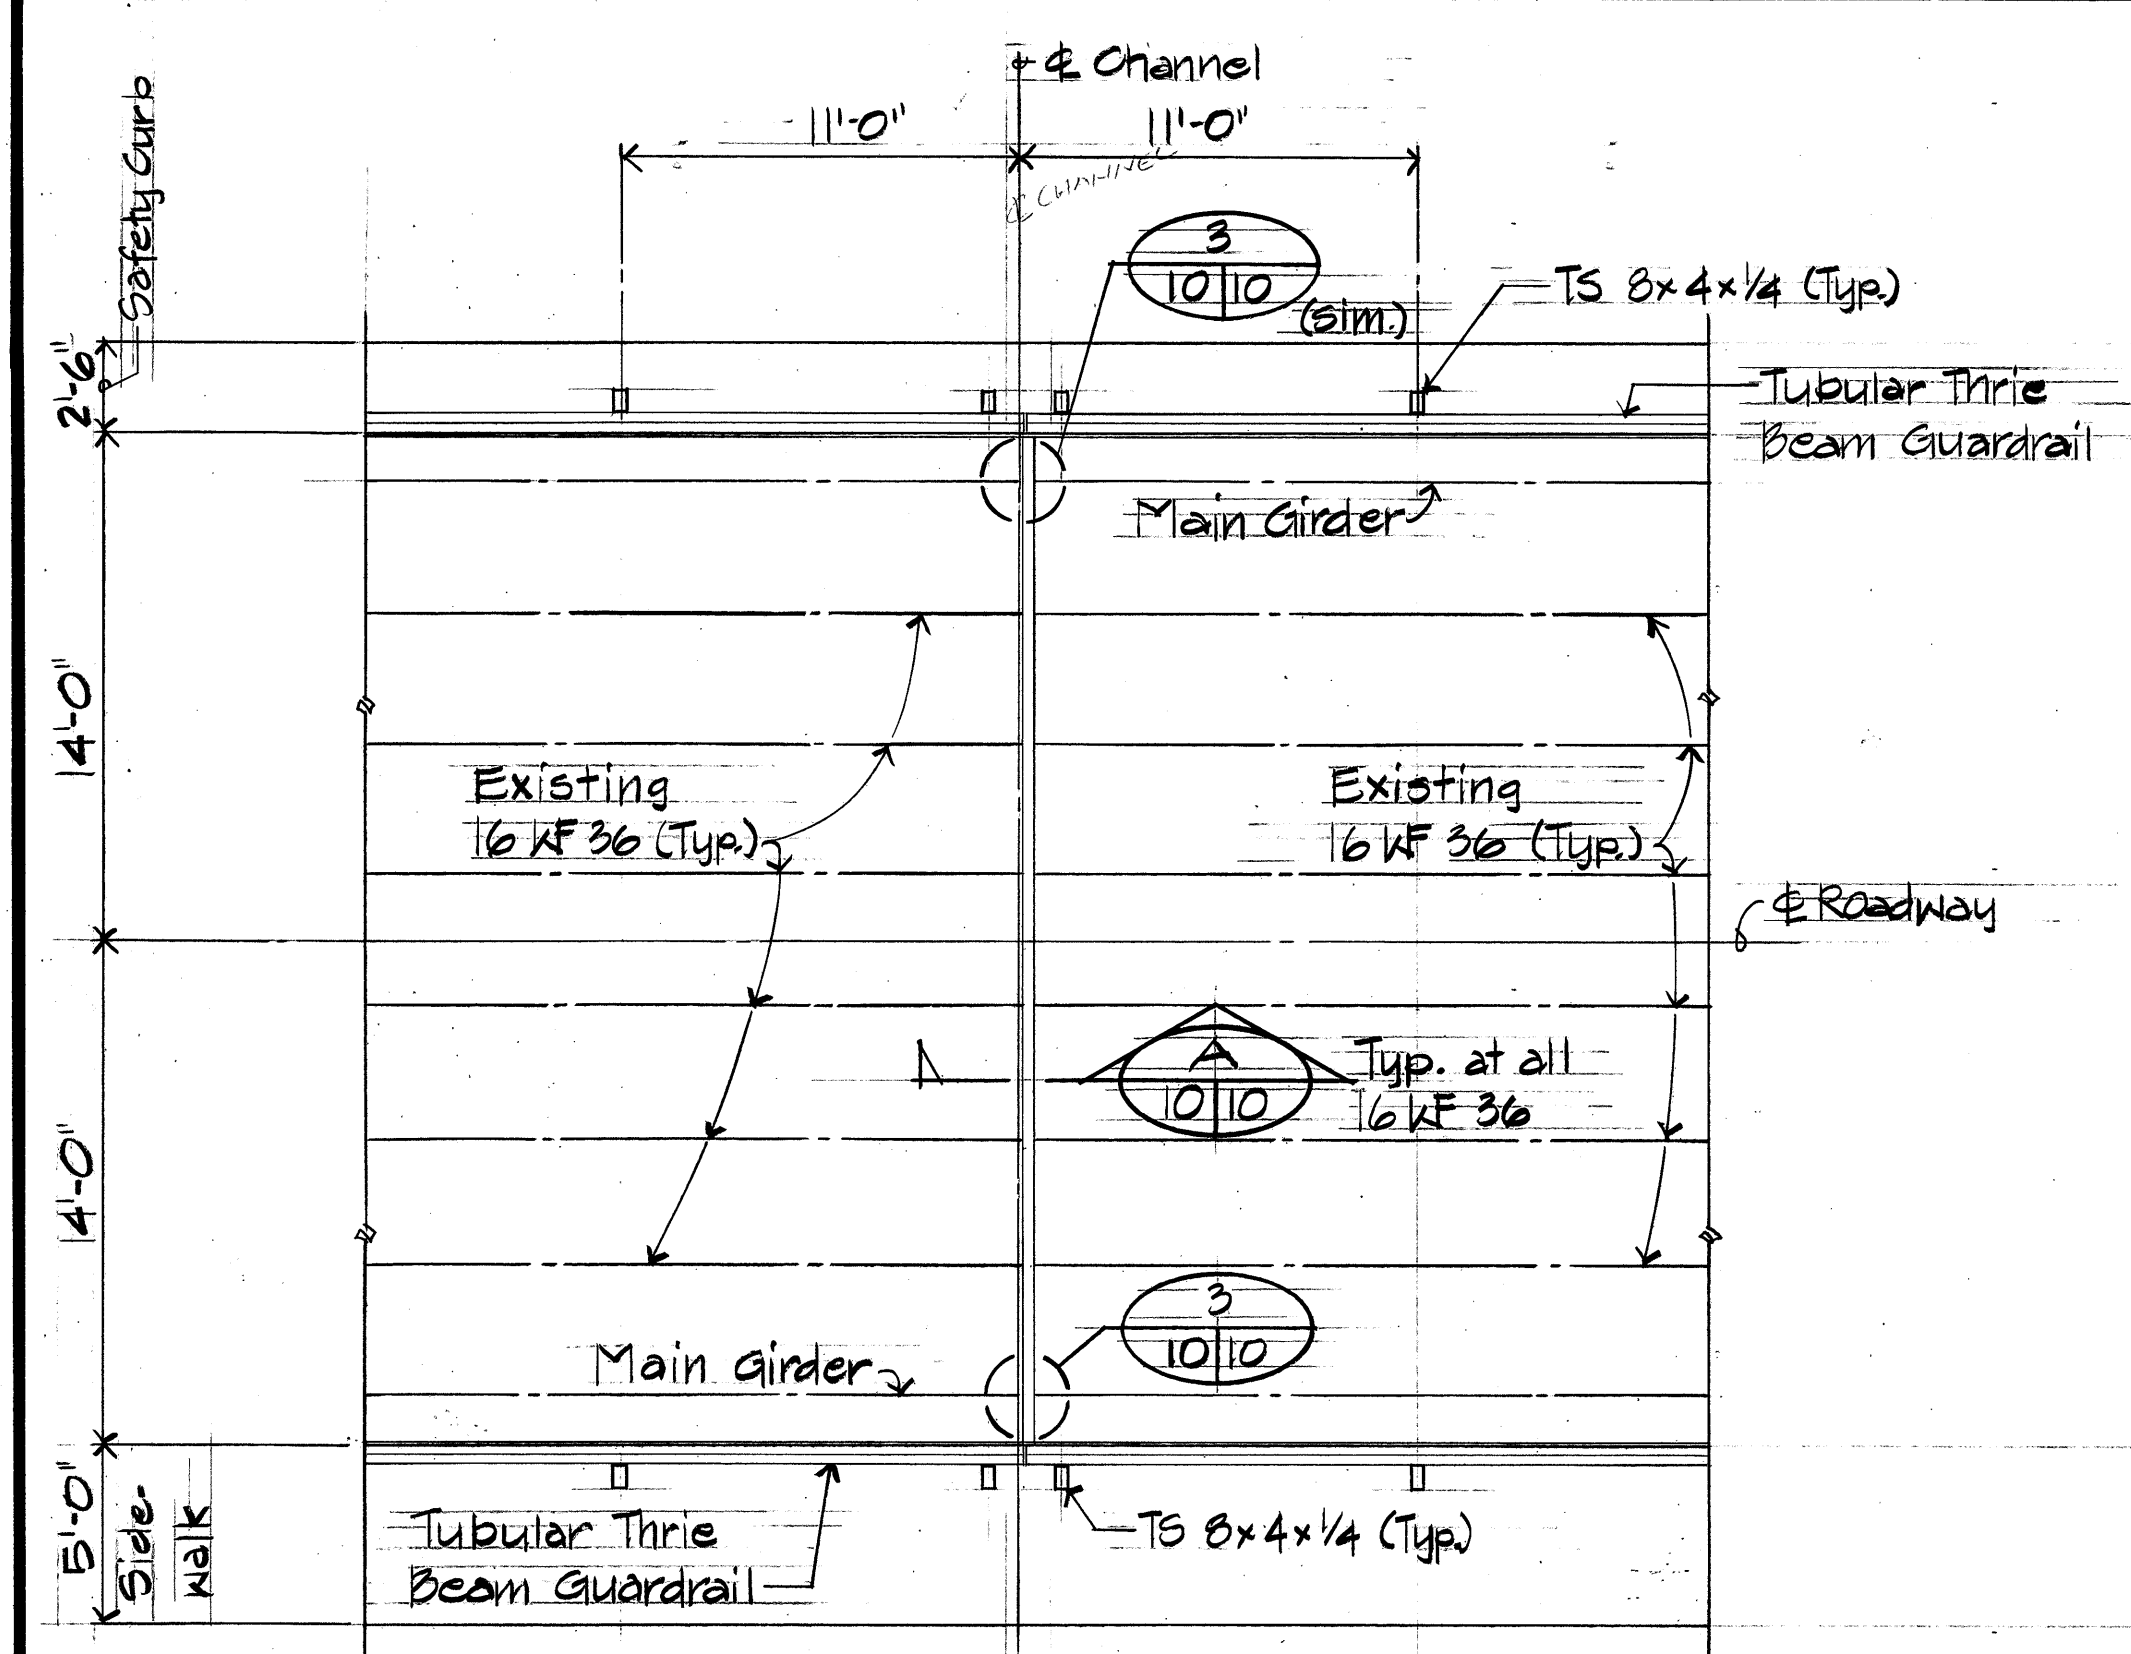
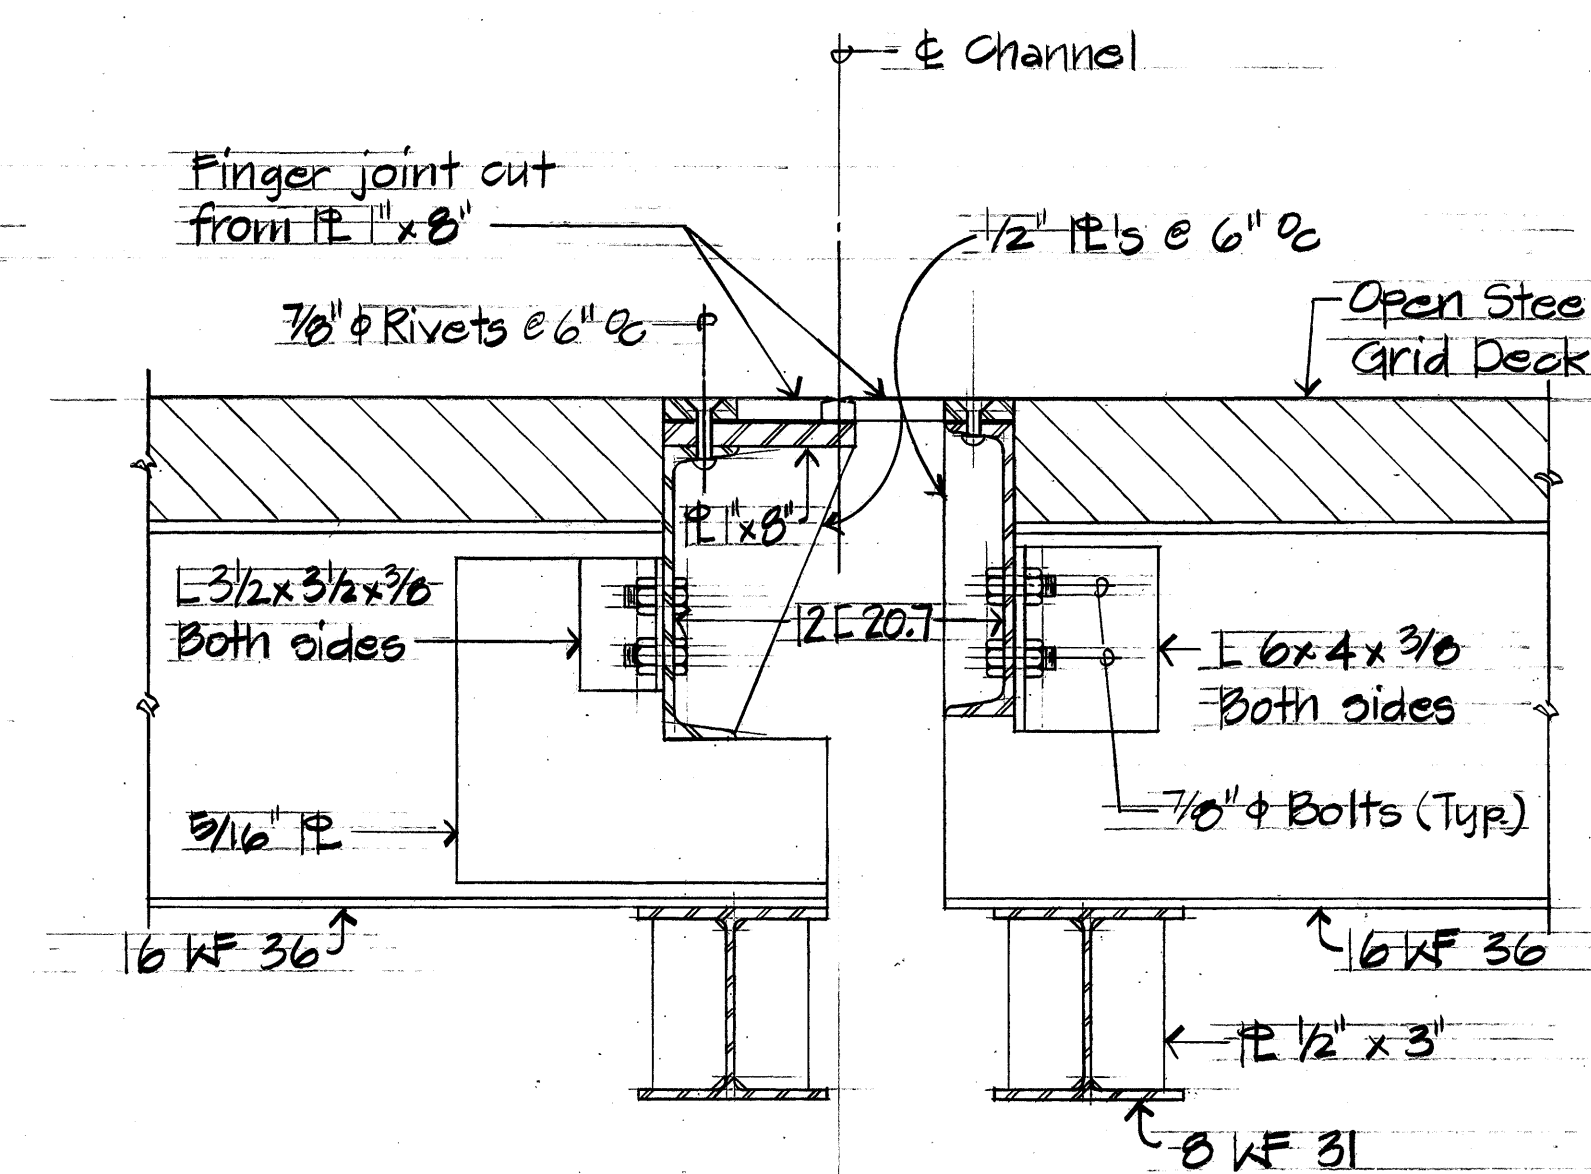
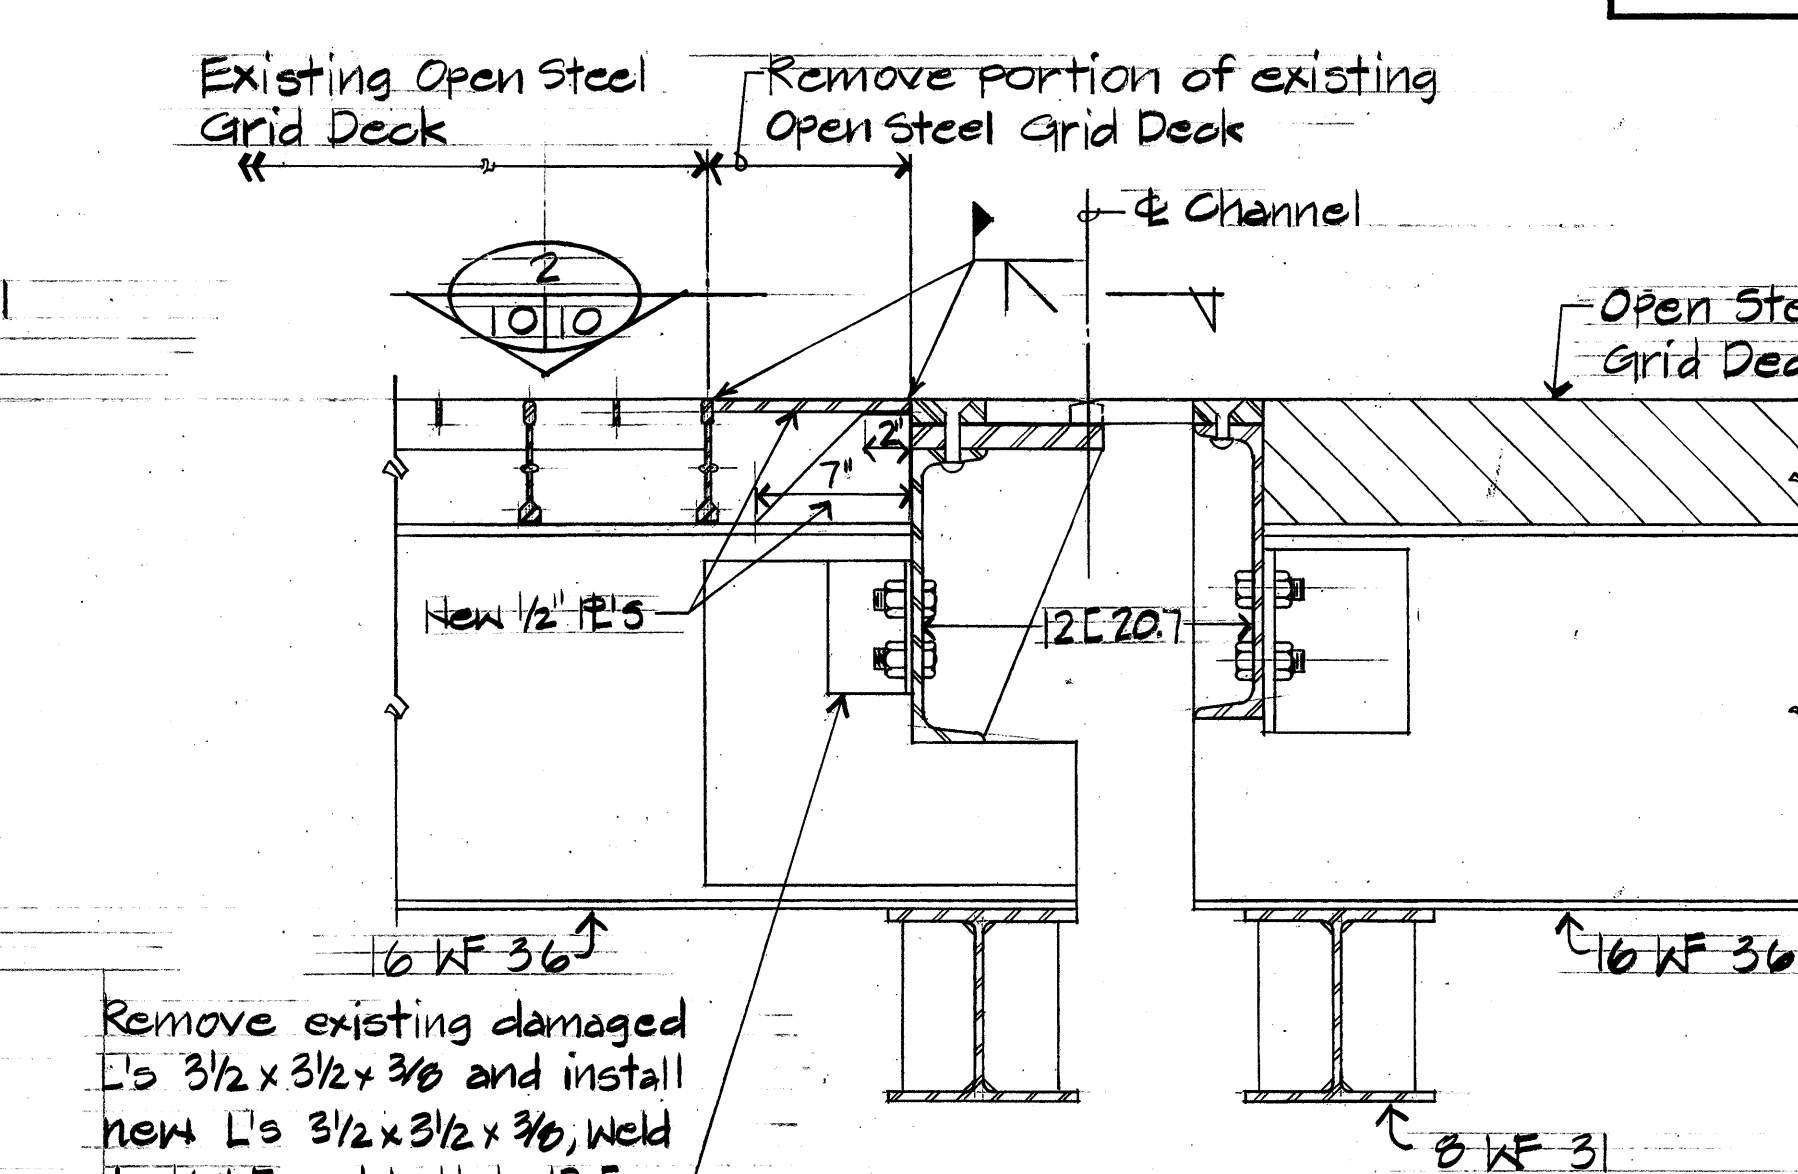
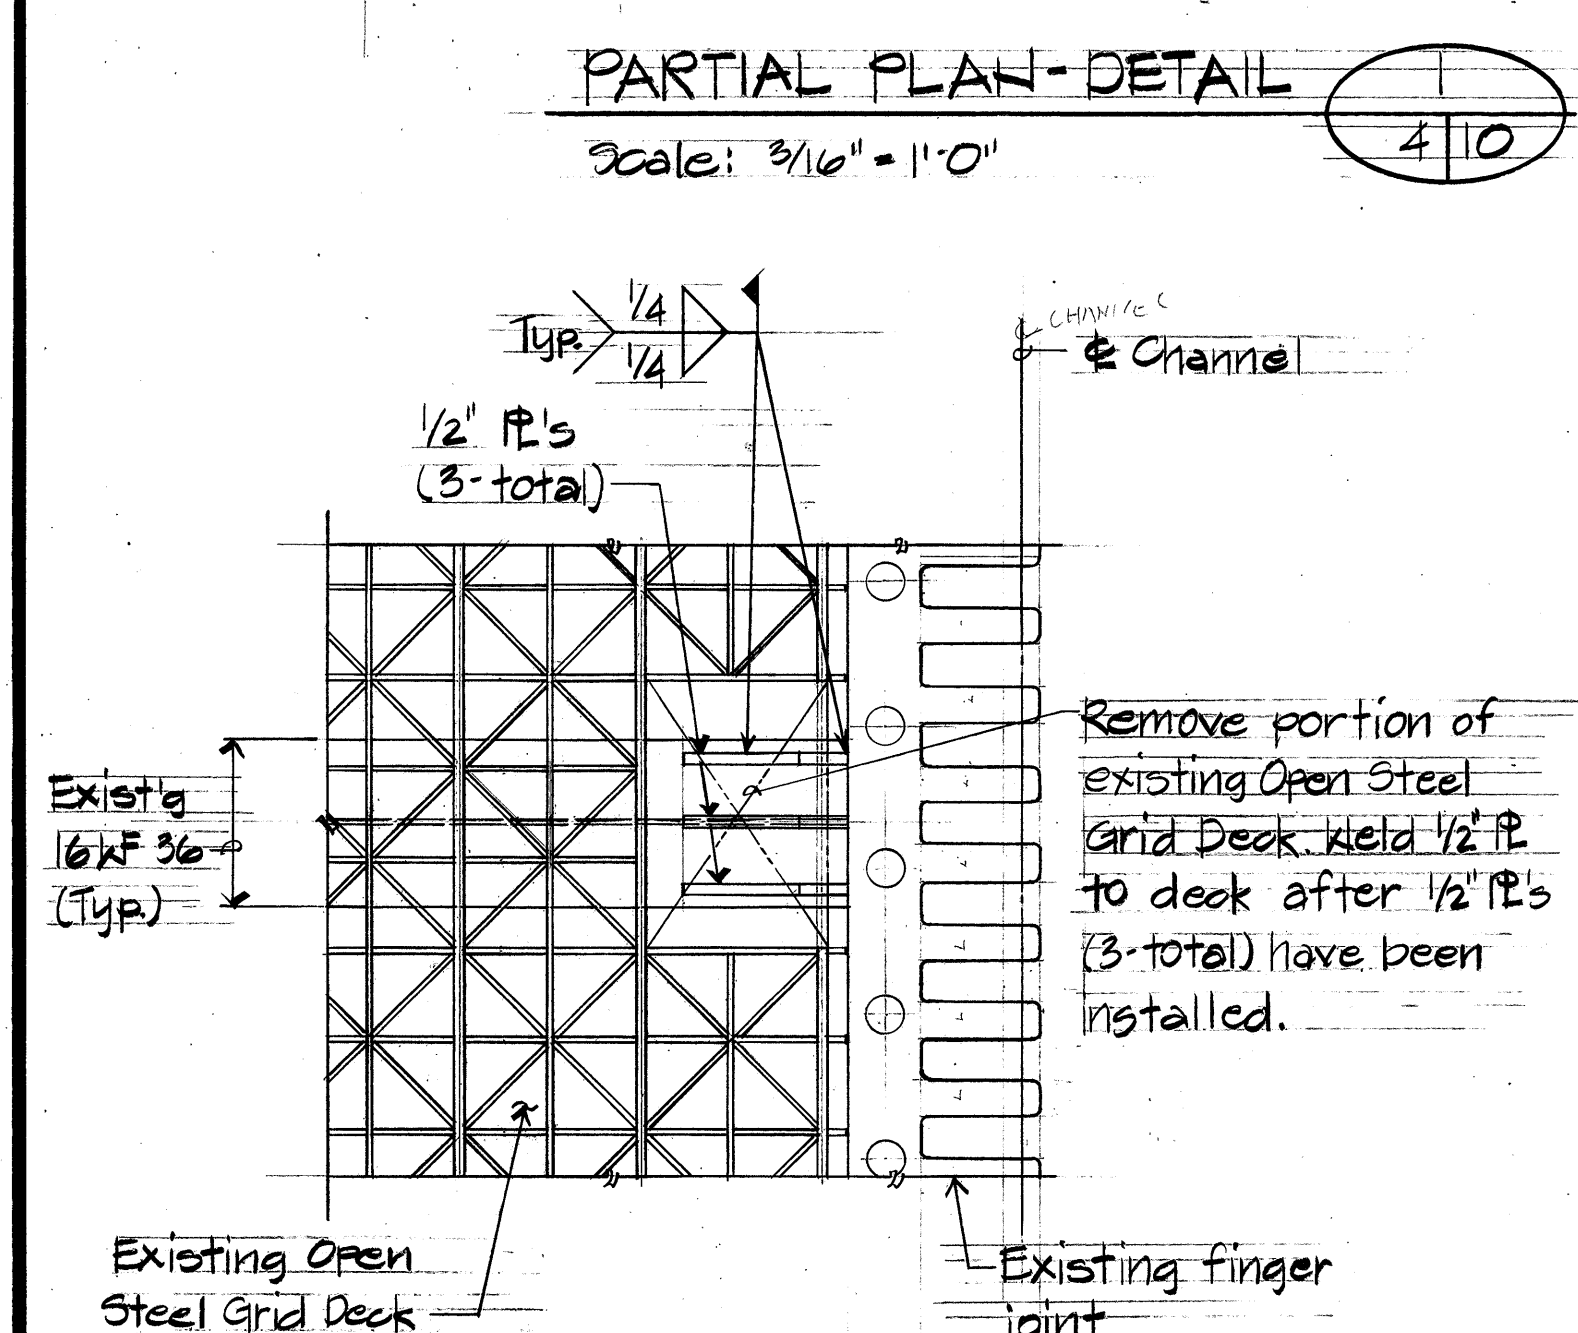
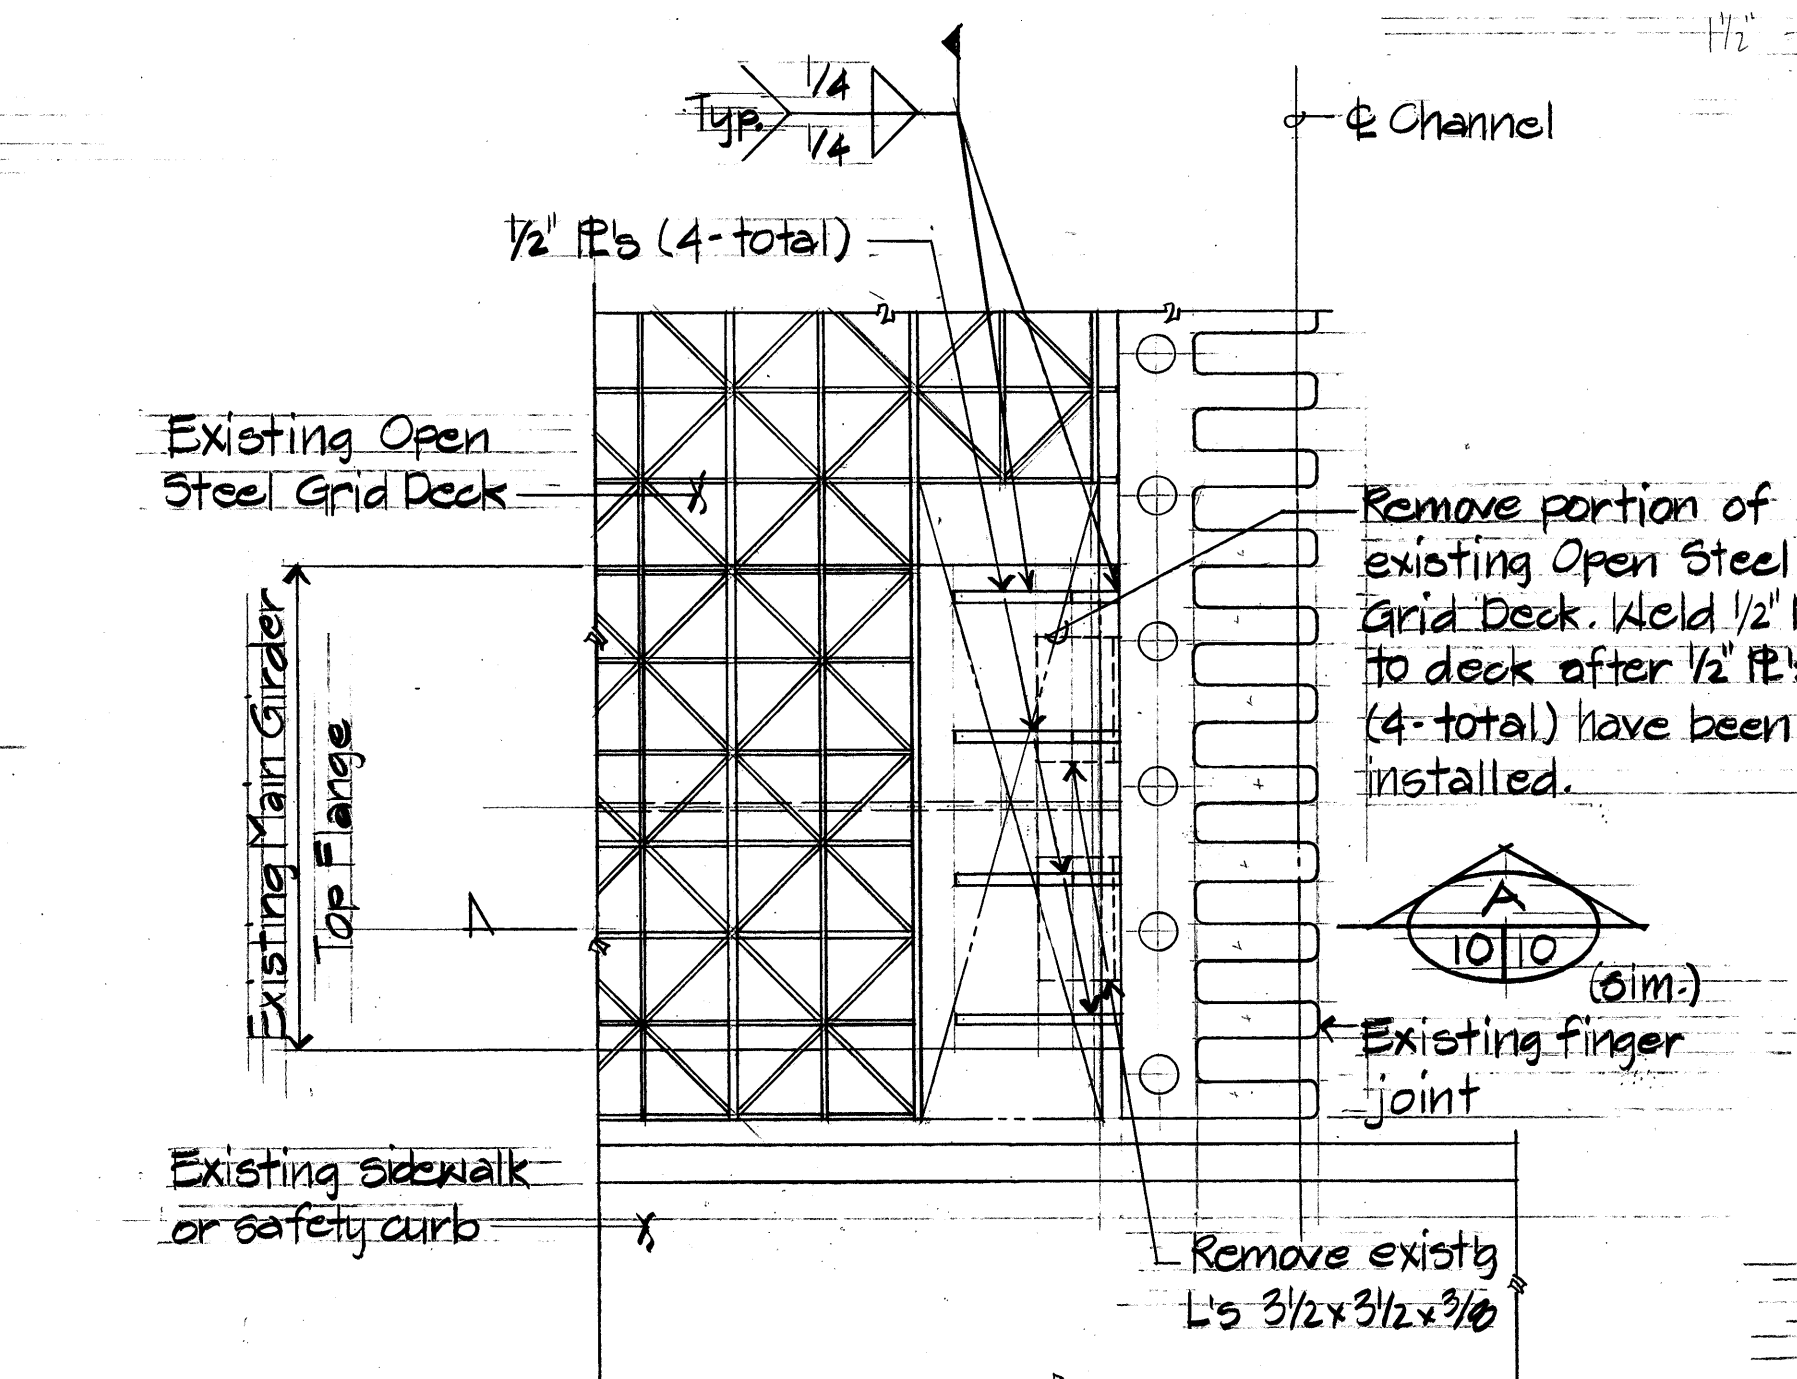
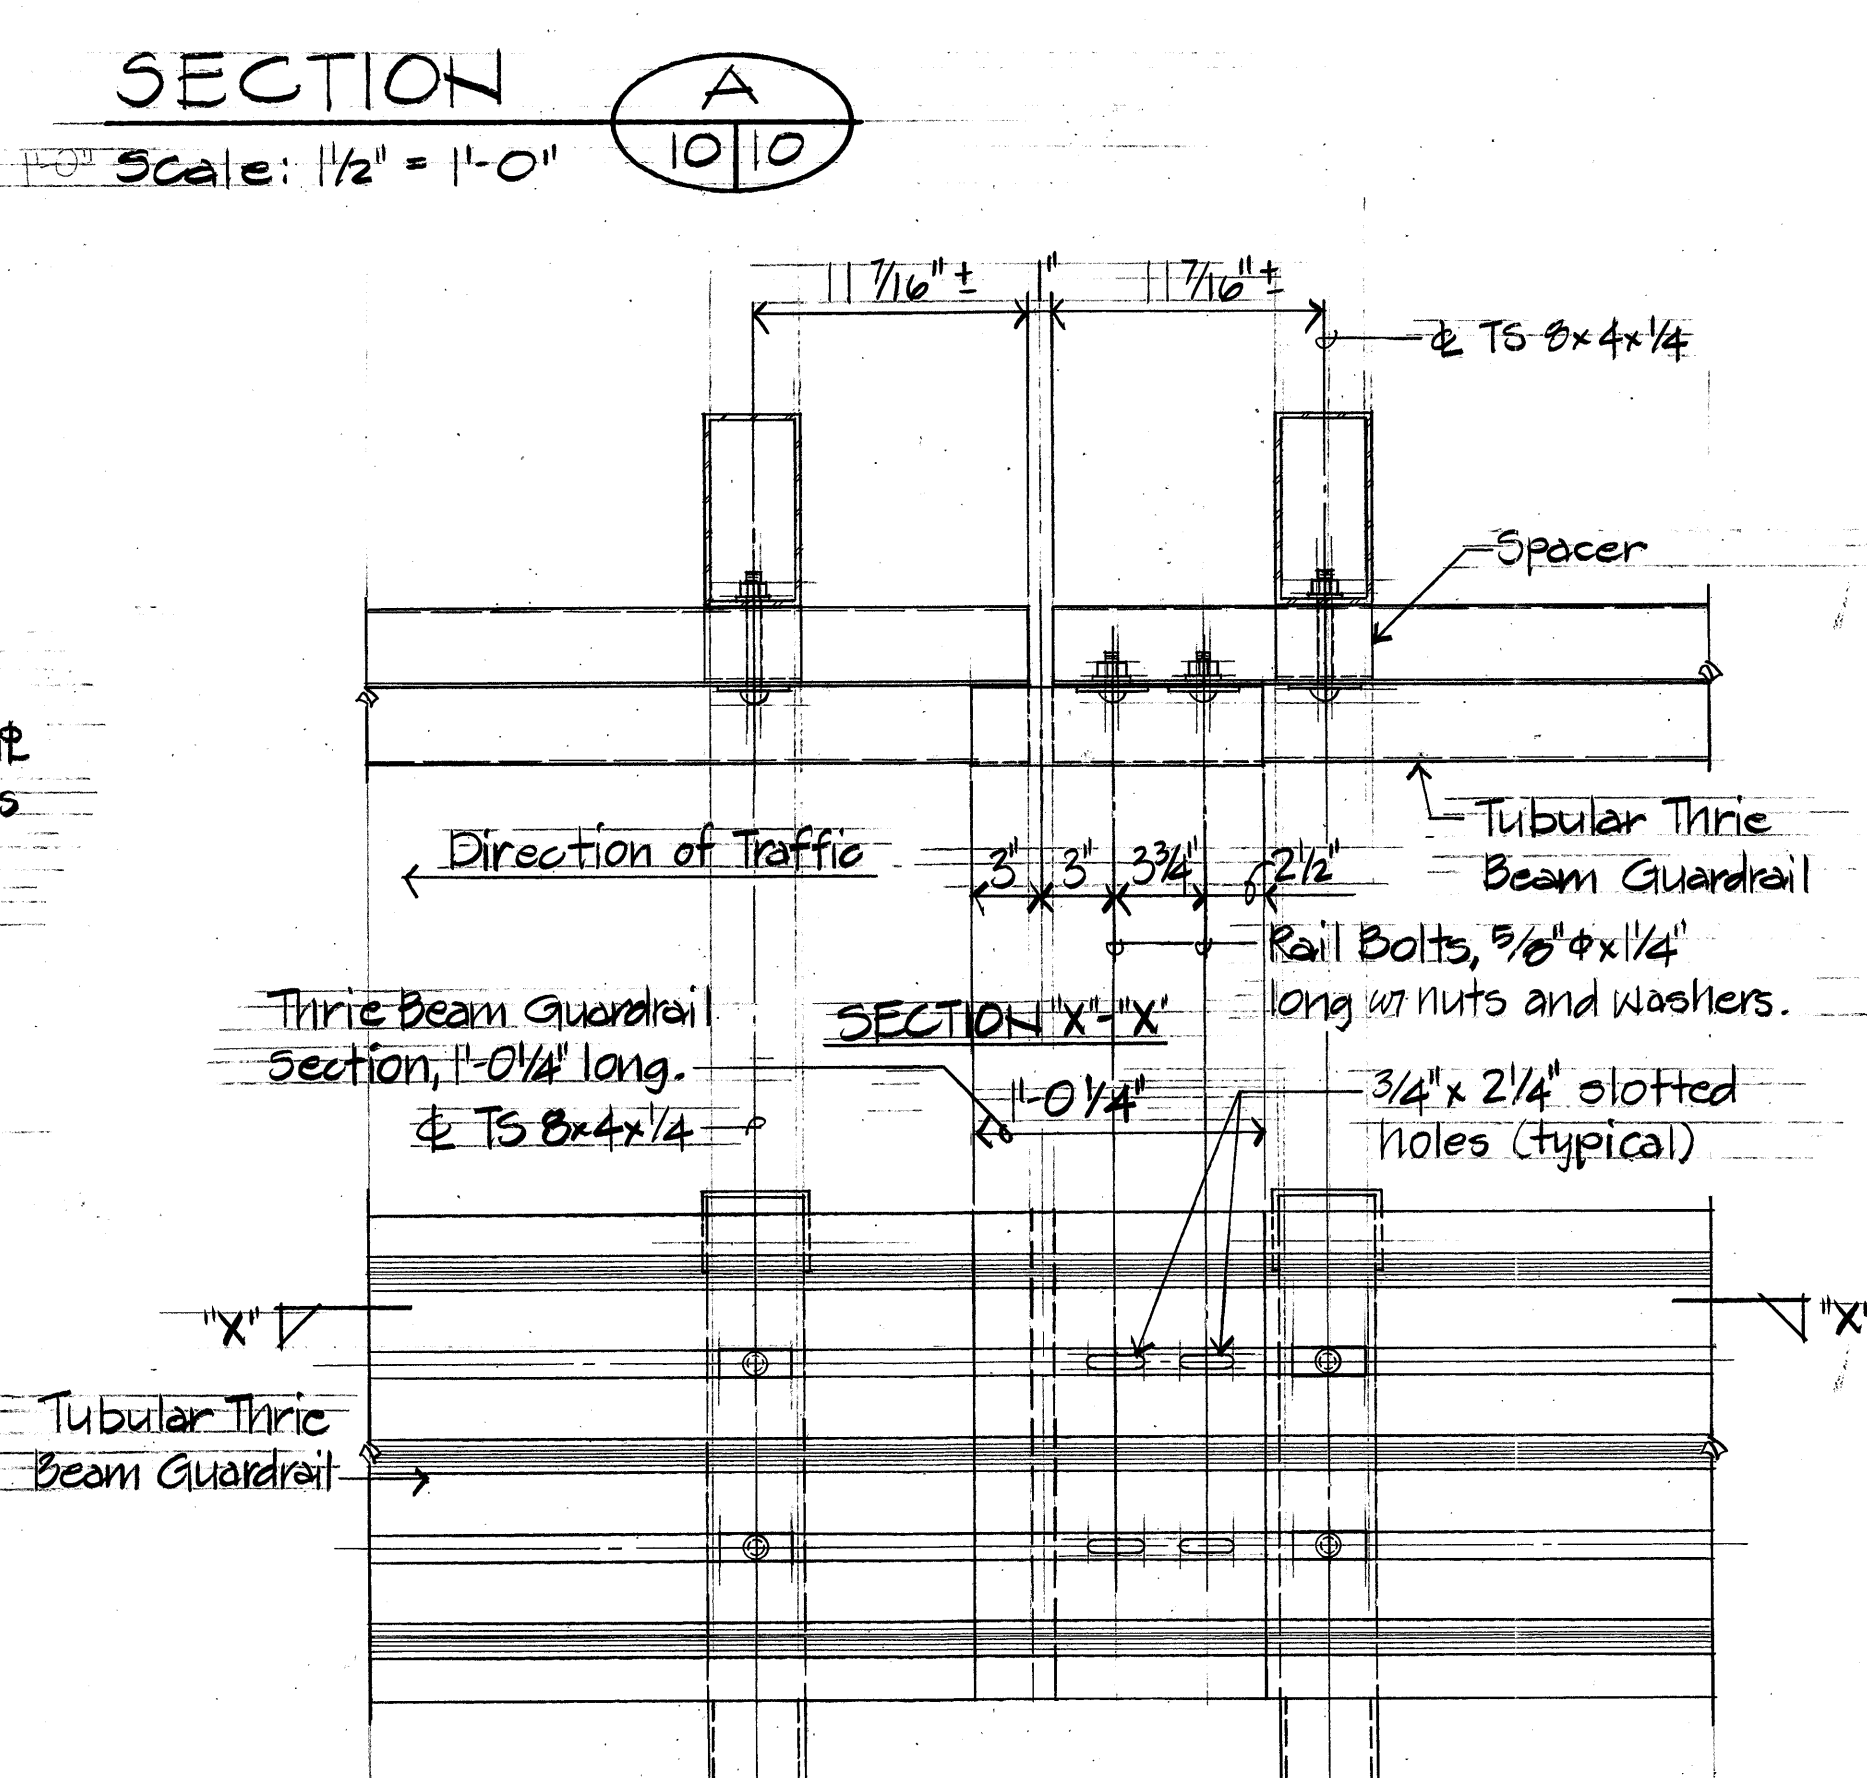
- Note to Contractor:
- The clip angle (L 3/2 x 3/2 x 3/8) connections supporting the finger joint assemblage on the Himitz Highway side have been sheared apart at each of the 16 WF 36 stringer supports. As a result, the channel section (12 C 20.7) has shifted away from the supporting stringers, closing the finger joint gap. In the repaired condition shown, the finger joint assemblage shall be set as close as possible to its "as-built" condition.
  - Anti-skid studs shall also be installed on the new 1/2" thick plates that replace the deck sections at each stringer.
