HAZARDOUS MATERIALS SURVEY REPORT

HAZARDOUS MATERIALS SURVEY REPORT
Kamehameha Highway – Kaipapau Stream Bridge Replacement
Abandoned Single Story Structure
Hauula, Oahu, Hawaii
TMK: 5-4-11:21

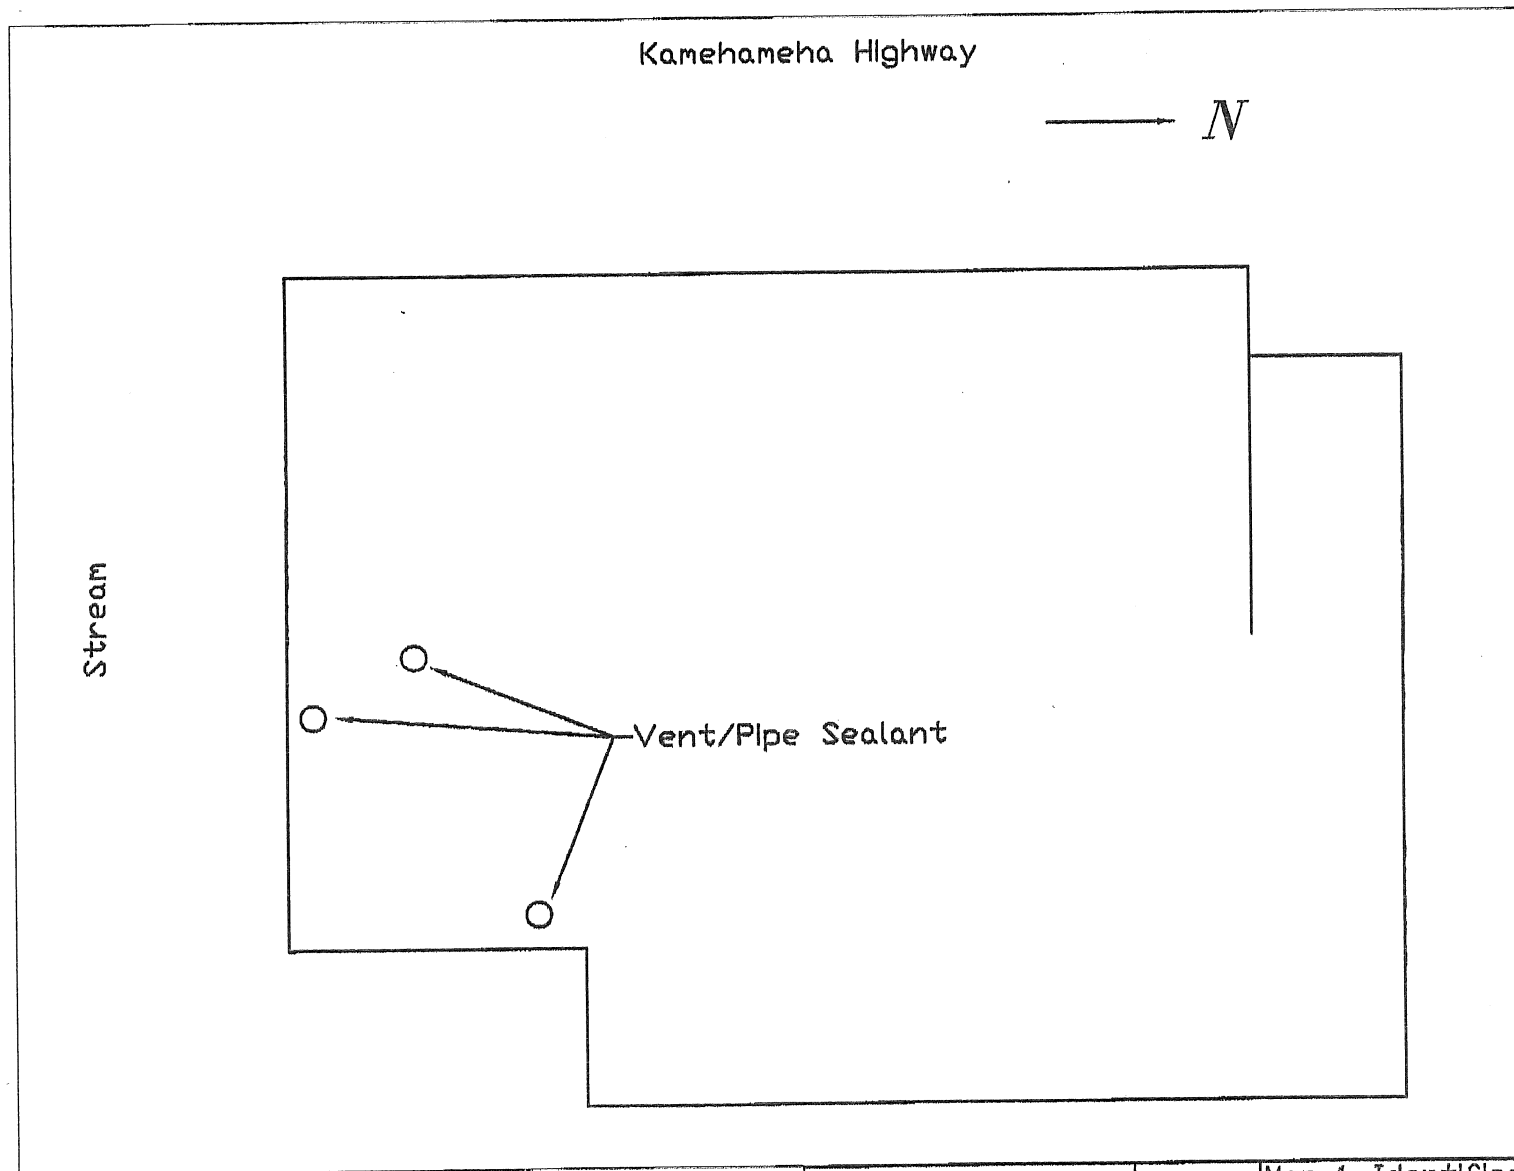
Map 1. Identified
Asbestos-Containing
Materials - Kalpapau
Stream Bridge Replacement

Forty-five (45) samples were taken during the course of this investigation. The results of this analysis are summarized in the attached Table 1. Laboratory analysis did identify levels of asbestos above the regulatory limit of 1% in the vent/pipe sealant material located on the roof of the Subject Location. Table 1 below summarizes these results. The attached Map 1 lists identified asbestos-containing materials.

- Any non-friable ACM which could be crumbled and pulverized during renovation/demolition activities must be removed and disposed of by a qualified asbestos abatement contractor. In addition, the services of a qualified consultant should be obtained to monitor and inspect the removal activities to ensure compliance with applicable Environmental Protection Agency (EPA), Occupational Safety and Health Administration (OSHA), and Hawaii Occupational Safety and Health (HIOSH) regulations pertaining to the handling of asbestos containing material.
