HAZARDOUS MATERIALS SURVEY REPORT

**KAIPAPAU STREAM BRIDGE REPLACEMENT
HAU'ULA, OAHU, HAWAII**

ETC Project No. 19-4007

April 26, 2019

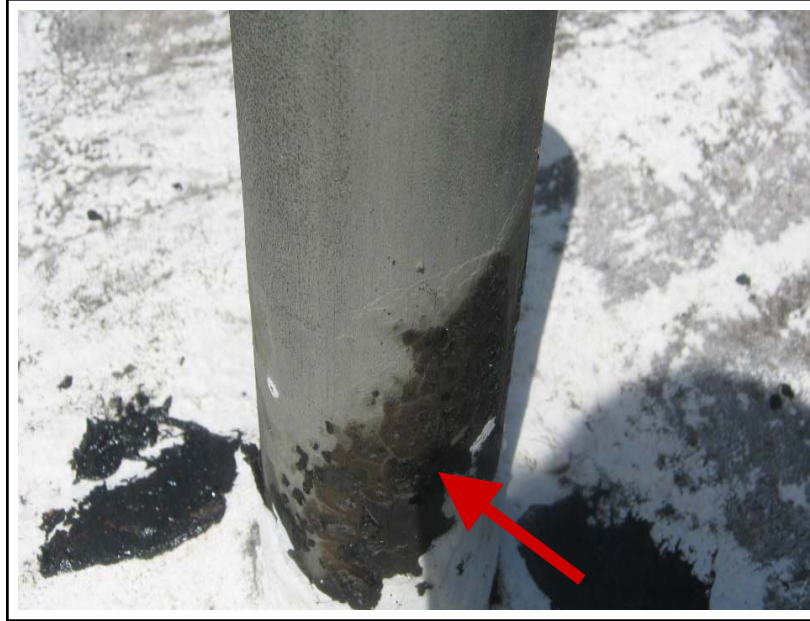
- Black mastic on pipe penetration on roof B
- Black Mastic under white caulking on pipe penetration on roof B
- Rolled on roofing on roof B

1907-003B-A04: Black Mastic on Pipe Penetration
Building B Studio Roof

- Any material that is suspected to contain a hazardous contaminant but was not tested as part of this survey should be tested prior to disturbance.
- All ACM must be removed and disposed of by a qualified asbestos abatement contractor.

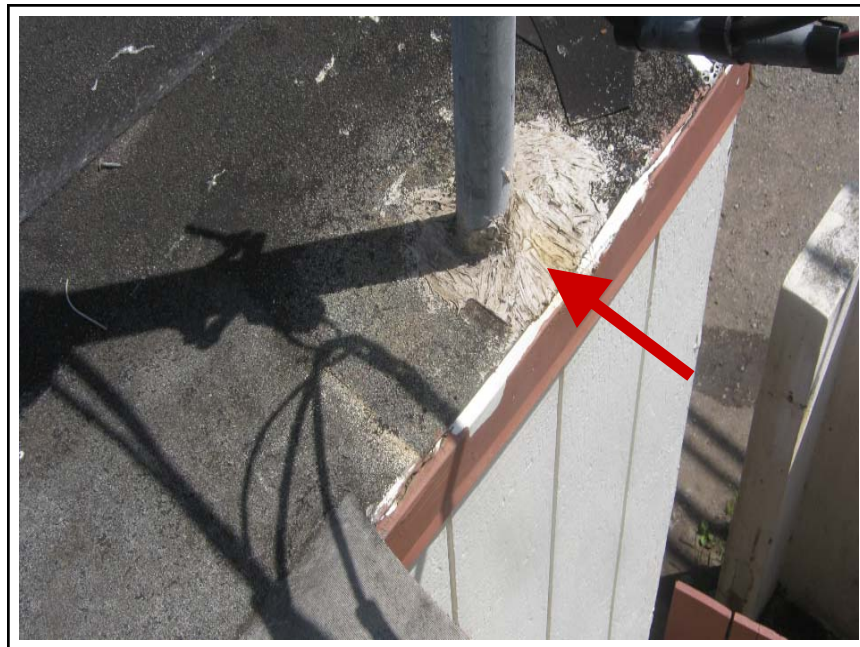
- Black mastic on pipe penetration on roof B
- White Caulking on pipe penetration with black mastic on roof B
- Rolled on roofing on roof B

1907-003B-A19: White Caulking on Pipe Penetration with Black
Mastic
Building B Studio Roof

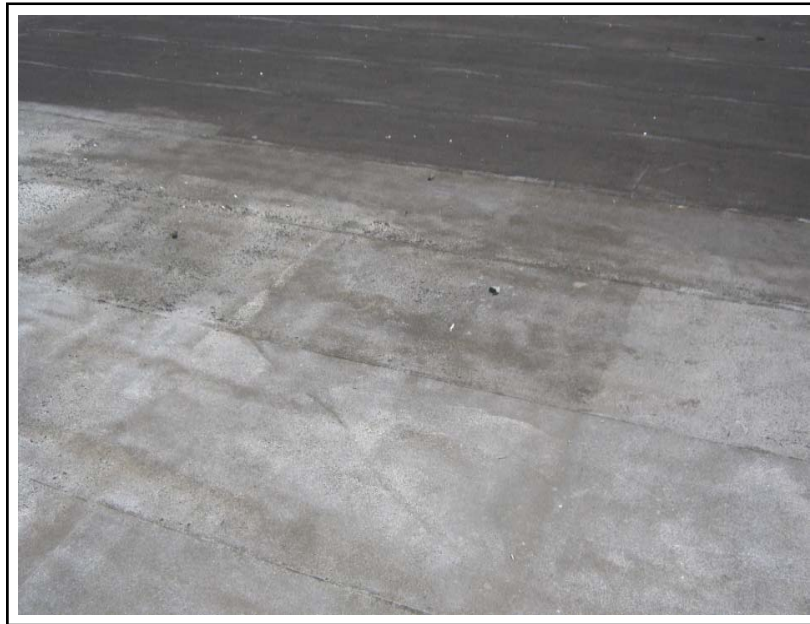
Sample ID	Homogeneous Area	Material	Condition	Category	Friability	Analysis Layer	Asbestos Content	Estimated Quantity
1907-003B-A31	Building B Studio	Rolled on Roofing Material	Good	Misc	Category II Non-Friable	Black Roofing	8% Chrysotile	150 square ft.
						Black/Off-White Roofing	None Detect	
1907-003B-A32						Not Analyzed	Not Applicable	
1907-003B-A33						Not Analyzed	Not Applicable

1907-003B-A31: Rolled on Roofing
Building B Studio Roof
