APPENDIX A: PHOTOGRAPHS

Farrington Highway Bridge No.2 over Hunehune Stream
Bridge No. 924
Structure No. 003924001100001

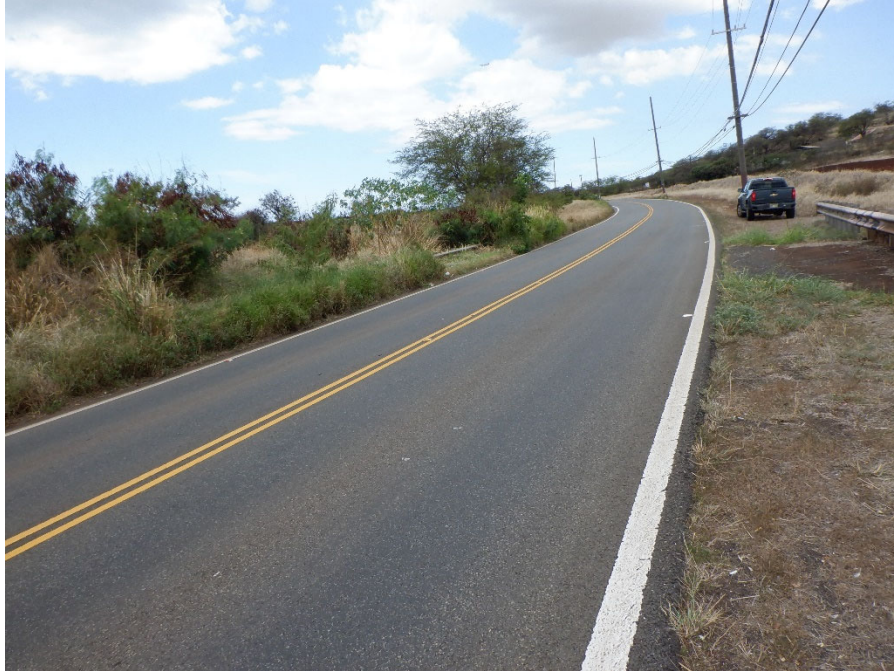
PHOTO 1 EAST APPROACH LOOKING WEST

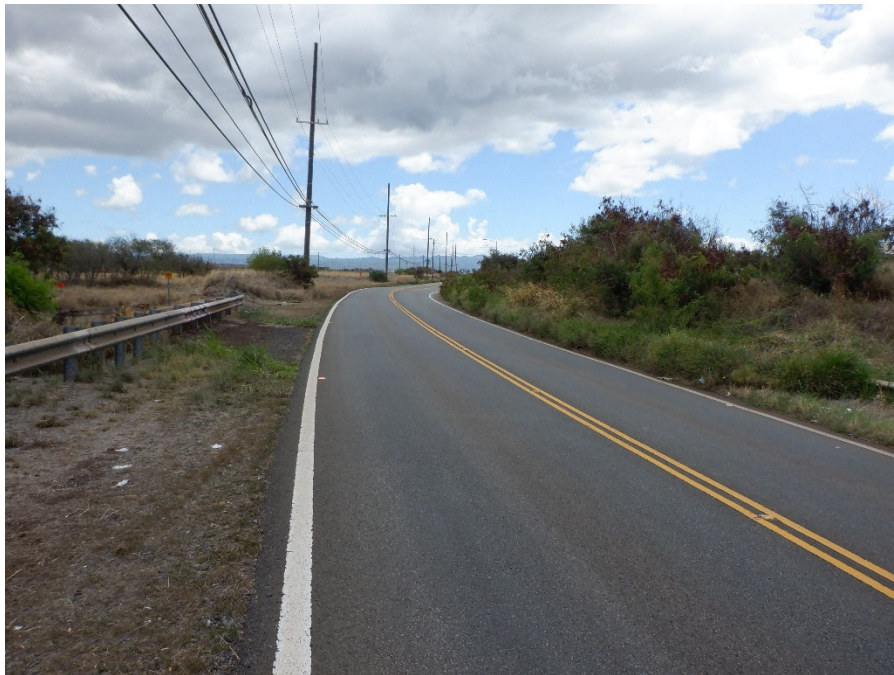
PHOTO 2 WEST APPROACH LOOKING EAST

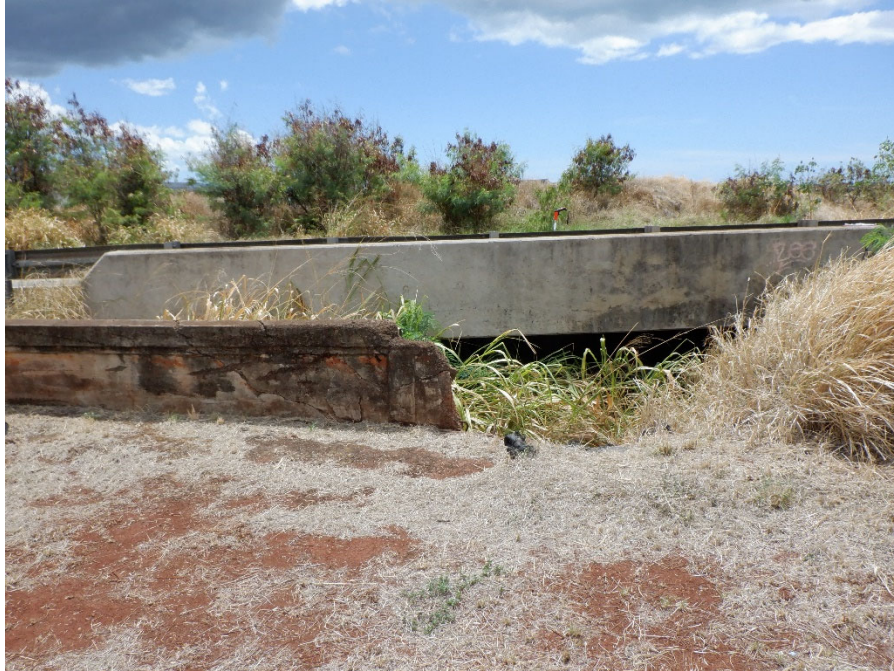
PHOTO 3 UPSTREAM ELEVATION

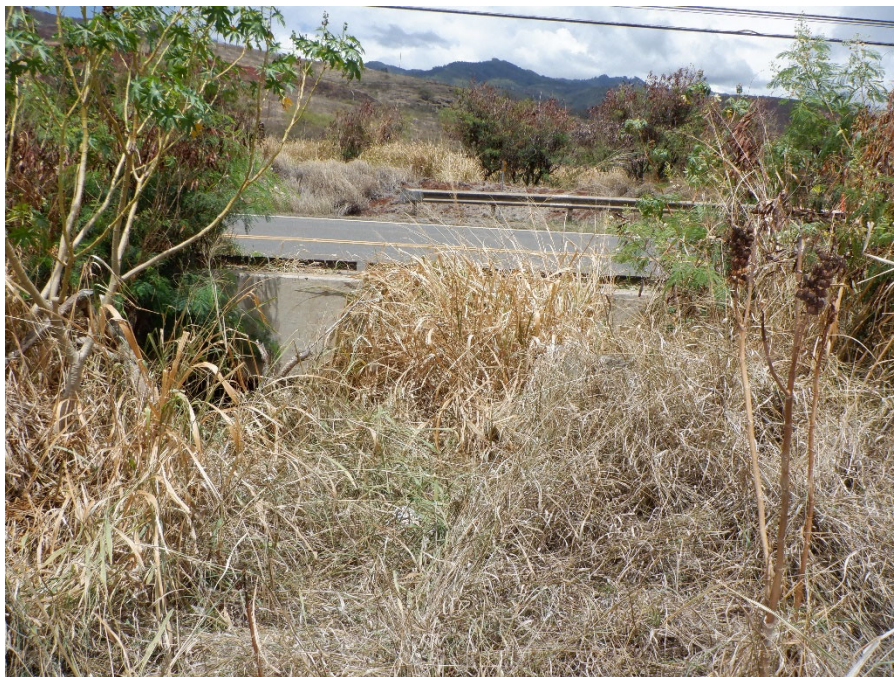
PHOTO 4 DOWNSTREAM ELEVATION

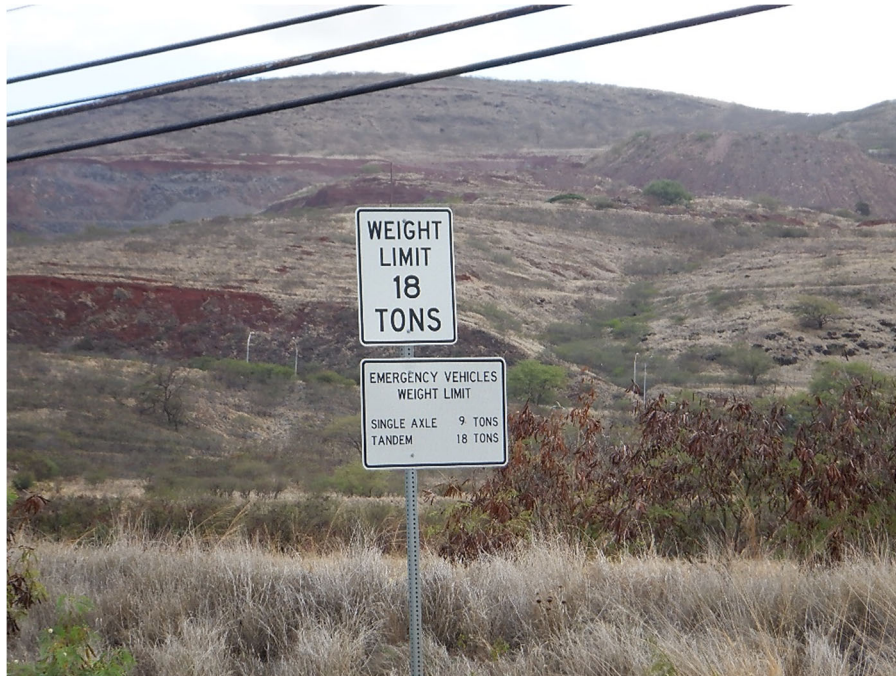
PHOTO 5 LOAD POSTING SIGNS ON FARRINGTON HIGHWAY AT EAST APPROACH TO BRIDGE

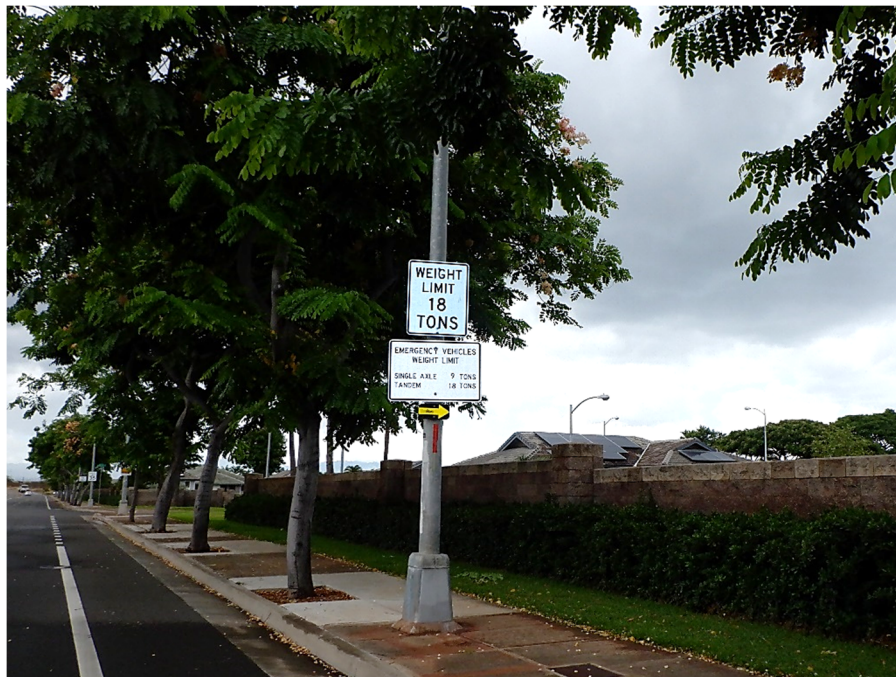
PHOTO 6 LOAD POSTING SIGNS ON FARRINGTON HIGHWAY, WEST OF KOWELO AVENUE

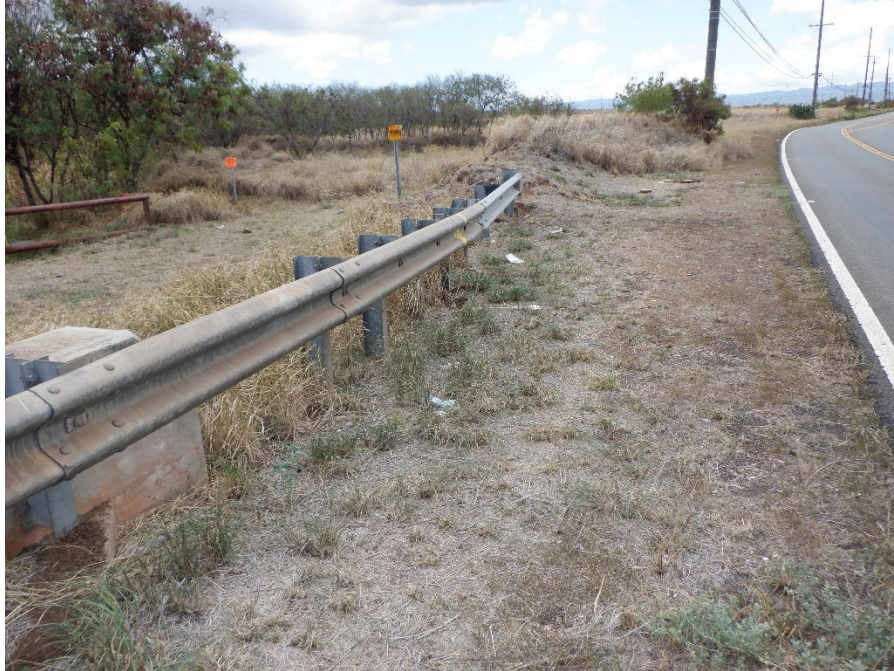
PHOTO 7 UPSTREAM EAST APPROACH GUARDRAIL

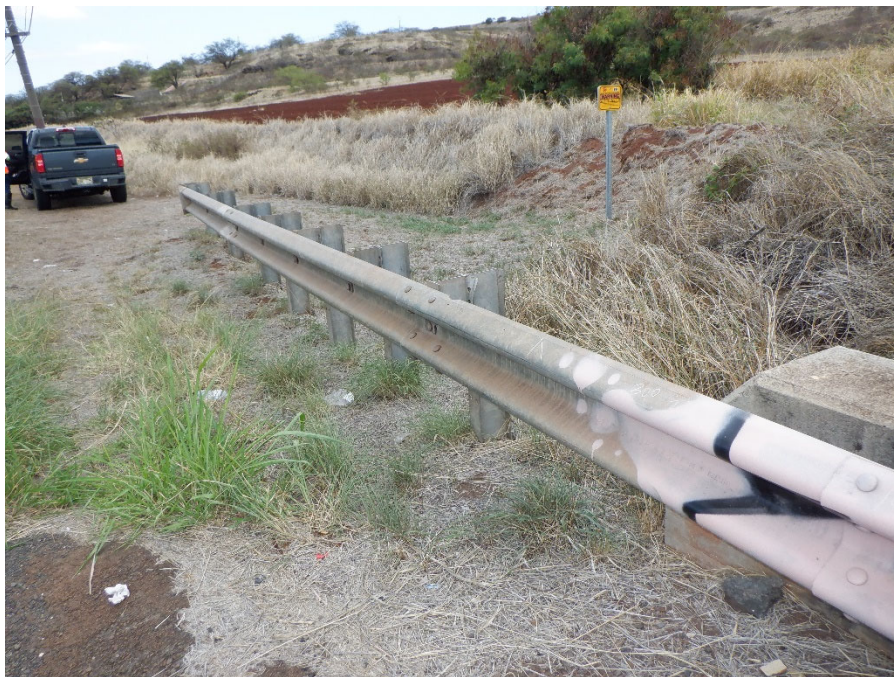
PHOTO 8 UPSTREAM WEST APPROACH GUARDRAIL

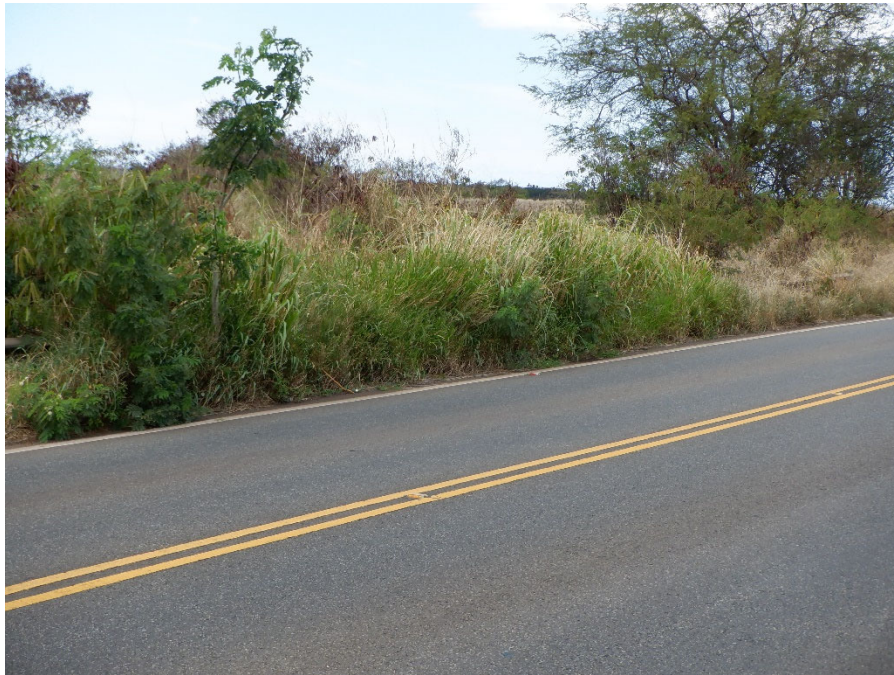
PHOTO 10 DOWNSTREAM WEST APPROACH GUARDRAIL COVERED BY HEAVY VEGETATION

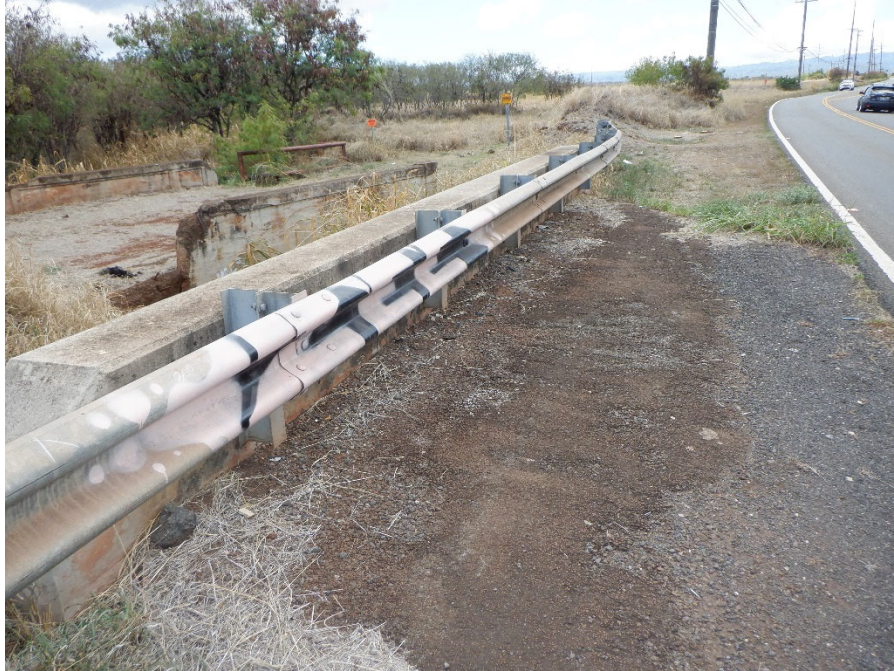
PHOTO 11 METAL GUARDRAIL ATTACHED TO UPSTREAM
CONCRETE BRIDGE RAILING

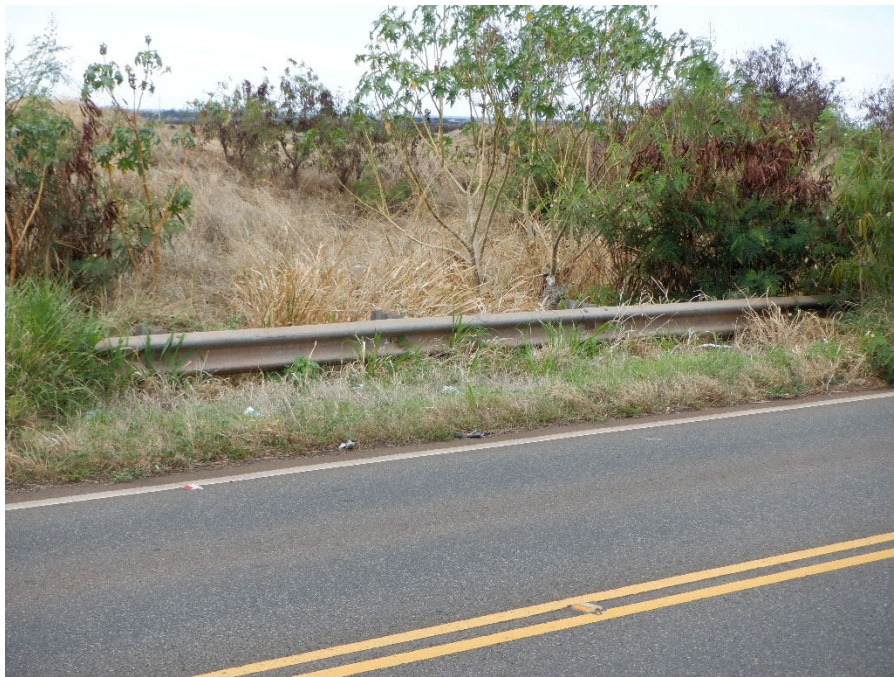
PHOTO 12 METAL GUARDRAIL ATTACHED TO DOWNSTREAM
CONCRETE BRIDGE RAILING

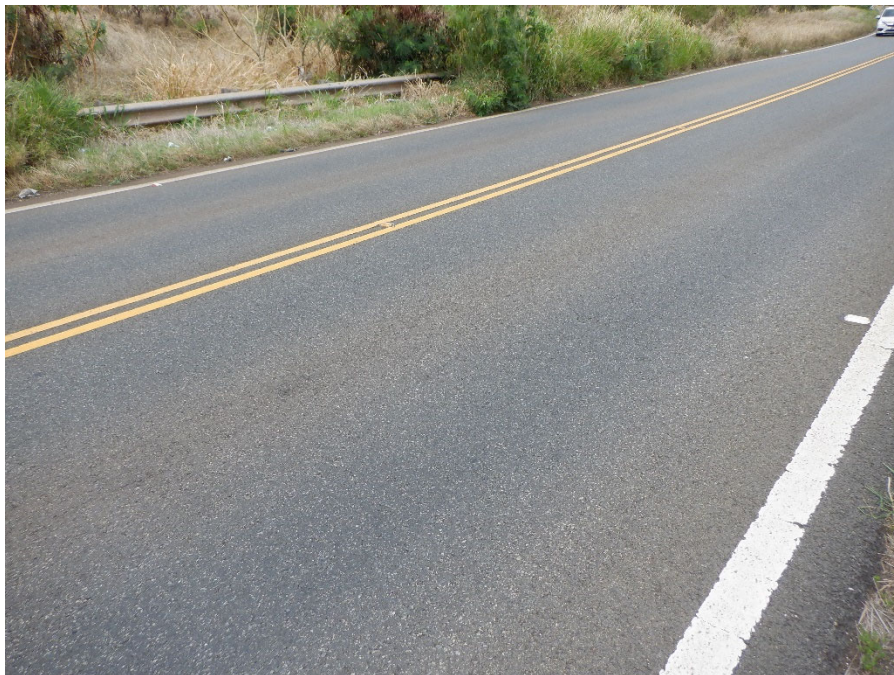
PHOTO 14 WEARING SURFACE

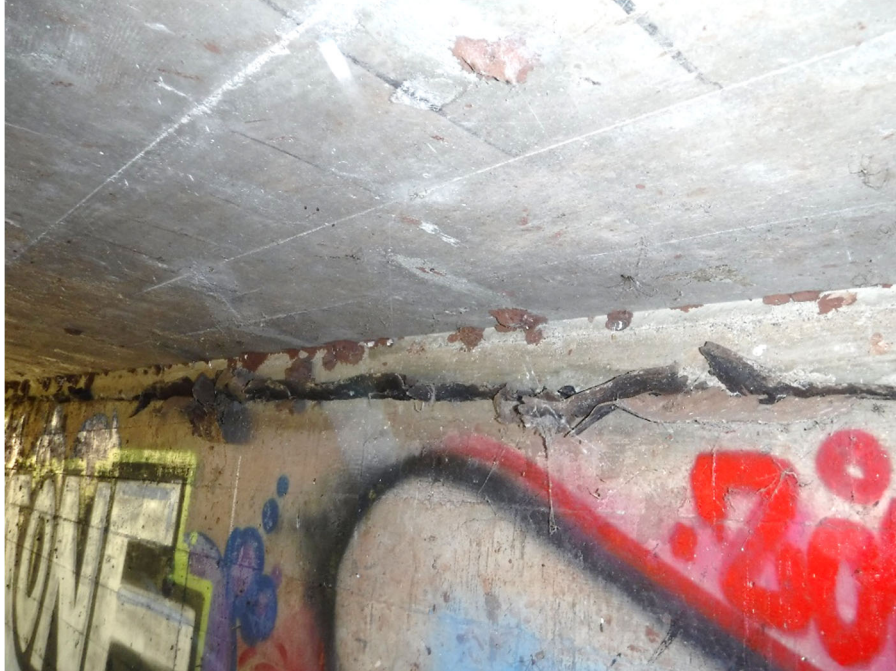
PHOTO 19 PROTRUDING ROOFING PAPER ALONG TOP OF ABUTMENT 1

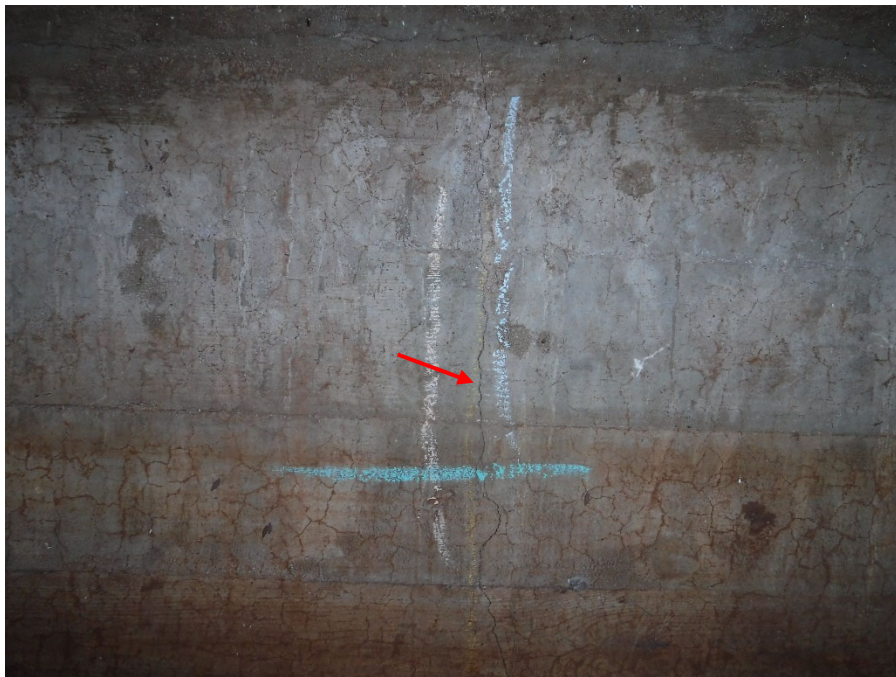
PHOTO 20 TYPICAL MODERATE WIDTH CRACK (1130 CS2) ON BOTH ABUTMENTS

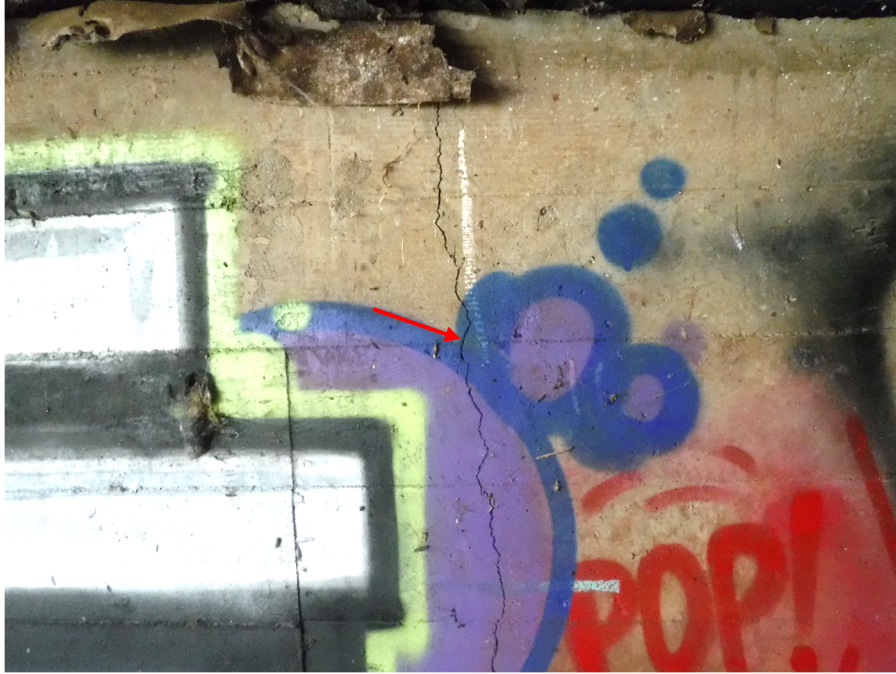
PHOTO 21 WIDE CRACK (1FT 1130 CS3) ON ABUTMENT 1, 25' FROM UPSTREAM END

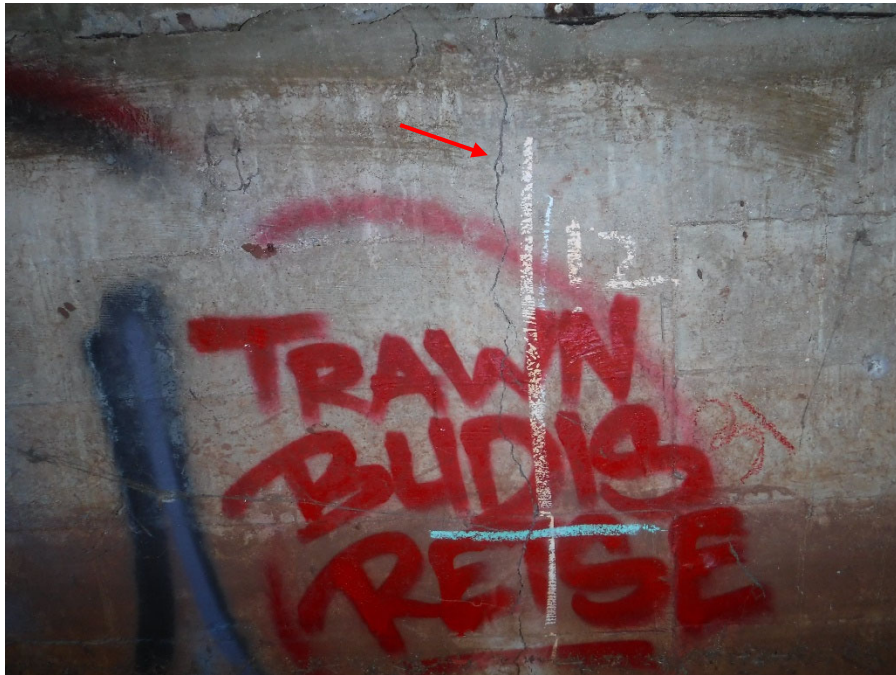
PHOTO 22 WIDE CRACK (1FT 1130 CS3) ON ABUTMENT 1, 45' FROM UPSTREAM END

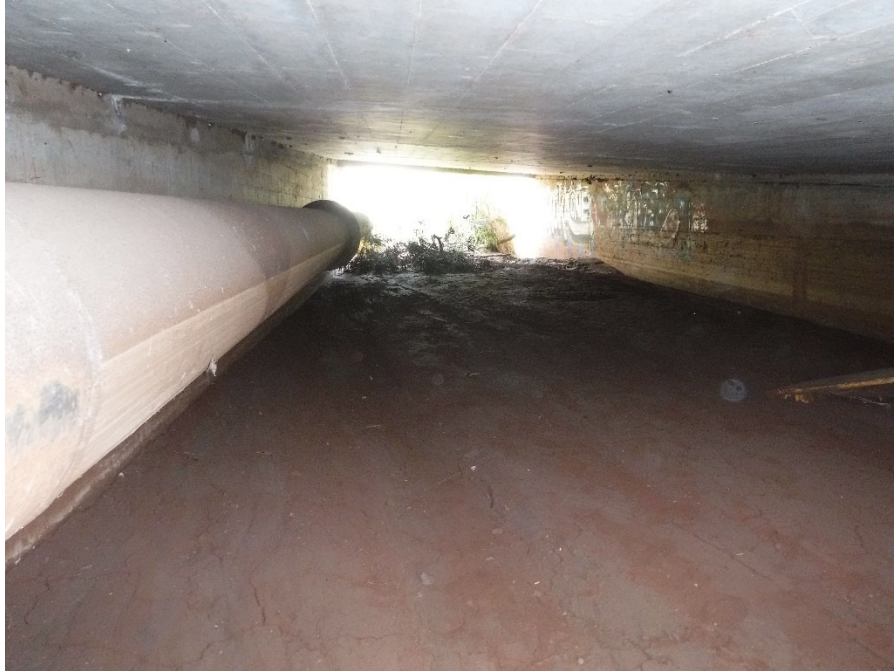
PHOTO 23 STREAM CHANNEL UNDER BRIDGE LOOKING
UPSTREAM, WITH UTILITY PIPE ALONG ABUTMENT 2

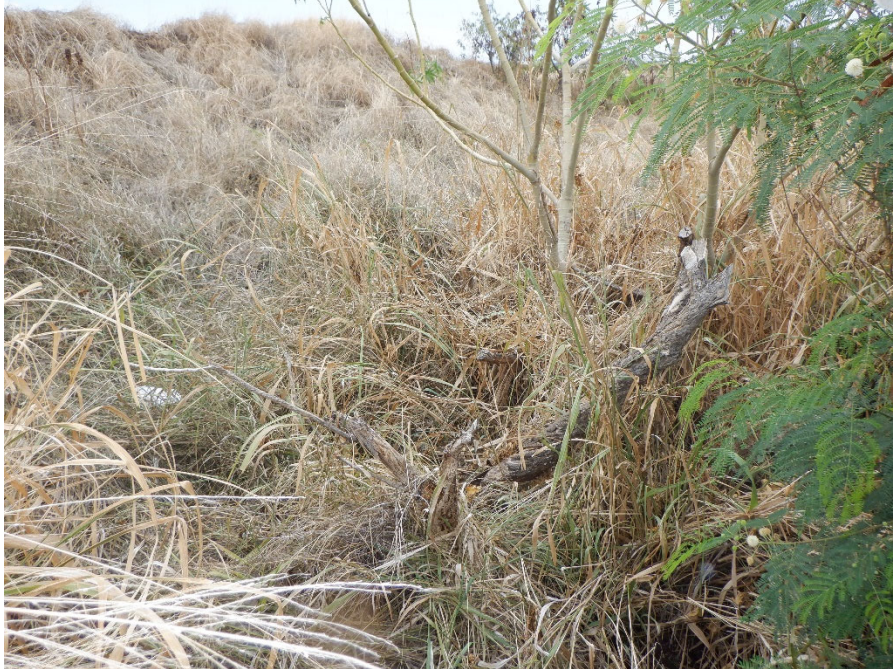
PHOTO 25 DOWNSTREAM CHANNEL WITH HEAVY VEGETATION
