APPENDIX A: PHOTOGRAPHS

Farrington Highway Bridge No. 3 Over Palehua Stream
Bridge No. 902
Structure No. 003902001100001

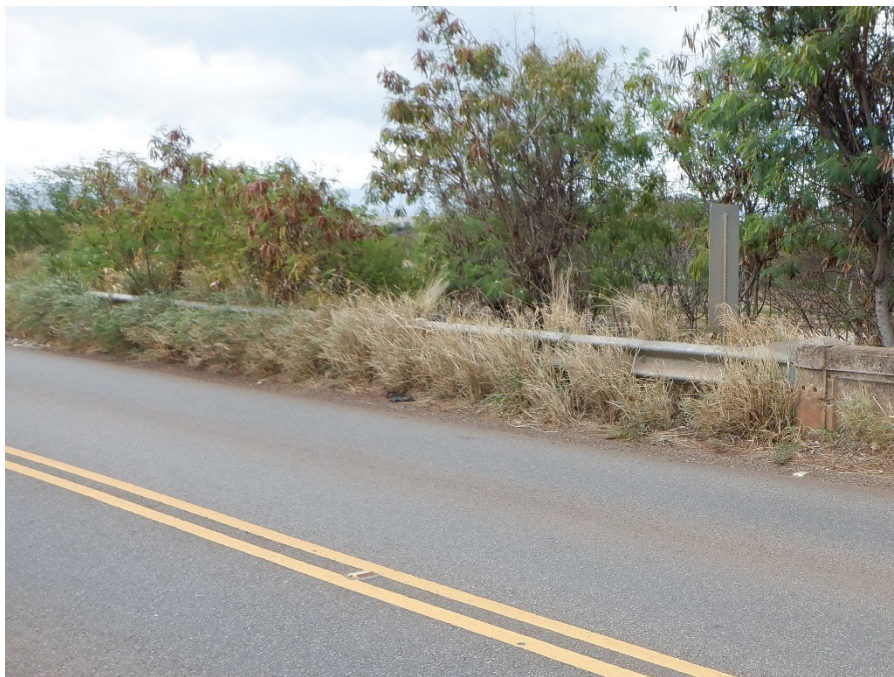
PHOTO 8 DOWNSTREAM NORTH APPROACH GUARDRAIL WITH VEGETATION

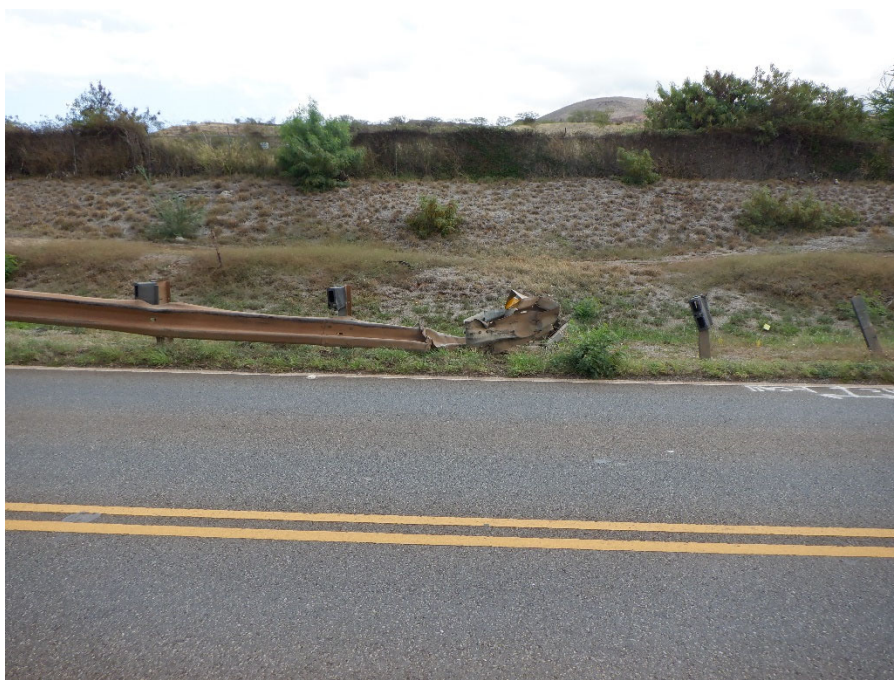
PHOTO 9 COLLISION DAMAGE TO UPSTREAM NORTH APPROACH
GUARDRAIL AND END TREATMENT

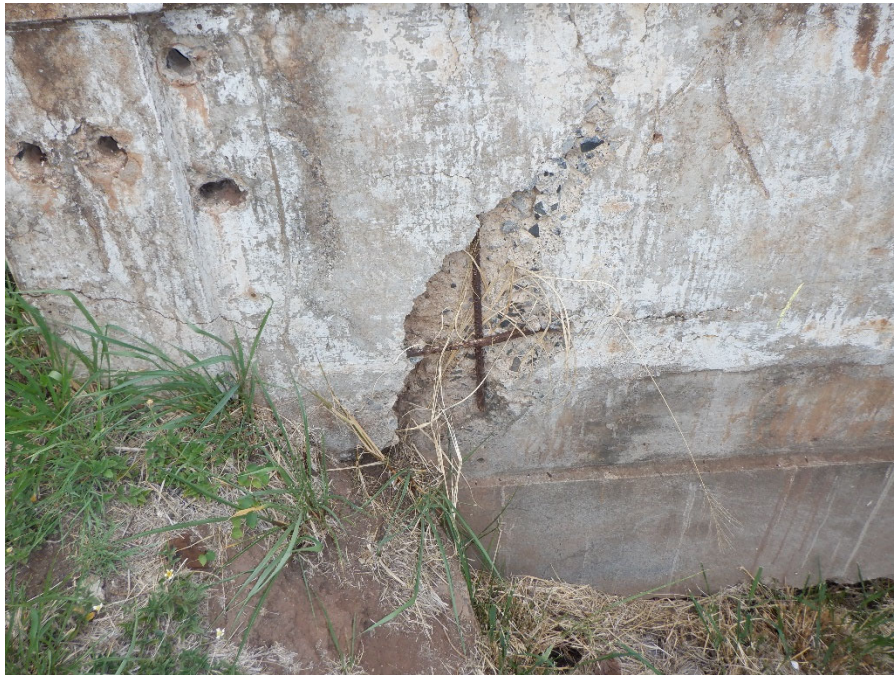
PHOTO 10 3'X3'X4" SPALL WITH EXPOSED REBAR (3FT 1080 CS3)
ON EXTERIOR FACE OF UPSTREAM RAILING, 2' FROM
NORTH END OF BRIDGE

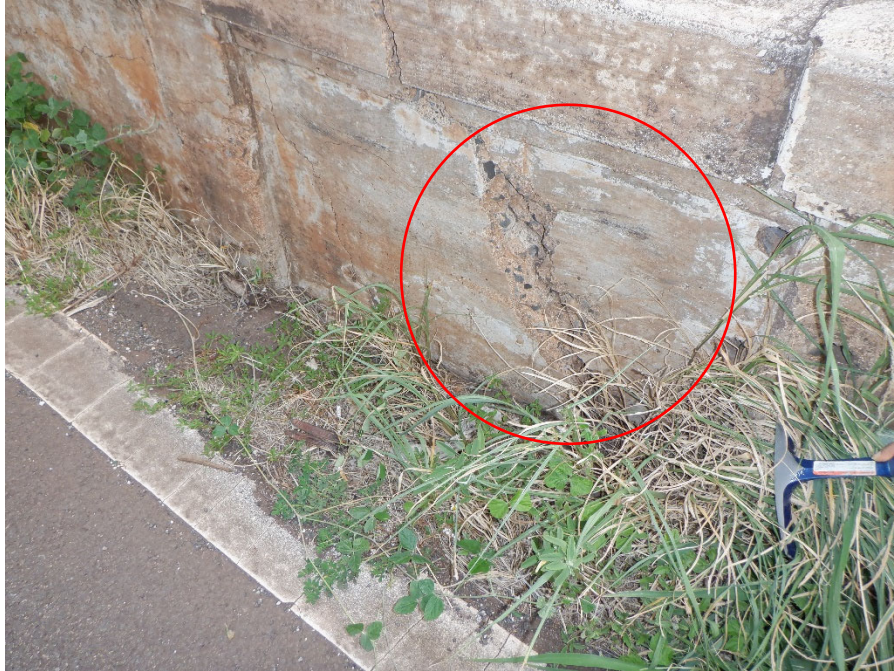
PHOTO 11 9"X1'-8"X2-1/2" SPALL (1FT 1080 CS3) ON INTERIOR FACE OF UPSTREAM RAILING, 2' FROM NORTH END OF BRIDGE

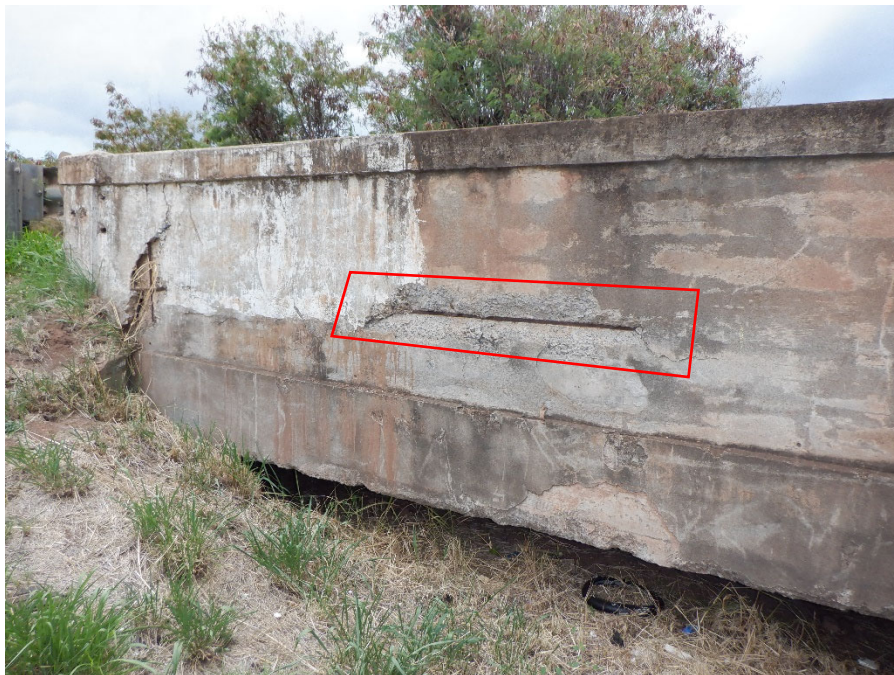
PHOTO 12 5'-3"X1'-6"X3" SPALL WITH EXPOSED REBAR (6FT 1080 CS3) ON EXTERIOR FACE OF UPSTREAM RAILING, 10' FROM NORTH END OF BRIDGE

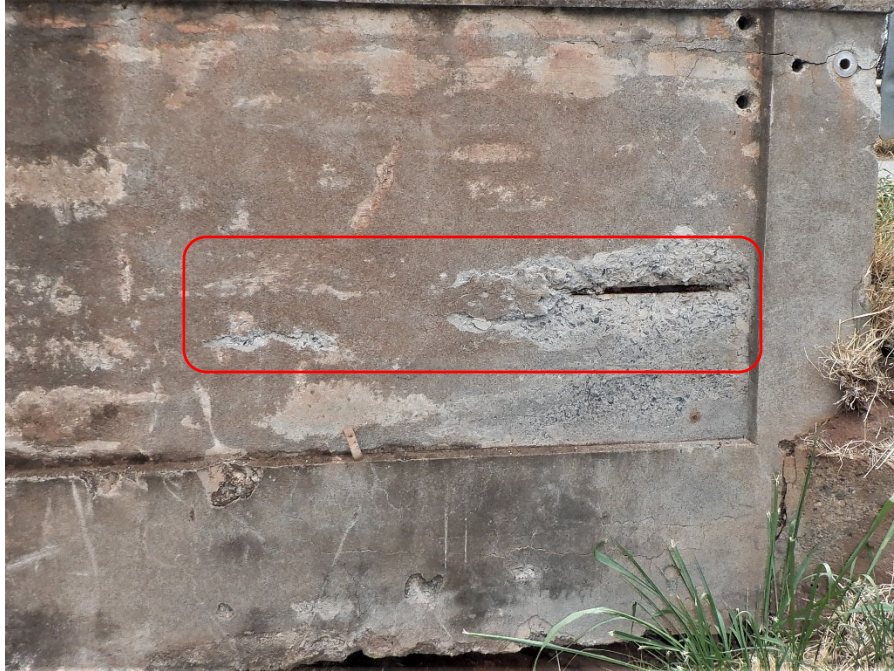
PHOTO 13 4'X1'-6"X2" SPALL WITH EXPOSED REBAR (4FT 1080 CS3)
ON EXTERIOR FACE OF UPSTREAM RAILING, 2' FROM
SOUTH END OF BRIDGE

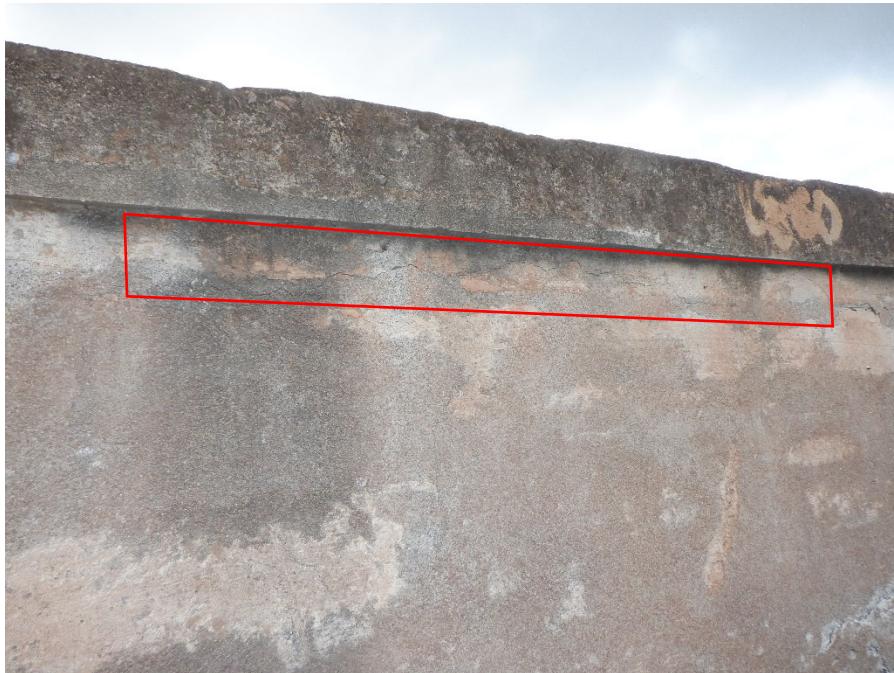
PHOTO 14 DELAMINATION (8FT 1080 CS2) ON EXTERIOR FACE OF
UPSTREAM RAILING

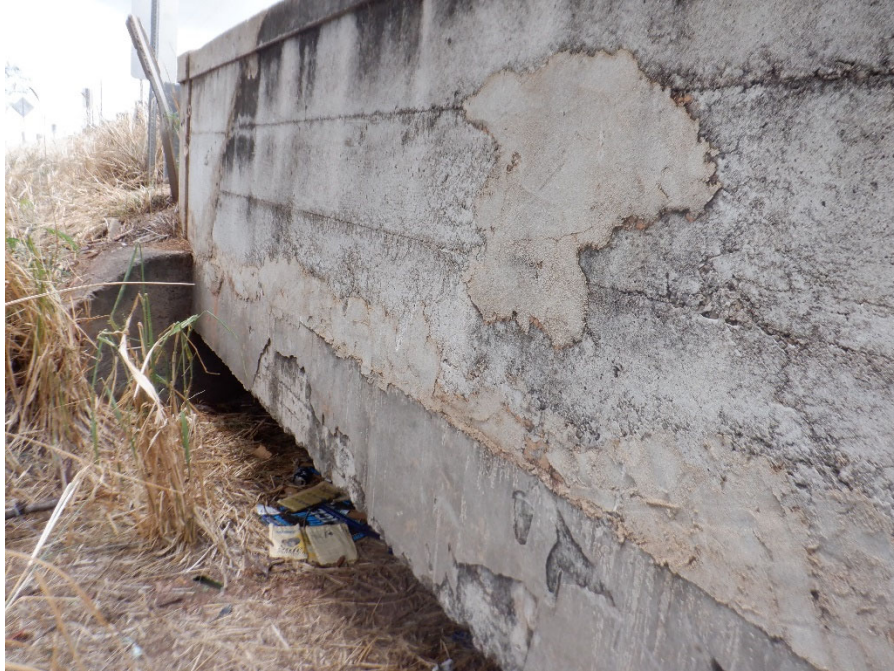
PHOTO 15 TYPICAL SOUND CONCRETE PATCHES (8FT 1080 CS2)
ON EXTERIOR FACE OF DOWNSTREAM RAILING

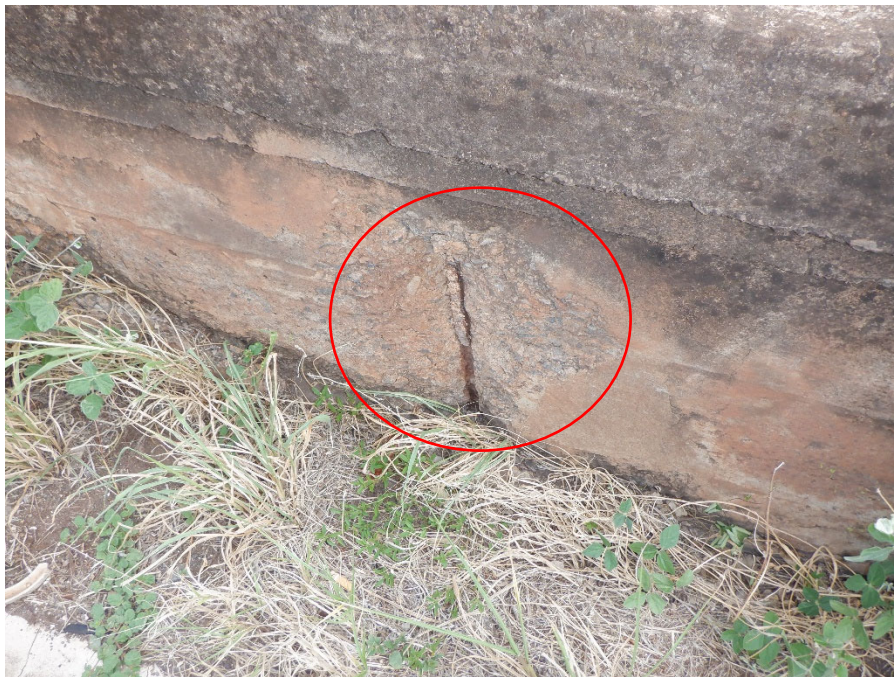
PHOTO 16 1'X1'-6"X2" SPALL WITH EXPOSED REBAR WITH 0.31 SQ.
IN SECTION LOSS (1FT 1090 CS3) ON INTERIOR FACE OF
UPSTREAM RAILING, 10' FROM NORTH END OF BRIDGE

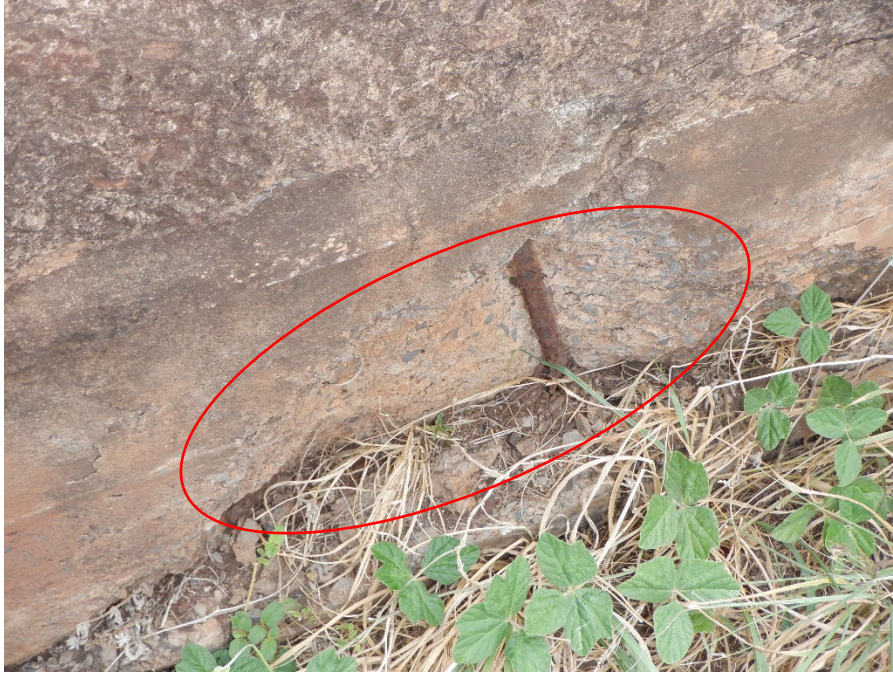
PHOTO 17 1'X1'X2" SPALL WITH EXPOSED REBAR WITH 0.31 SQ. IN SECTION LOSS (1FT 1090 CS3) ON INTERIOR FACE OF UPSTREAM RAILING, 12' FROM NORTH END OF BRIDGE

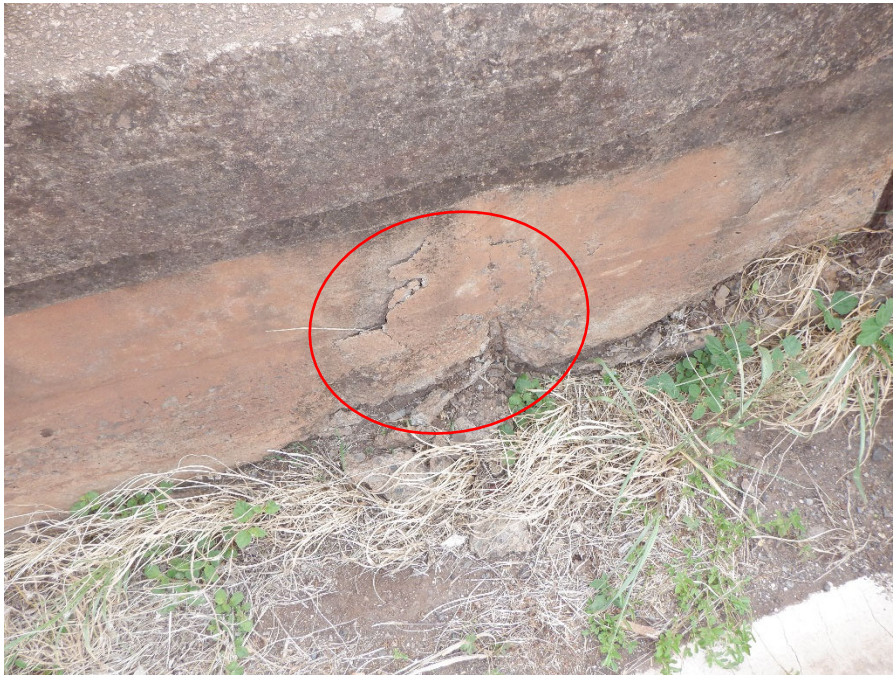
PHOTO 18 1'X1'-6"X2" SPALL WITH EXPOSED REBAR WITH 0.31 SQ. IN SECTION LOSS (1FT 1090 CS3) ON INTERIOR FACE OF UPSTREAM RAILING, 14' FROM NORTH END OF BRIDGE

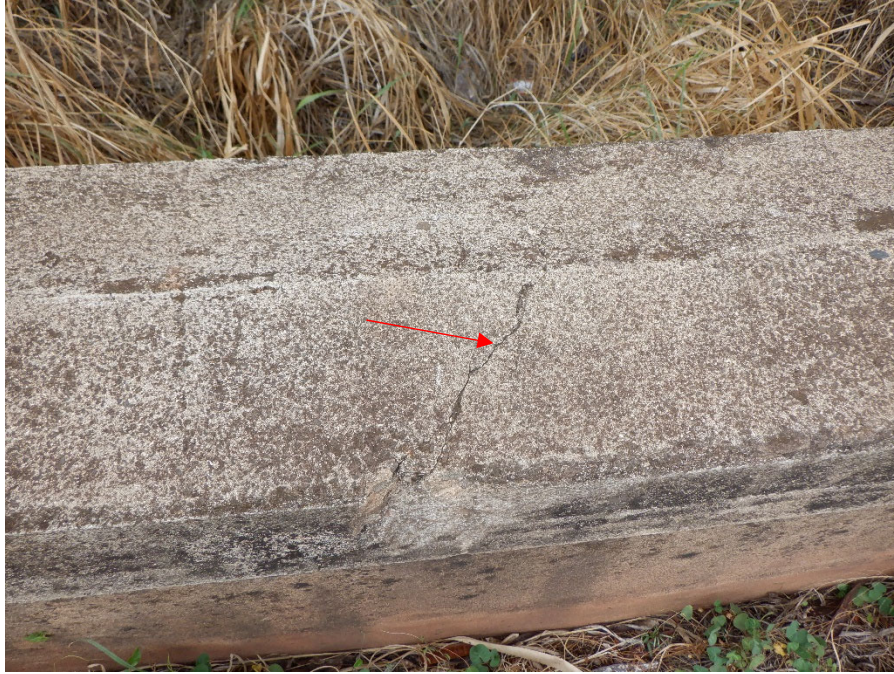
PHOTO 19 TYPICAL MODERATE WIDTH CRACK (1130 CS2) ON BOTH BRIDGE RAILINGS

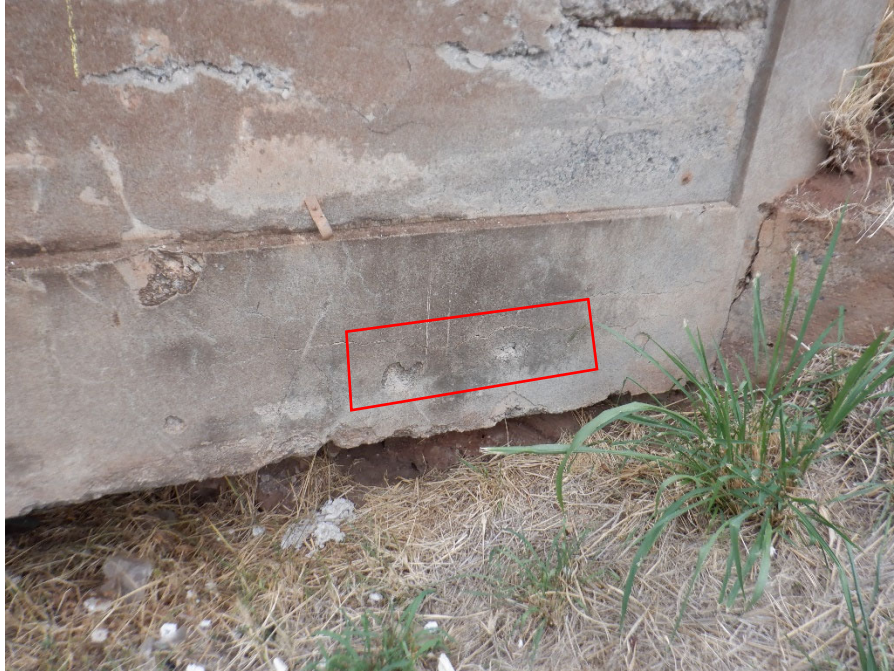
PHOTO 21 3'X1' DELAMINATION (3SF 1080 CS3) ON UPSTREAM
FACE OF SLAB ADJACENT TO ABUTMENT 1

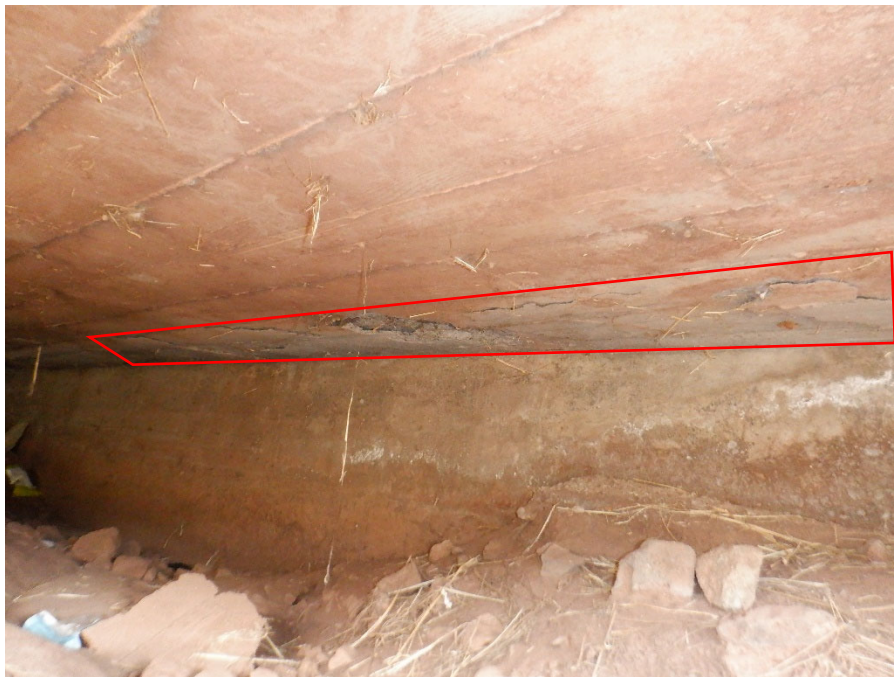
PHOTO 22 14'X2' DELAMINATION (28SF 1080 CS3) ON SLAB SOFFIT
ALONG ABUTMENT 1 STARTING FROM UPSTREAM END

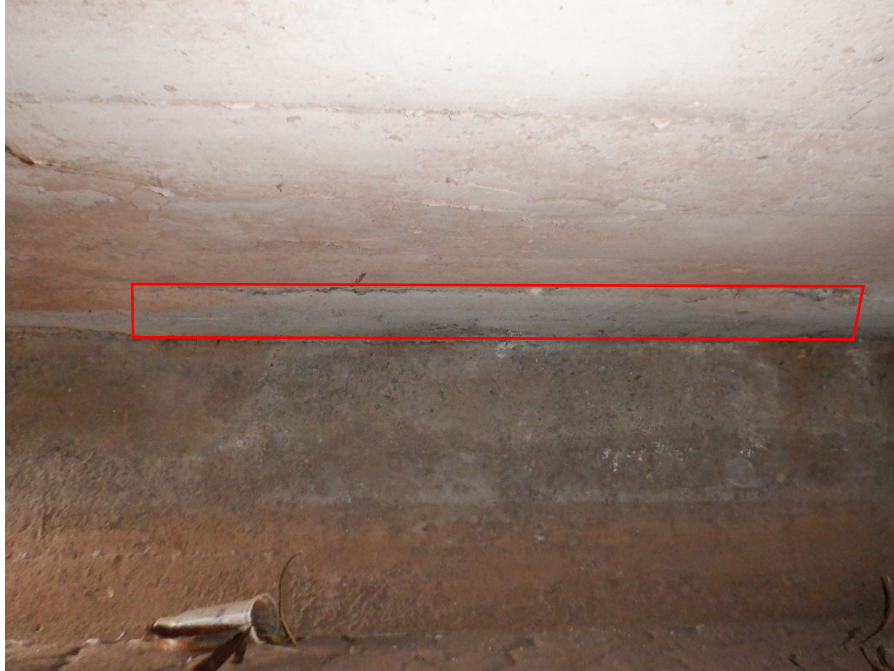
PHOTO 23 8'X2' DELAMINATION (16SF 1080 CS3) ON SLAB SOFFIT
ALONG ABUTMENT 1, 5' FROM DOWNSTREAM END

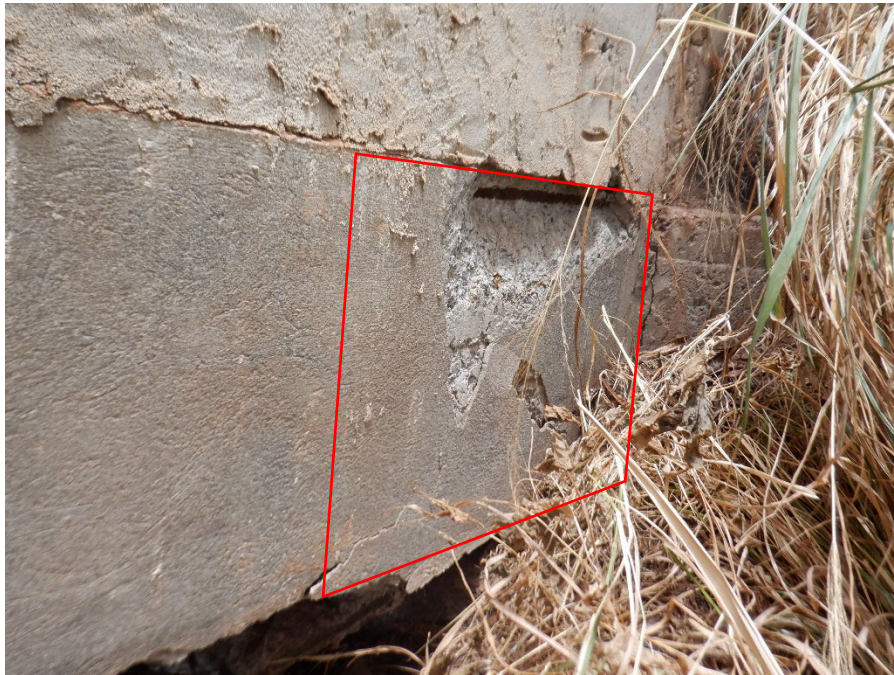
PHOTO 24 2'X2' DELAMINATION AND SPALL WITH EXPOSED REBAR
(4SF 1080 CS3) ON DOWNSTREAM FACE OF SLAB AT
ABUTMENT 2

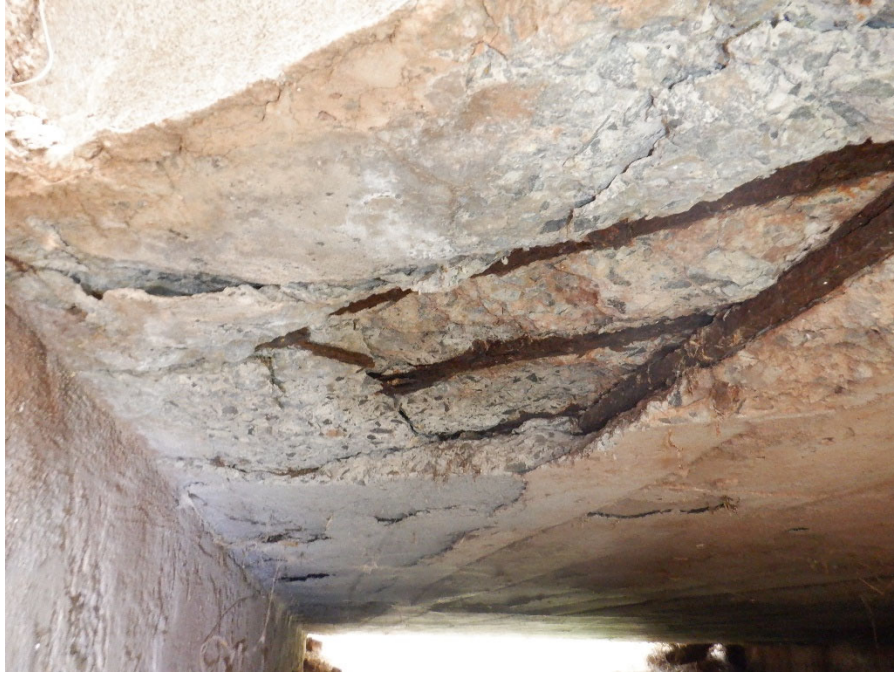
PHOTO 25 2'X2' SPALL WITH EXPOSED REBAR WITH 0.0123 SQ. IN SECTION LOSS (4SF 1090 CS3) ON SLAB SOFFIT AT DOWNSTREAM END OF SLAB SOFFIT ADJACENT TO ABUTMENT 1

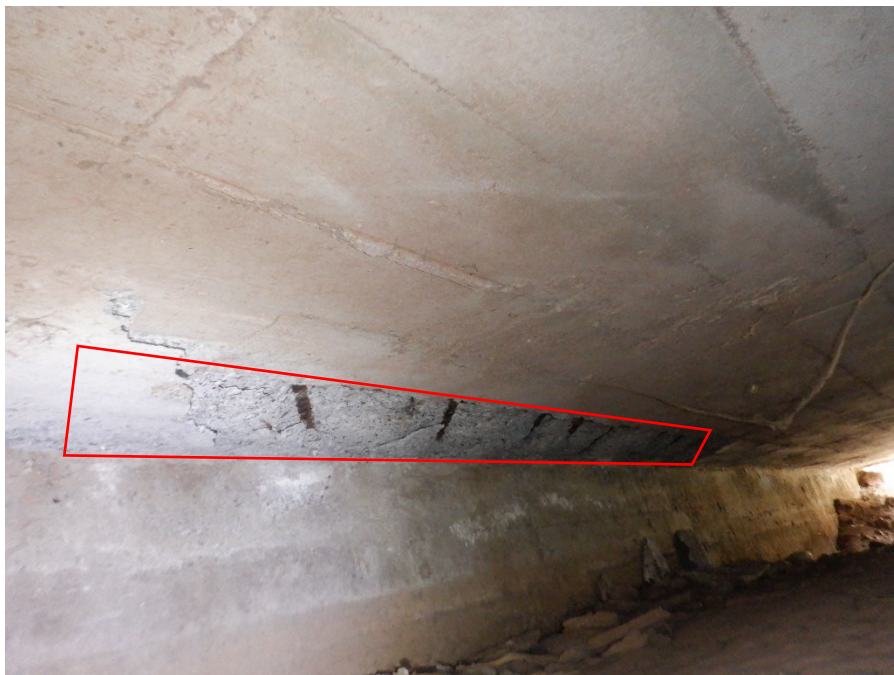
PHOTO 26 12'X2' SPALL WITH EXPOSED REBAR WITH 0.0123 SQ. IN SECTION LOSS (24SF 1090 CS3) ON SLAB SOFFIT ALONG ABUTMENT 1, 10' FROM DOWNSTREAM END

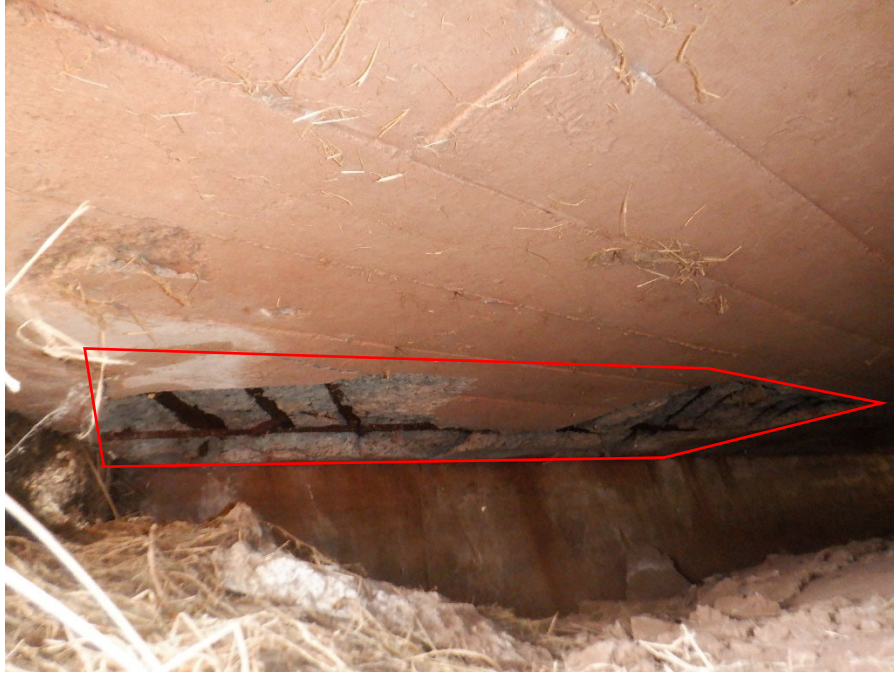
PHOTO 27 10'X2' SPALL WITH EXPOSED REBAR WITH 0.0123 SQ. IN SECTION LOSS (20SF 1090 CS3) ON SLAB SOFFIT ALONG ABUTMENT 2 STARTING FROM UPSTREAM END

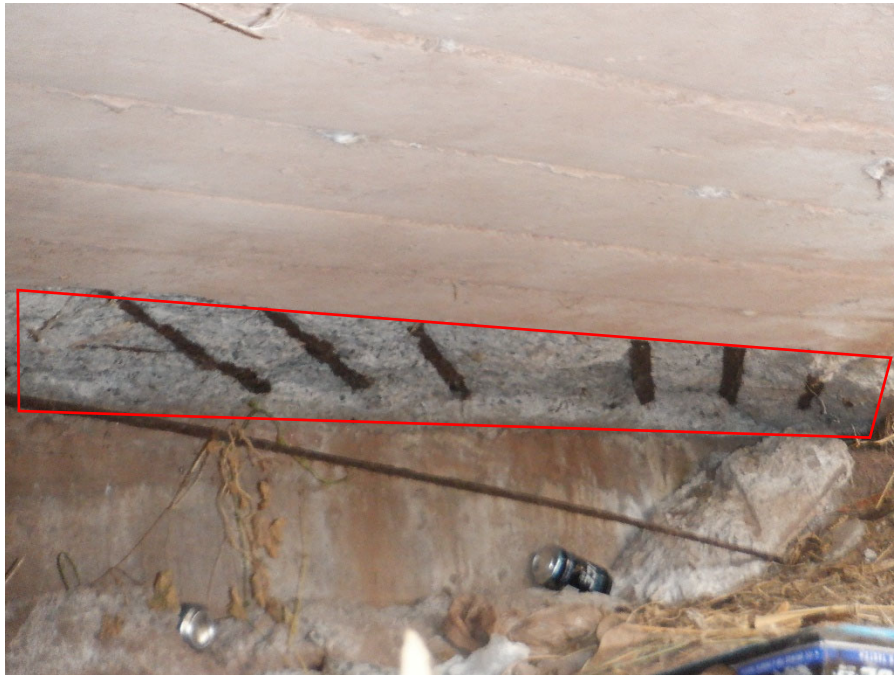
PHOTO 28 8'X3' SPALL WITH EXPOSED REBAR WITH 0.0123 SQ. IN SECTION LOSS (24SF 1090 CS3) ON SLAB SOFFIT ALONG ABUTMENT 2 STARTING FROM DOWNSTREAM END

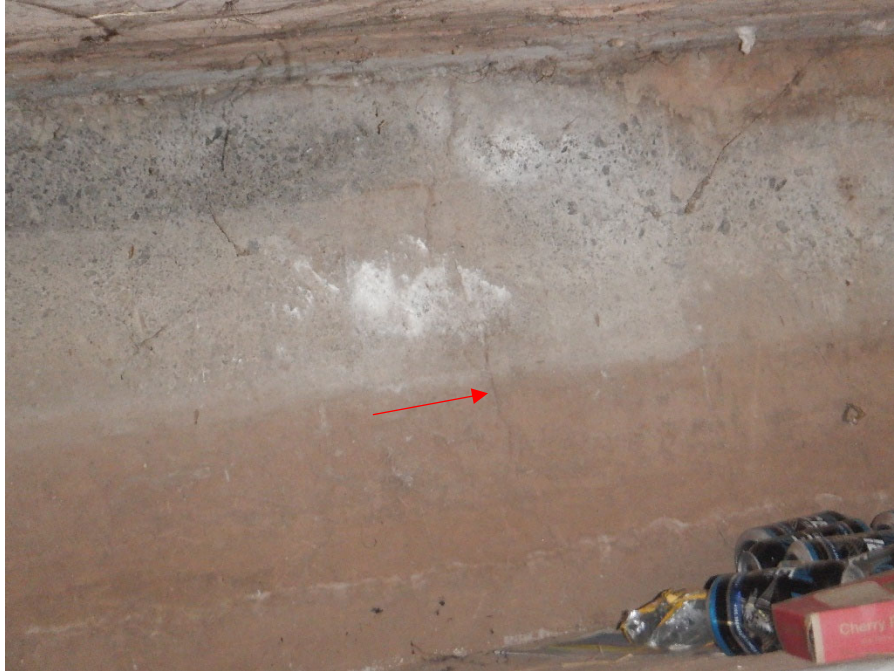
PHOTO 31 MODERATE WIDTH VERTICAL CRACK (1FT 1130 CS2) ON ABUTMENT 2

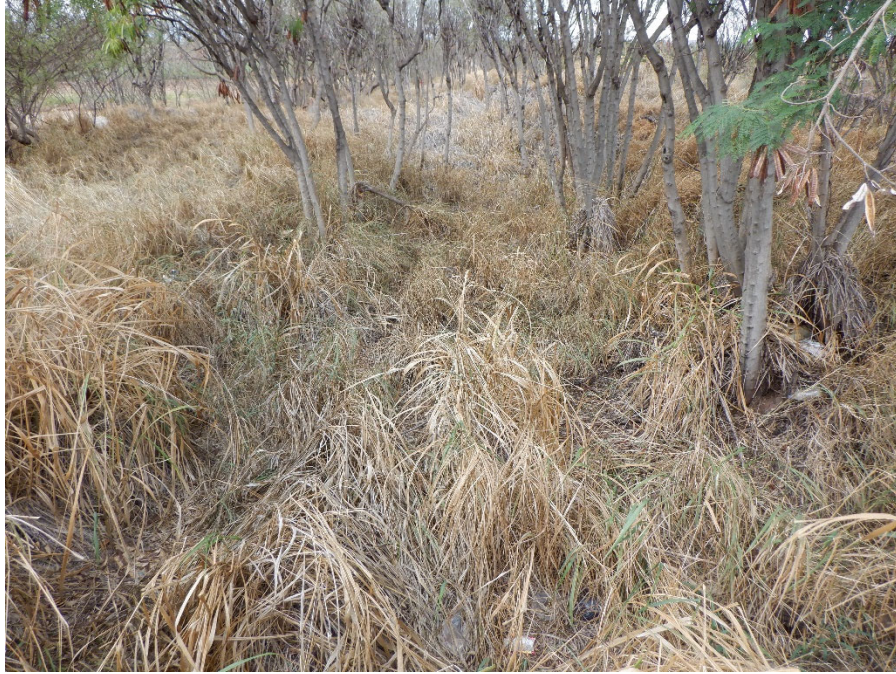
PHOTO 33 DOWNSTREAM CHANNEL WITH VEGETATION GROWTH
