APPENDIX A: PHOTOGRAPHS

Farrington Highway Bridge Over Honouliuli Stream
Bridge No. 922
Structure No. 003922001100001

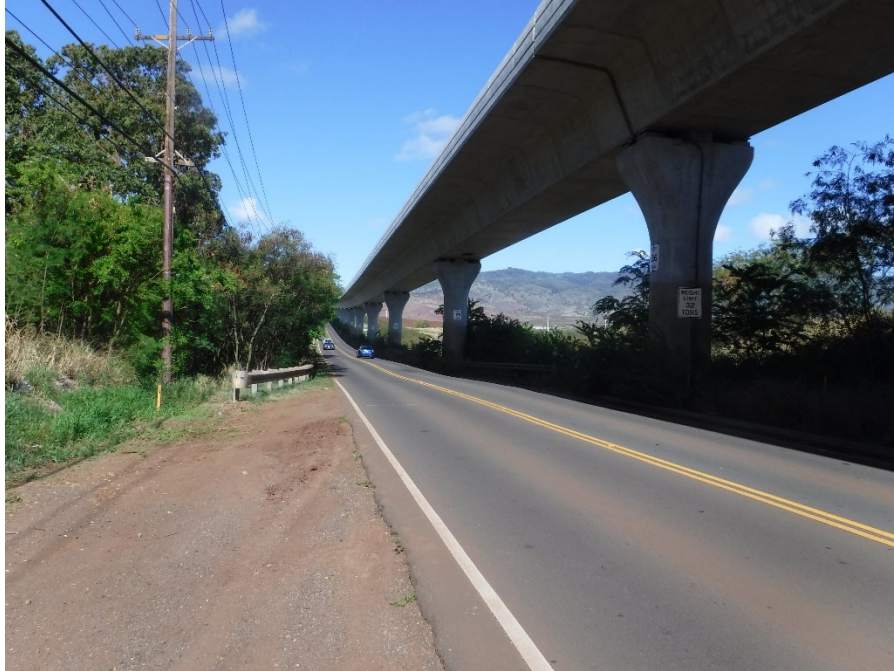
PHOTO 1 EAST APPROACH LOOKING WEST

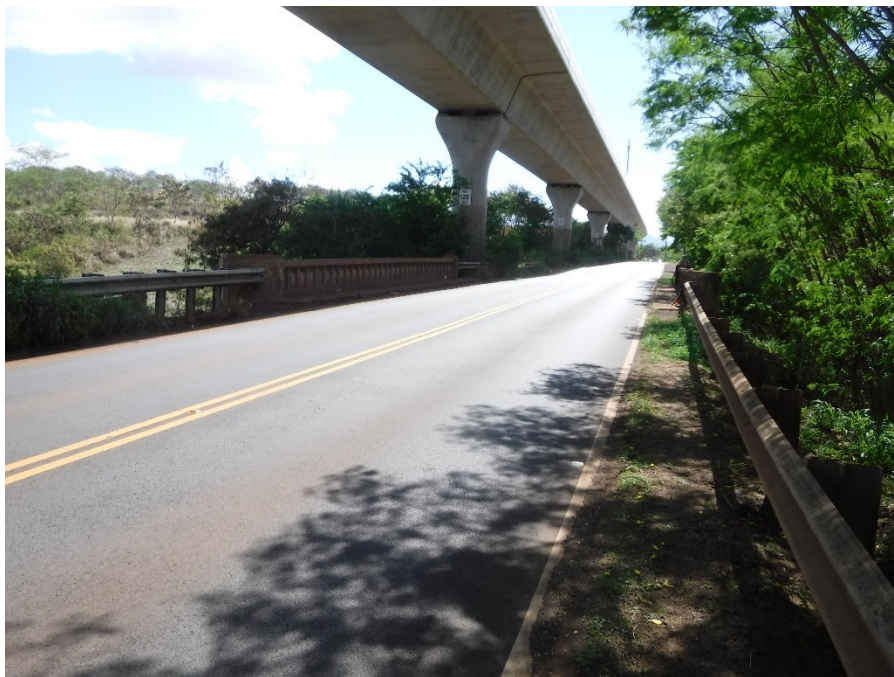
PHOTO 2 WEST APPROACH LOOKING EAST

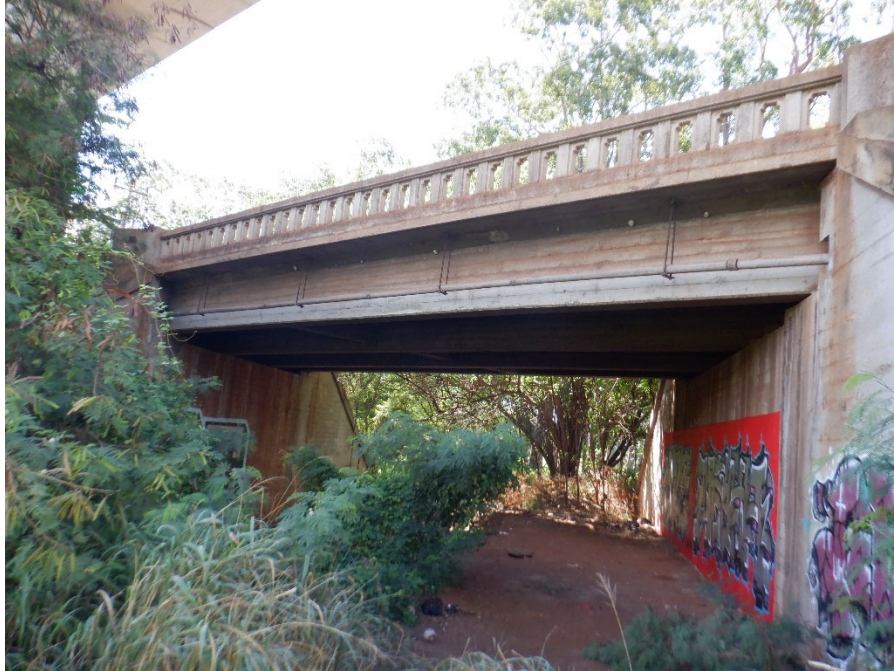
PHOTO 3 UPSTREAM ELEVATION

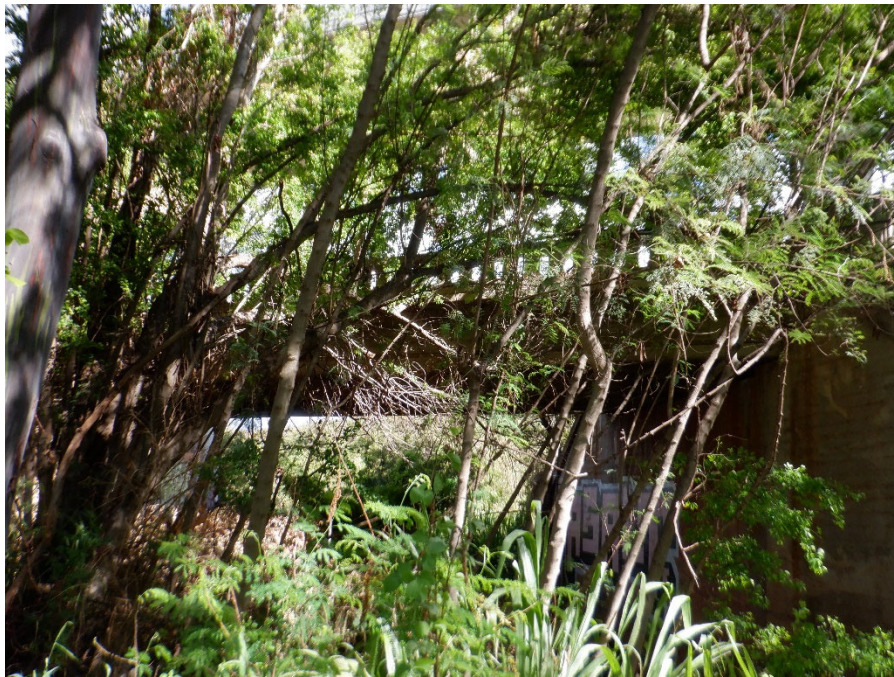
PHOTO 4 DOWNSTREAM ELEVATION

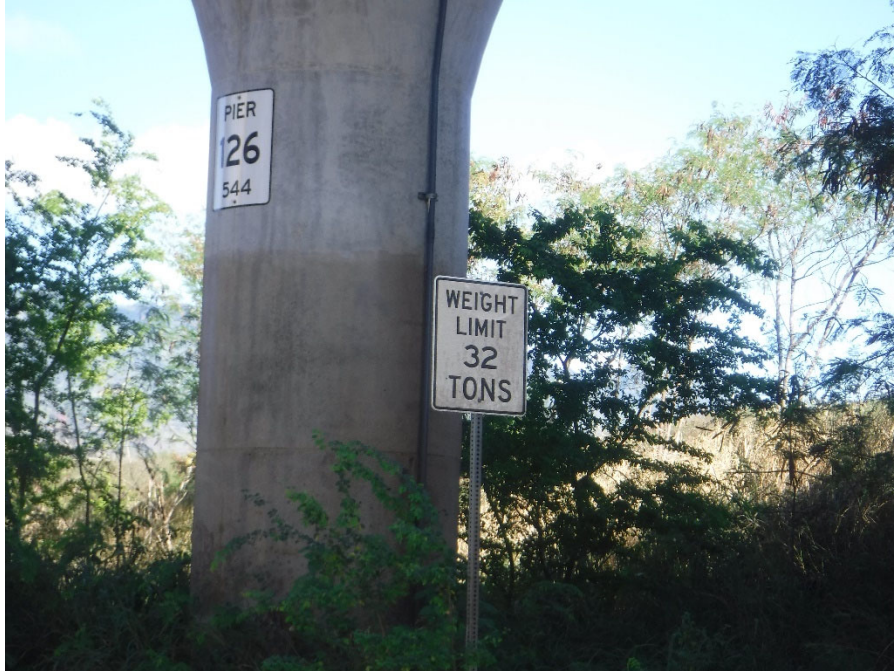
PHOTO 5 LOAD POSTING SIGN ON FARRINGTON HIGHWAY AT
UPSTREAM EAST APPROACH TO BRIDGE

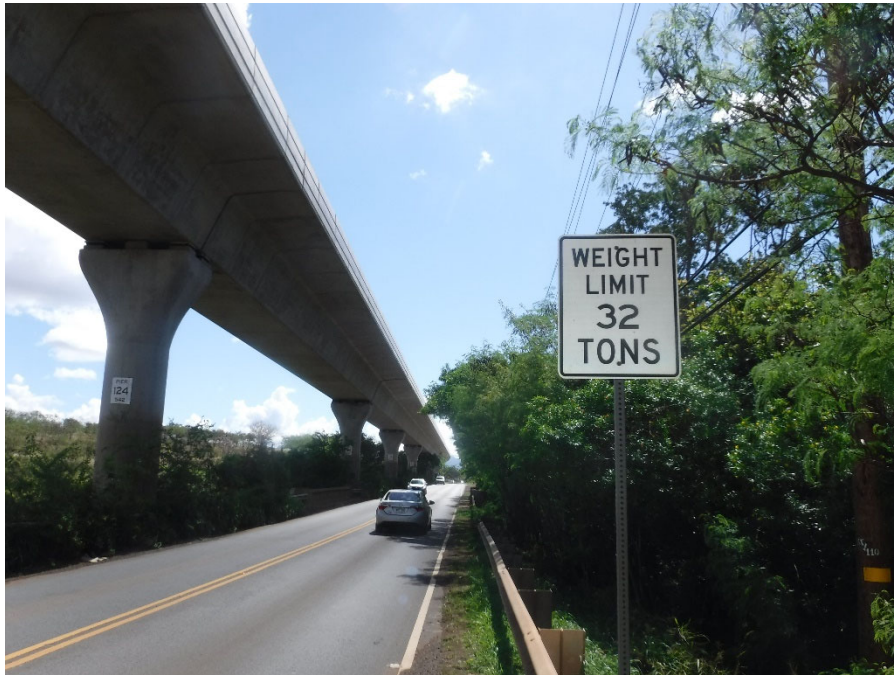
PHOTO 6 LOAD POSTING SIGN ON FARRINGTON HIGHWAY AT
DOWNSTREAM WEST APPROACH TO BRIDGE

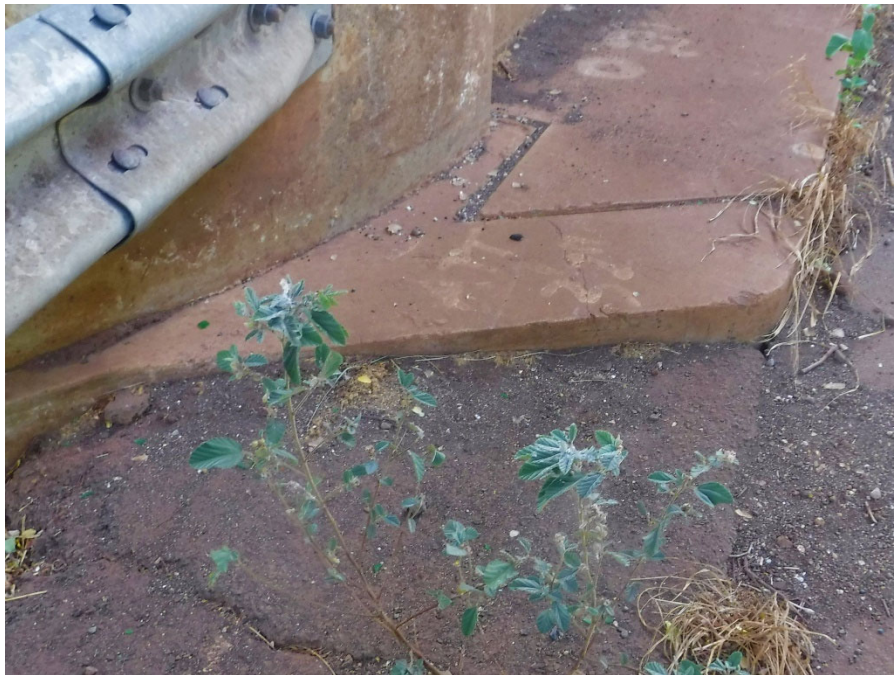
PHOTO 8 3-1/2" VERTICAL DIFFERENTIAL AT WEST APPROACH TO UPSTREAM SIDEWALK

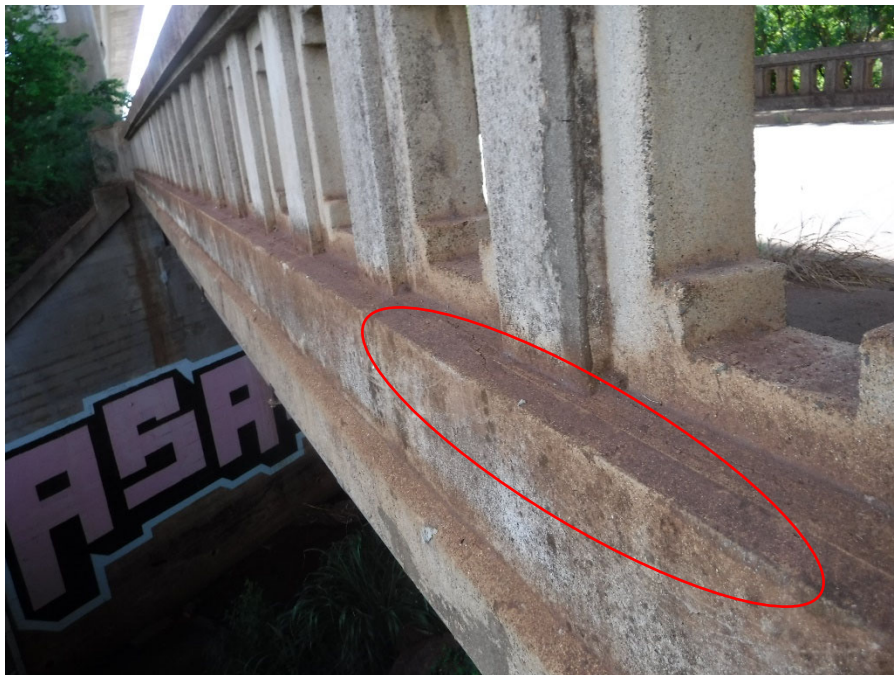
PHOTO 10 3'X4" DELAMINATION (3FT 1080 CS2) ON EXTERIOR FACE OF UPSTREAM BOTTOM RAIL NEAR WEST END OF BRIDGE

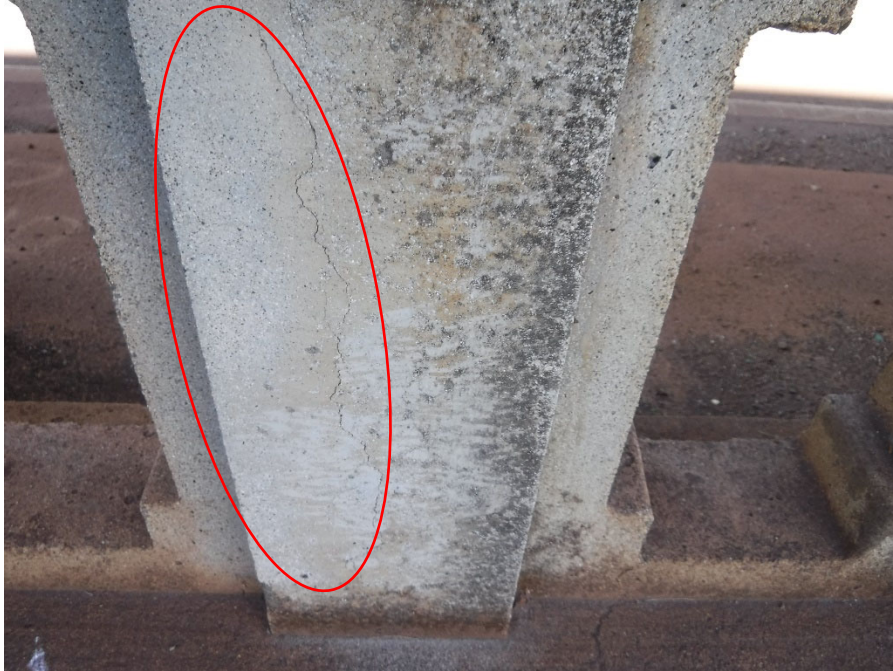
PHOTO 11 TYPICAL DELAMINATION (1080 CS2) ON EXTERIOR FACE OF UPSTREAM RAILING PICKET

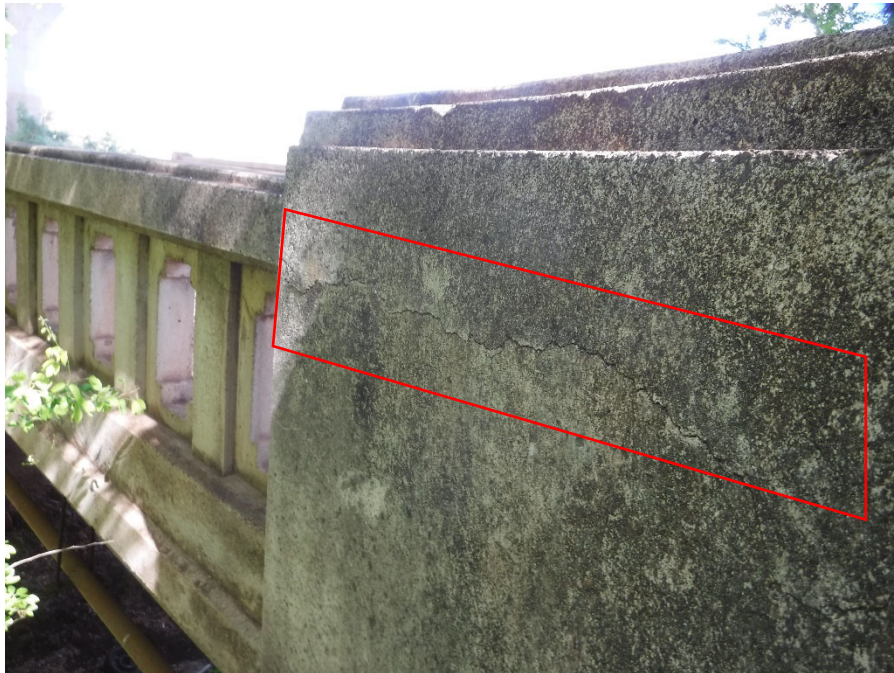
PHOTO 14 4FT LONG HORIZONTAL CRACK AND DELAMINATION
(4FT 1080 CS2) ON EXTERIOR FACE OF DOWNSTREAM
EAST END POST

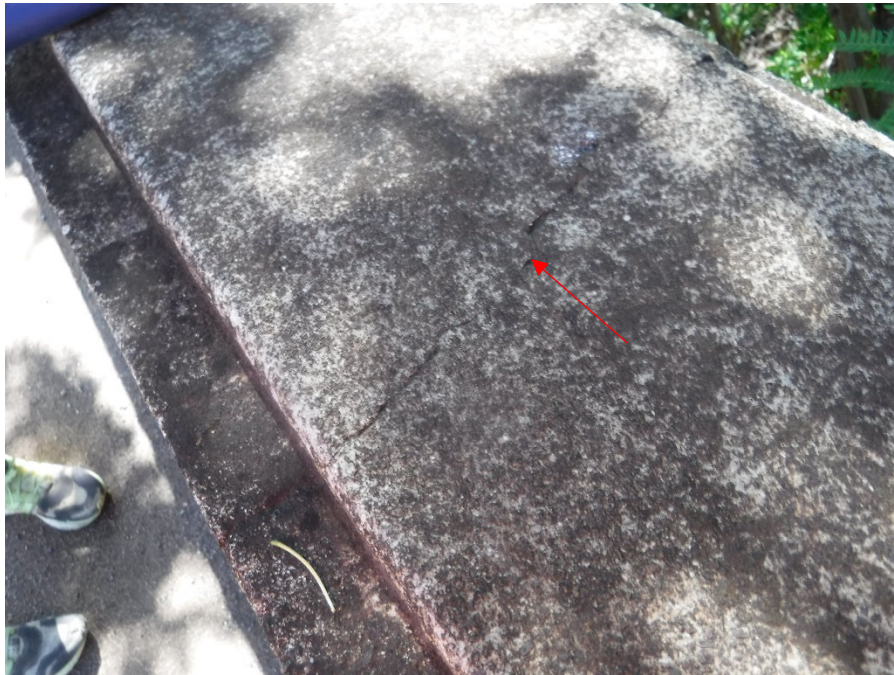
PHOTO 16 TYPICAL MODERATE WIDTH CRACK (1130 CS2) ON BOTH BRIDGE RAILINGS

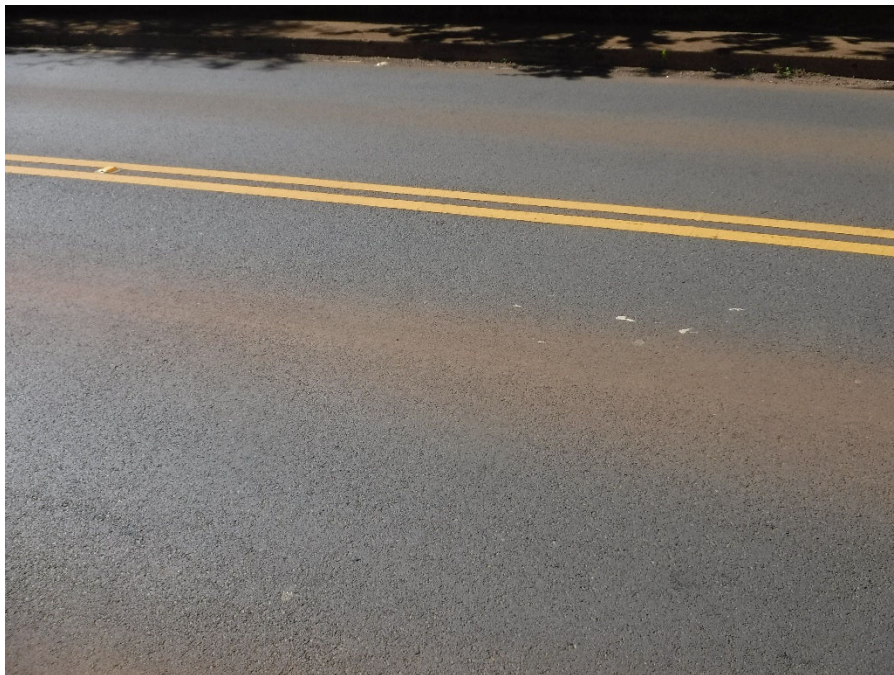
PHOTO 18 WEARING SURFACE

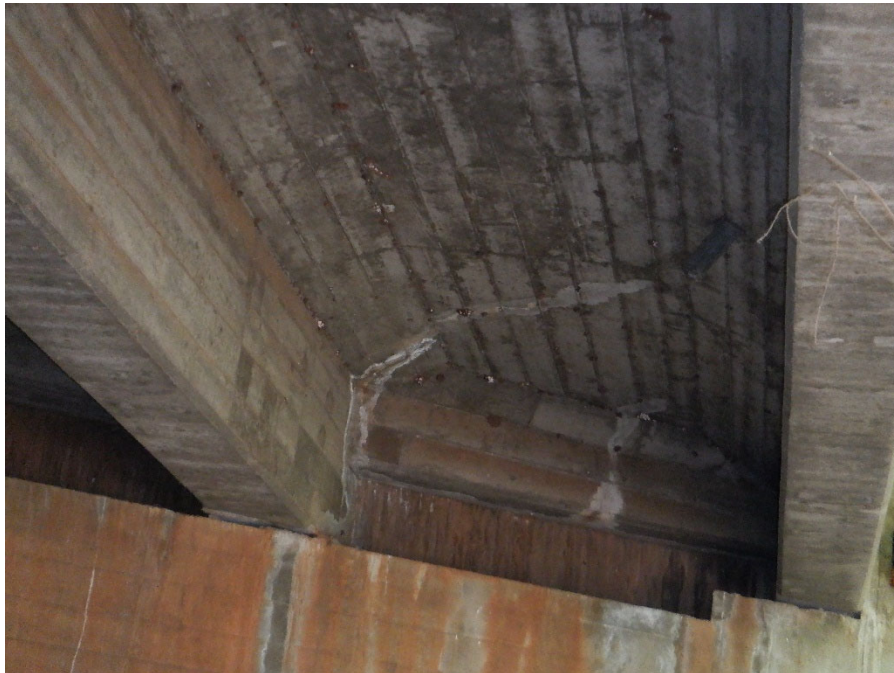
PHOTO 20 MODERATE WIDTH DIAGONAL CRACK WITH EFFLORESCENCE (8SF 1120 CS2) ON TOP FLANGE SOFFIT BETWEEN GIRDERS G3 AND G4 NEAR ABUTMENT 1

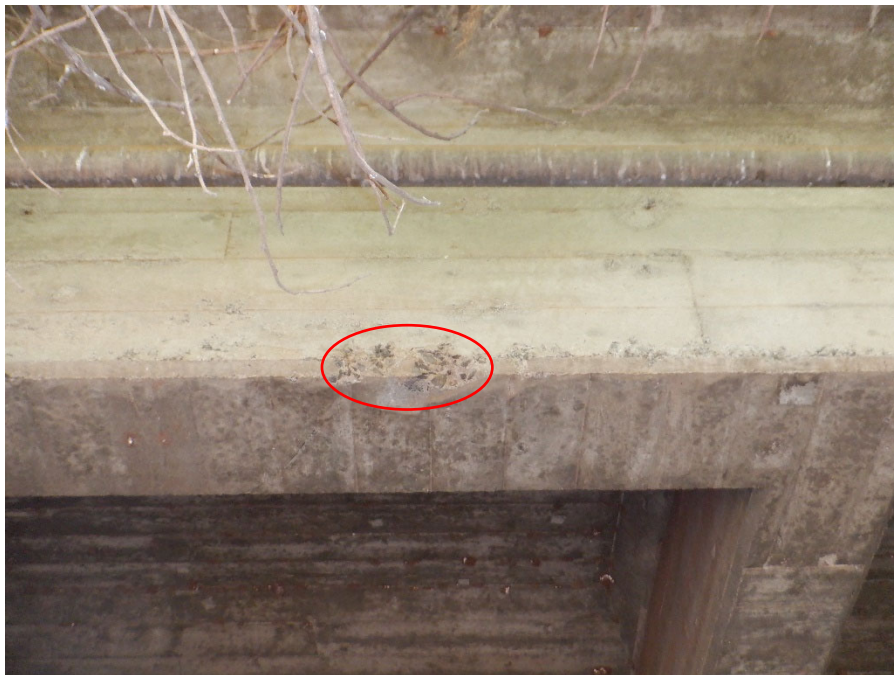
PHOTO 22 6"X2"X2" EDGE SPALL (1FT 1080 CS2) ON GIRDER G4

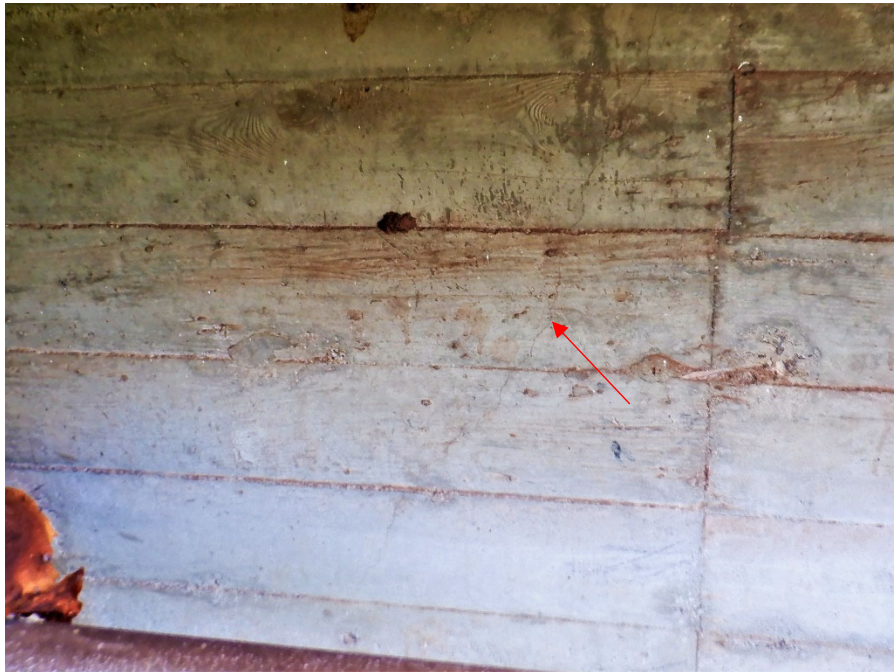
PHOTO 24 TYPICAL MODERATE WIDTH DIAGONAL CRACK (1130 CS2) ON ALL GIRDERS

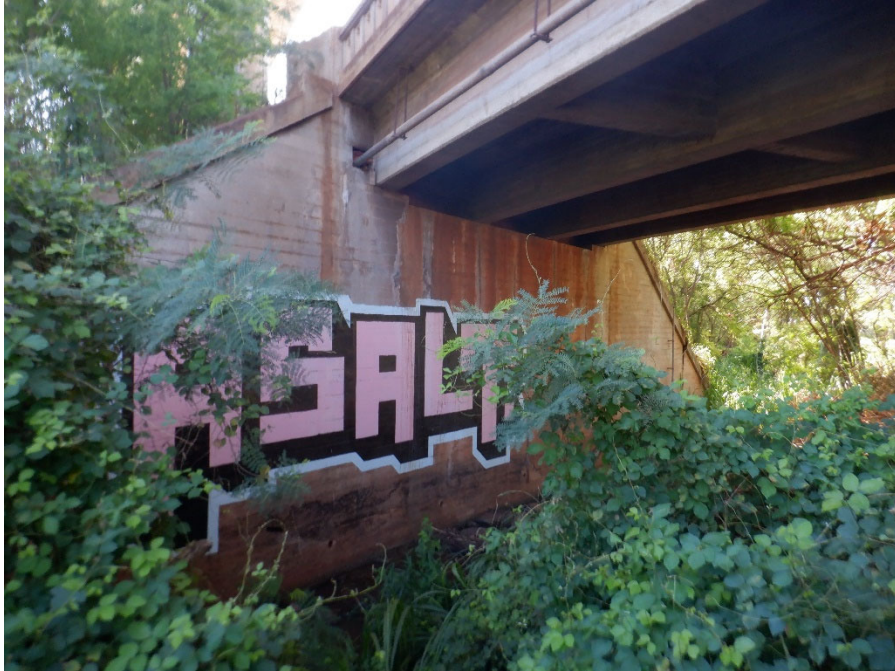
PHOTO 25 ABUTMENT 1

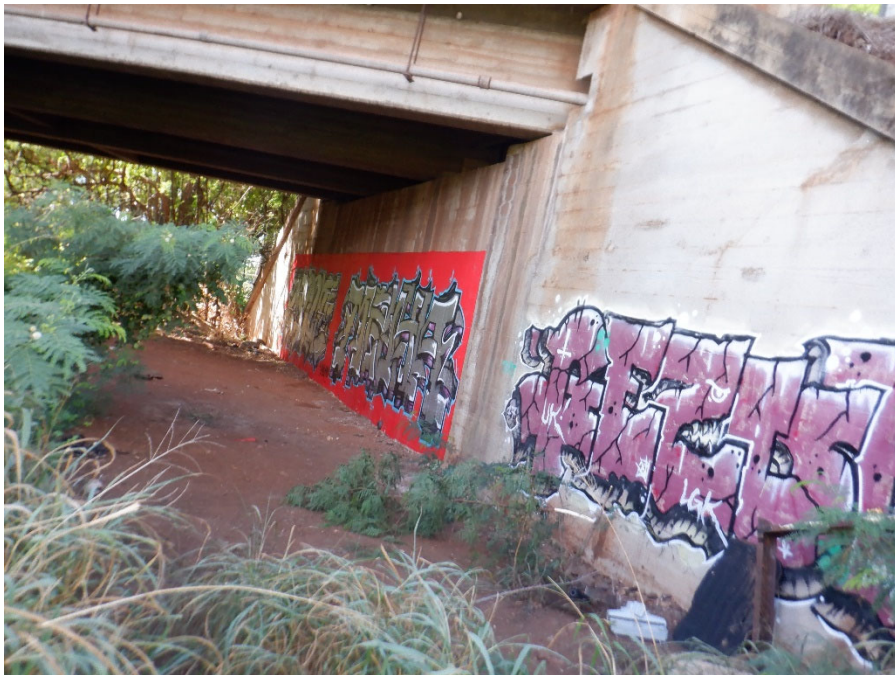
PHOTO 26 ABUTMENT 2

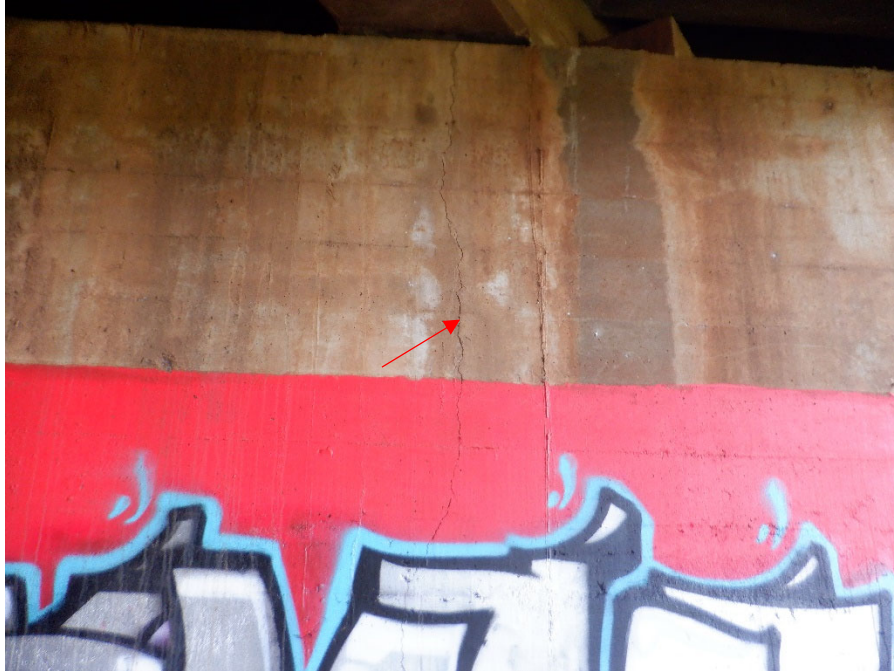
PHOTO 27 WIDE VERTICAL CRACK (1FT 1130 CS3) ON ABUTMENT 2
BELOW GIRDER G2

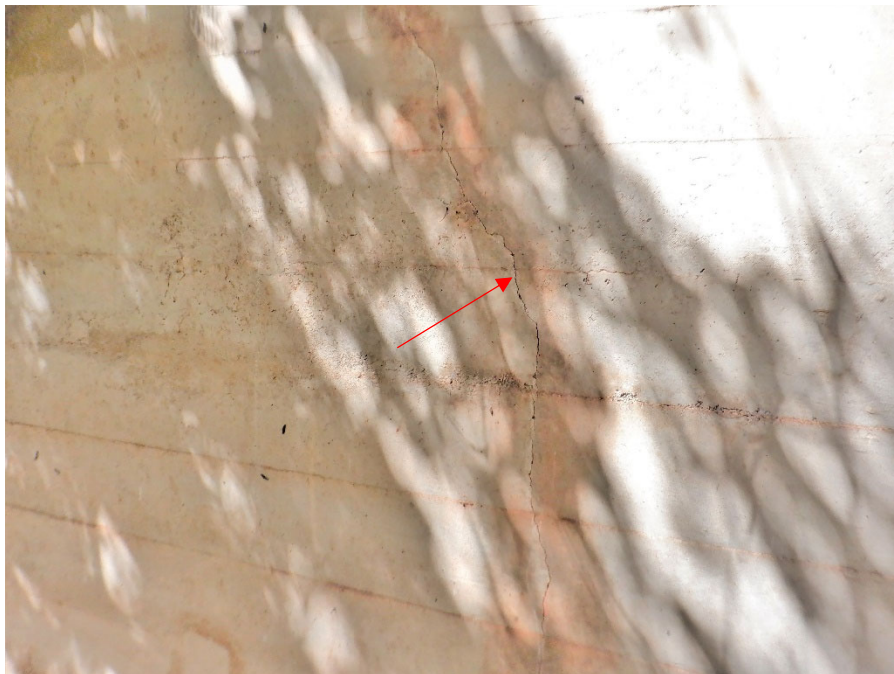
PHOTO 28 WIDE VERTICAL CRACK (1FT 1130 CS3) ON
DOWNSTREAM WEST WINGWALL

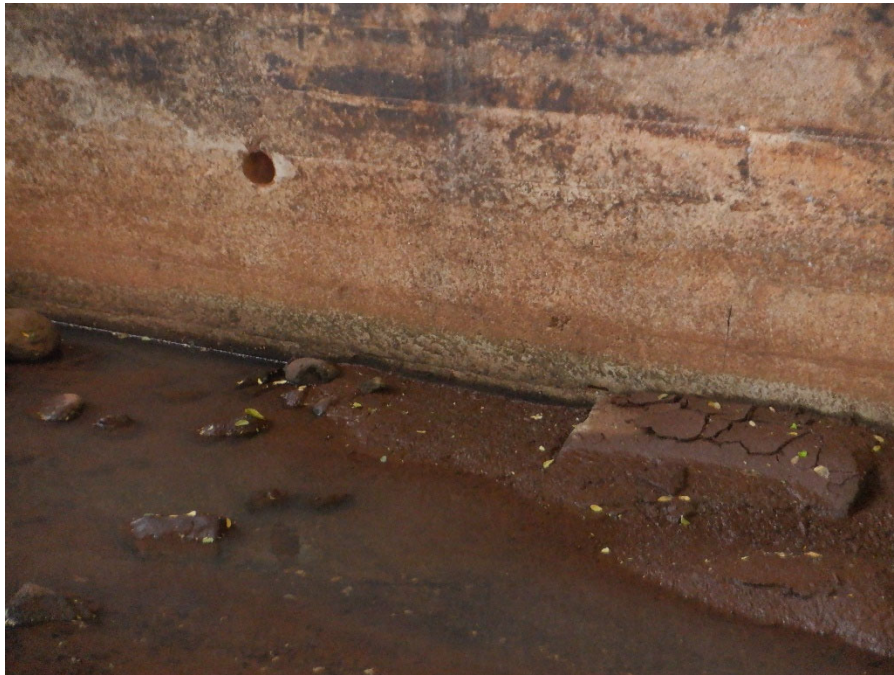
PHOTO 30 PARTIAL ABRASION (1190 CS2) ALONG ENTIRE LENGTH OF ABUTMENT 1 AND WINGWALLS

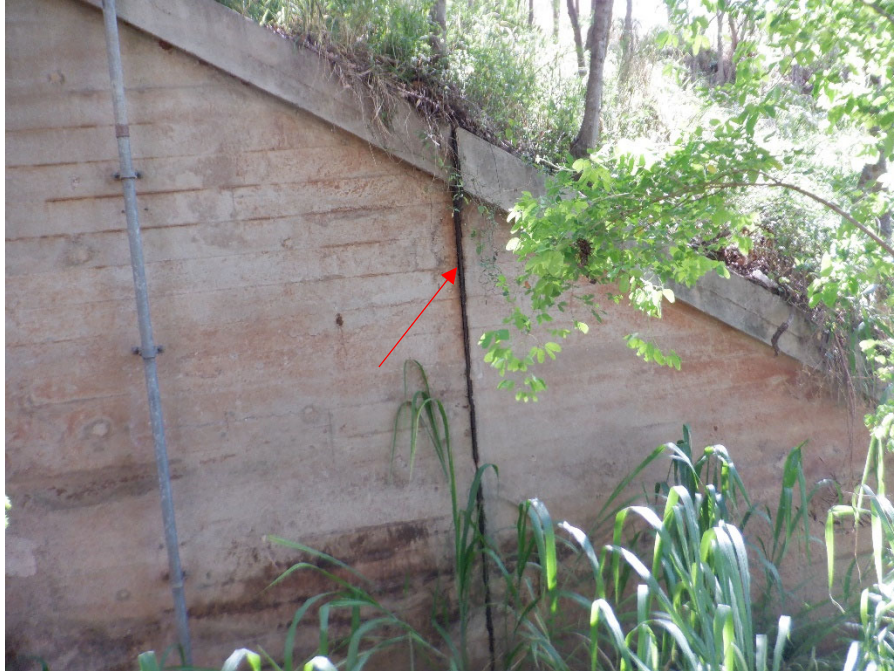
PHOTO 31 JOINT FILLER PROTRUDING FROM JOINT AT
DOWNSTREAM EAST WINGWALL AND 1/2" GAP
BETWEEN DOWNSTREAM EAST WINGWALL AND
CHANNEL WALL

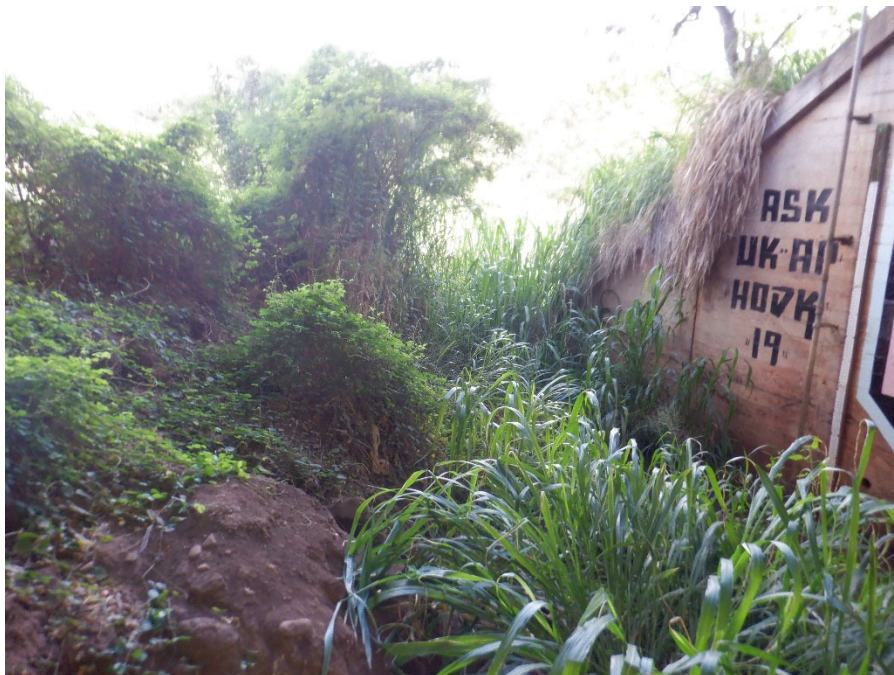
PHOTO 32 UPSTREAM CHANNEL WITH HEAVY VEGETATION
GROWTH
