APPENDIX B

Photographs

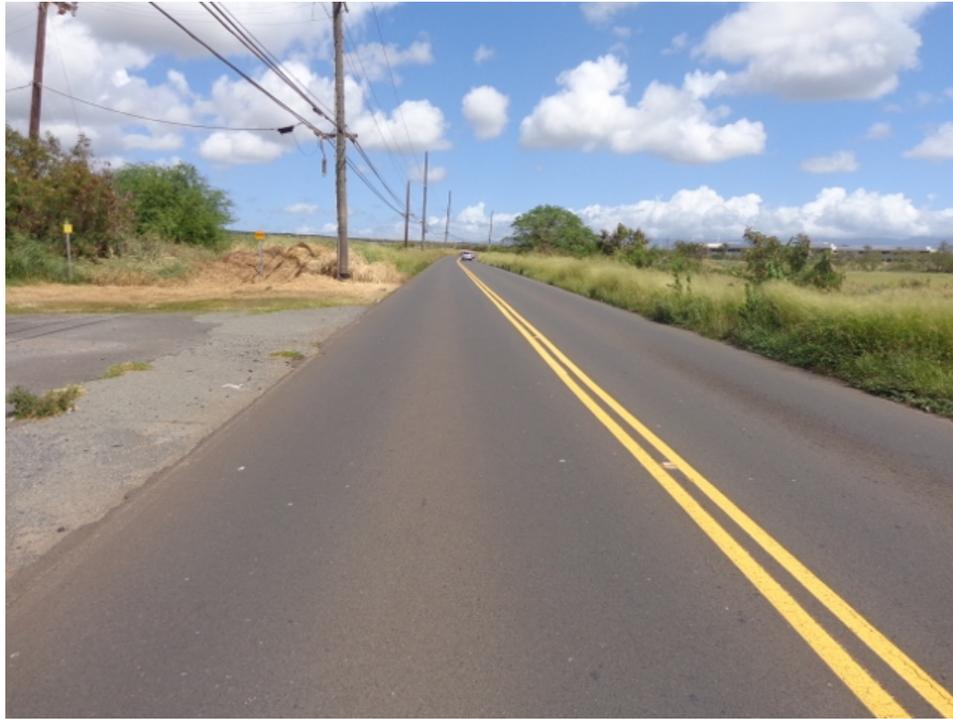
Photo 1: East approach

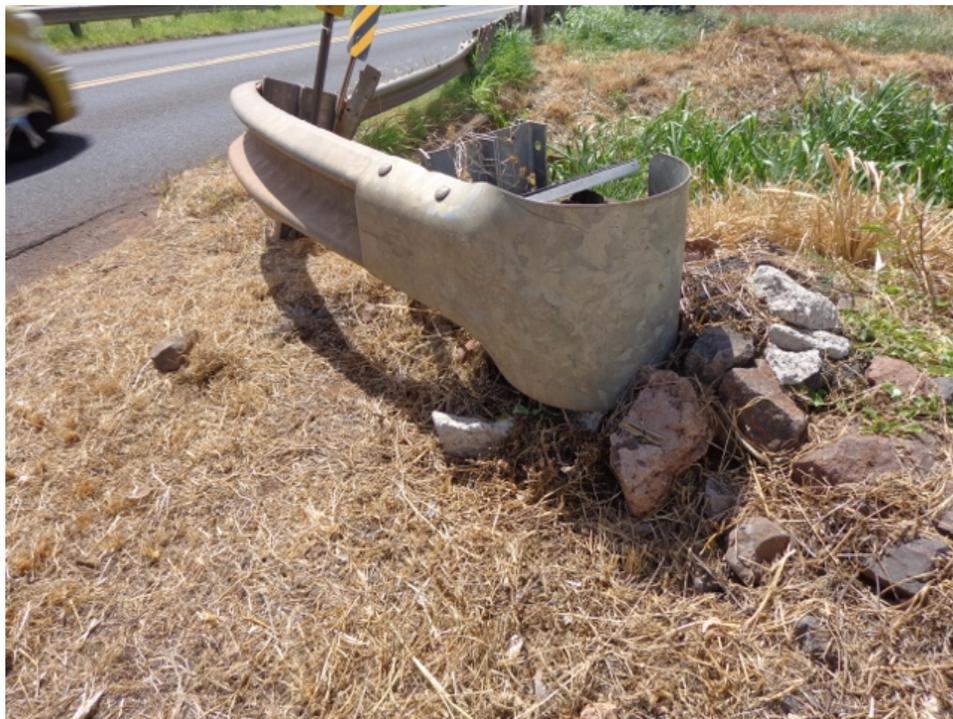
Photo 2: Upstream east approach guardrail end

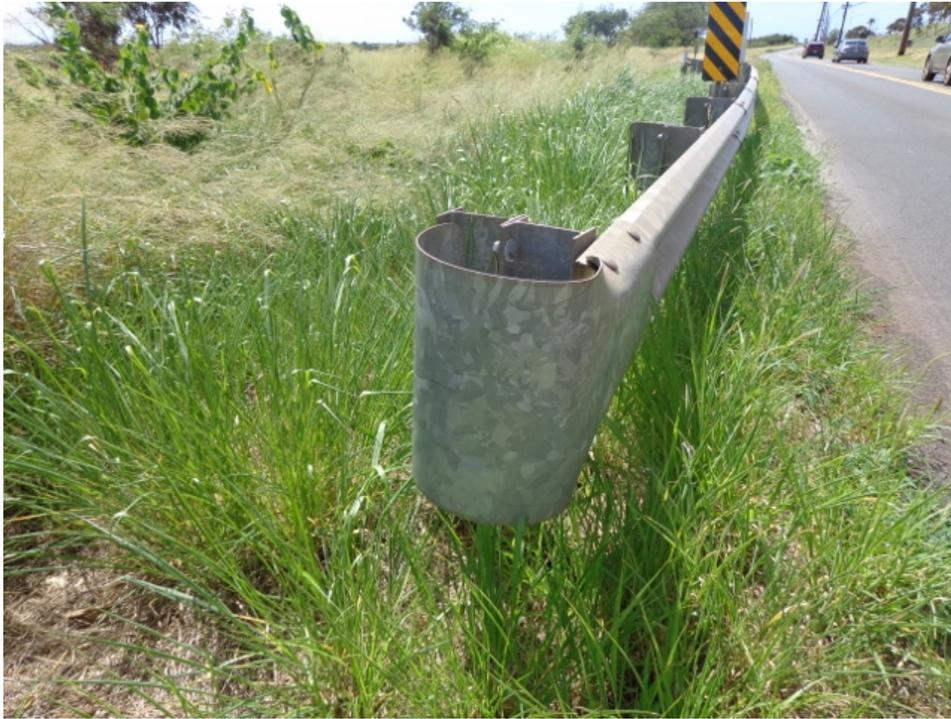
Photo 3: Downstream east approach guardrail end

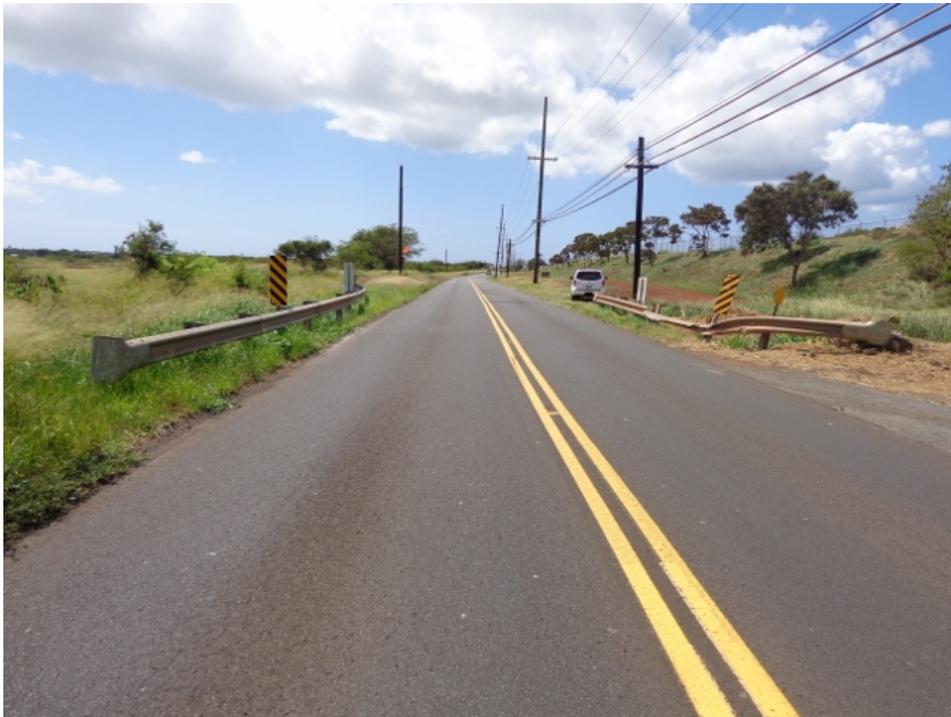
Photo 4: Structure as seen from east approach

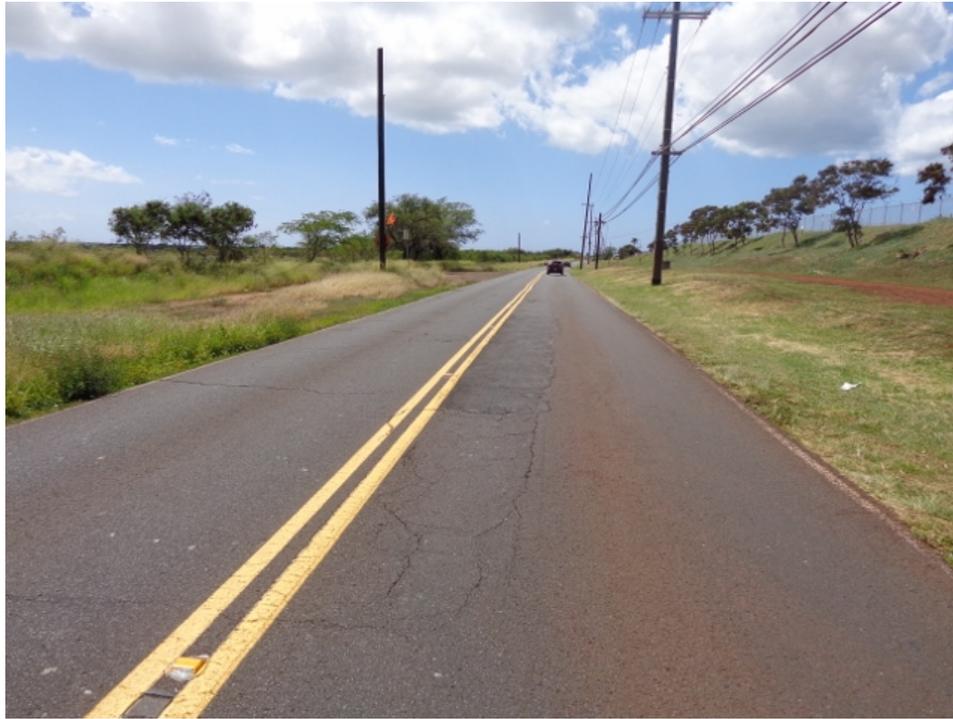
Photo 5: West approach

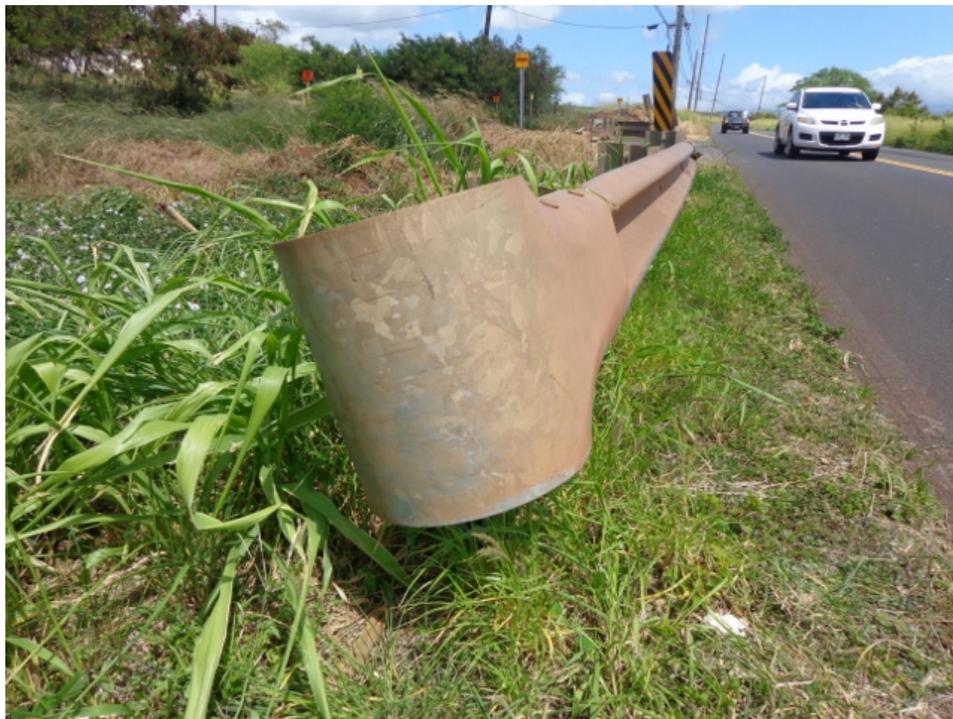
Photo 6: Upstream west approach guardrail end

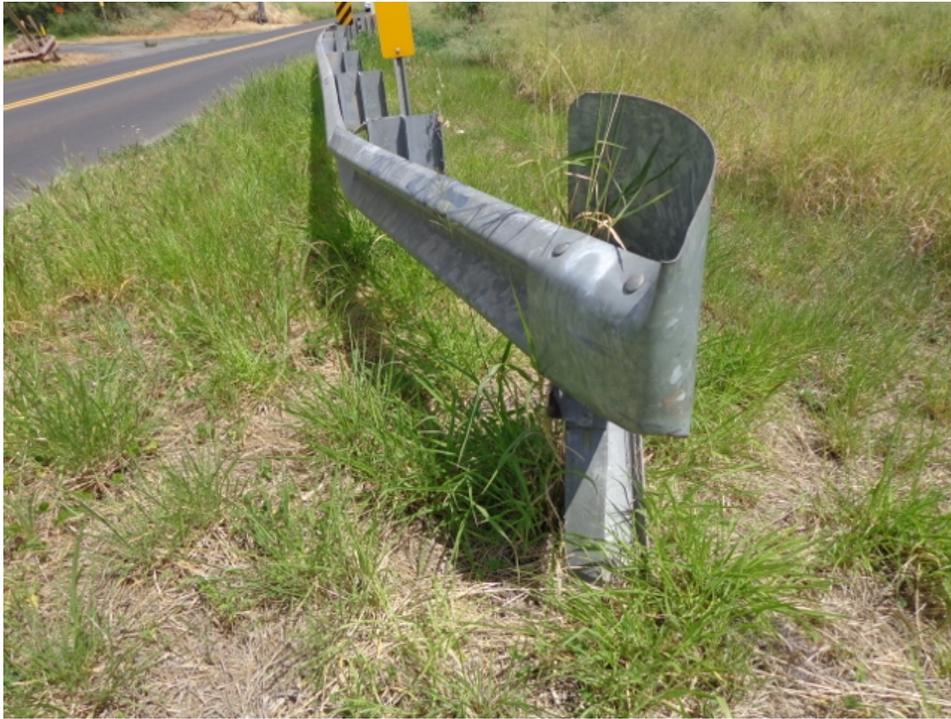
Photo 7: Downstream west approach guardrail end

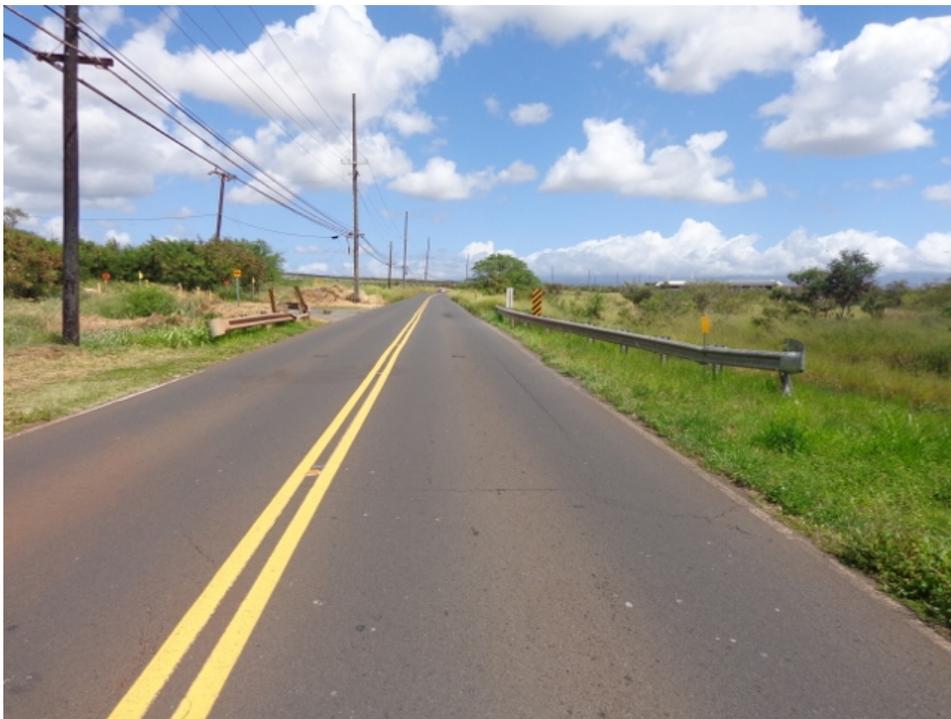
Photo 8: Structure as seen from west approach

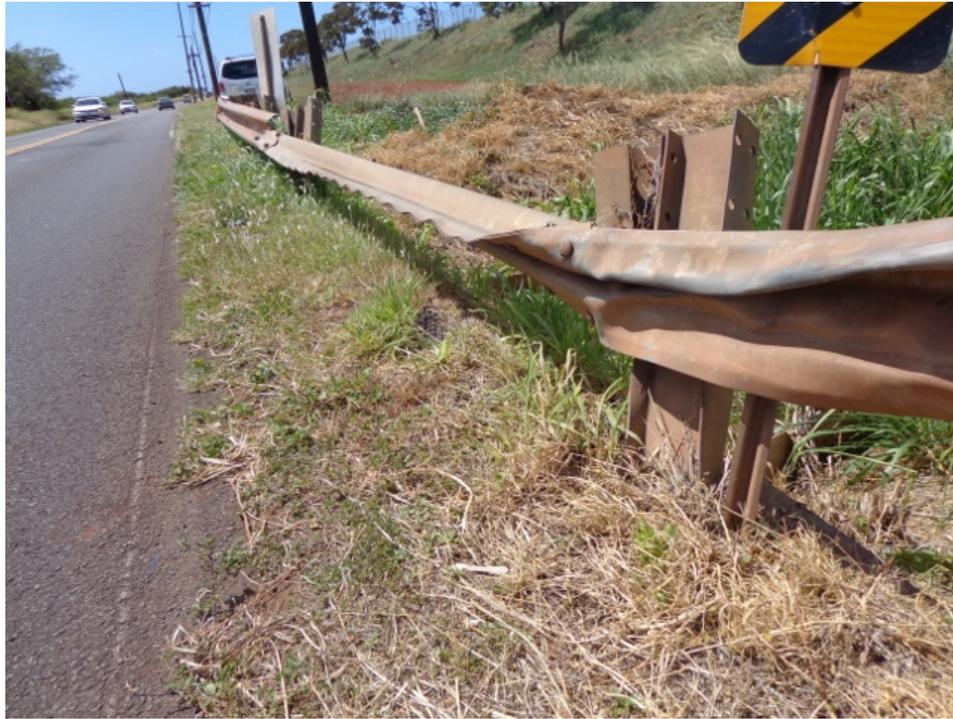
Photo 9: Upstream guardrail/railing

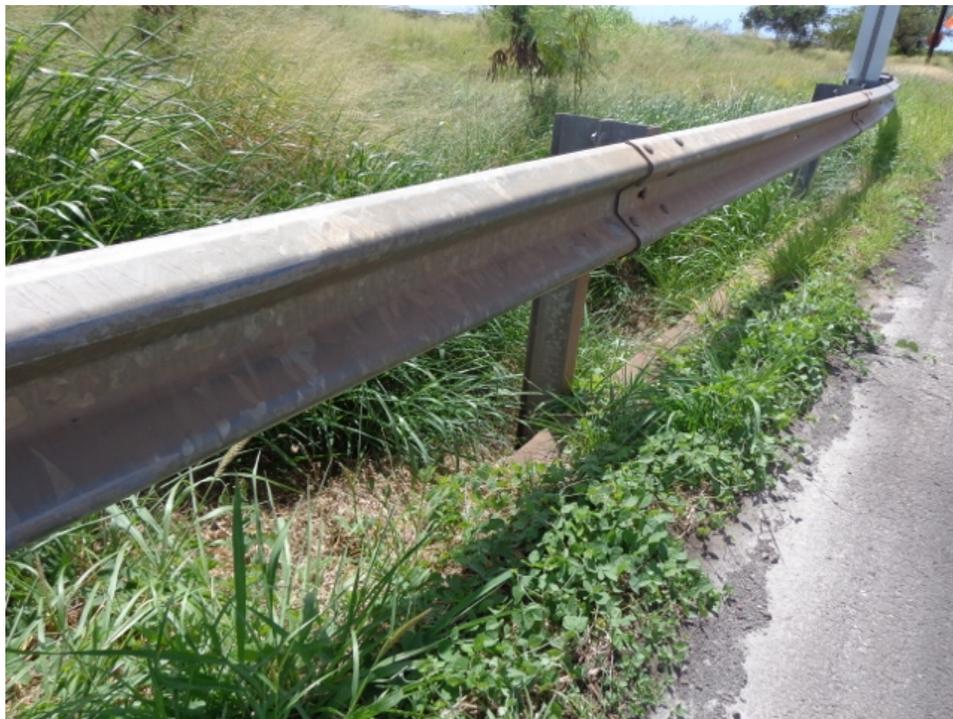
Photo 10: Downstream guardrail/railing

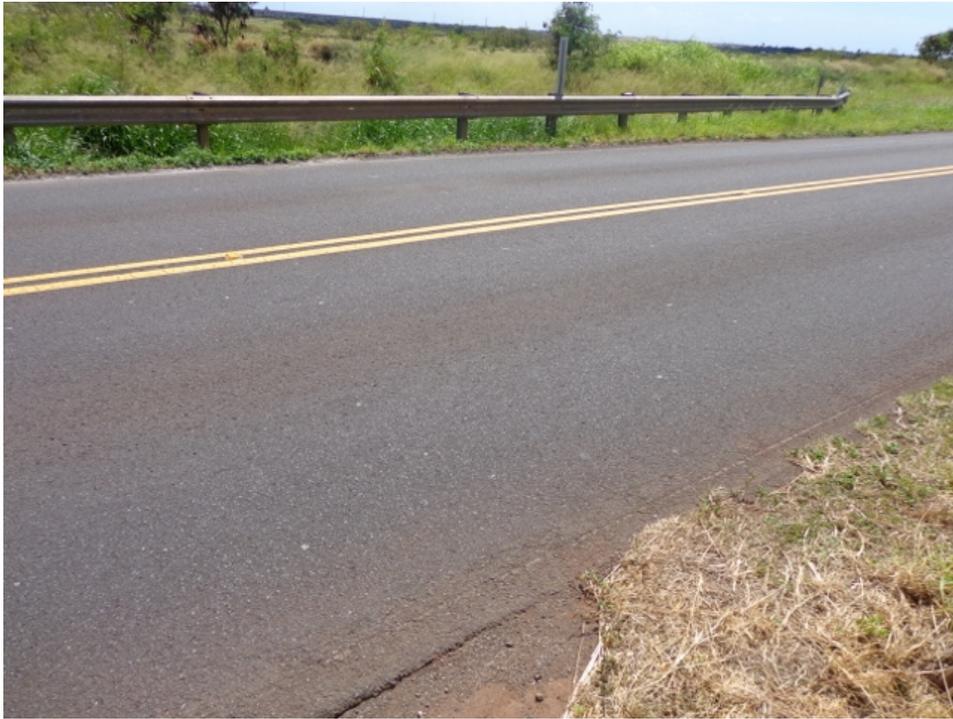
Photo 11: Roadway

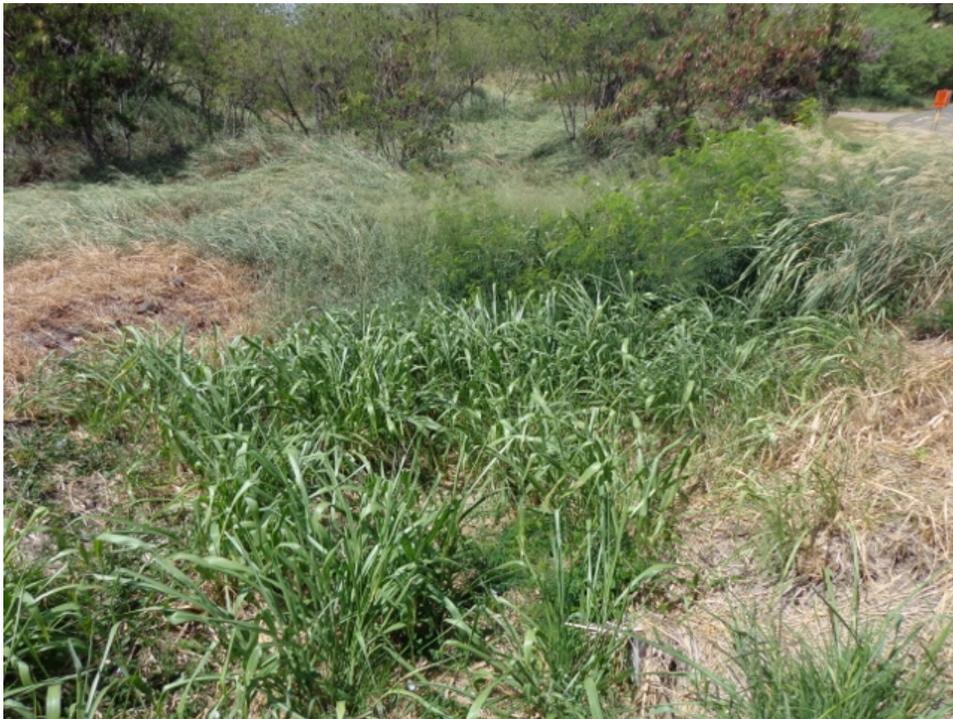
Photo 12: Upstream channel

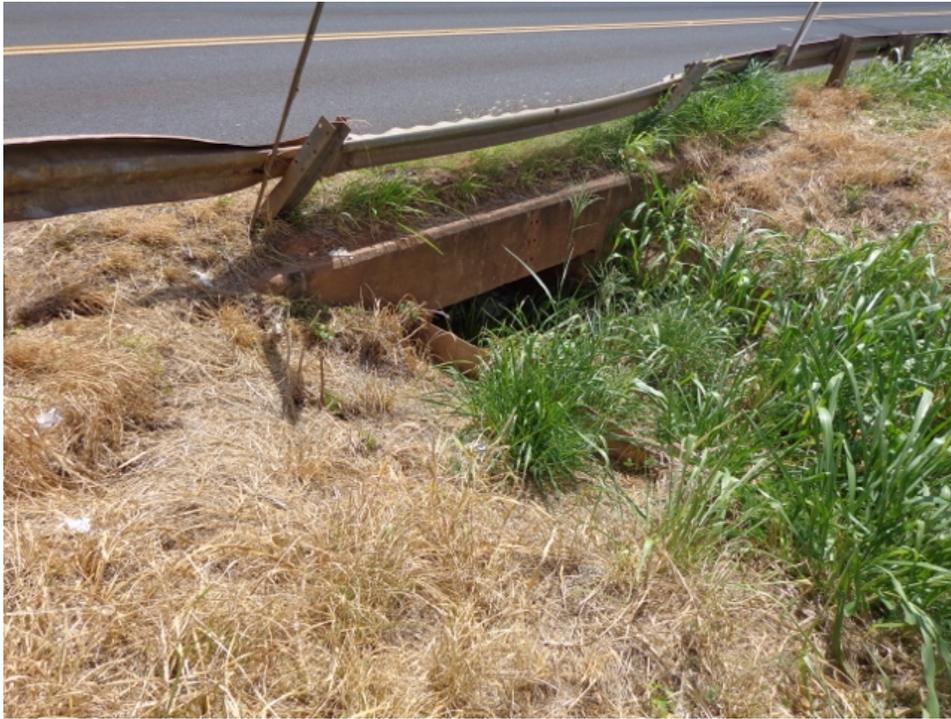
Photo 13: Upstream elevation

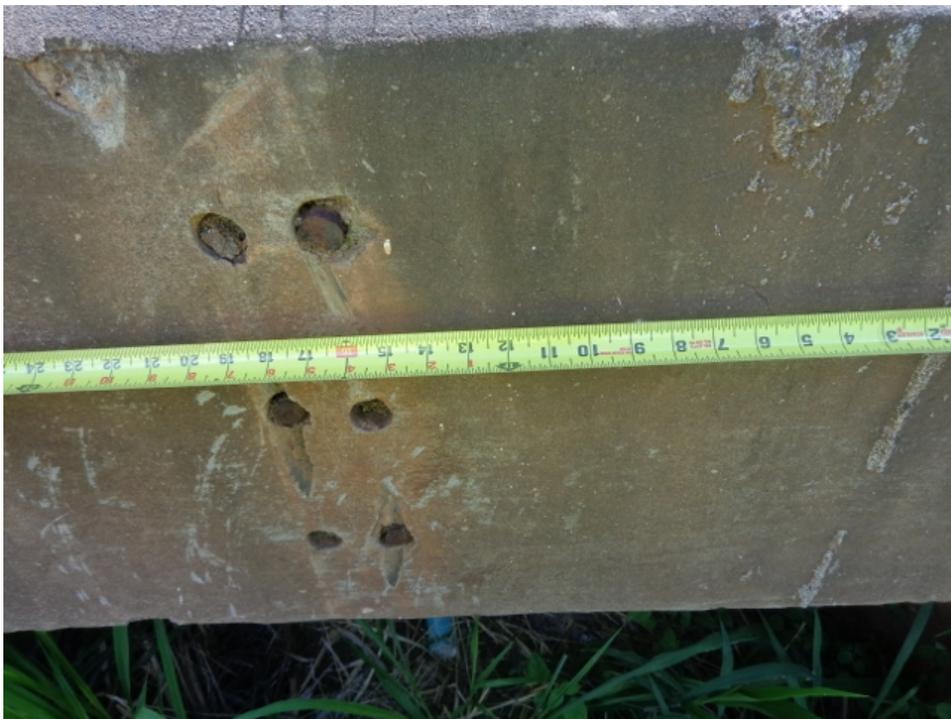
Photo 14: Corroded upstream guardrail posts embedments in upstream headwall

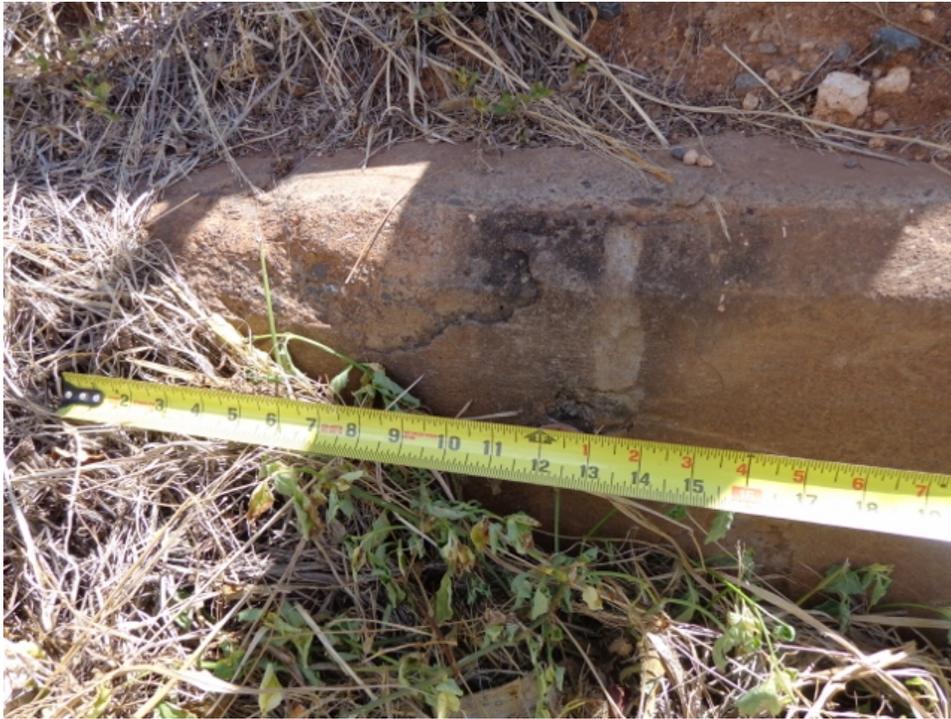
Photo 15: Spall measuring 8" high x 16" wide x 1" deep occurring at the top east corner of the upstream headwall

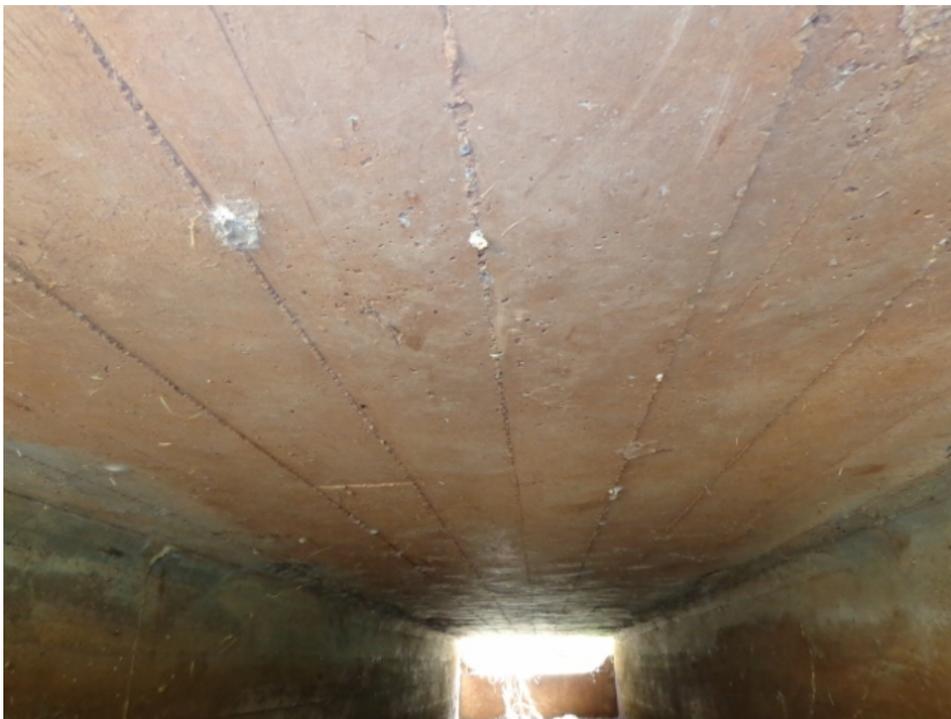
Photo 16: View of culvert soffit

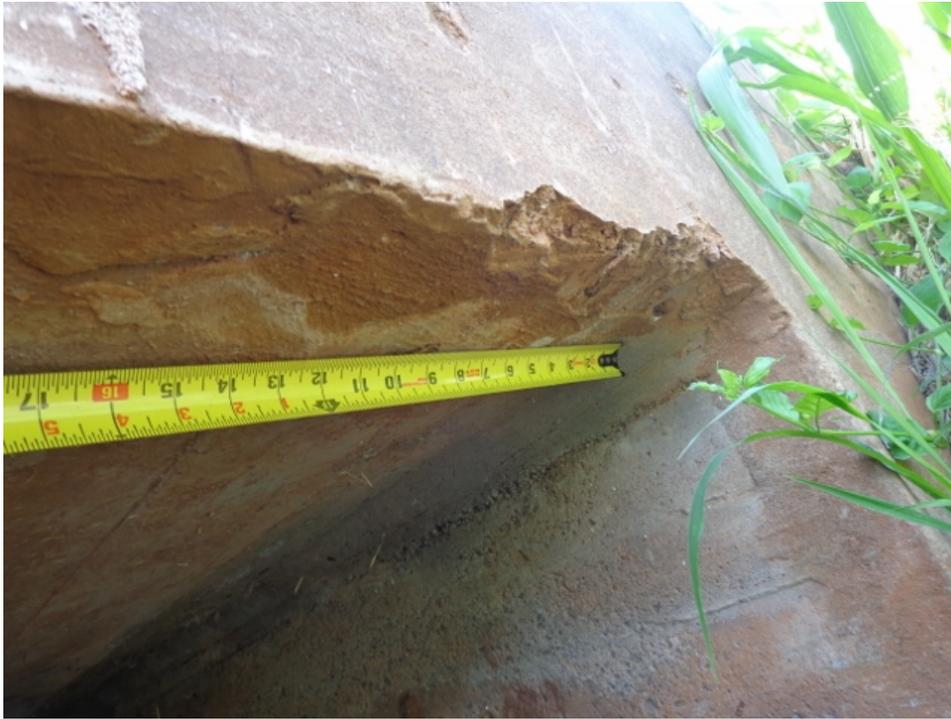
Photo 17: 12" long x 72" wide area of delamination occurring in culvert soffit at inlet

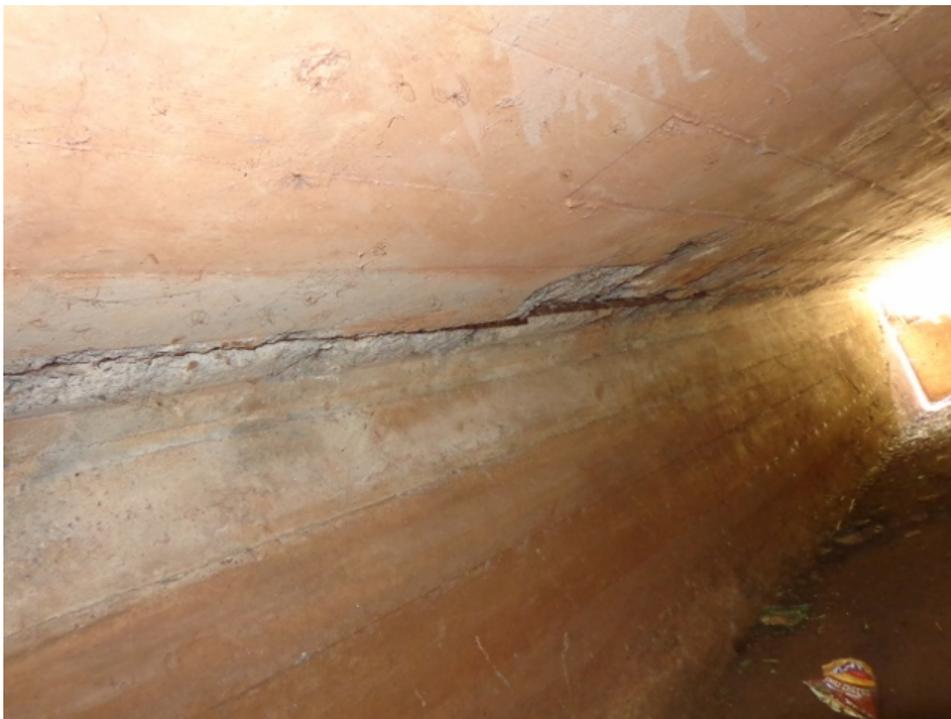
Photo 18: Spall measuring 10' long x 30" wide x 2" deep with 8 exposed reinforcing bars occurring in culvert soffit near outlet above the east culvert wall

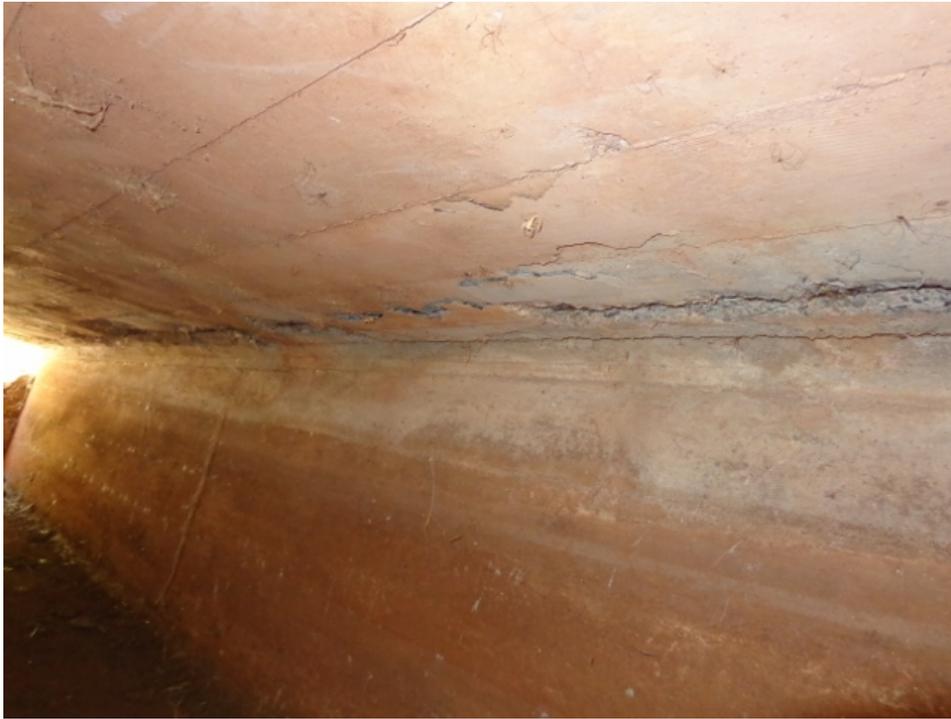
Photo 19: Spall measuring 10' long x 24" wide x 2" deep with 8 exposed reinforcing bars occurring in culvert soffit near outlet above the west culvert wall

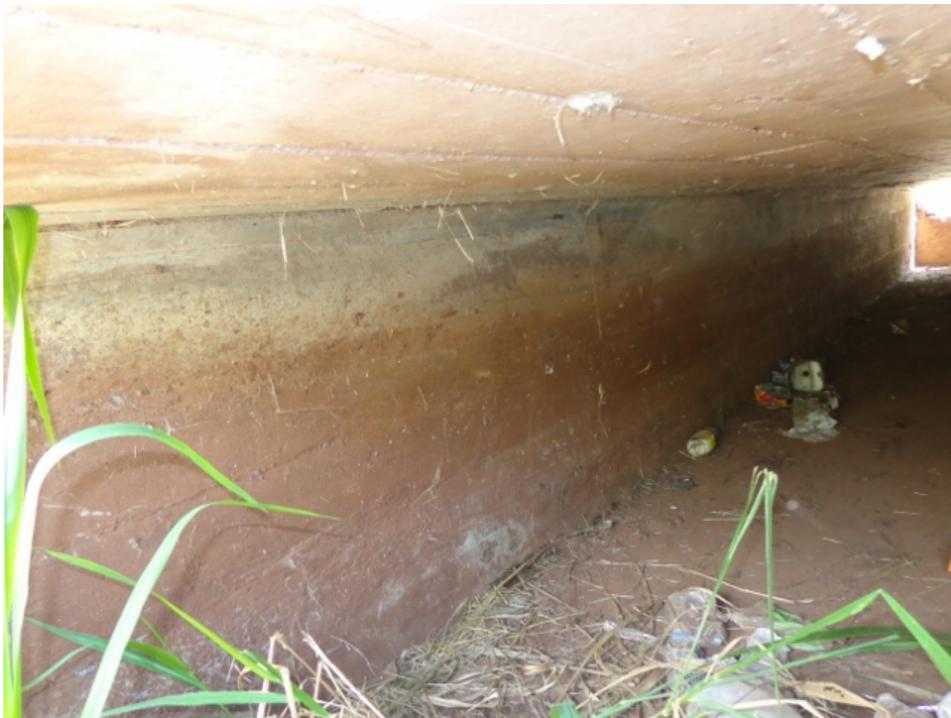
Photo 20: View of east culvert wall

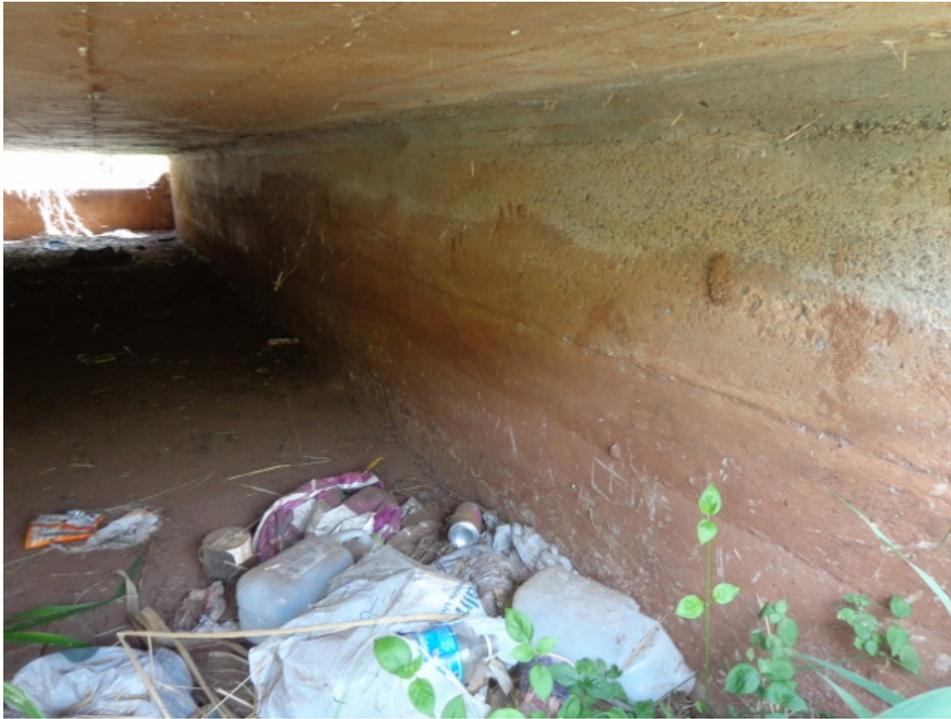
Photo 21: View of west culvert wall

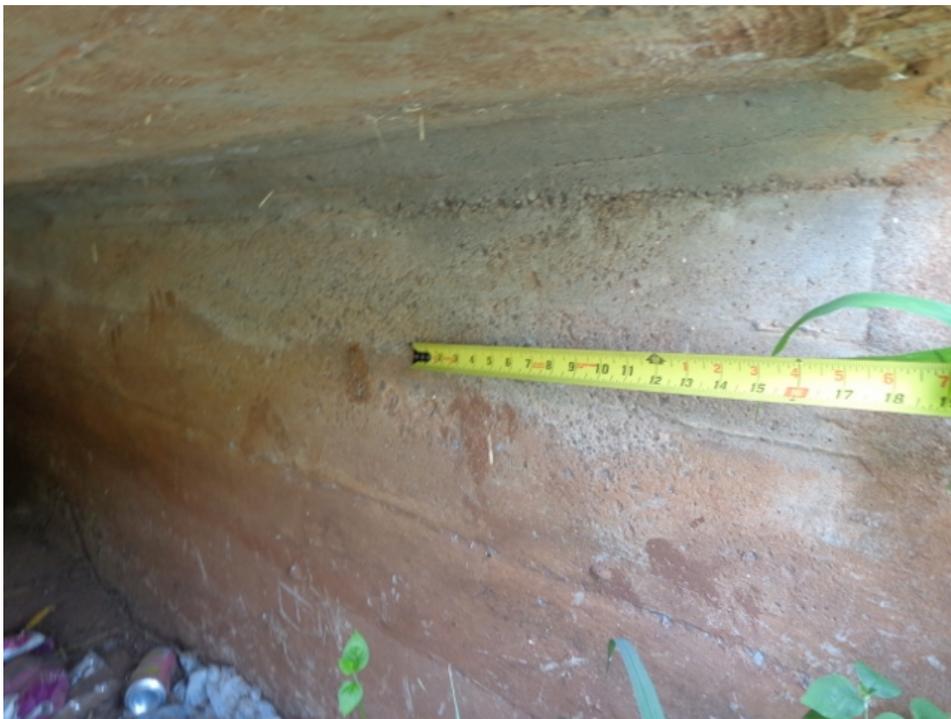
Photo 22: Scaling occurring along the top 12" of the culvert walls, typical

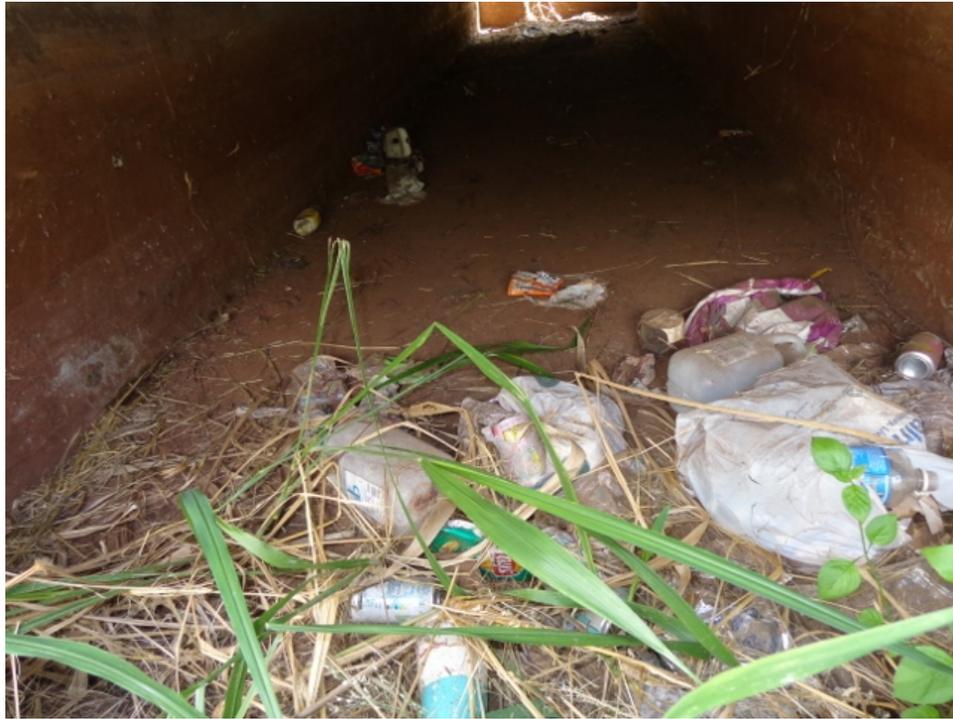
Photo 23: View of culvert invert

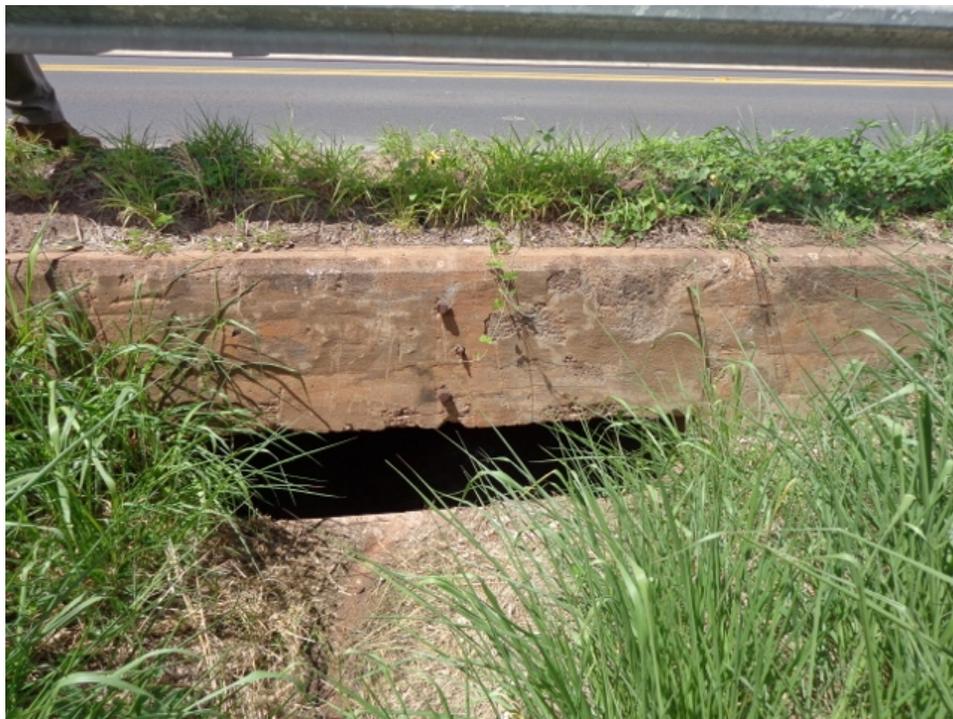
Photo 24: Downstream elevation

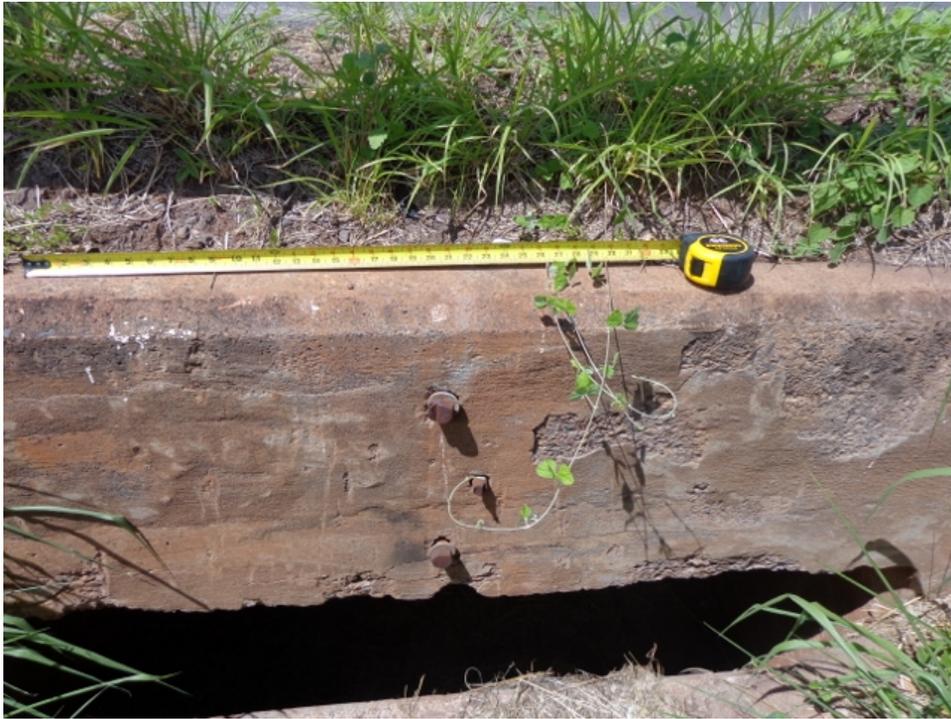
Photo 25: Scattered spalls occurring throughout downstream headwall

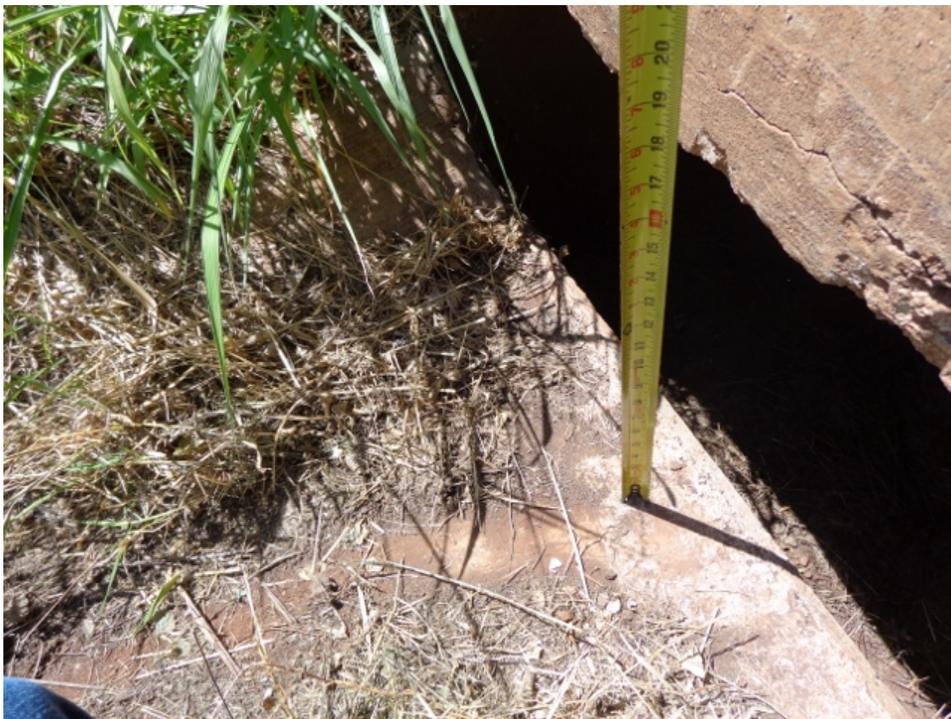
Photo 26: Concrete block built at outlet leaves only the top 16" of the culvert for water to flow through

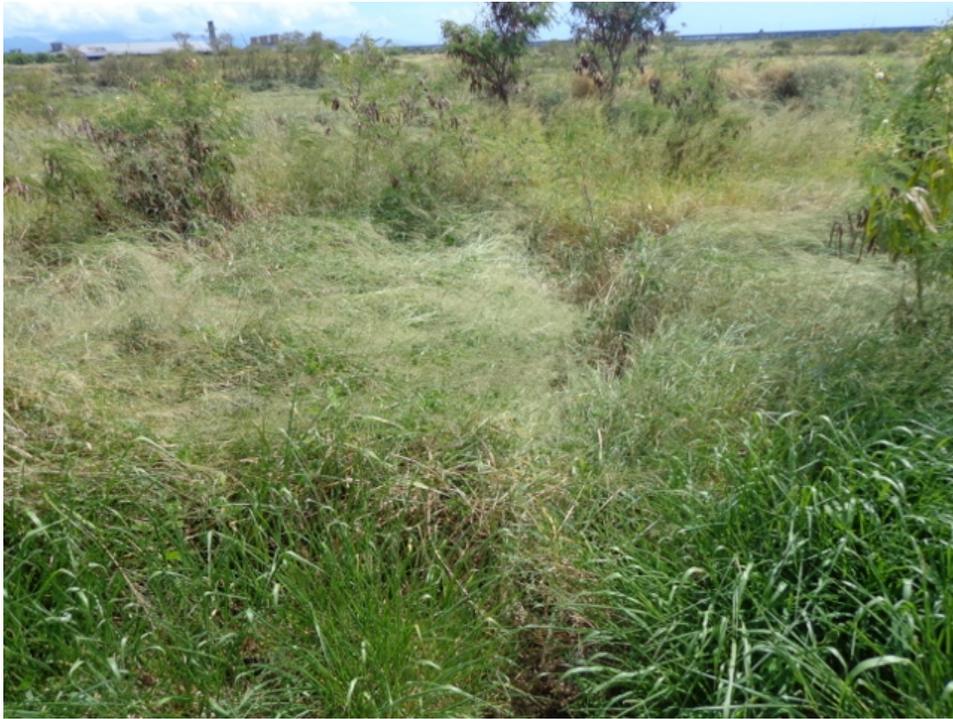
Photo 27: Downstream channel
