**GEOTECHNICAL ENGINEERING EXPLORATION  
INTERSTATE ROUTE H-1 REHABILITATION,  
EASTBOUND LANES  
WAI'AU INTERCHANGE TO KAIMAKANI STREET  
EWA, OAHU, HAWAII**

**JULY 11, 2005**

*Prepared for*  
**PARSONS BRINCKERHOFF**  
*and*  
**STATE OF HAWAII  
DEPARTMENT OF TRANSPORTATION  
HIGHWAYS DIVISION**

**W.O. 5088-00(A) & 5088-10     JULY 11, 2005**

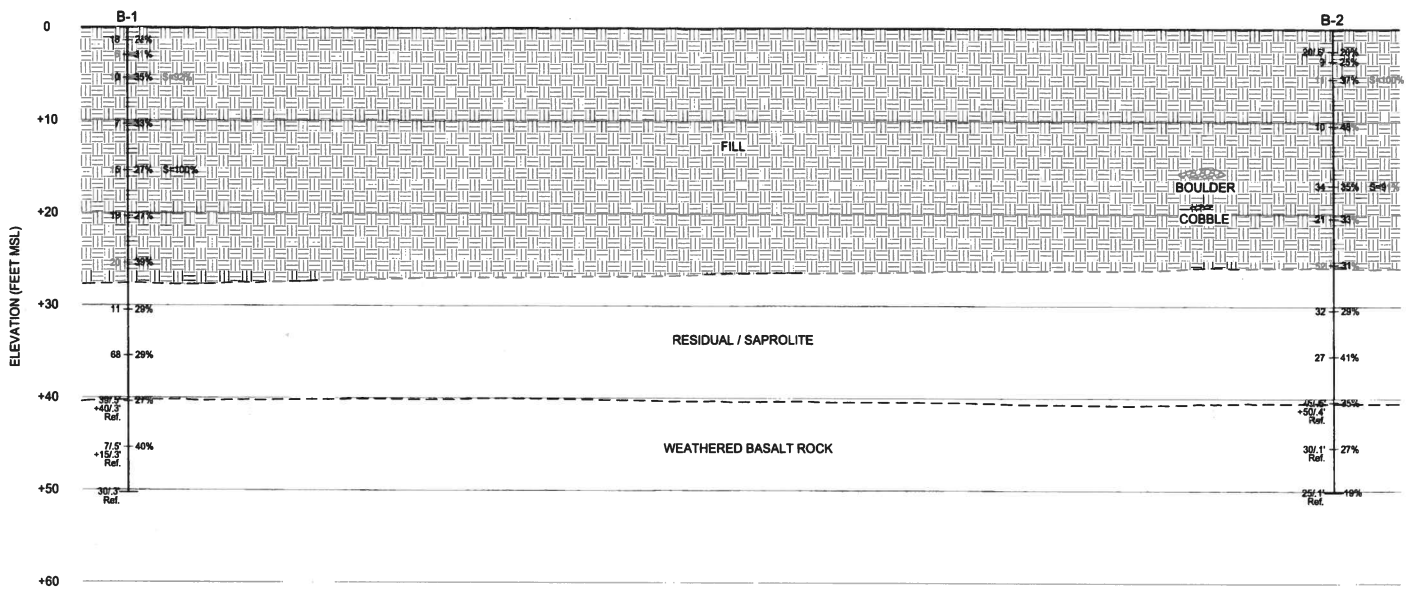
**SOIL PROFILE IN AREA 1**  
 INTERSTATE ROUTE H-1 REHAB., EB LANES  
 WAIU INTERCHANGE TO KAIMAKANI STREET  
 EWA, OAHU, HAWAII

As mentioned previously, Area 1 is located in the approach slab area of the Waiau Interchange structure eastern abutment. Our boring information indicated that the subsurface conditions consist of about 28 feet of medium stiff to very stiff clayey and silty fill material and 13 feet of stiff to hard residual and/or saprolite over weathered basalt formation at greater depth, as shown on the Soil Profile in Area 1, Plate 4. The moisture content of the fill material ranged from 27 to 48 percent. Based on results of our laboratory tests and engineering analysis, saturation of the fill material is about 90 to 100 percent.

Based on the above results of testing and analysis, we believe that settlement experienced in Area 1 may be caused primarily by fill compression and hydro-compression. Fill hydro-compression may be nearly completed based on the estimated saturation in the fill. However, completion of saturation may cause additional settlement in the future. We estimate the potential additional settlement to be on the order of 1 to 2 inches.

Based on the as-built plans provided, we understand that the existing approach slab is supported on the 6-inch wide corbel, which was structurally connected to the abutment wall. It is likely that the concrete slab has experienced settlement on the order of 1.5 inches. Therefore, the integrity of the concrete corbel is suspect. We recommend that a new concrete approach slab supported on a new foundation system be constructed to replace the existing approach slab.

The new concrete approach slab may be constructed to replace the existing concrete approach slab in Area 1, next to the eastern side abutment wall of the Waiau Interchange structure. The new approach slab may be supported on a micropile foundation system. The micropile foundation consist of drilling 7-inch diameter holes reinforced by epoxy coated rebar grouted in place in the pattern of 5 feet by 5 feet center-to-center.

Area 1 is located next to the eastern abutment wall of the Waiau Interchange adjacent to the Pearl City Off-Ramp. Extremely high traffic volume and demand of lane usage require the repair solution to result in minimum lane closure. With consideration of the length of the construction period, the type of approach slab structure, and the cost, we recommend that a micropile foundation system be installed to support the new approach slab. Details of micropile foundation is discussed in the "Micropile Foundation" section.
