STATE OF HAWAII
DEPARTMENT OF TRANSPORTATION
HIGHWAYS DIVISION

HAZARDOUS MATERIALS PLAN

HONOKAA BASEYARD IMPROVEMENTS
Project No. HWY-H-05-06

SHEET No. 6-1 OF 6-1 SHEETS

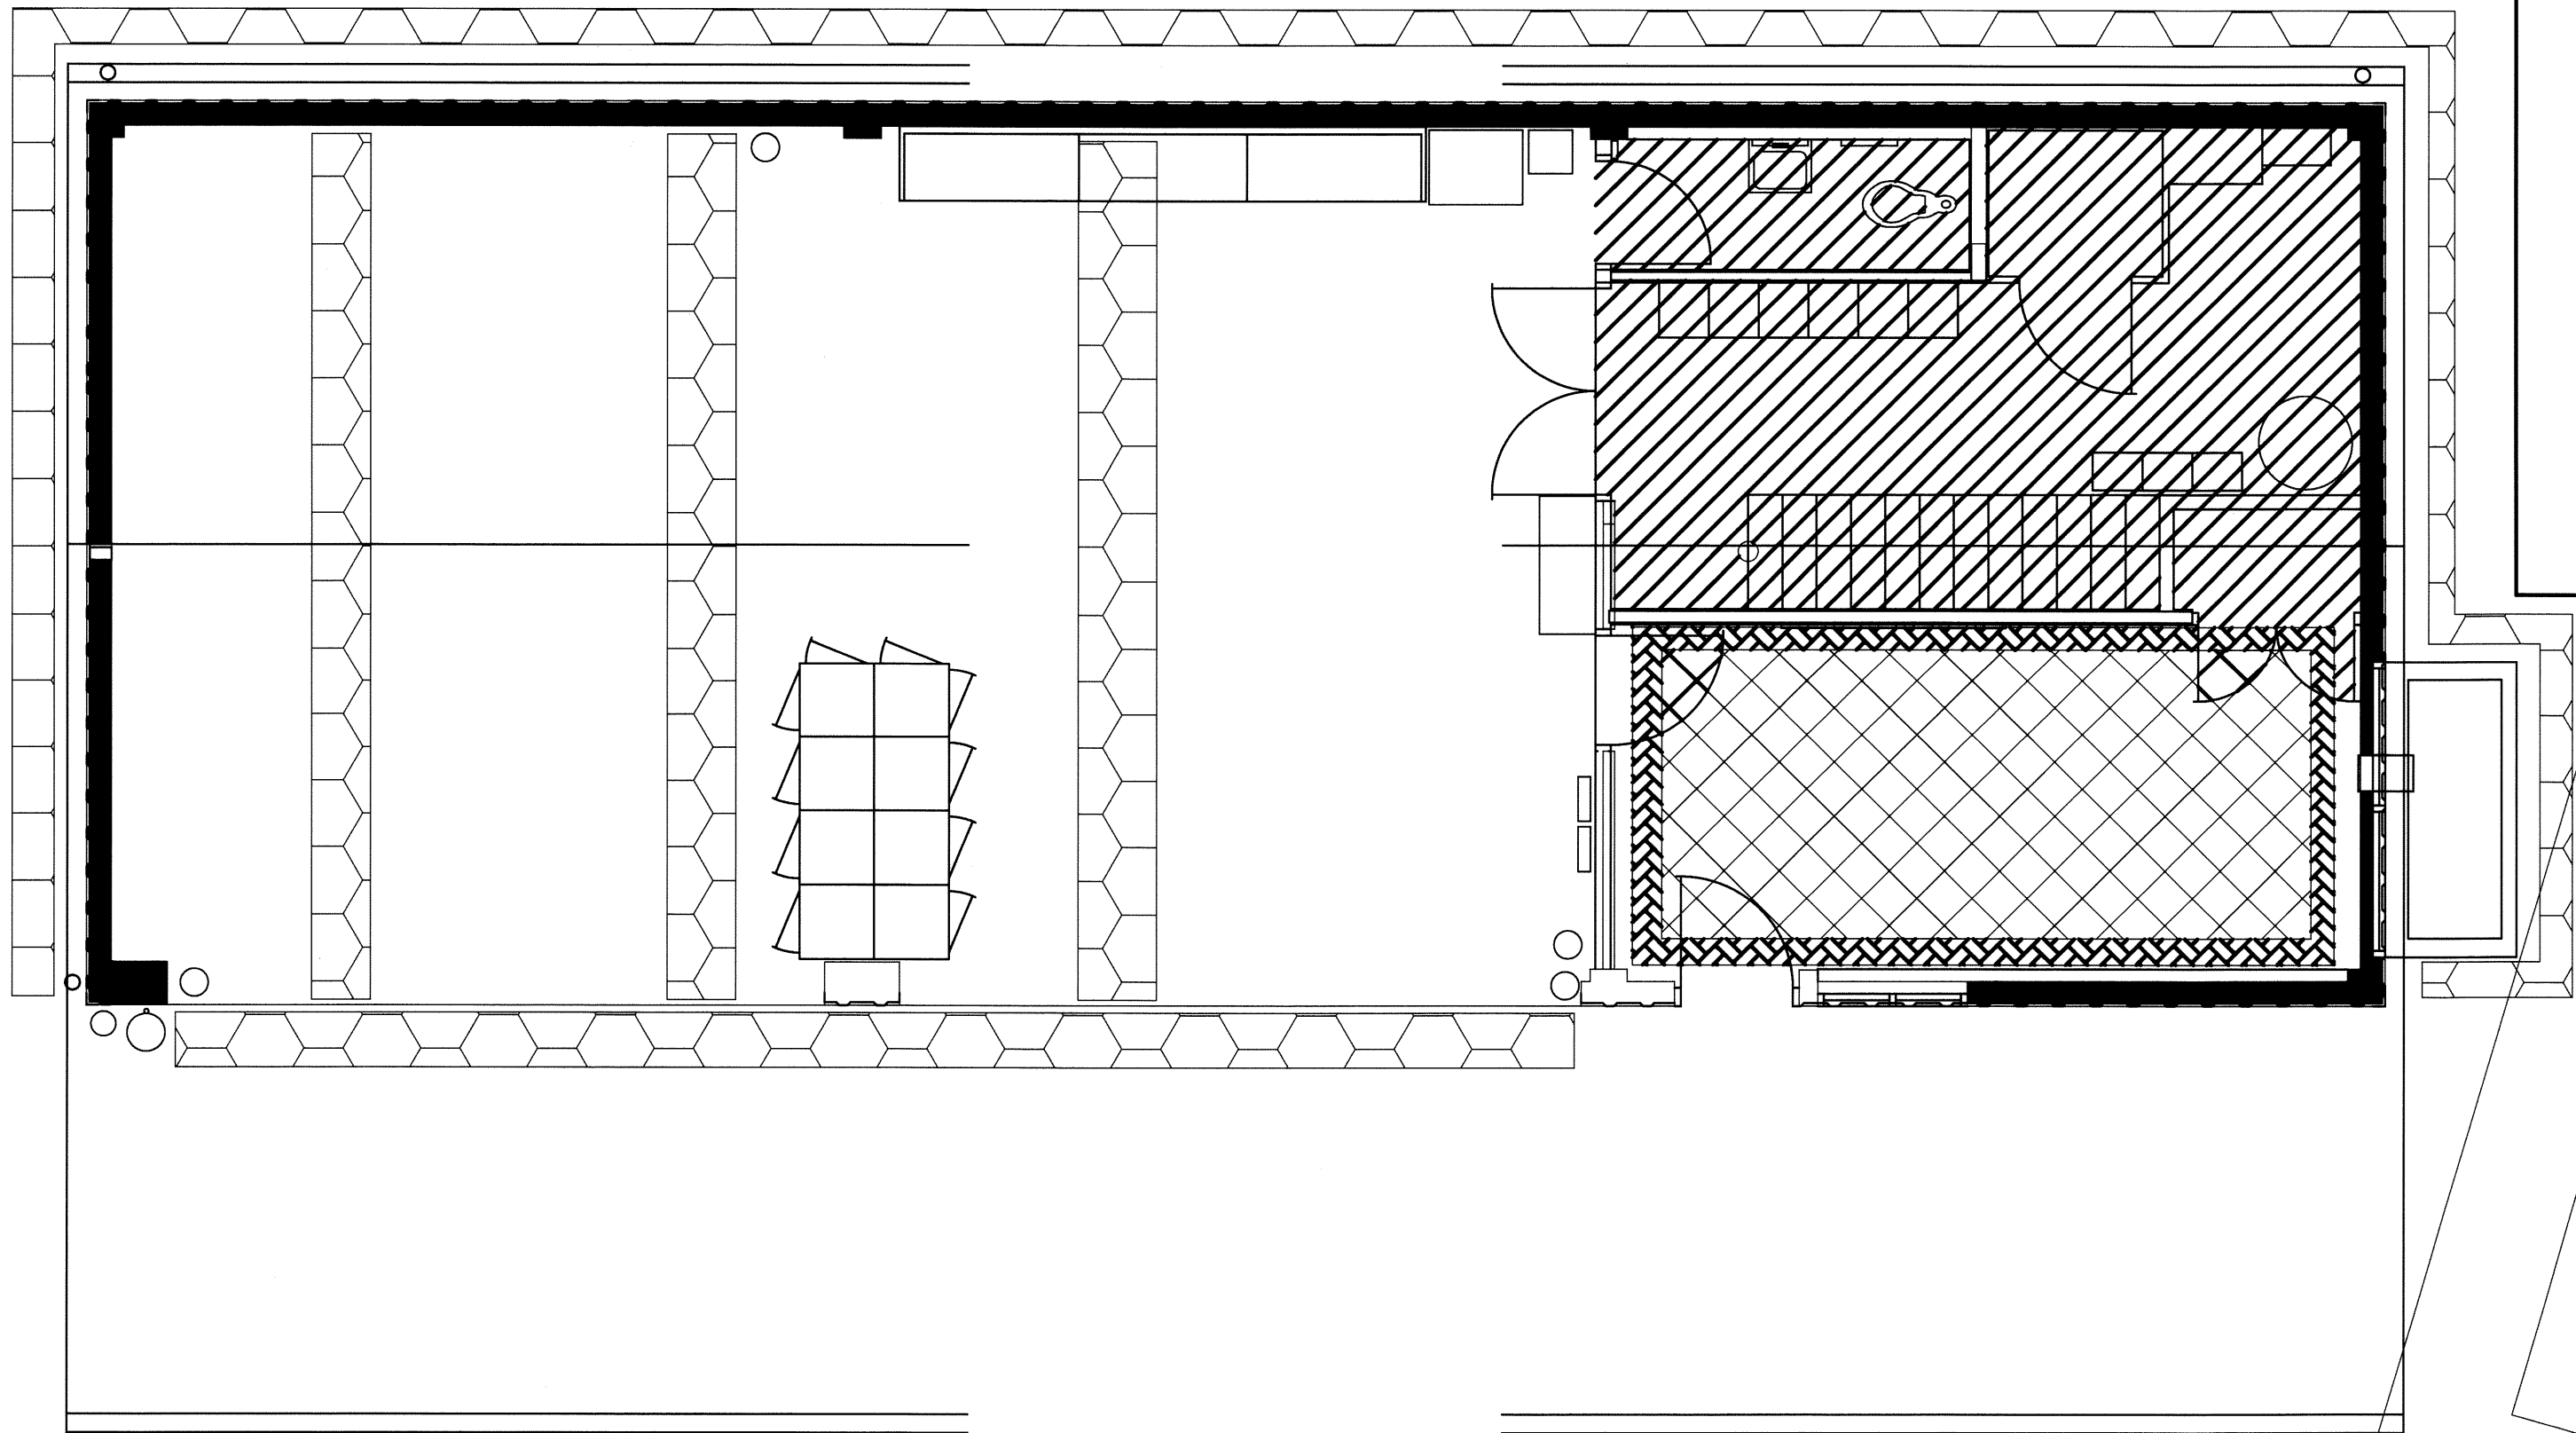
Asbestos Materials

- Joint Compound
- Textured Acoustical Ceiling

Lead Painted Components

- Yellow Metal Trusses
- Flashing On Roof, Metal Beams In Garage Frame Of Entrance, Roof And Poles Of Fuel Station
- Exterior And Interior Walls
- Walls Of Office

- Contractor Shall Coordinate All Work Pertaining To The Disturbance Of Hazardous Materials Identified On This Drawing With Other Trades.
- Remove Loose And Flaky Paint From Building Components That Are Scheduled For Demolition Prior To Demolishing. See Architectural Drawings For Areas To Be Demolished. Remove All Paint From All Other Building Components That Shall Remain In Place.
- Joint Compound On The Office Drywall Contains Asbestos. Remove Drywall In Accordance With Section 13281. If The Drywall Is Determined To Be Nonhazardous Waste, Dispose Drywall In Accordance With Section 13281. If The Drywall Is Determined To Be Hazardous Waste, Dispose Drywall In Accordance With Section 13282.
- Textured Acoustical Ceiling Plaster Contains Asbestos. Remove And Dispose In Accordance With Section 13281.
- Assume All Painted Surfaces Are Lead-Containing.
