2 Background

Address	Nanue Bridge, Hawaii Belt Rd (Route 19) Hawaii County, HI
TMK #	(TMK) (3) 3-2-001 Parcel 008, and (3) 3-2-001:001
Latitude/Longitude	19.927035°, -155.156125°

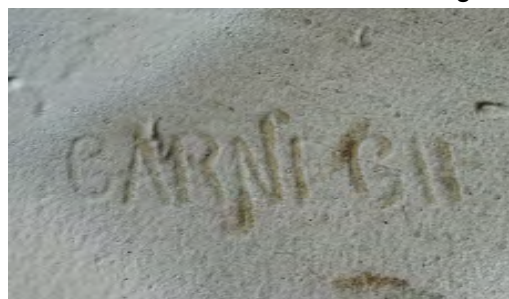
Steel Girder Detail at Nanue Bridge

The bridge is the tallest one in Hawaii (286 ft) and was originally constructed in 1911/1912 for the Hilo Railroad Company to access the sugar plantations along the coast (Historic Hawaii 2014). Multiple supporting steel beams are original to the bridge and marked with the Carnegie Steel (US Steel) Logo that was in use from the late 1890s throughout the 1910s (Historic Bridges 2024).
