REVISION DATE DESCRIPTION BY APPROVED	
STATE OF HAWAII DEPARTMENT OF TRANSPORTATION HARBORS DIVISION			
JOB TITLE SUBSTRUCTURE REPAIRS AT PIERS 16 AND 17 HONOLULU HARBOR, OAHU, HAWAII			
SHEET TITLE BEAM SPALL REPAIR DETAILS			
DESIGNED BY: GO DRAWN BY: DL CHECKED BY: GM DATE: 04/2023 SCALE: AS SHOWN	JOB NUMBER S10852		
THIS WORK WAS PREPARED BY ME OR UNDER MY SUPERVISION EXP. 4-30-24 MKE ASSOCIATES LLC			SHEET S-9 11 of 14 SHTS.

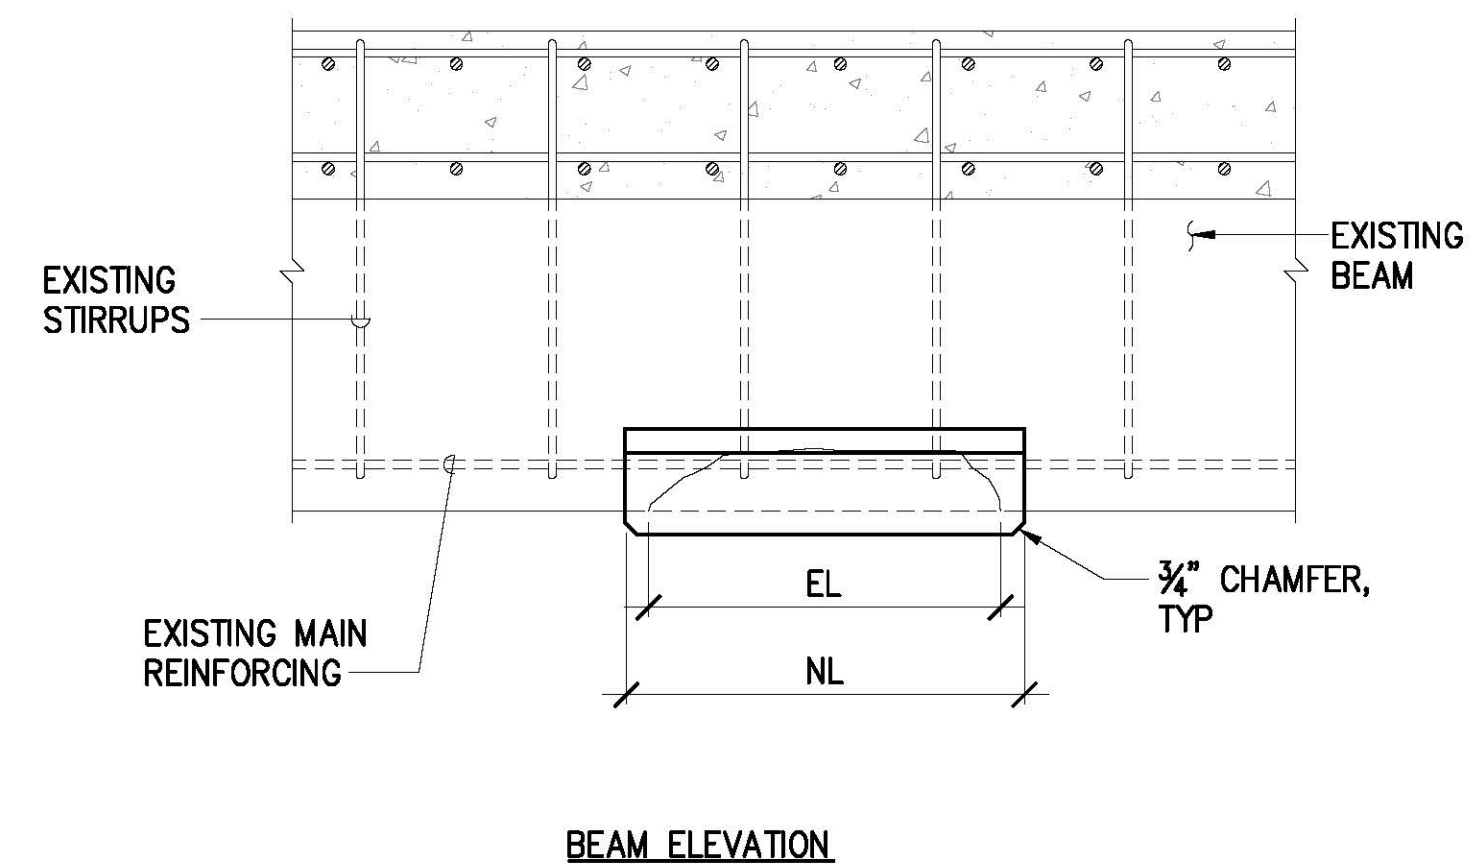
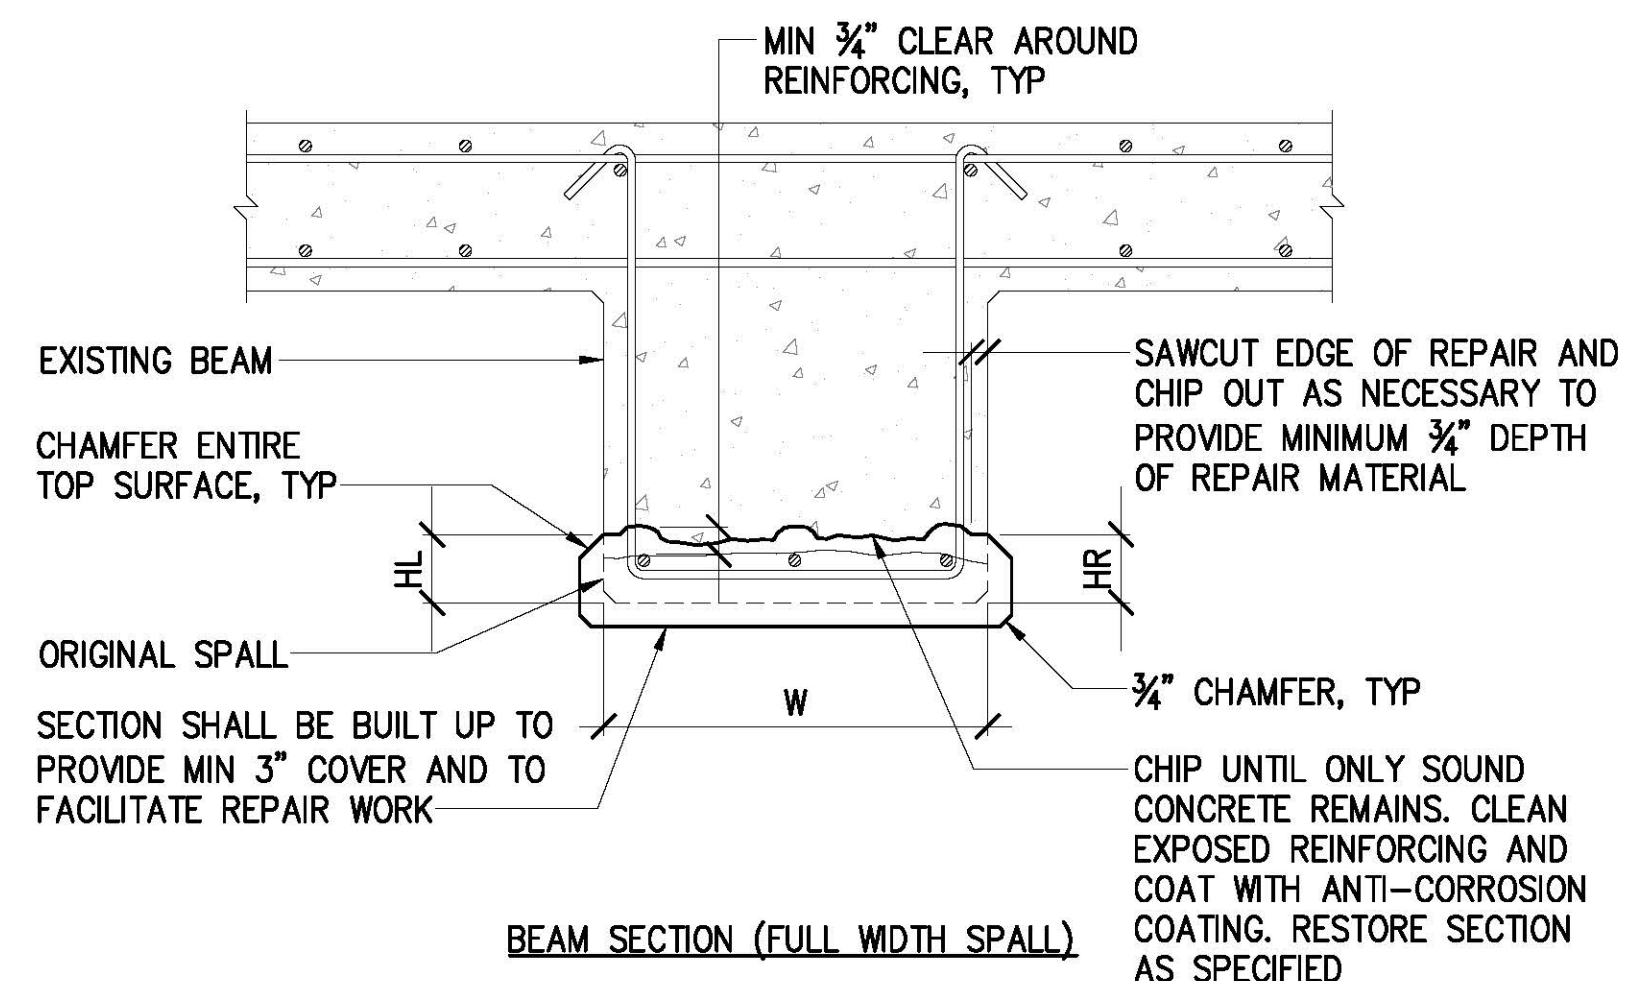
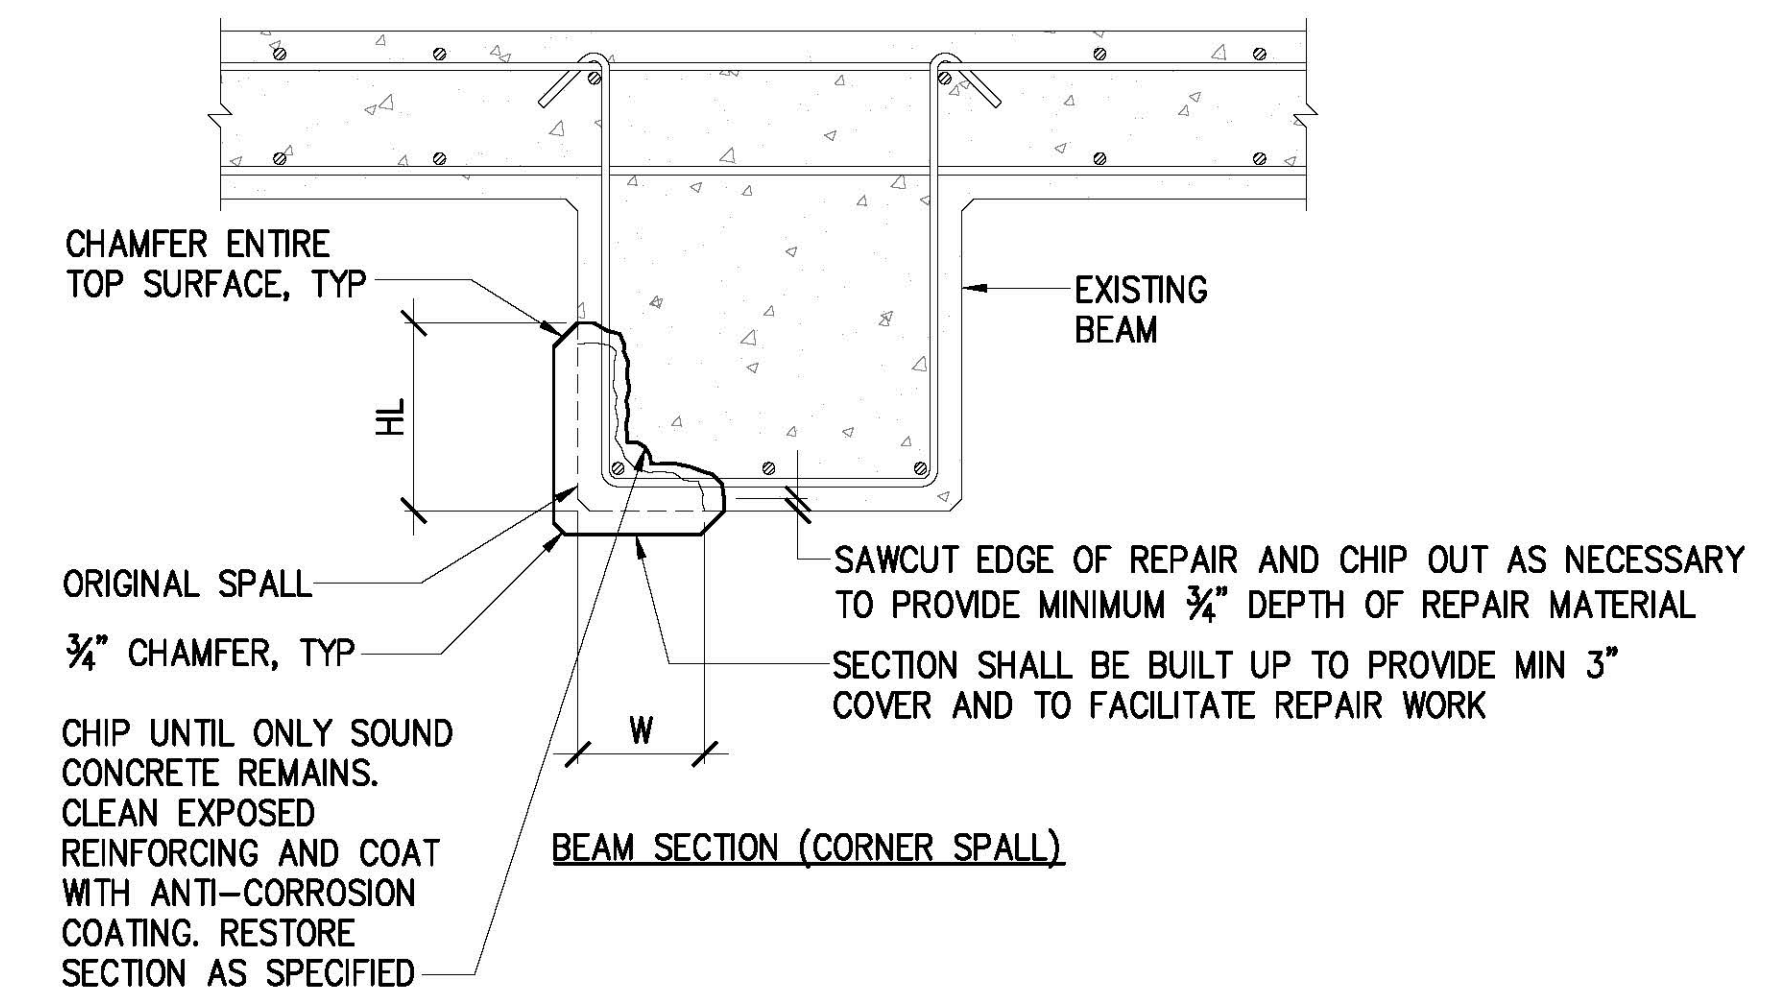
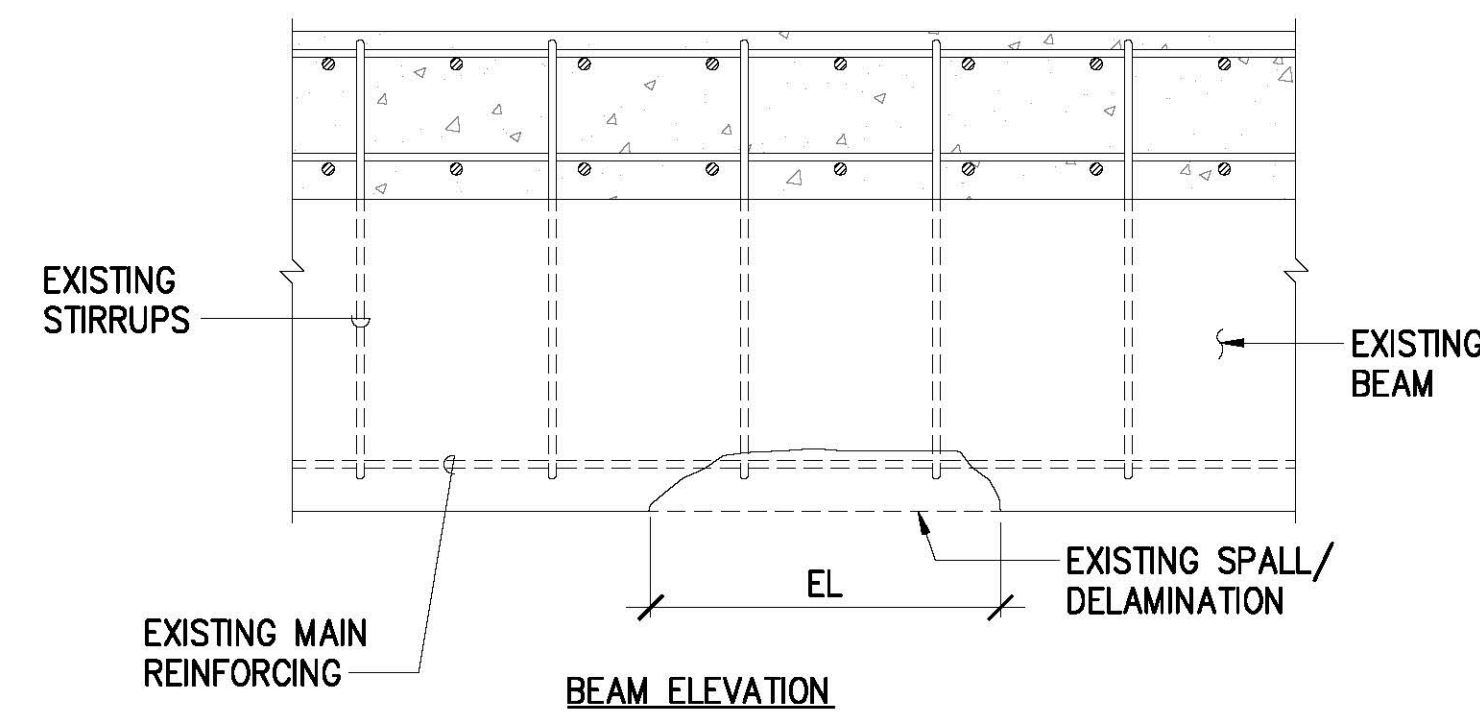
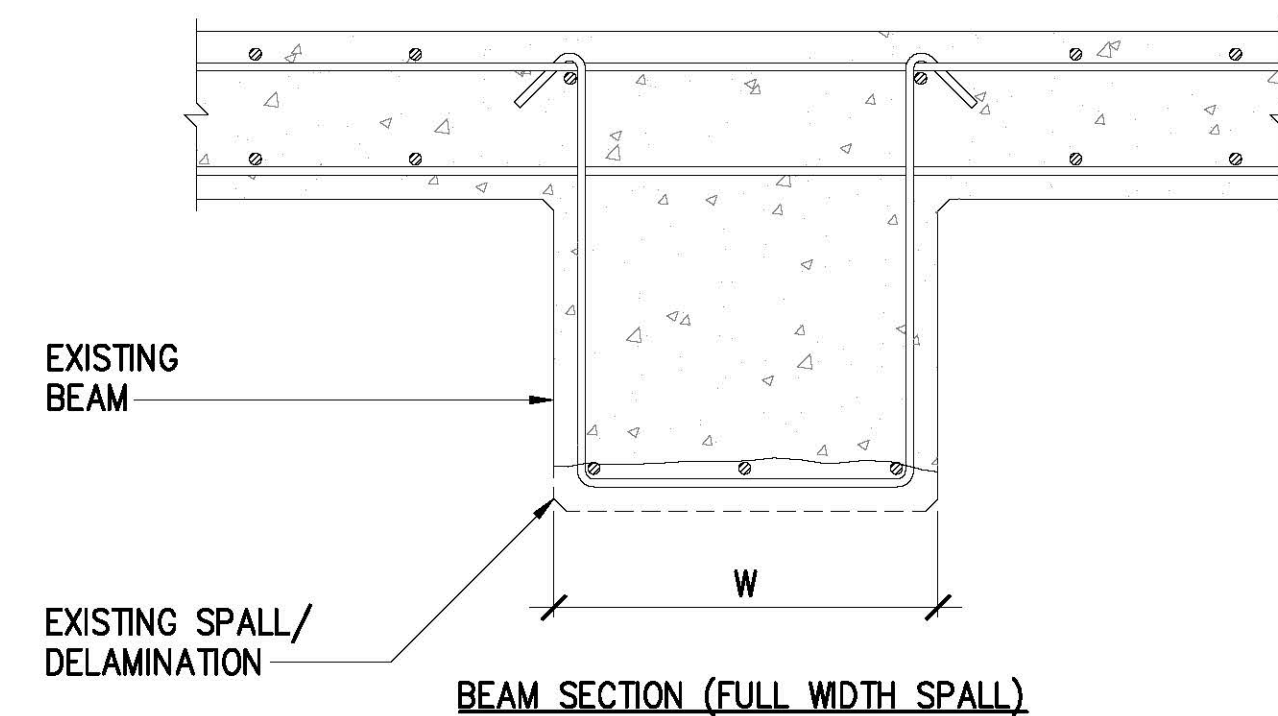
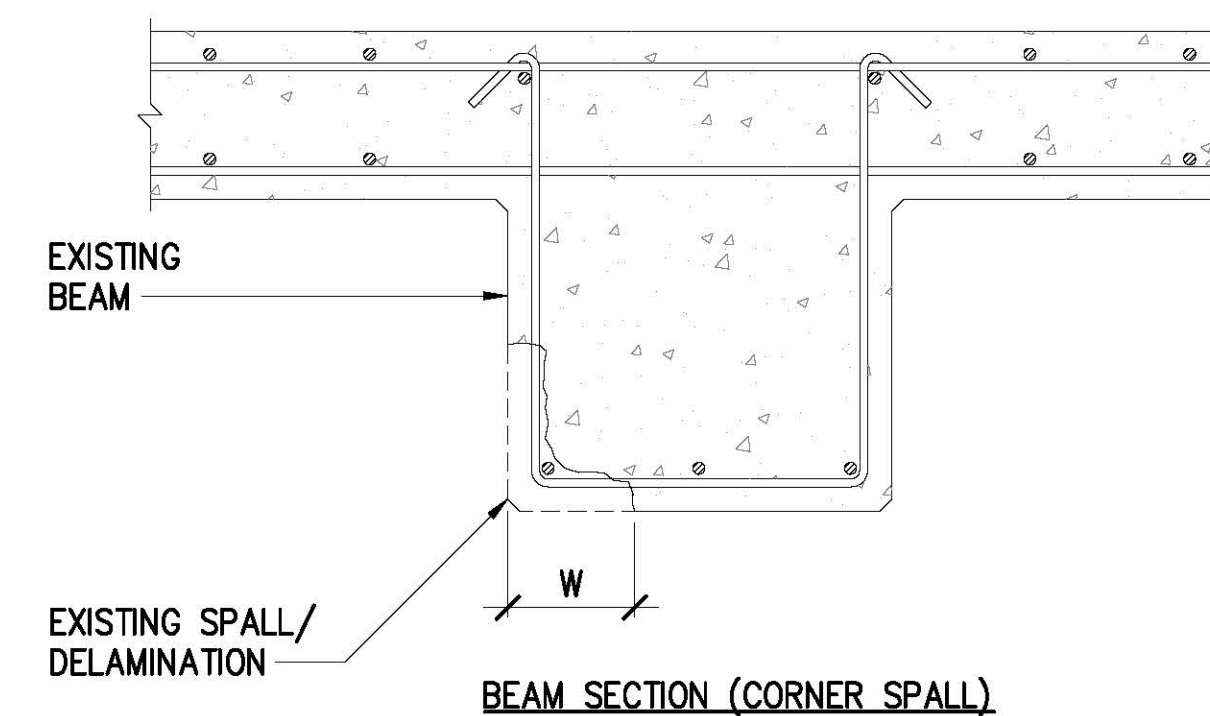
**1 BEAM SPALL REPAIR (TYPE B)**  
 S-9 NOT TO SCALE

**EXISTING CONDITION**

**REPAIRED CONDITION**

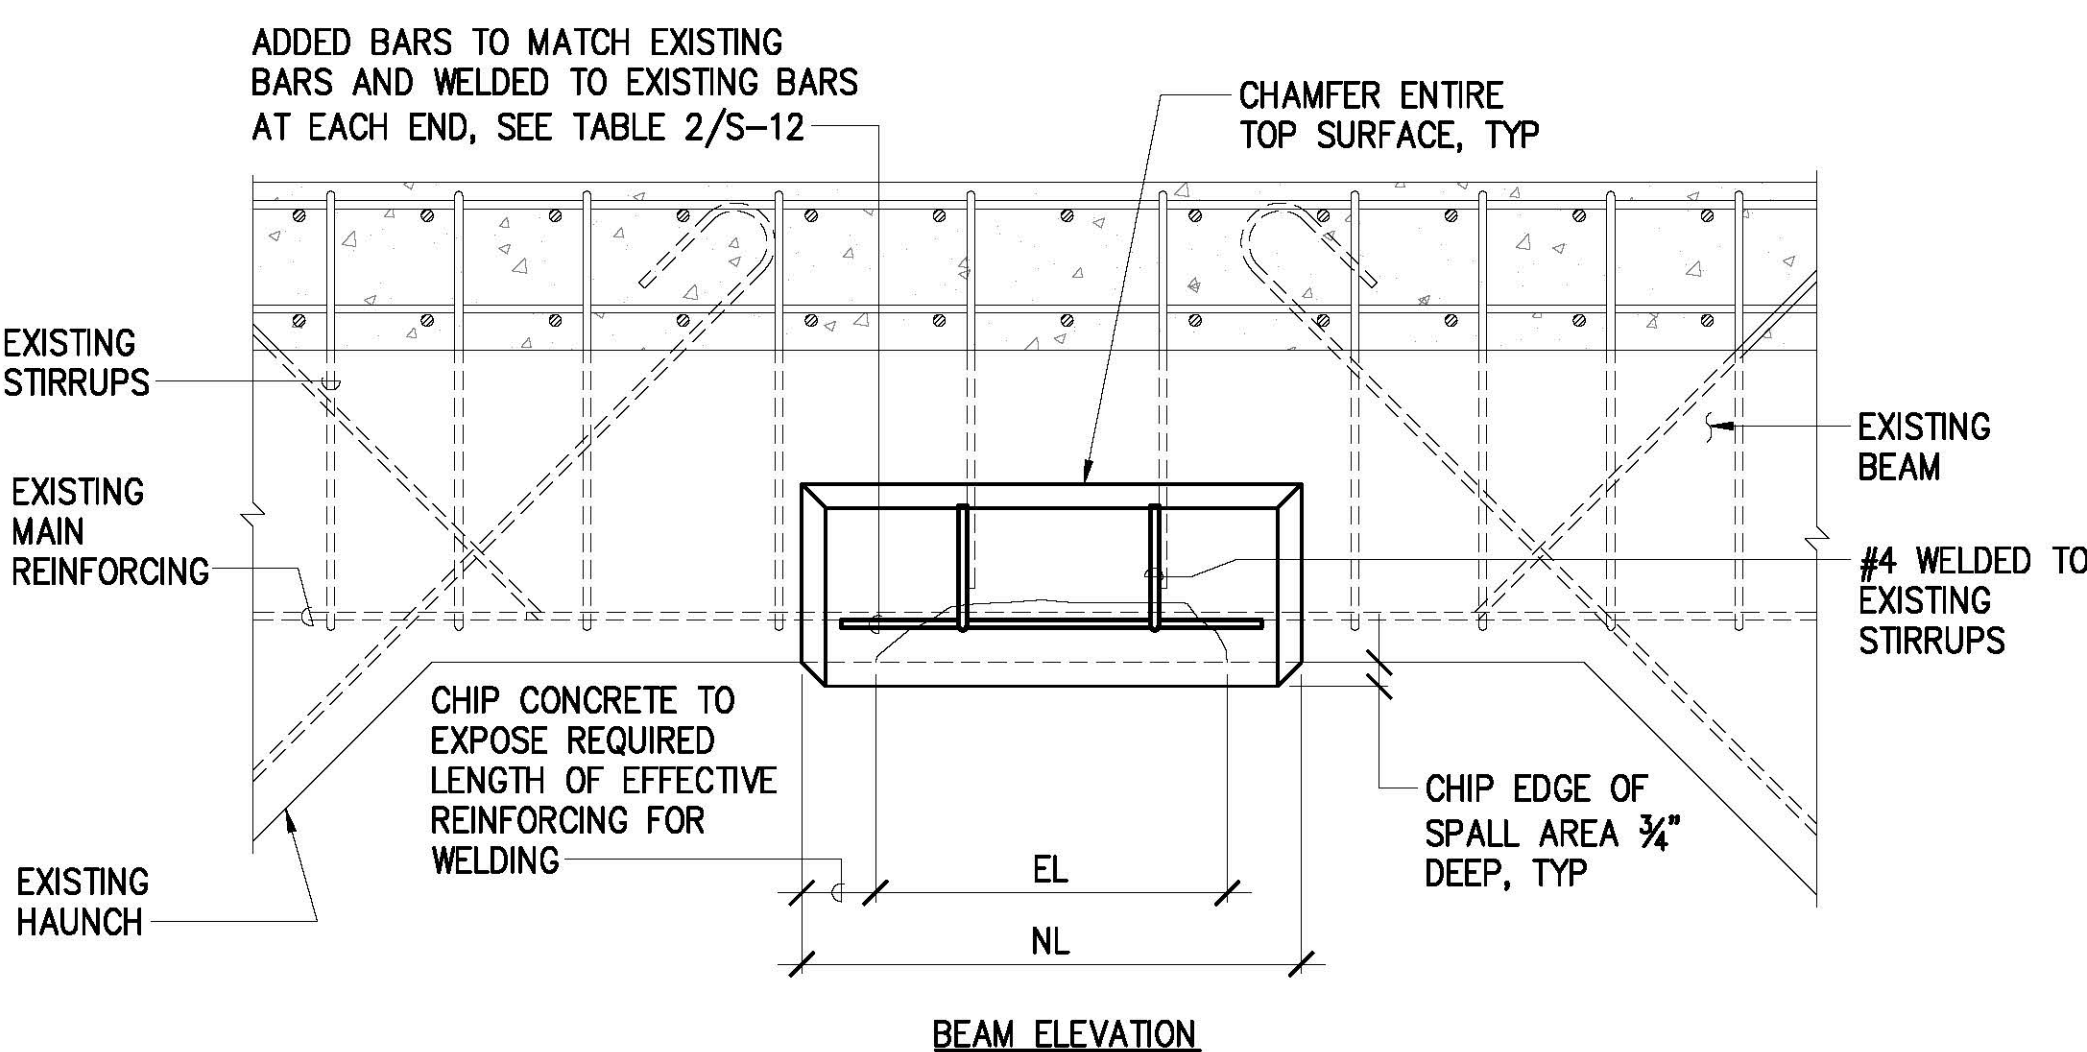
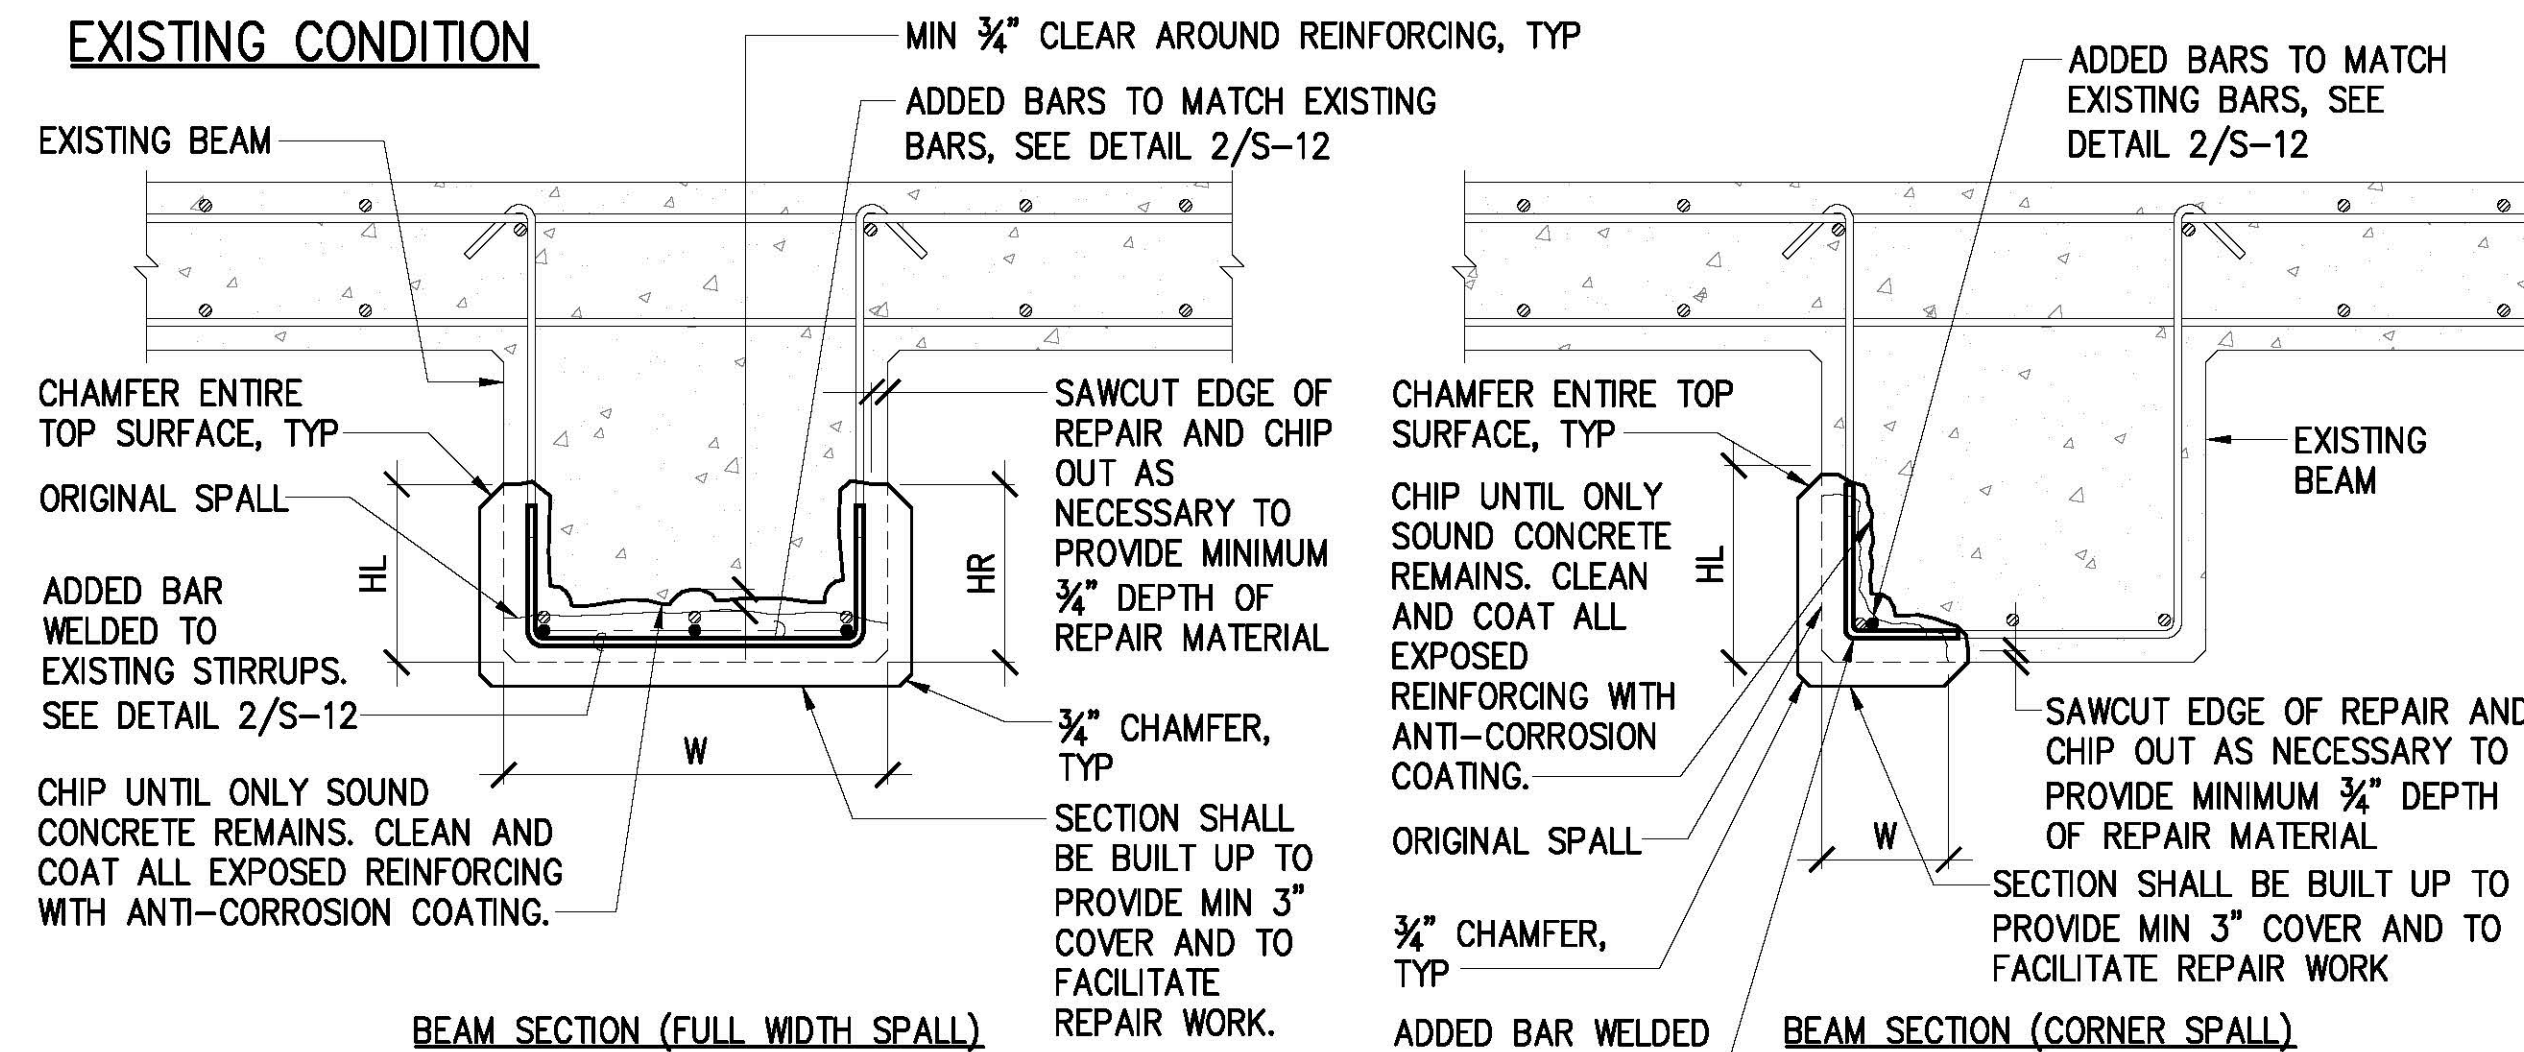
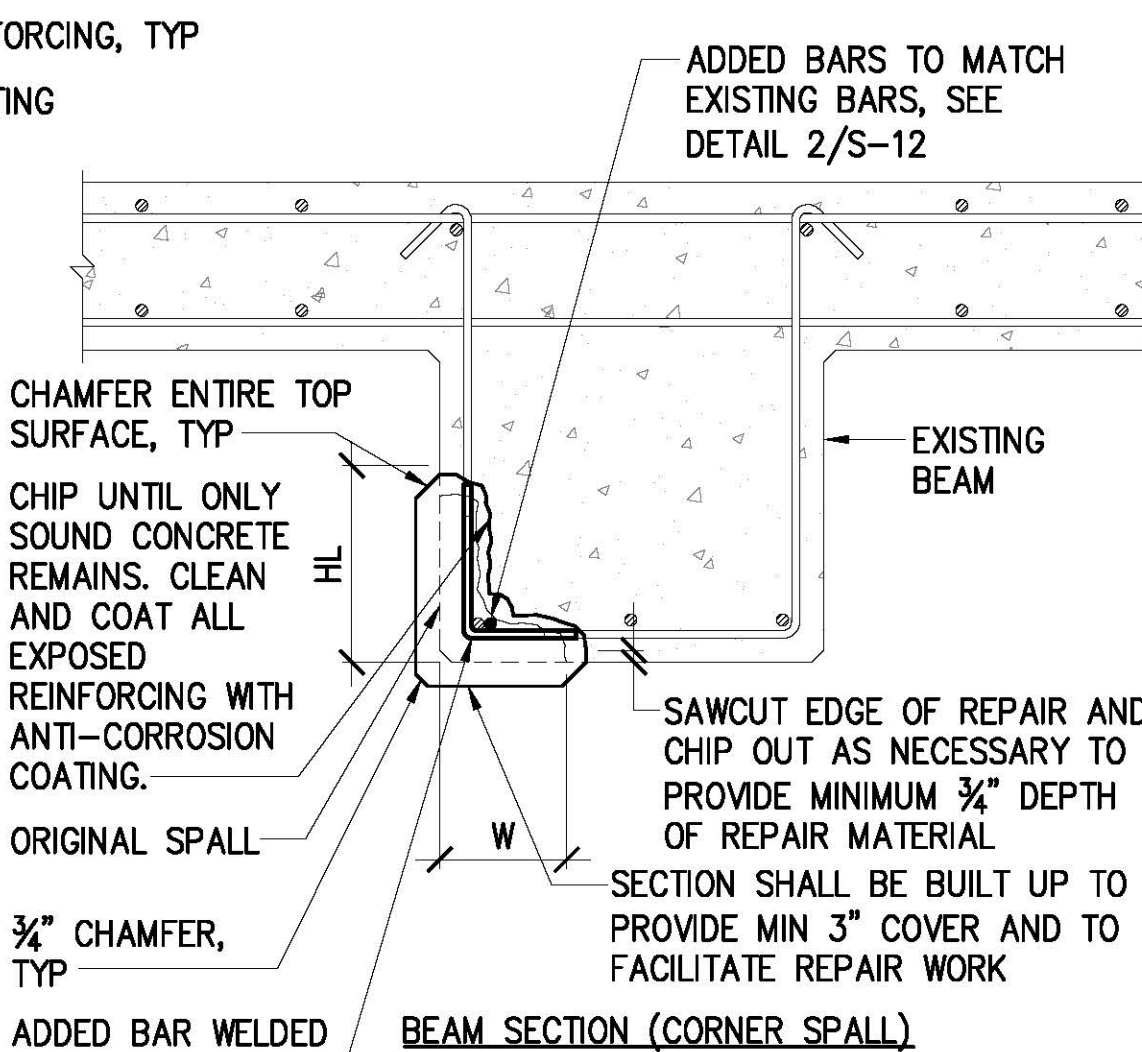
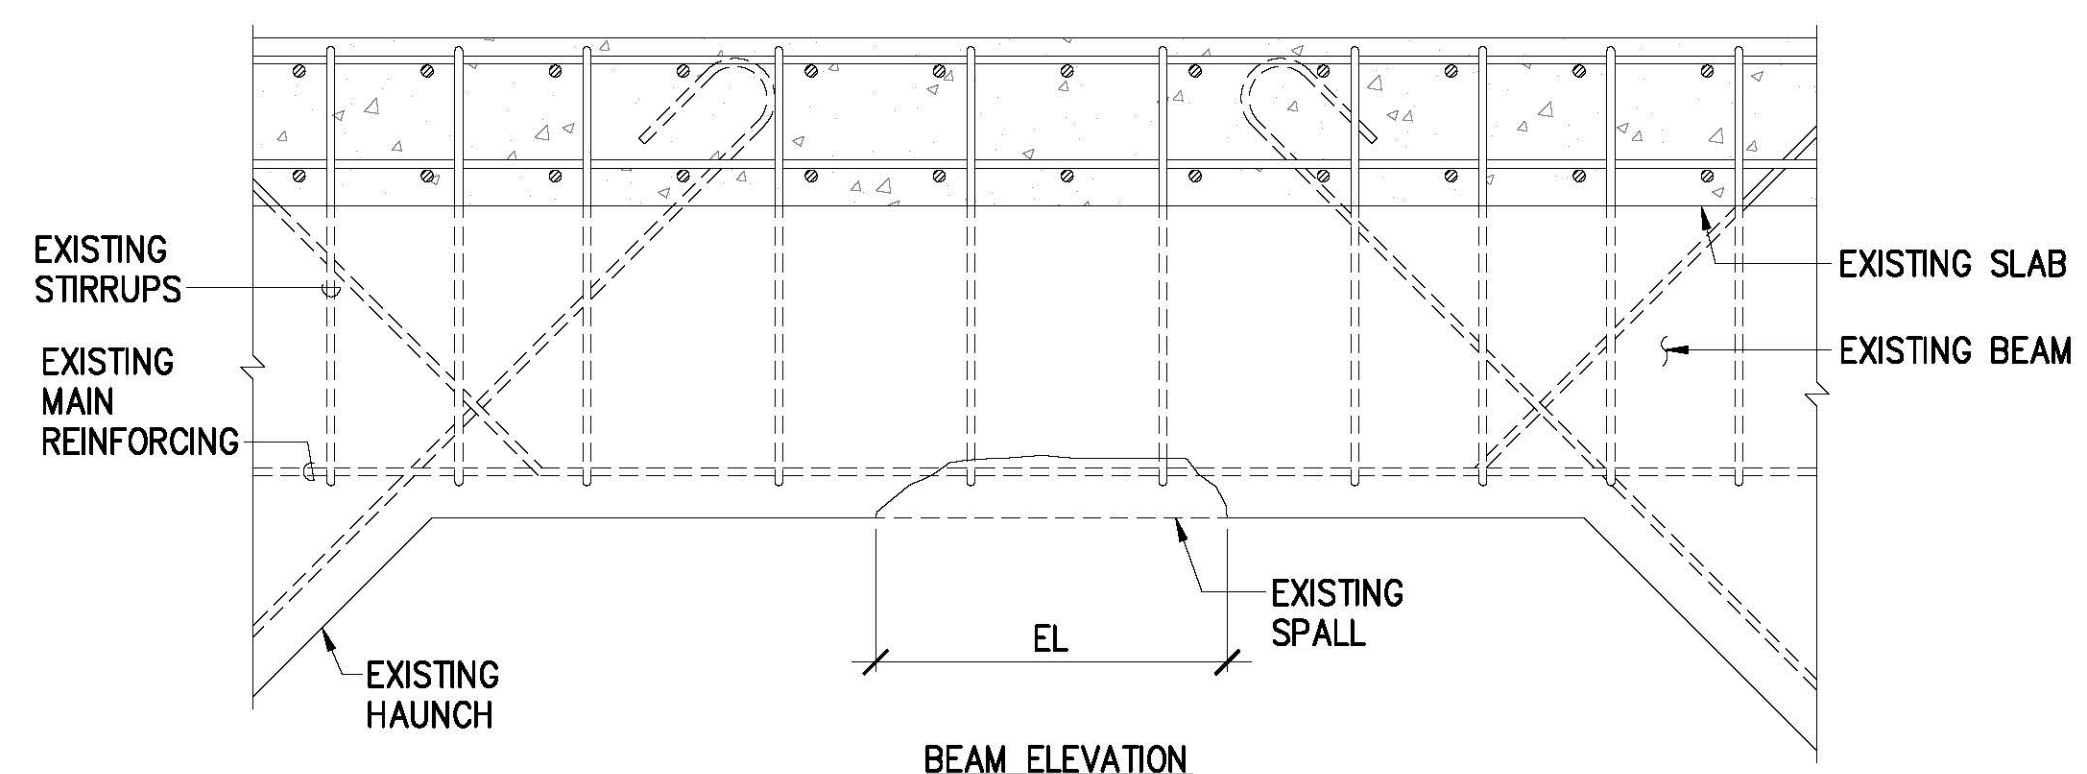
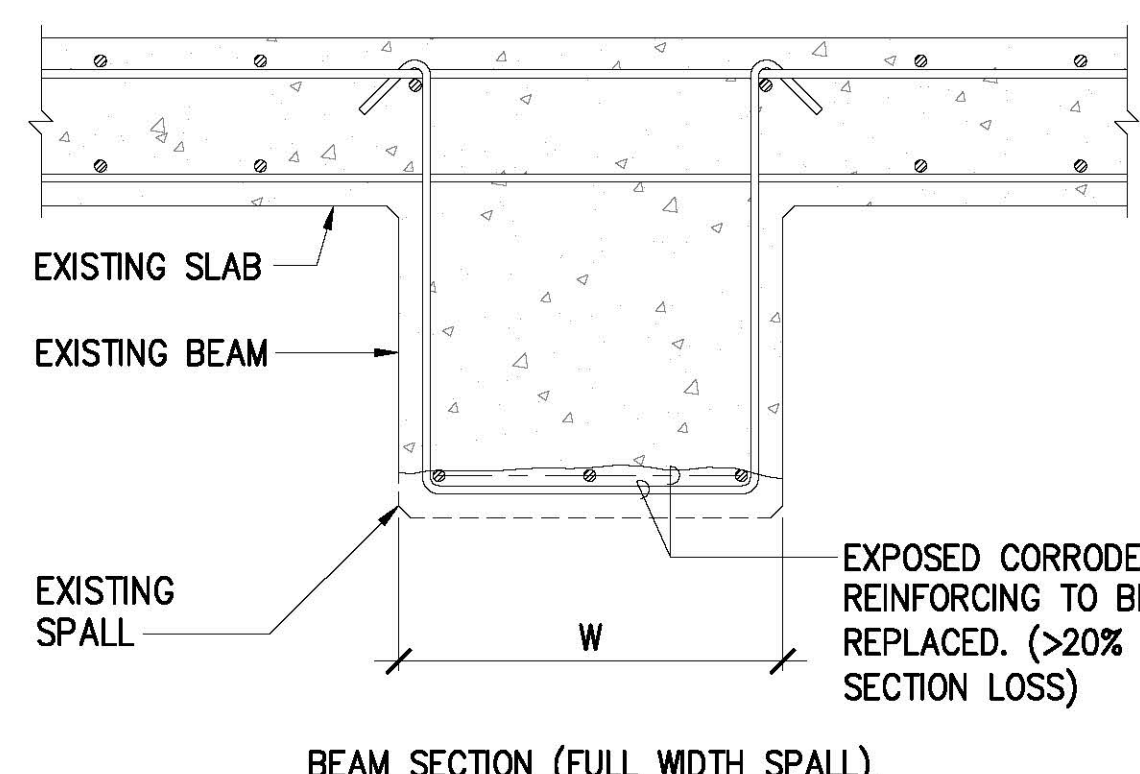
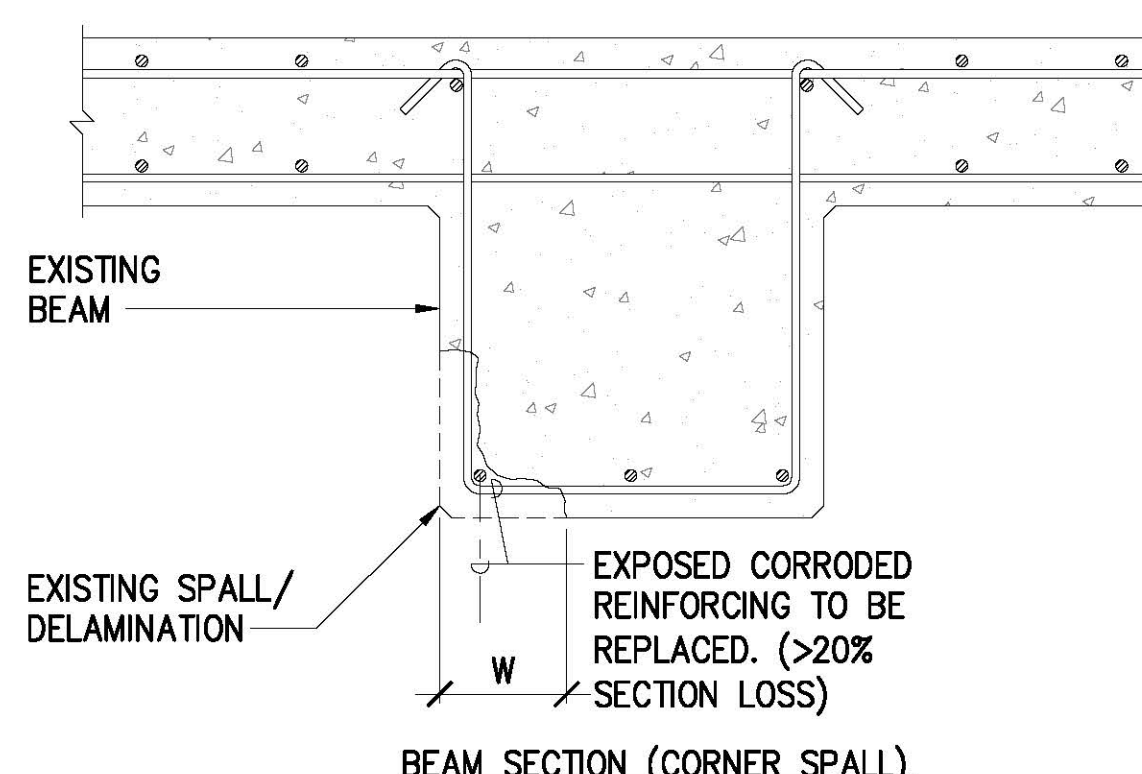
**2 BEAM SPALL REPAIR WITH REINFORCING STEEL REPLACEMENT (TYPE BR)**  
 S-9 NOT TO SCALE

**EXISTING CONDITION**

**REPAIRED CONDITION**
