REVISION	DATE	DESCRIPTION	BY	APPROVED
STATE OF HAWAII				
DEPARTMENT OF TRANSPORTATION				
HARBORS DIVISION				
JOB TITLE				
SUBSTRUCTURE REPAIRS AT PIERS 16 AND 17				
HONOLULU HARBOR, OAHU, HAWAII				
SHEET TITLE				
PRESTRESS DOUBLE TEE SPALL REPAIR DETAILS				
DESIGNED BY: GO		JOB NUMBER		SHEET
DRAWN BY: DL				S-10
CHECKED BY: GW				
DATE: 04/2023				
SCALE: AS SHOWN		12 OF 14 SHEETS

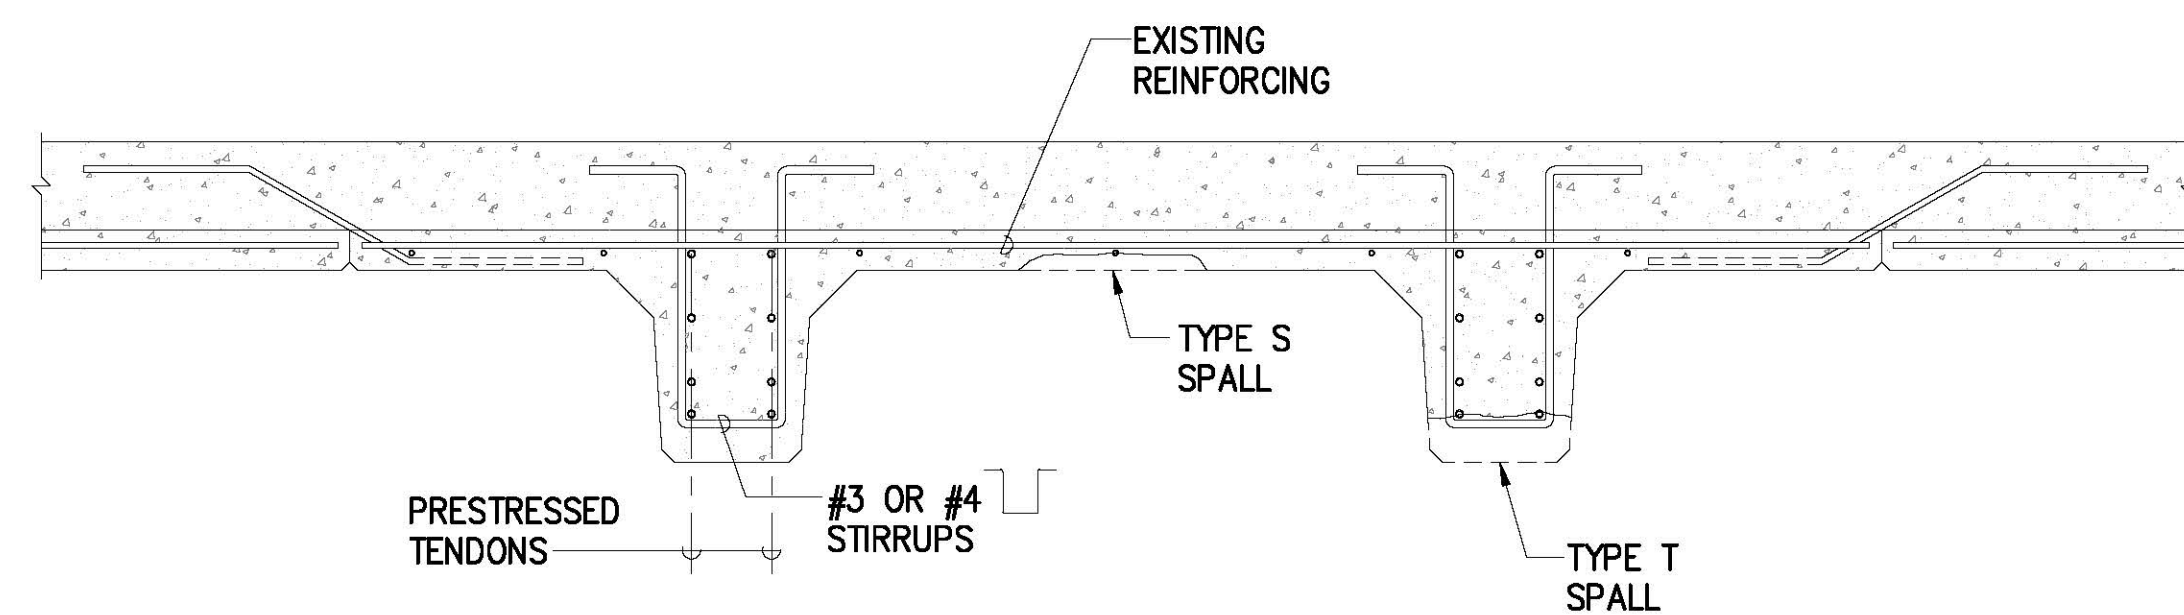
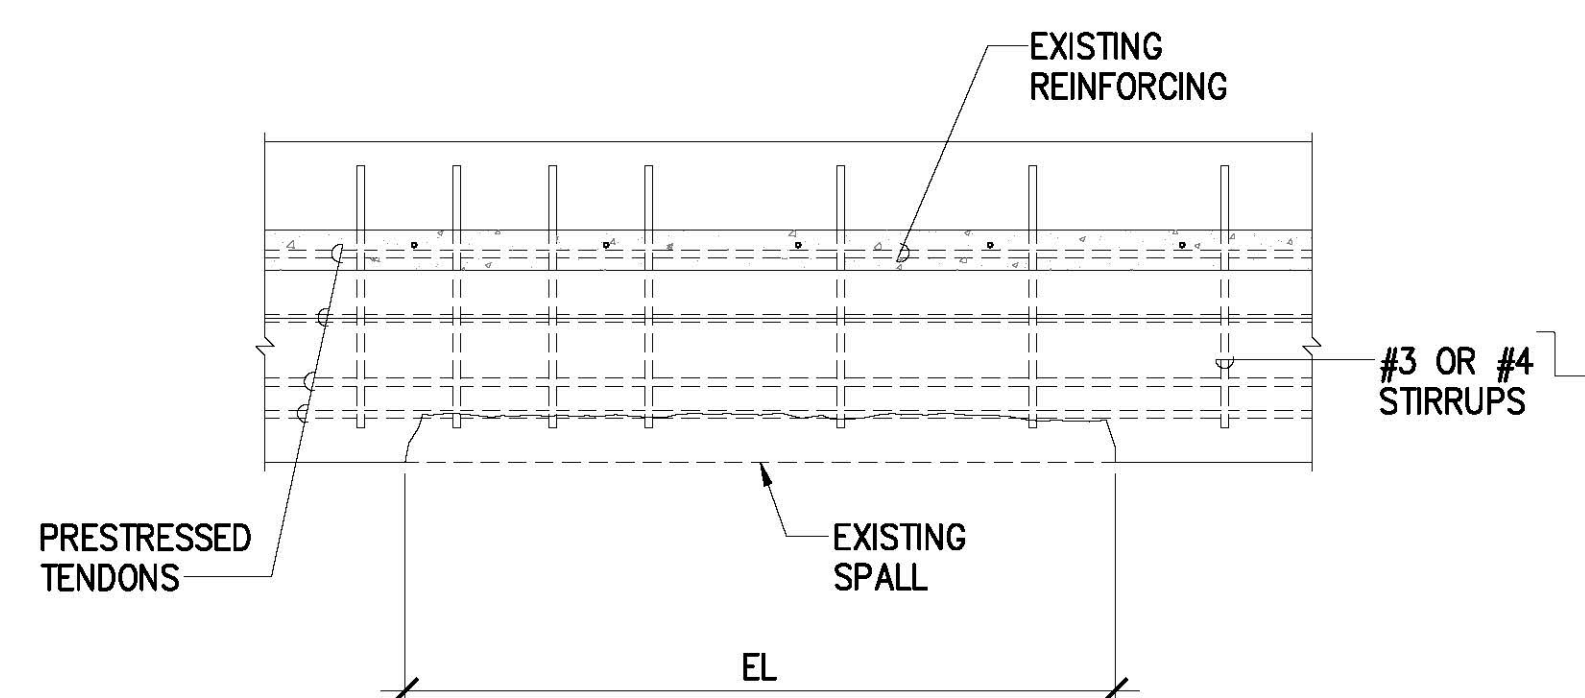
TYPE T SPALL SIDE ELEVATION

EXISTING CONDITION

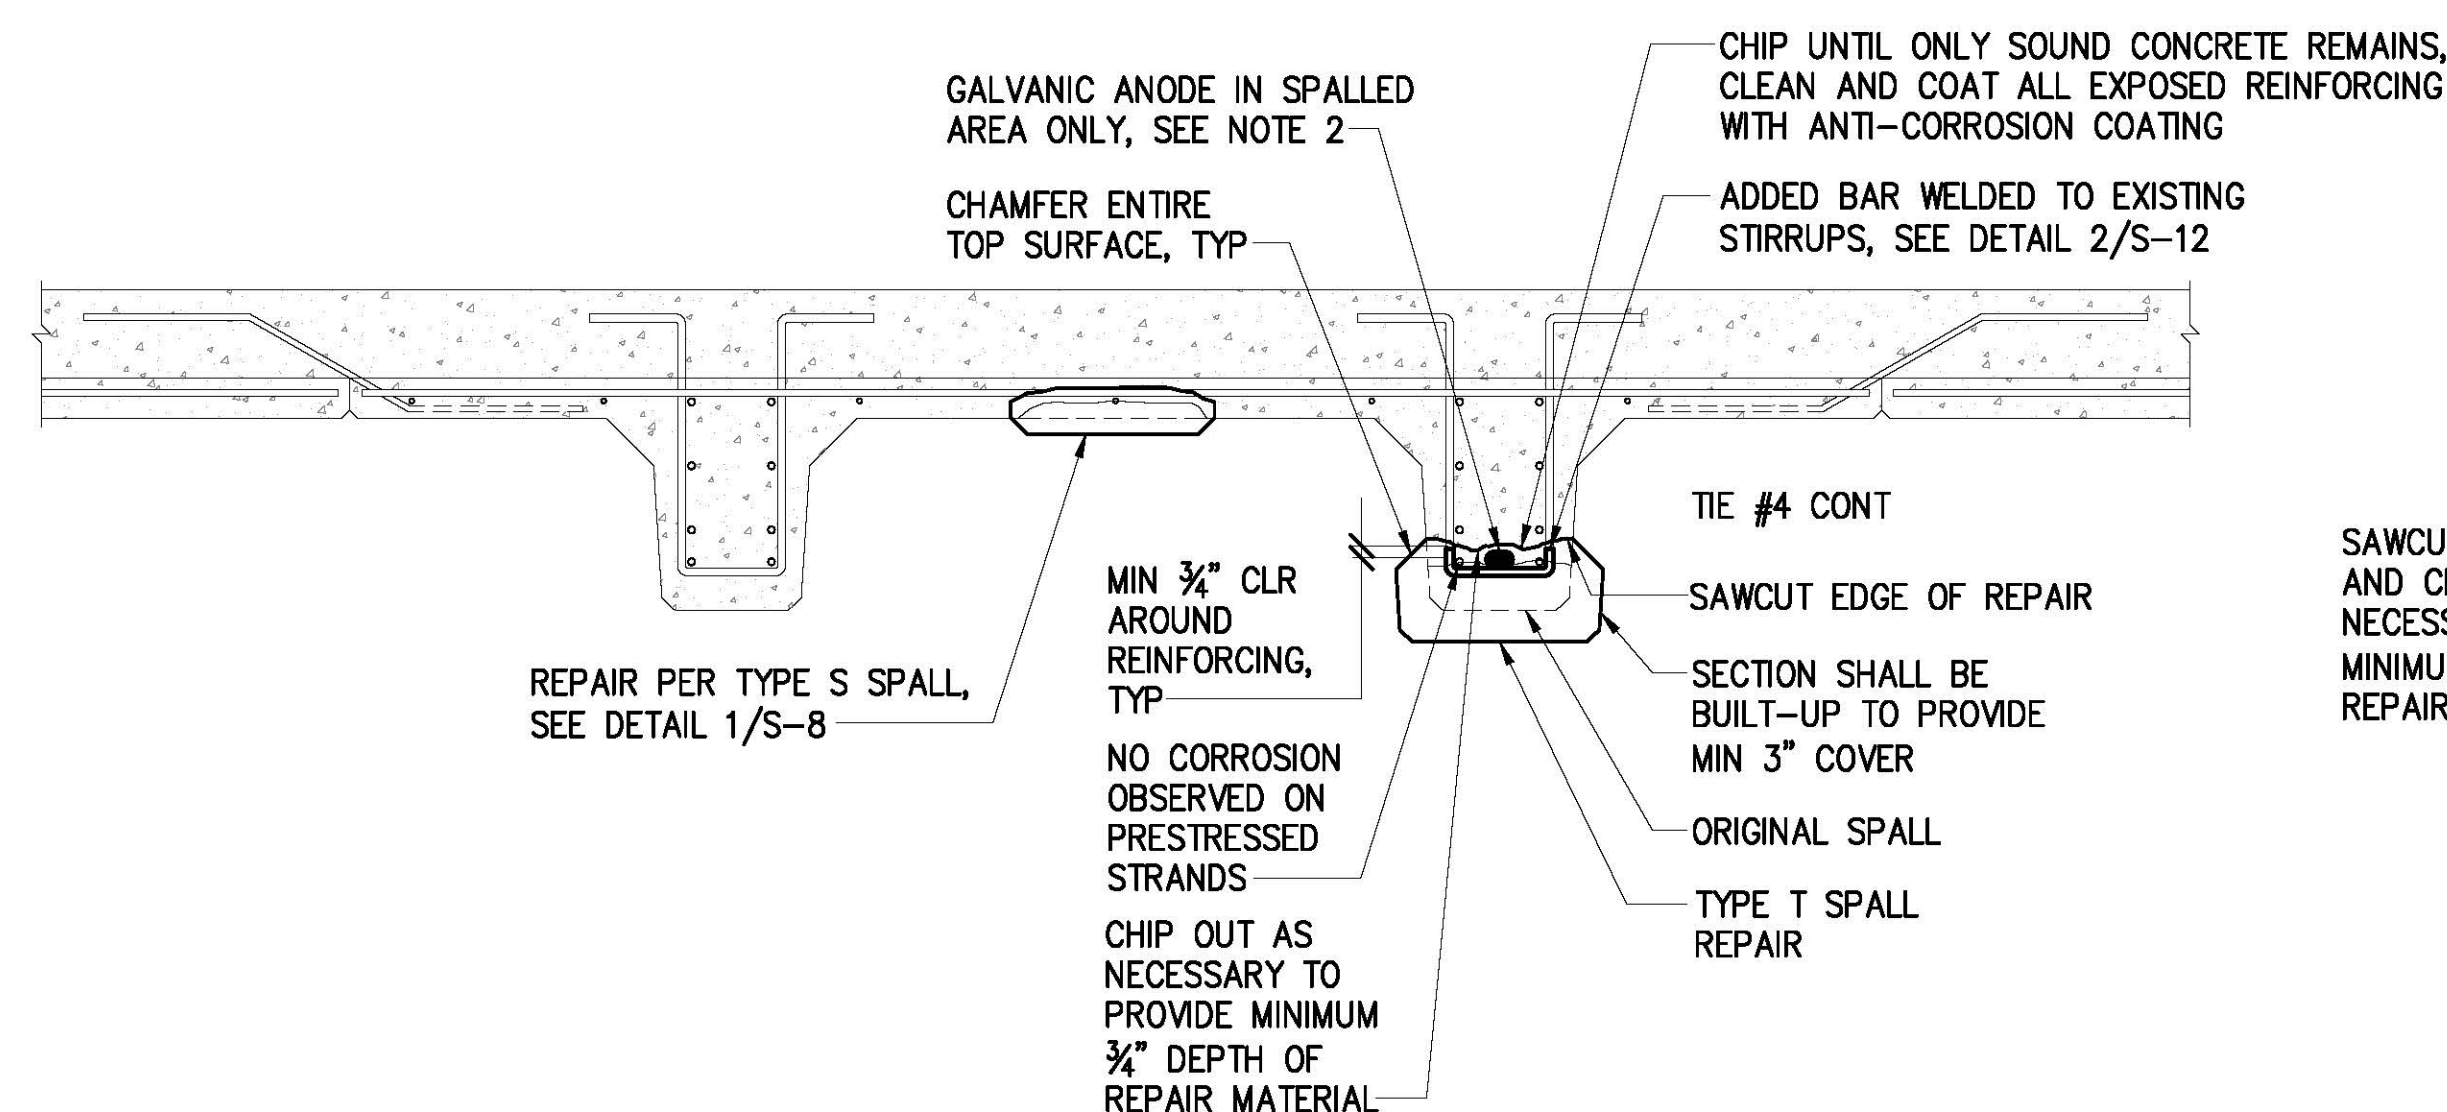
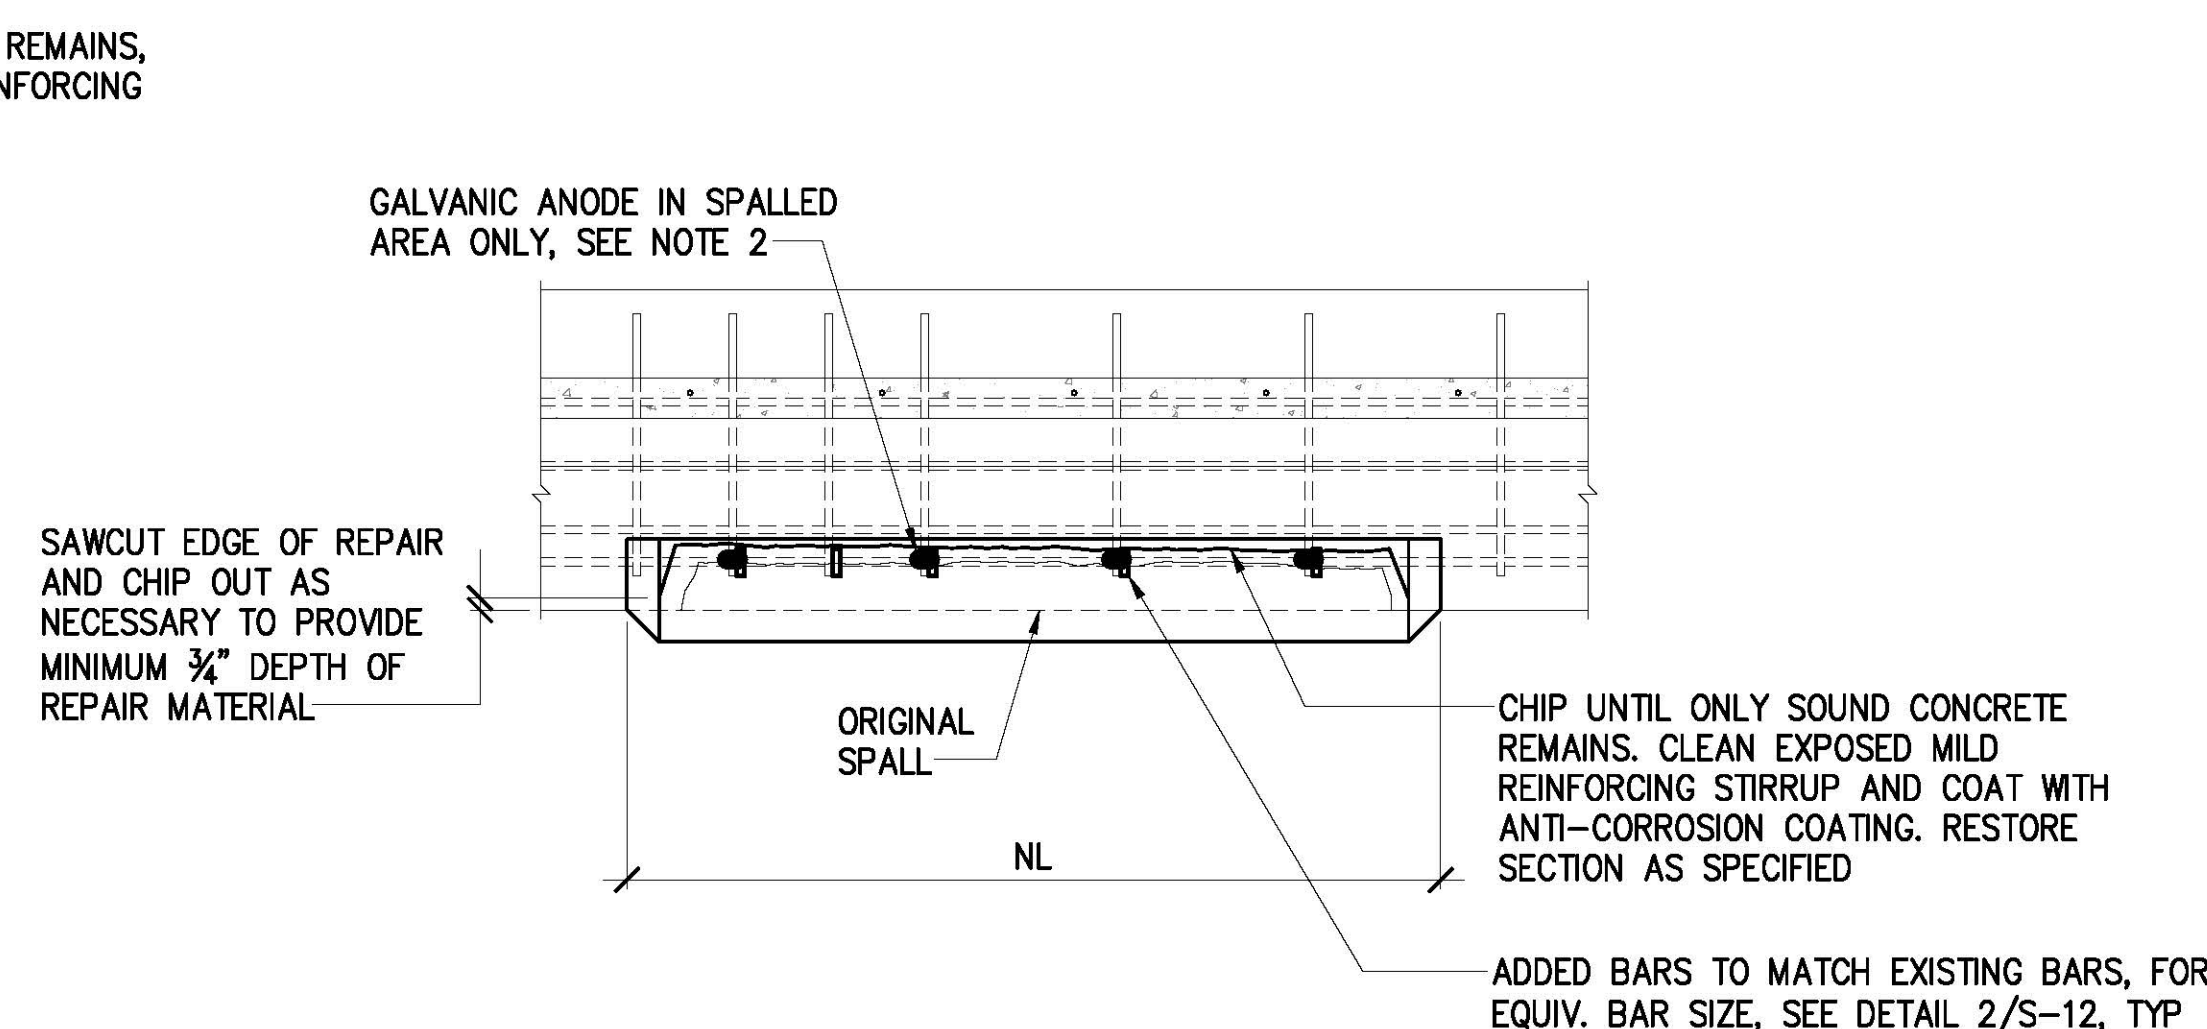
TYPE T SPALL SIDE ELEVATION

REPAIRED CONDITION

1. CONCRETE TOPPING REINFORCING STEEL NOT SHOWN FOR CLARITY.
2. GALVANIC ANODES SHALL BE INSTALLED AT 17" MAX ALONG LENGTH OF REPAIR.
3. ANY PRESTRESSED STRAND WHICH HAS LOST MORE THAN 20 PERCENT OF ITS CROSS-SECTIONAL AREA SHALL BE CALLED TO THE ATTENTION OF THE HARBORS DIVISION CONSTRUCTION ENGINEER.
4. TYPE S SPALLS ON DOUBLE TEES SHALL BE REPAIRED AND PAID FOR SIMILAR TO TYPICAL TYPE S SPALLS, SEE DETAIL 1/S-8.
