STATE OF HAWAII
DEPARTMENT OF TRANSPORTATION
HIGHWAYS DIVISION

**MILE POST 29.01
SITE IMPROVEMENTS**
**HAWAII BELT ROAD DRAINAGE
IMPROVEMENTS**
Project No. 19FGH-01-07M

SHEET No. C8.1 OF 1 SHEETS

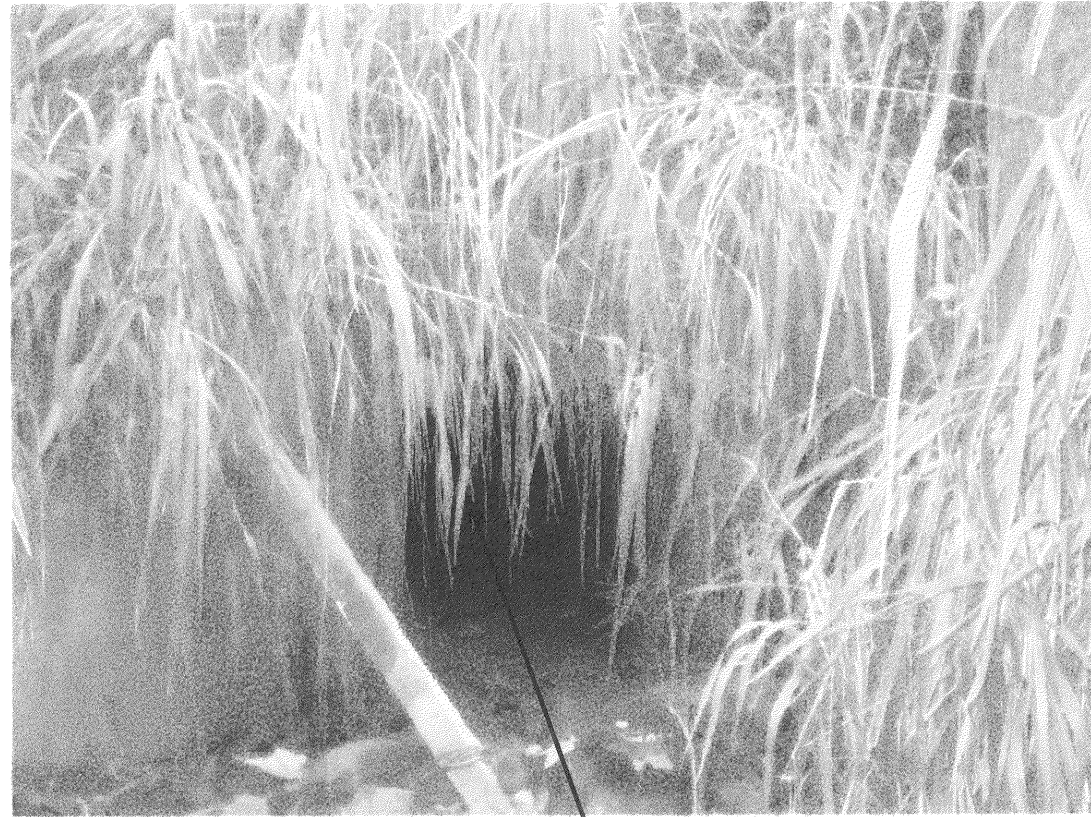
Photo 1

Trim vegetation from around inlet opening

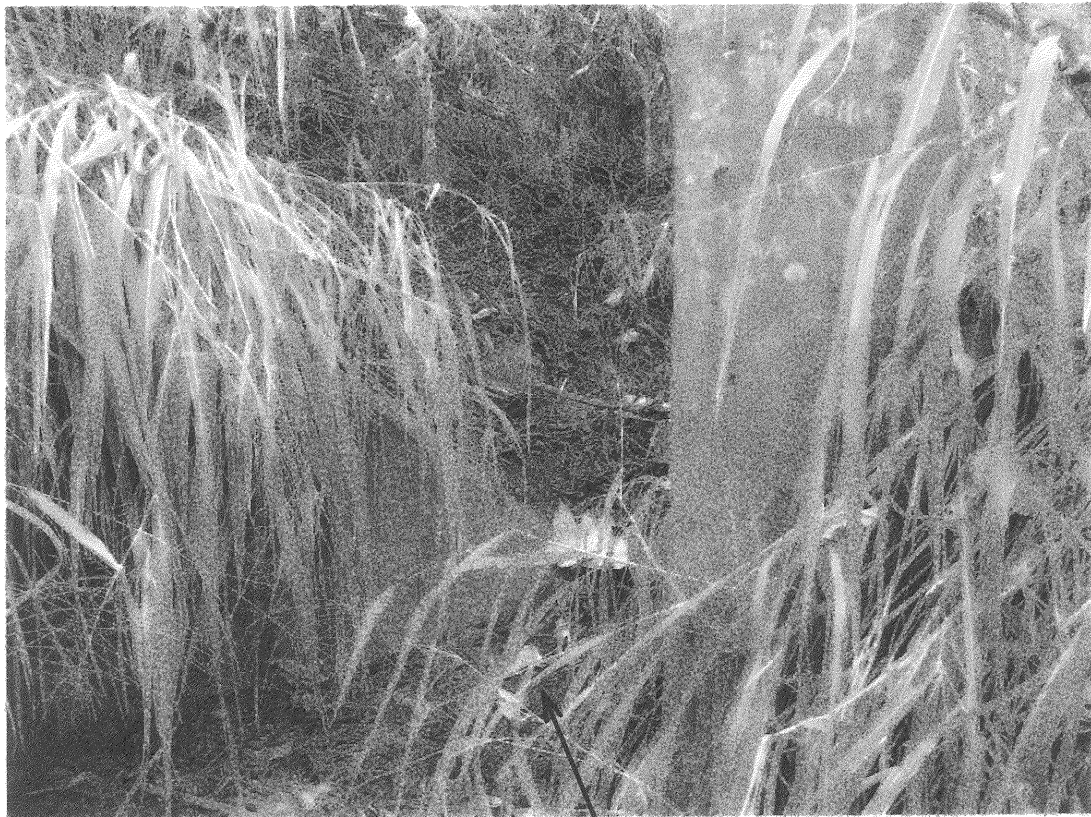
Photo 4

Remove silt deposit & loose vegetation

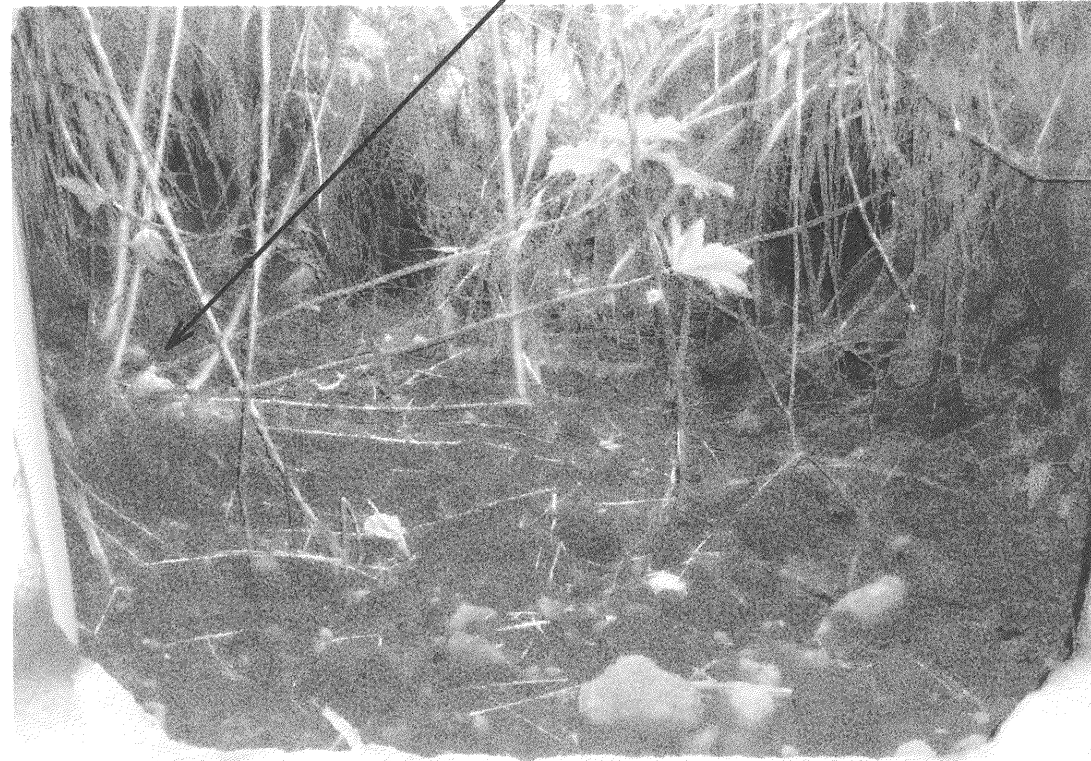
Photo 5

Trim vegetation from around outlet opening

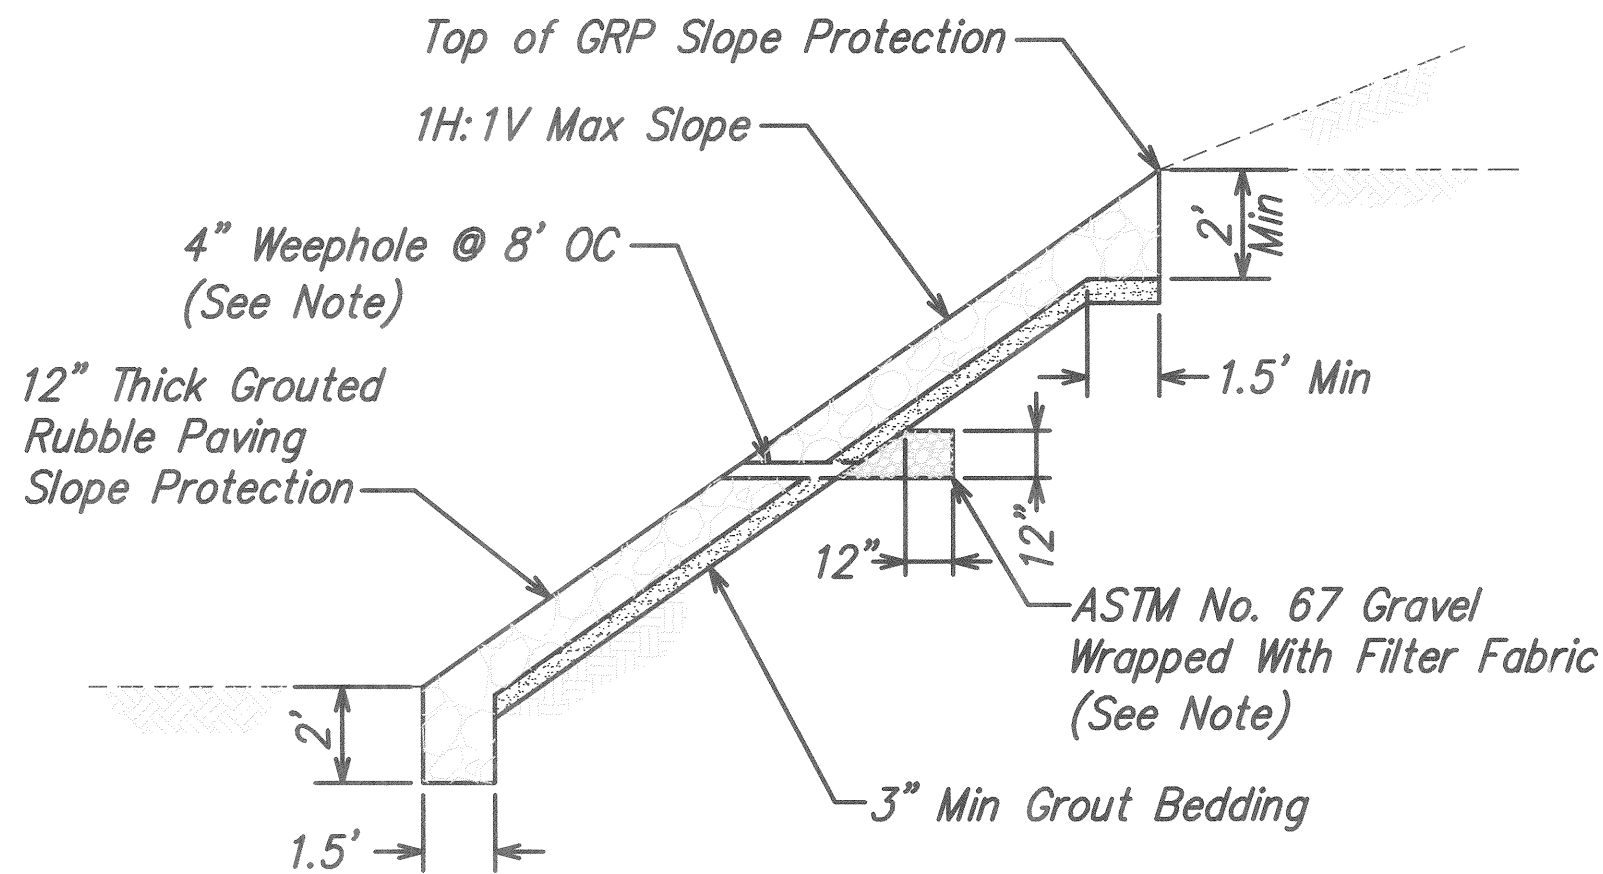
Weepholes & continuous gravel layer shall be located at approximately 1/3-height of slope protection.
