FED. ROAD DIST. NO.	STATE	PROJ. NO.	FISCAL YEAR	SHEET NO.	TOTAL SHEETS
HAWAII	HAW	19FGH-01-07M	2008	26	51

STATE OF HAWAII
DEPARTMENT OF TRANSPORTATION
HIGHWAYS DIVISION

**MILE POST 40.33
SITE IMPROVEMENTS**
**HAWAII BELT ROAD DRAINAGE
IMPROVEMENTS**
Project No. 19FGH-01-07M

SHEET No. C17.1 OF 1 SHEETS

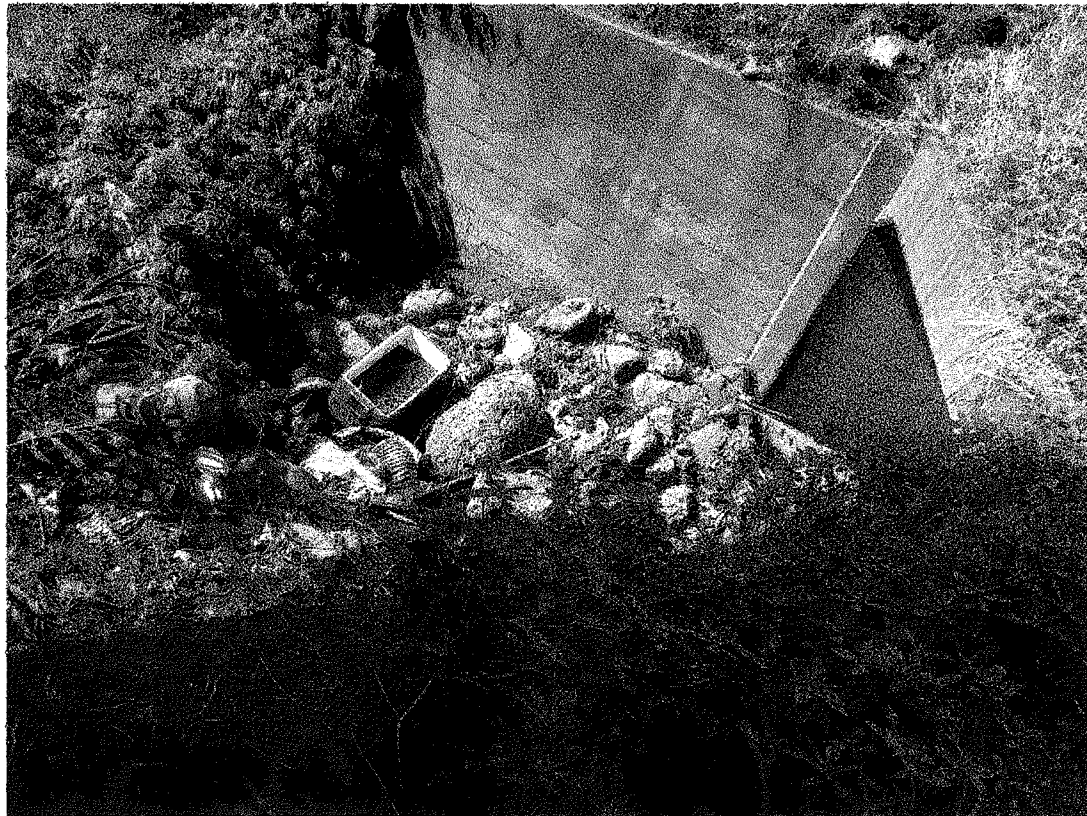
Photo 1
Clear silt deposit & loose debris from inlet opening

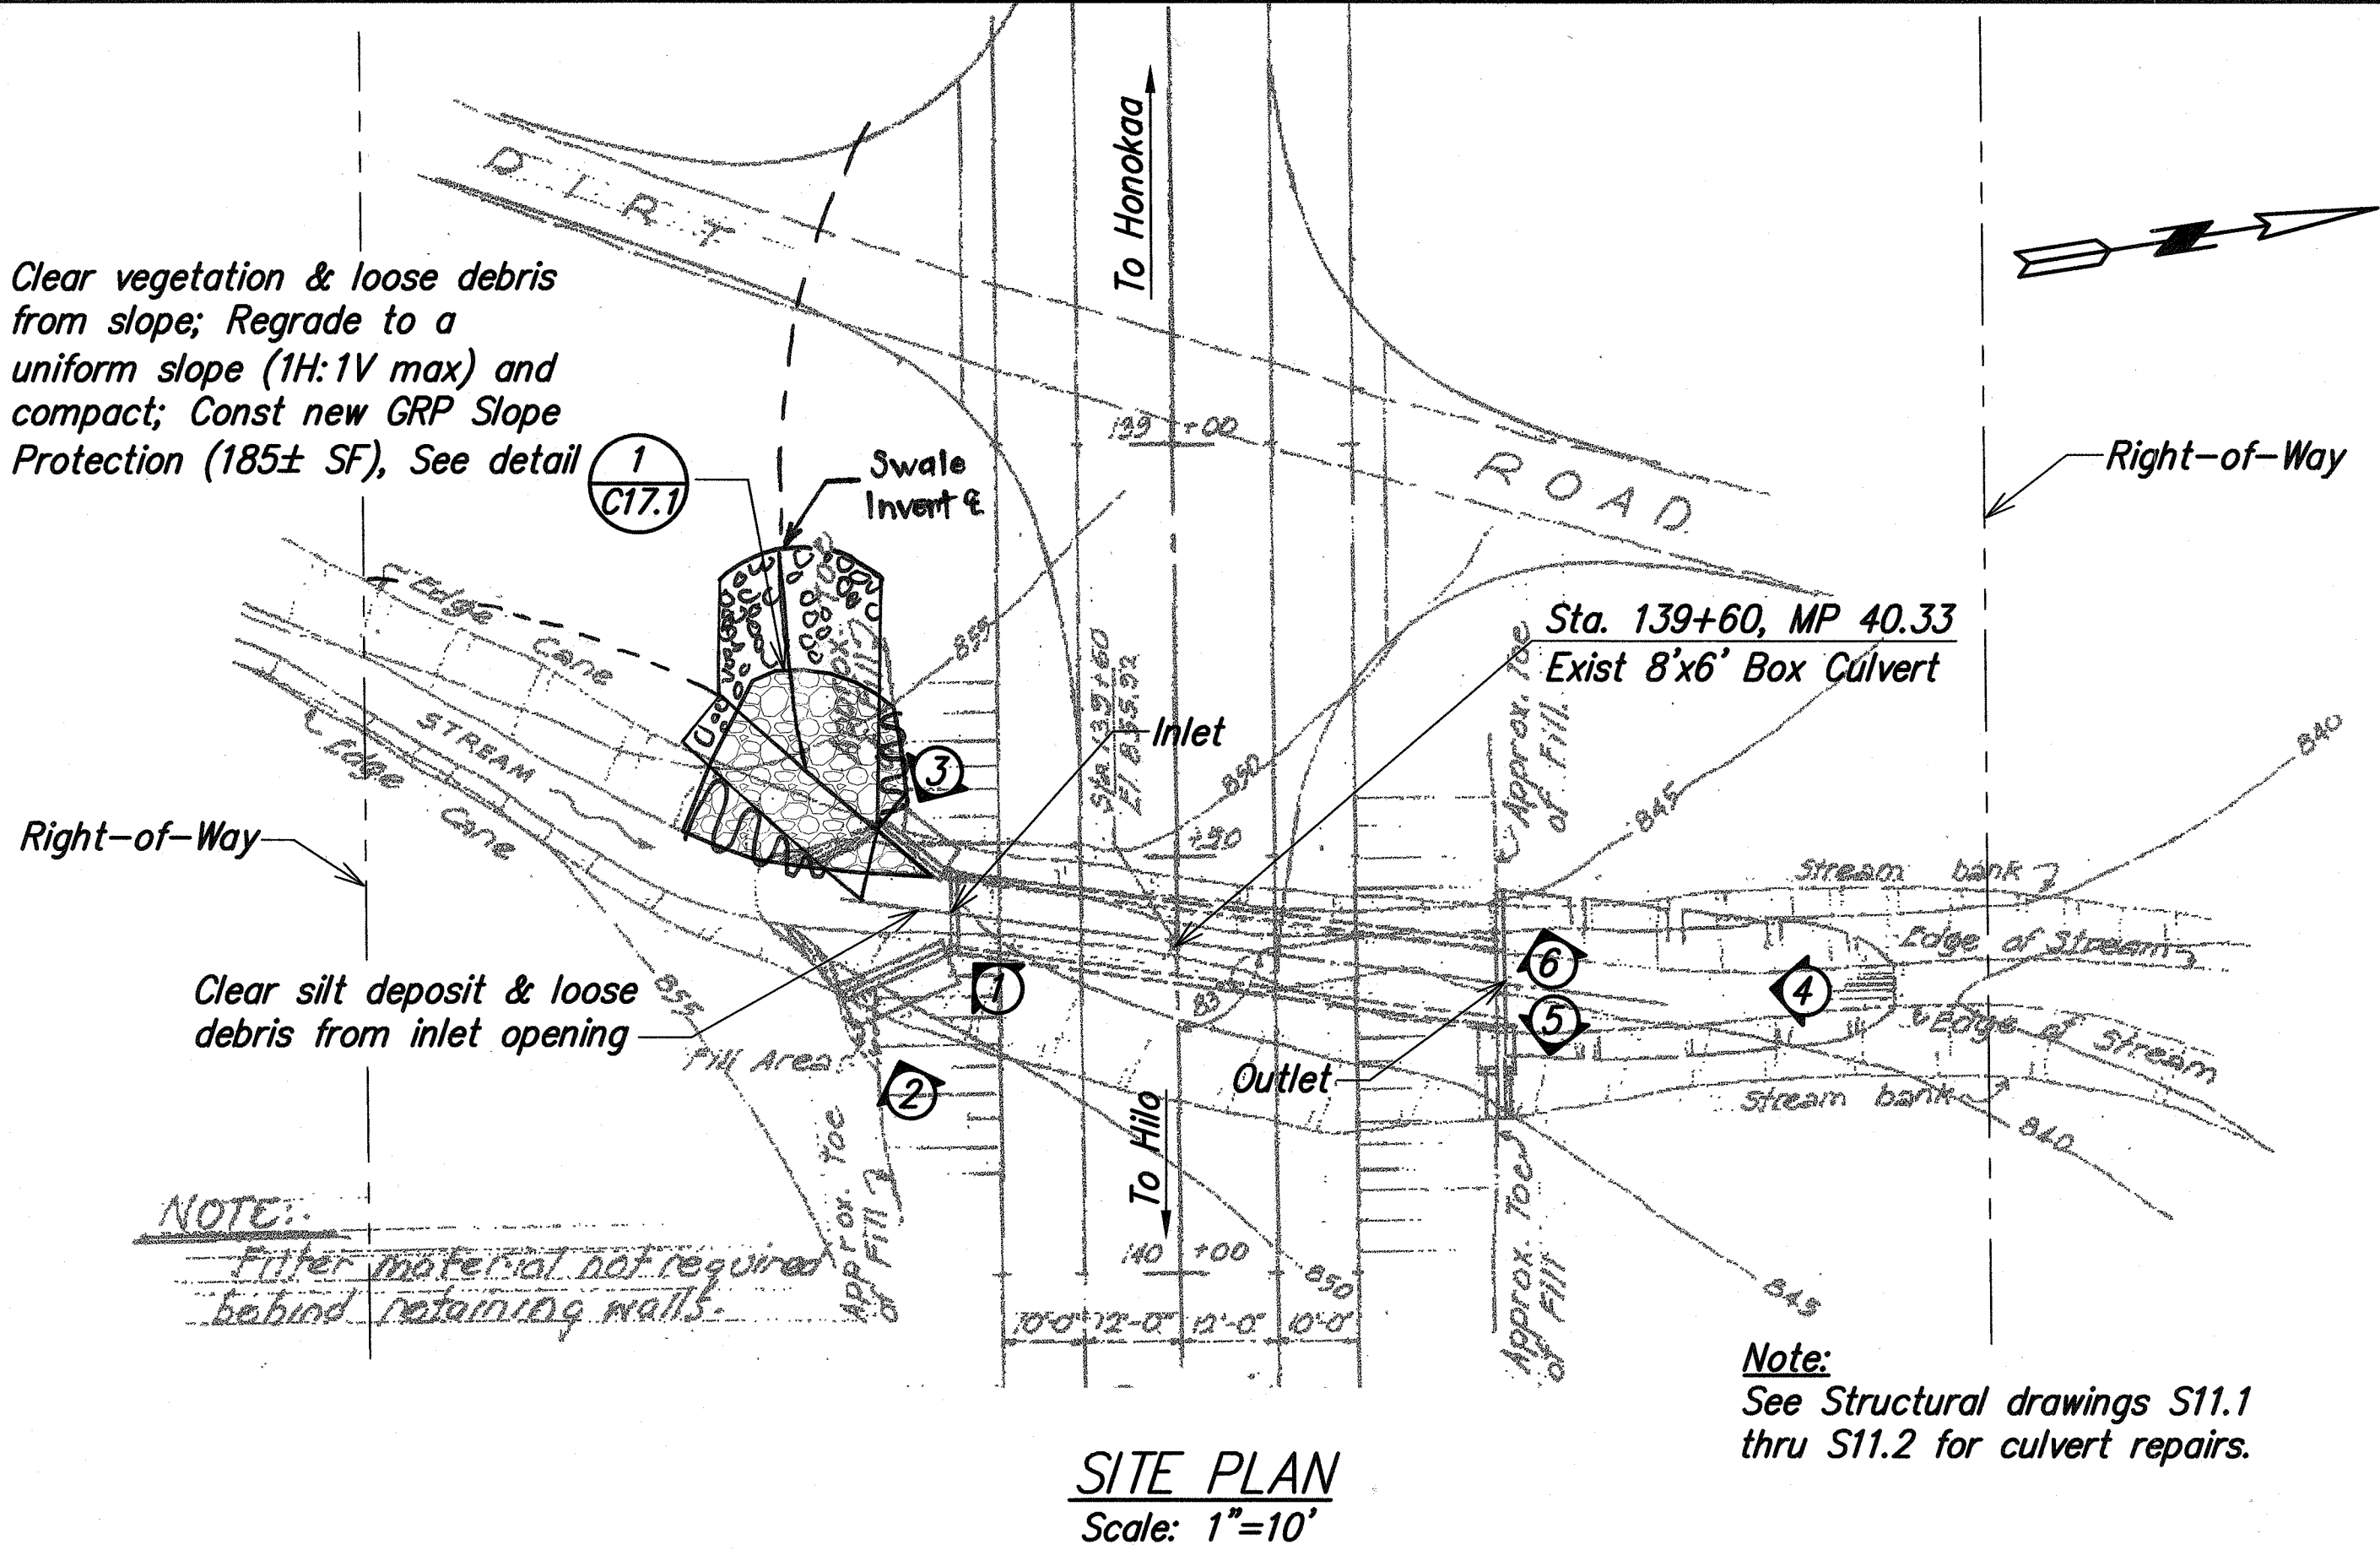
Note:
Weepholes & continuous gravel layer shall be located at approximately 1/3-height of slope protection.
