TOPOGRAPHIC SURVEY MAP  
 UMAUMA BRIDGE  
 WAILUA, ISLAND OF HAWAII, HAWAII  
 JOB NO. : 10003-01 FIELD BOOK : M-173  
 FEBRUARY 23, 2010

**BORING LOCATION PLAN**

HAWAII BELT ROAD  
 Rehabilitation of Umauma Stream Bridge  
 Federal Aid Project No. BR-019-2(61)

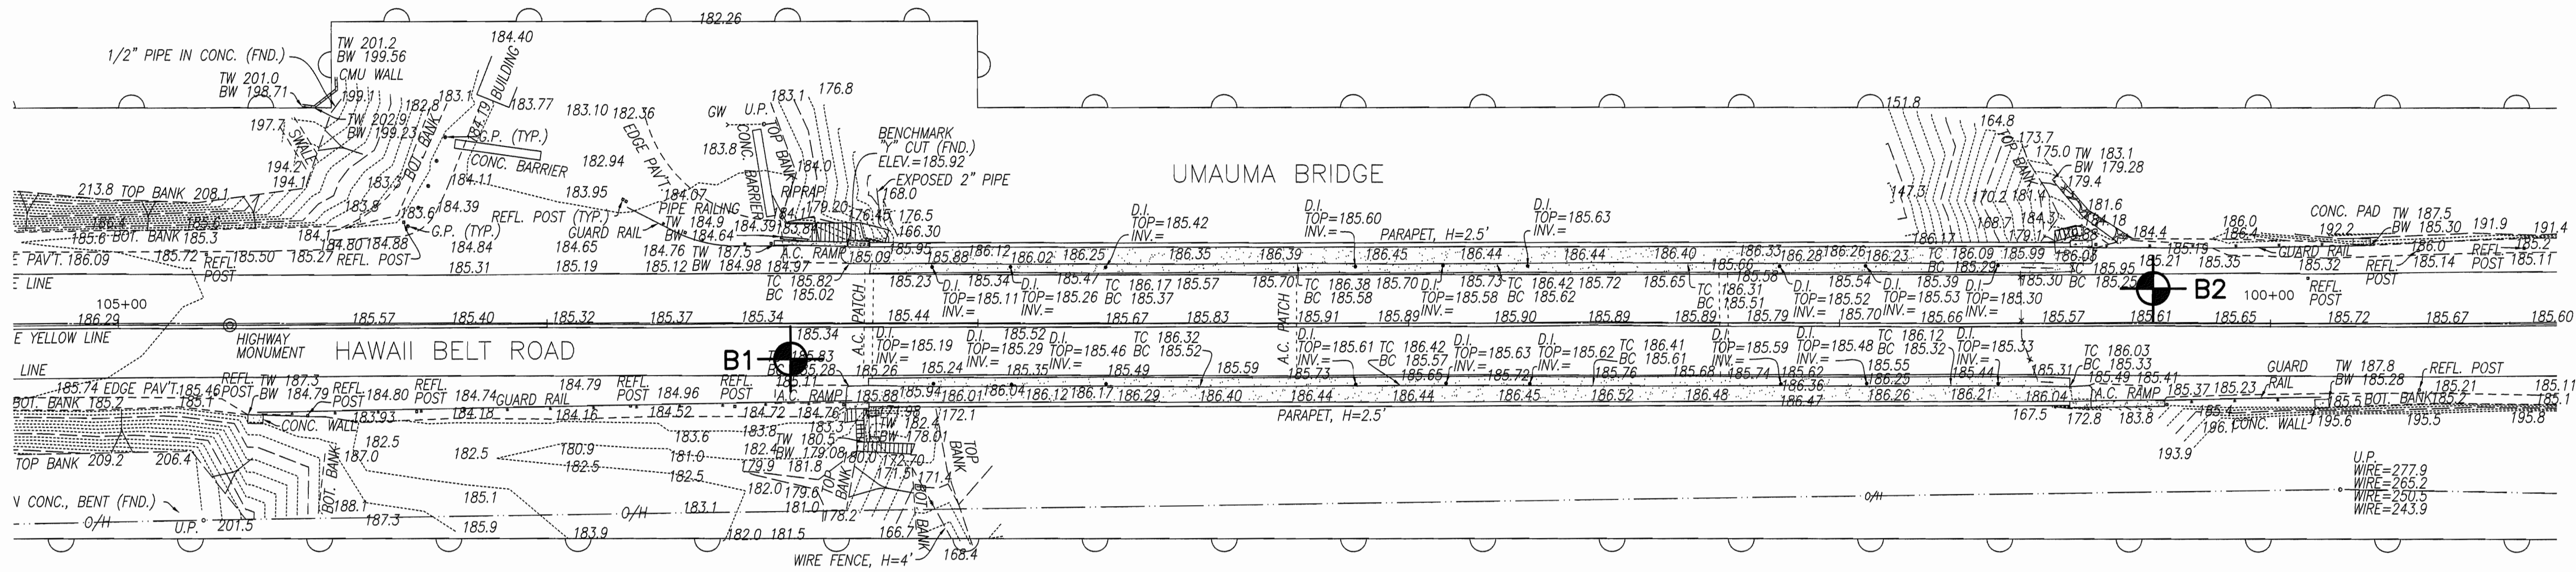
**Legend:**  
 Approximate location of borings.

**BENCHMARK**  
 REFERRED TO "4" CUT ON SOUTH END OF BRIDGE AS SHOWN ON HAWAII BELT ROAD AS-BUILTS PLANS, F.A.P. NO. SDR-3(13) SHEET 7  
 ELEV. = 185.92

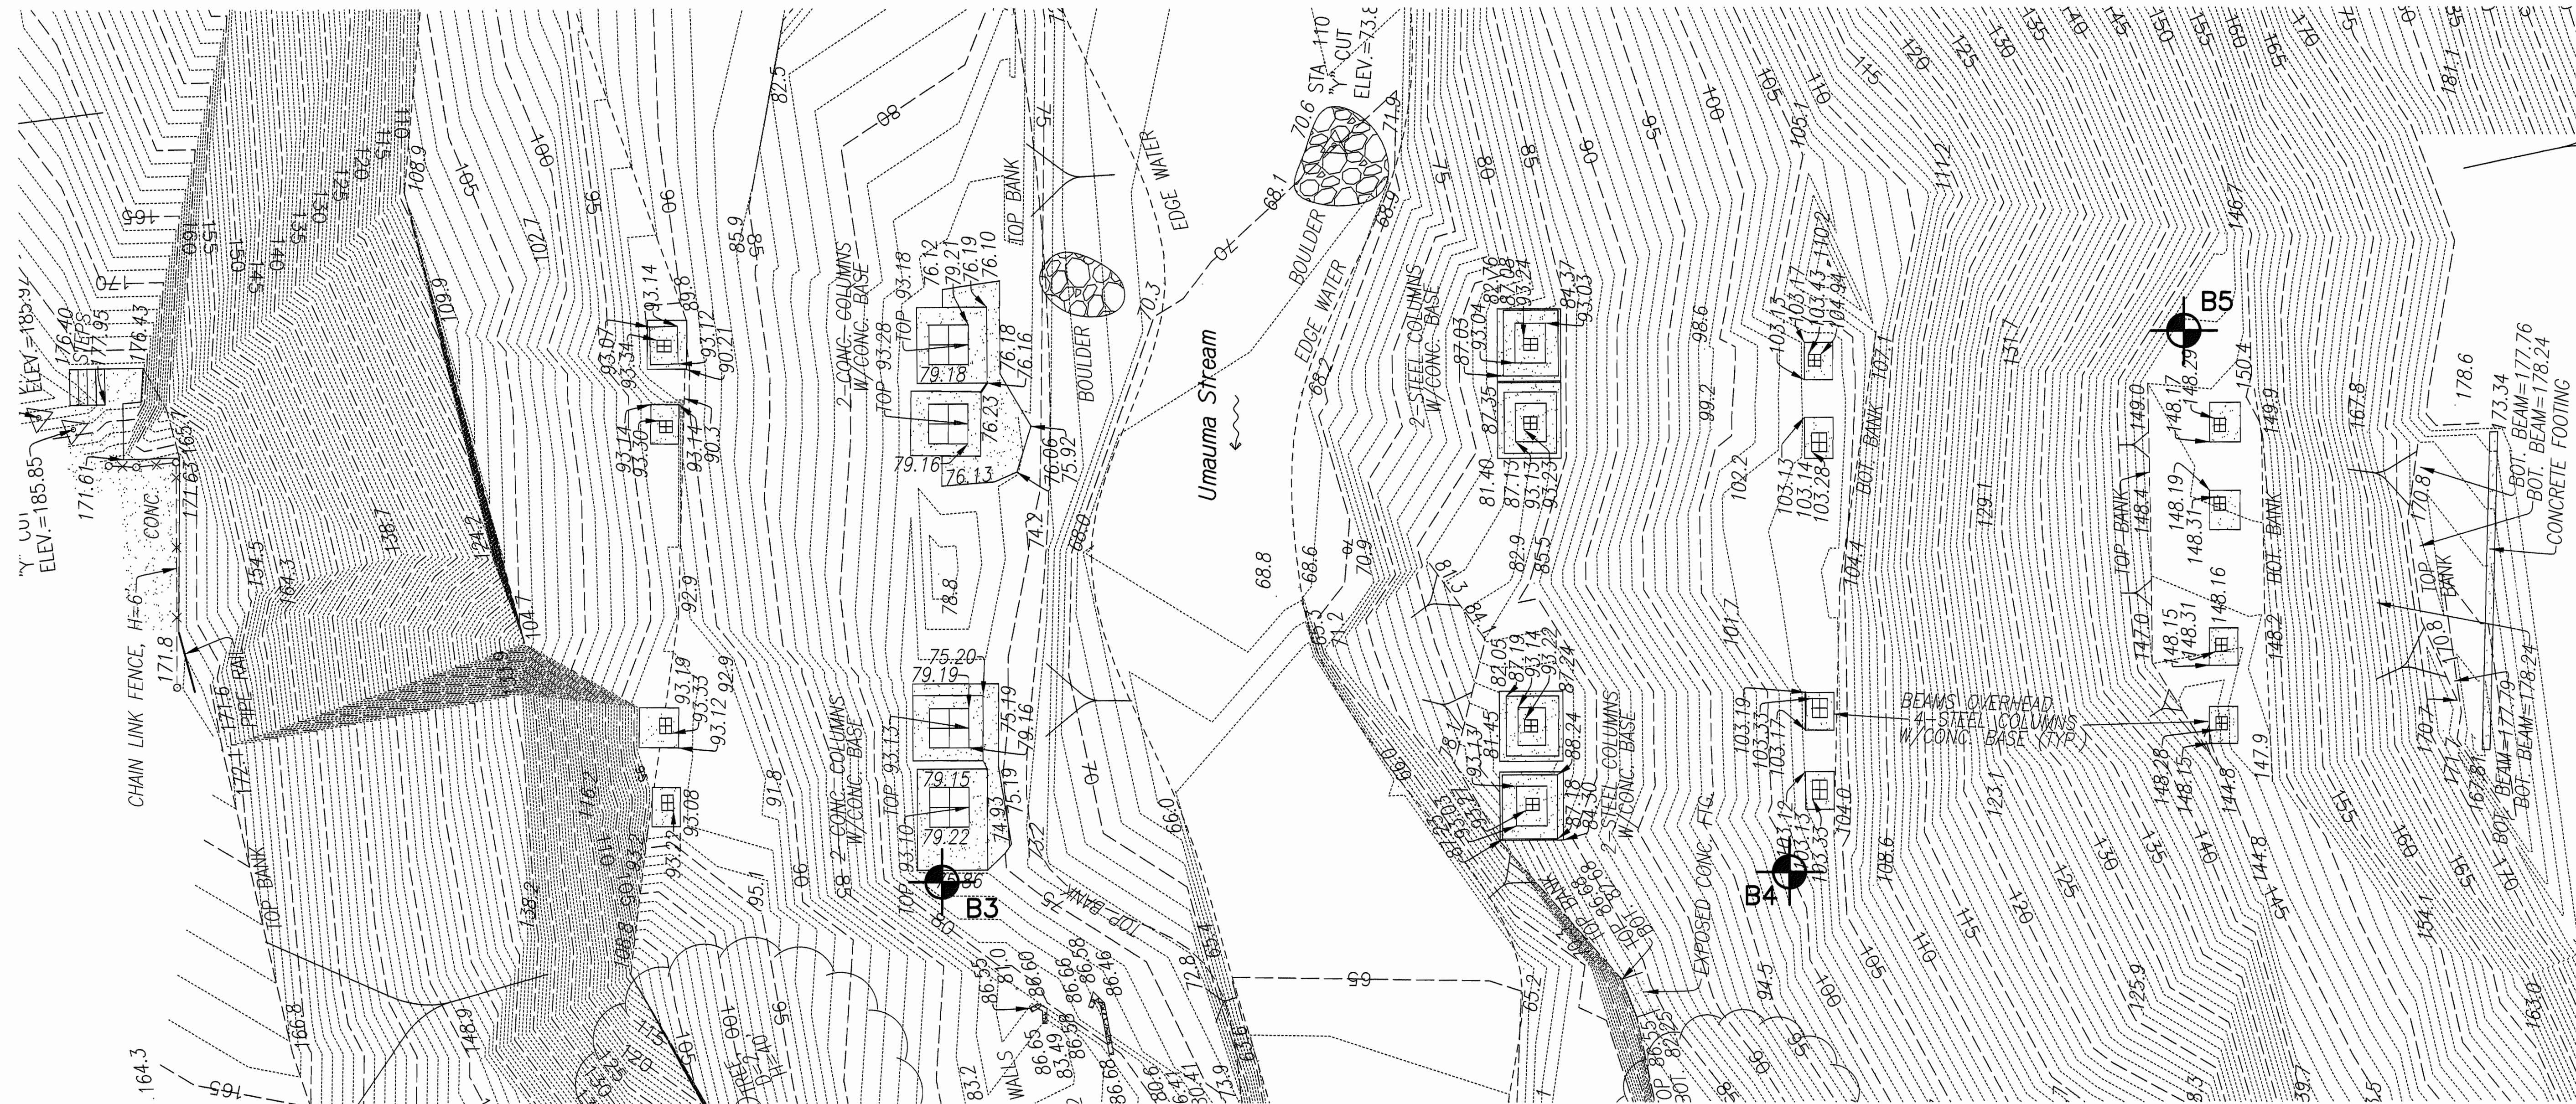
**BORING LOCATION PLAN**

ControlPoint Surveying topographic map dated 02/23/2010

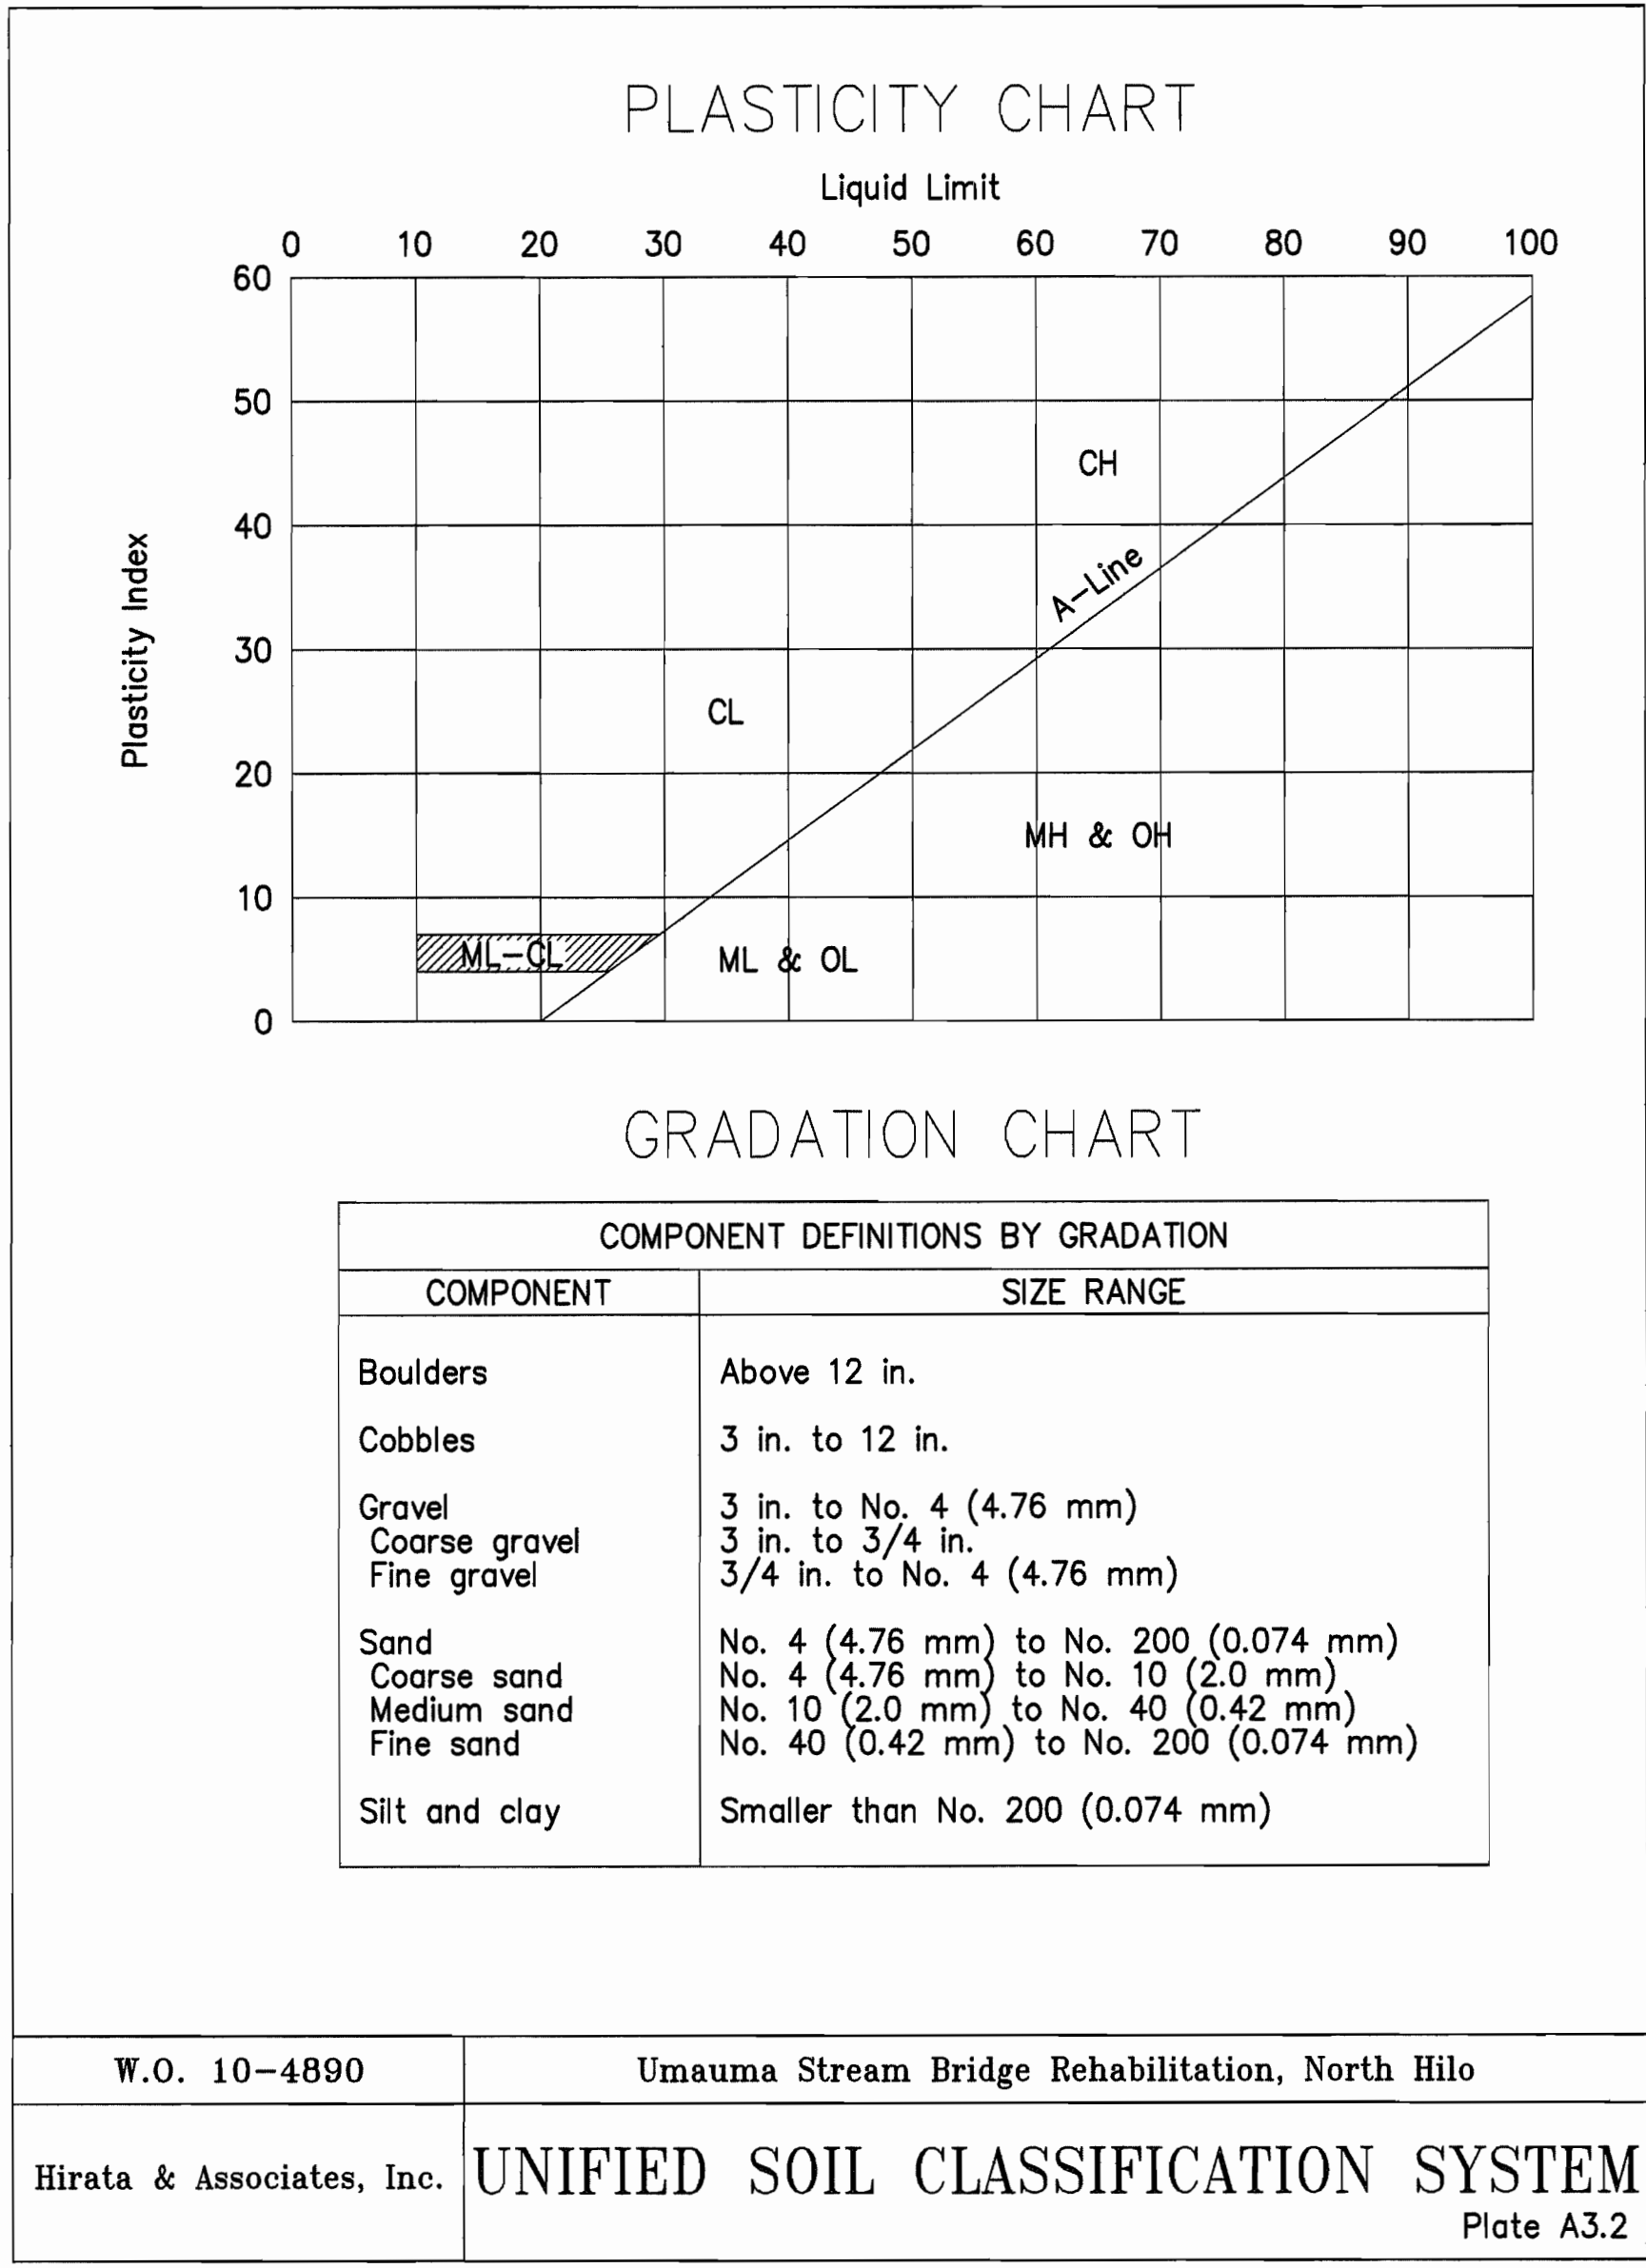
**SOIL CLASSIFICATIONS**

MAJOR DIVISIONS		GROUP SYMBOLS	TYPICAL NAMES	
COARSE GRAINED SOILS (More than 50% of the material is LARGER than No. 200 sieve size.)	GRAVELS (More than 50% of coarse fraction is LARGER than the No. 4 sieve size.)	CLEAN GRAVELS (Little or no fines.)	GW Well graded gravels, gravel-sand mixtures, little or no fines.	
		GRAVELS WITH FINES (Appreciable amt. of fines.)	GP Poorly graded gravels or gravel-sand mixtures, little or no fines.	
		SANDS (More than 50% of coarse fraction is SMALLER than the No. 4 sieve size.)	CLEAN SANDS (Little or no fines.)	GM Silty gravels, gravel-sand-silt mixtures.
			SANDS WITH FINES (Appreciable amt. of fines.)	GC Clayey gravels, gravel-sand-clay mixtures.
	FINE GRAINED SOILS (More than 50% of the material is SMALLER than No. 200 sieve size.)	SILTS AND CLAYS (Liquid limit LESS than 50.)	SW Well graded sands, gravelly sands, little or no fines.	
			SP Poorly graded sands or gravelly sands, little or no fines.

SM Silty sands, sand-silt mixtures.	
			SC Clayey sands, sand-clay mixtures.	
SILTS AND CLAYS (Liquid limit GREATER than 50.)	ML Inorganic silts and very fine sands, rock flour, silty or clayey fine sands or clayey silts with slight plasticity.			
	CL Inorganic clays of low to medium plasticity, gravelly clays, sandy clays, silty clays, lean clays.			
	OL Organic silts and organic silty clays of low plasticity.			
	MH Inorganic silts, micaceous or diatomaceous fine sandy or silty soils, elastic silts.			
	CH Inorganic clays of high plasticity, fat clays.			
	OH Organic clays of medium to high plasticity, organic silts.			
HIGHLY ORGANIC SOILS		PT Peat and other highly organic soils.		
		FRESH TO MODERATELY WEATHERED BASALT		
		VOLCANIC TUFF / HIGHLY TO COMPLETELY WEATHERED BASALT		
		CORAL

SAMPLE DEFINITION		
<input checked="" type="checkbox"/> 2" O.D. Standard Split Spoon Sampler	<input checked="" type="checkbox"/> Shelby Tube	RQD Rock Quality Designation
<input type="checkbox"/> 3" O.D. Split Tube Sampler	<input type="checkbox"/> NX / PQ / 4" Coring	<input type="checkbox"/> Water Level

Grade	Symbol	Description
Fresh	F	No visible signs of decomposition or discoloration. Rings under hammer impact.
Slightly Weathered	WS	Slight discoloration inwards from open fractures, otherwise similar to F.
Moderately Weathered	WM	Discoloration throughout. Weaker minerals such as feldspar decomposed. Strength somewhat less than fresh rock but cores cannot be broken by hand or scraped by knife. Texture preserved.
Highly Weathered	WH	Most minerals somewhat decomposed. Specimens can be broken by hand with effort or shaved with knife. Core stones present in rock mass. Texture becoming indistinct but fabric preserved.
Completely Weathered	WC	Minerals decomposed to soil but fabric and structure preserved (Saprolite). Specimens easily crumbled or penetrated.
Residual Soil	RS	Advanced state of decomposition resulting in plastic soils. Rock fabric and structure completely destroyed. Large volume change.
