**REMEDIAL ALTERNATIVES ANALYSIS REPORT
For LEAD IMPACTED SOIL
AT
NANUE BRIDGE, NINOLE, HAWAII**

**Prepared For:
Hawaii State Department of Transportation**

**Prepared By:
EnviroQuest, Inc.
98-029 Hekaha Street, #21
Aiea, Hawaii, 96701**

August 2024

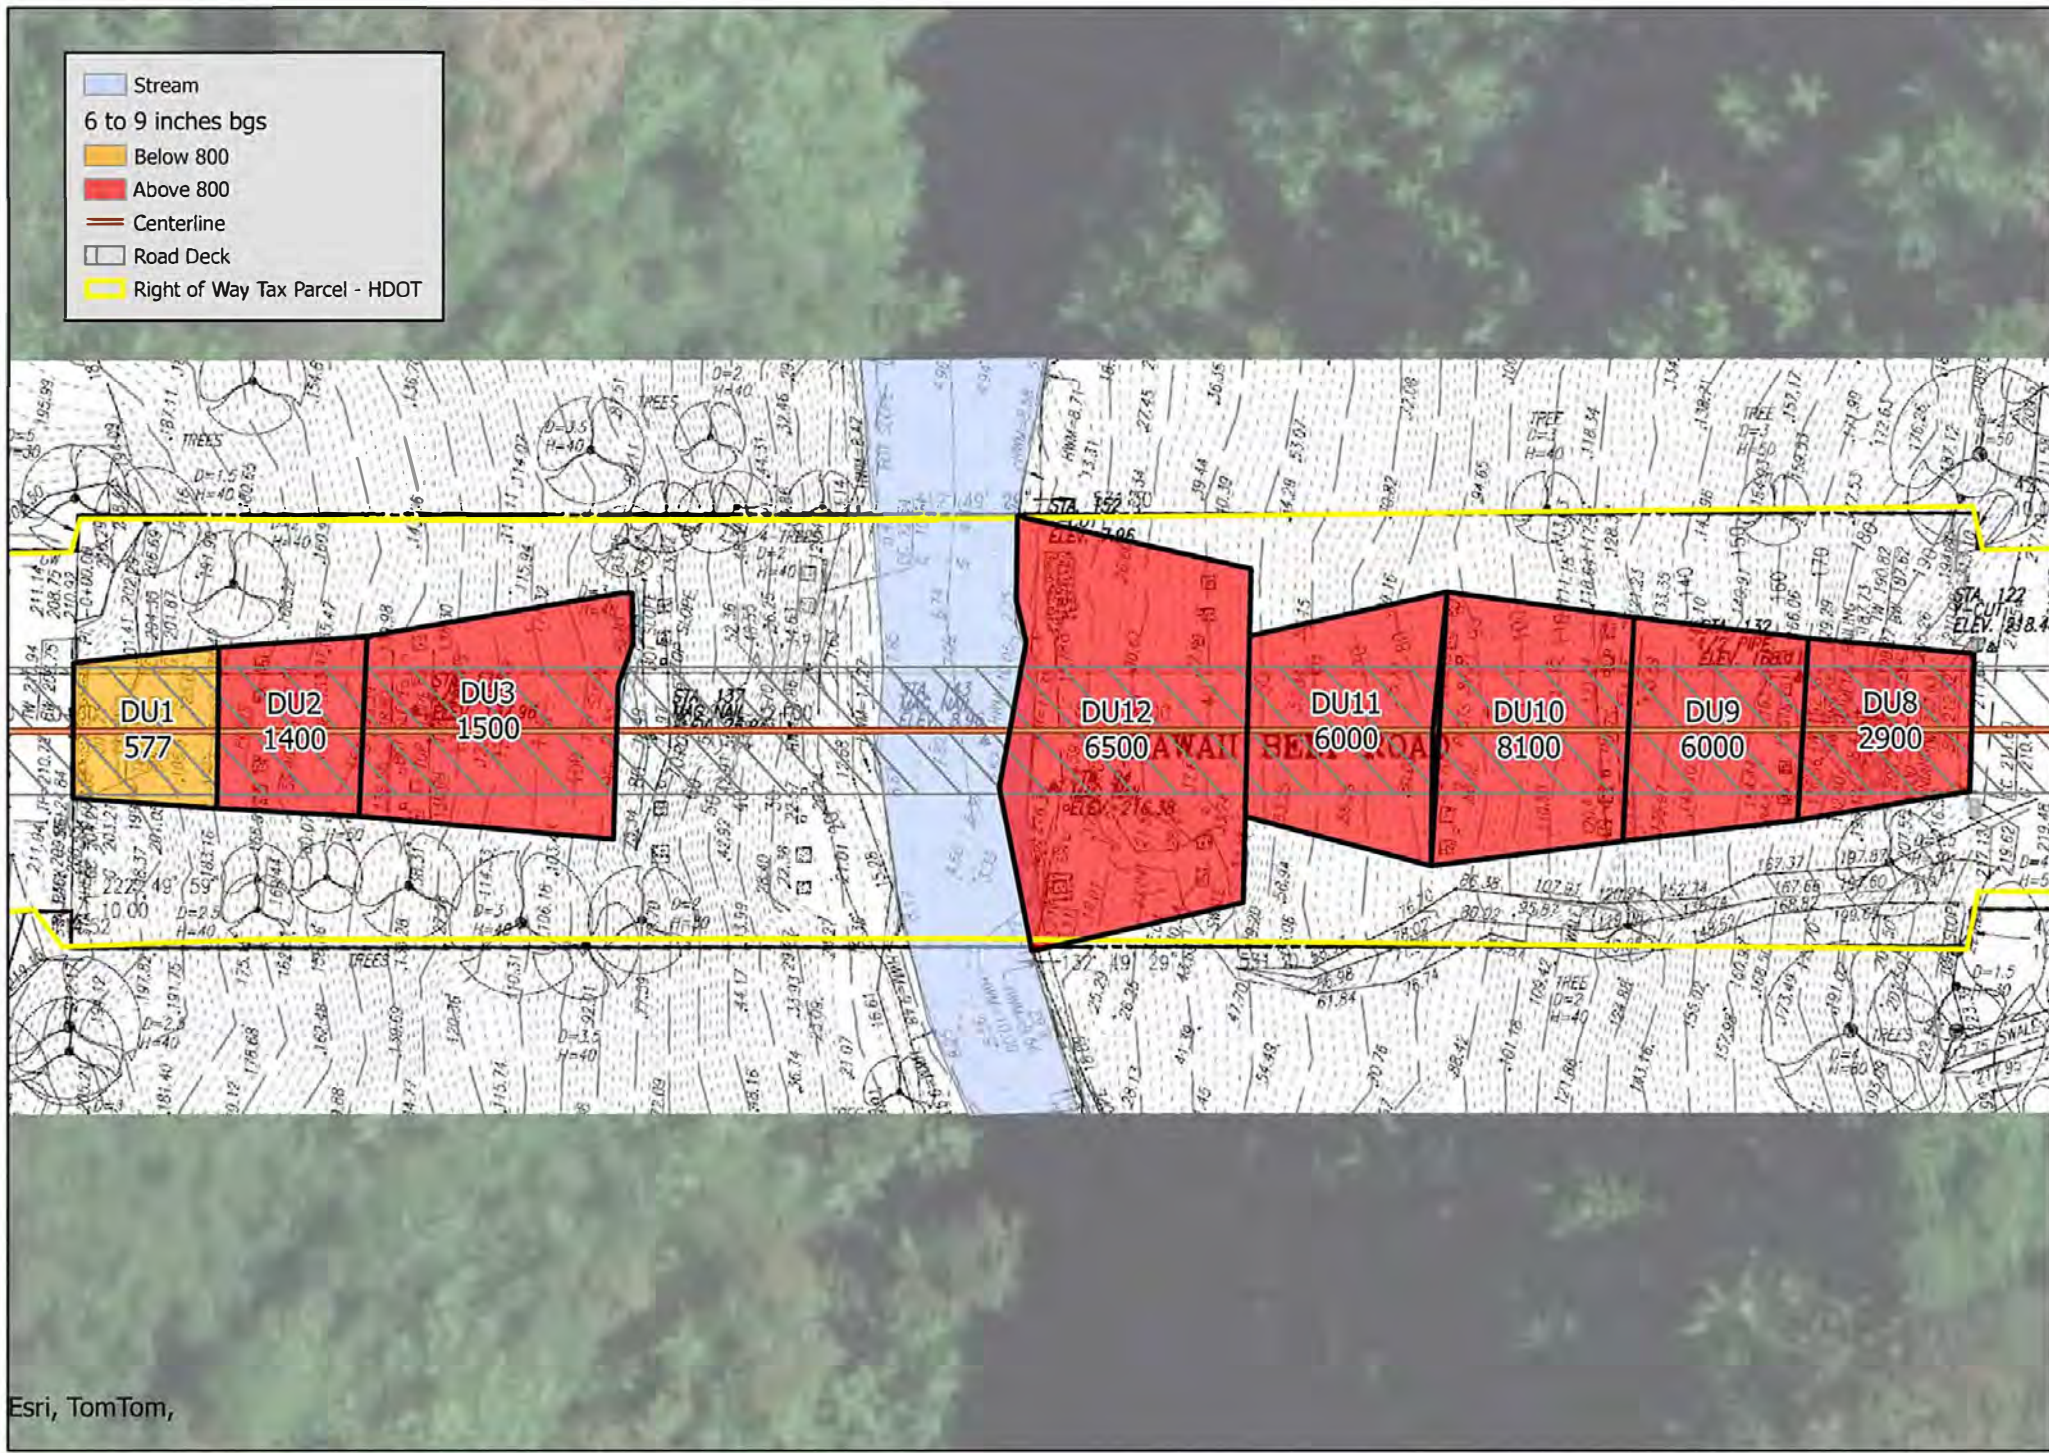
Figure 3c
Total Lead Results 6 - 9 inches bgs
Nanue Stream Bridge, Hawaii County, HI

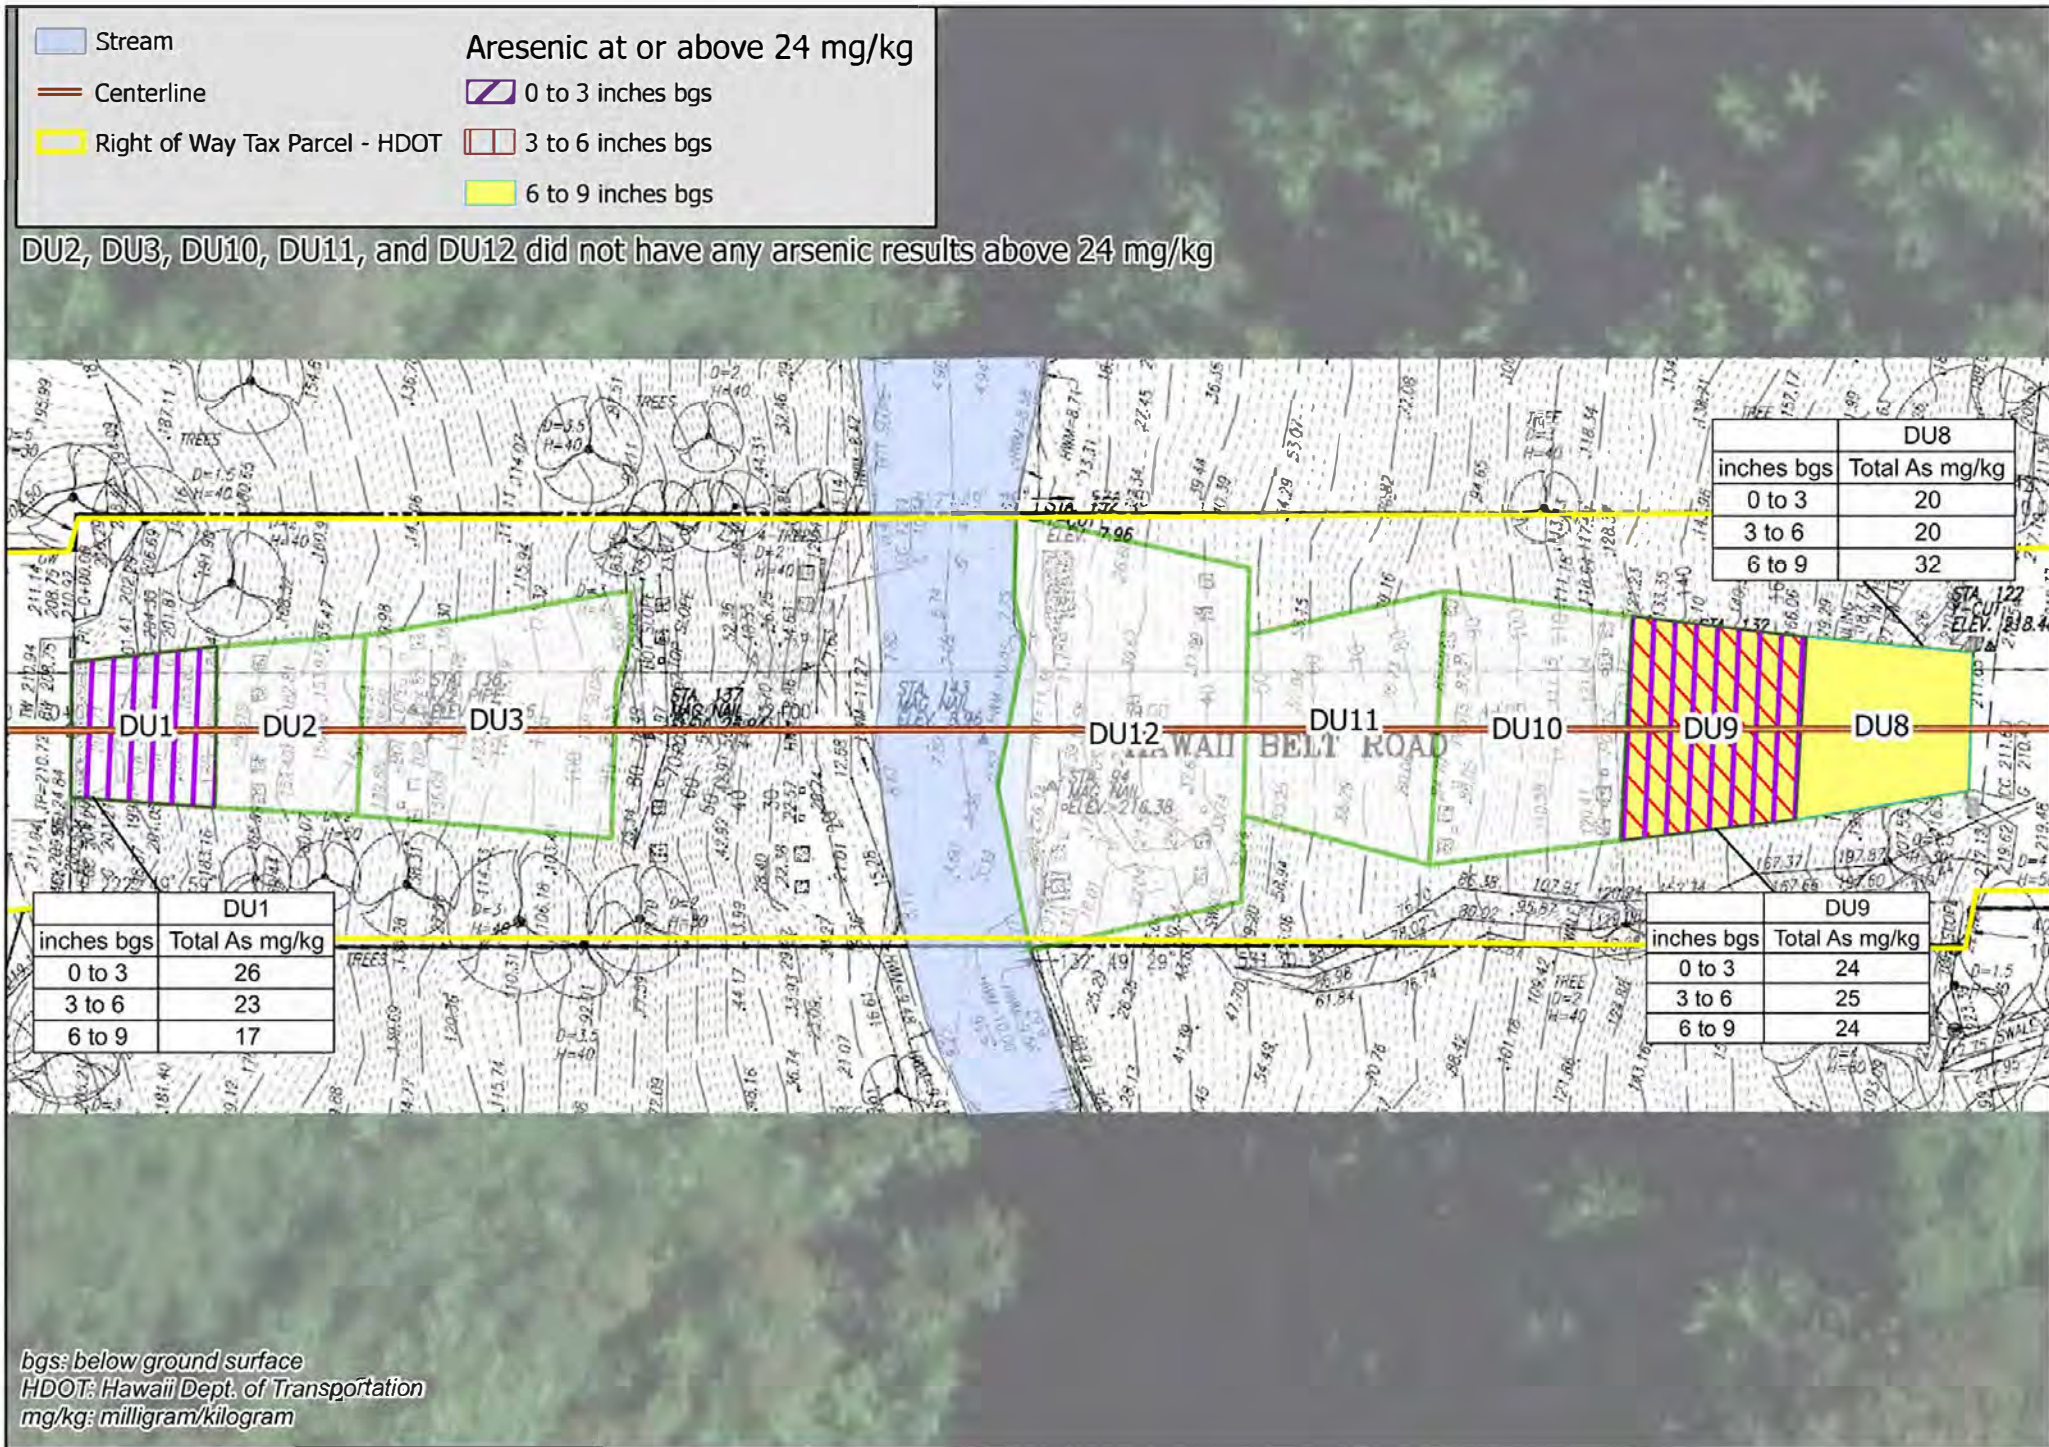
Figure 4

Total Arsenic Results 0 to 9 inches bgs
Nanue Stream Bridge, Hawaii County, HI

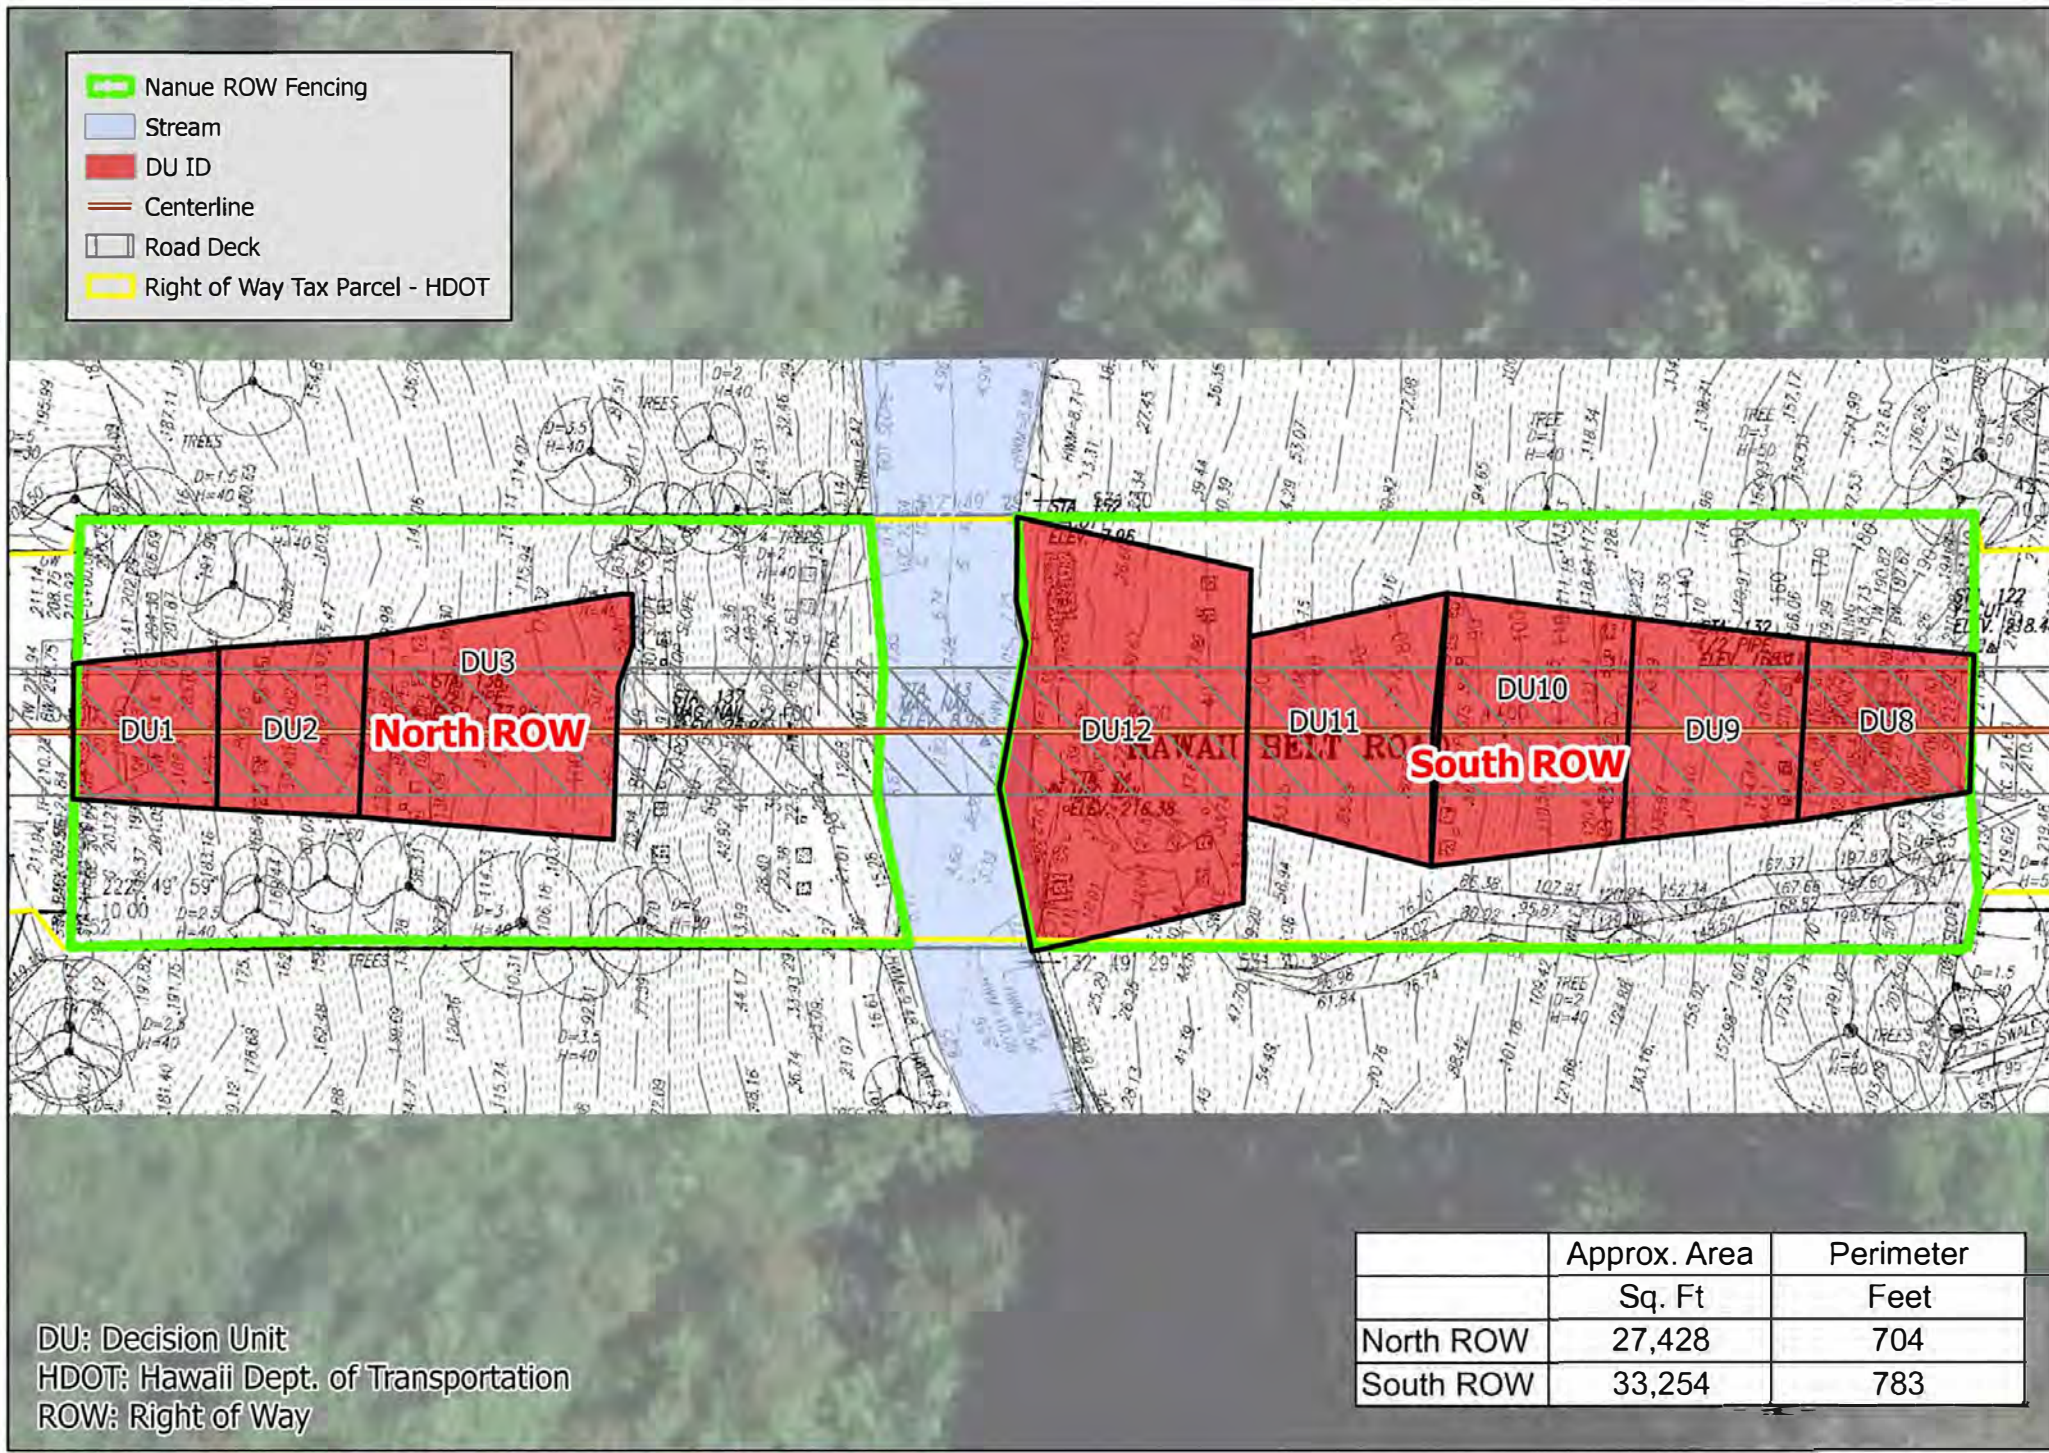
Approx. Area	Perimeter
	Sq. Ft	Feet
North ROW	27,428	704
South ROW	33,254	783

- Alternative 7b: This alternative would include the site-specific EHMP and PPE identified in Alternative 7a, and in addition, fencing and signage would be installed but no remediation activities will be performed. Signage and fencing would be installed to prevent access to the ROW and to warn workers and trespassers of the hazards (Figure 7).
