Subject: Limited Lead Paint Sampling
Nanue Bridge
Hawaii County, Hawaii

TABLE 1
Paint Chip Sample Summary
Nanue Bridge, HI

Figure 2
Lead Paint Sample Locations and ID
Nanue Stream Bridge, Hawaii County, HI

Nanue Bridge Lead Paint Chip Samples: August 4, 2024

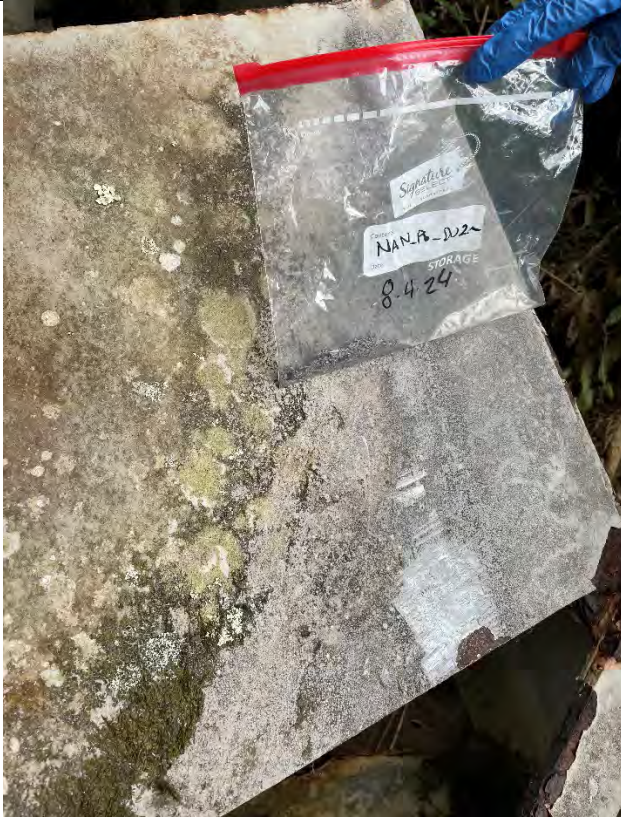
Sample NAN_PB_DU2a

| Sample No. | Sample Location/Description | Result (wt. %) | LBP ₁ (Y/N) | LCP ₂ (Y/N) |
|---|--|---|---|---|
| NAN_Pb_DU2a | N. Embankment, DU2, eastern support girder | 0.14 | N | Y |

Prior to the disturbance of any LCP, the contractor's employees disturbing the painted materials must be informed that it contains lead and must conduct all lead paint disturbance work in accordance with Occupational Safety and Health Administration (OSHA) 29 CFR 1926.62 *Lead*.

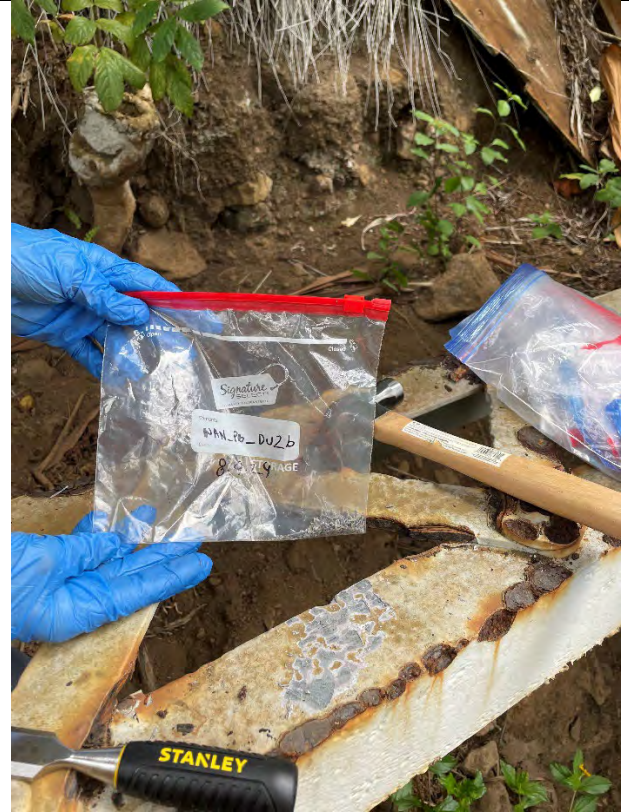
Sample NAN_PB_DU2b

| Sample No. | Sample Location/Description | Result (wt. %) | LBP ₁ (Y/N) | LCP ₂ (Y/N) |
|---|--|---|---|---|
| NAN_Pb_DU2b | N. Embankment, DU2, middle | 0.041 | N | Y |

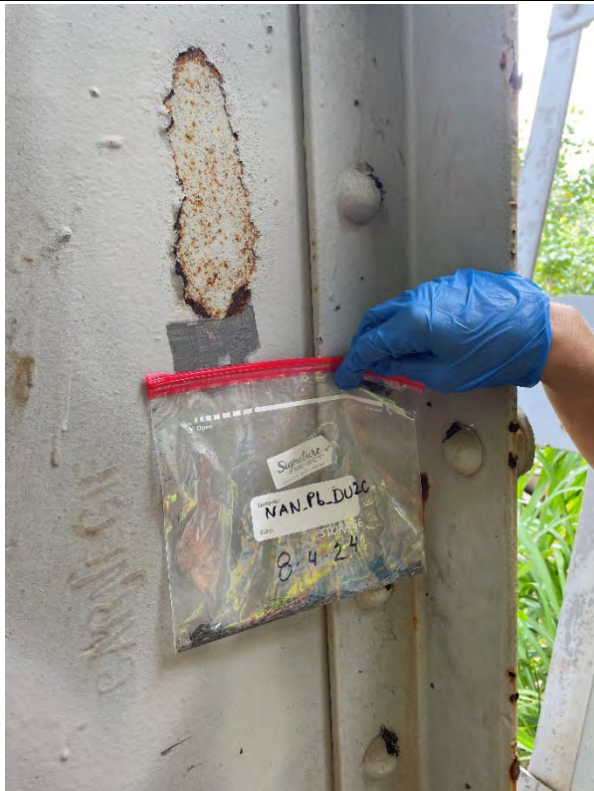
Sample NAN_PB_DU2c

| Sample No. | Sample Location/Description | Result (wt. %) | LBP ₁ (Y/N) | LCP ₂ (Y/N) |
|---|--|---|---|---|
| NAN_Pb_DU2c | N. Embankment, DU2, western support | 0.021 | N | Y |

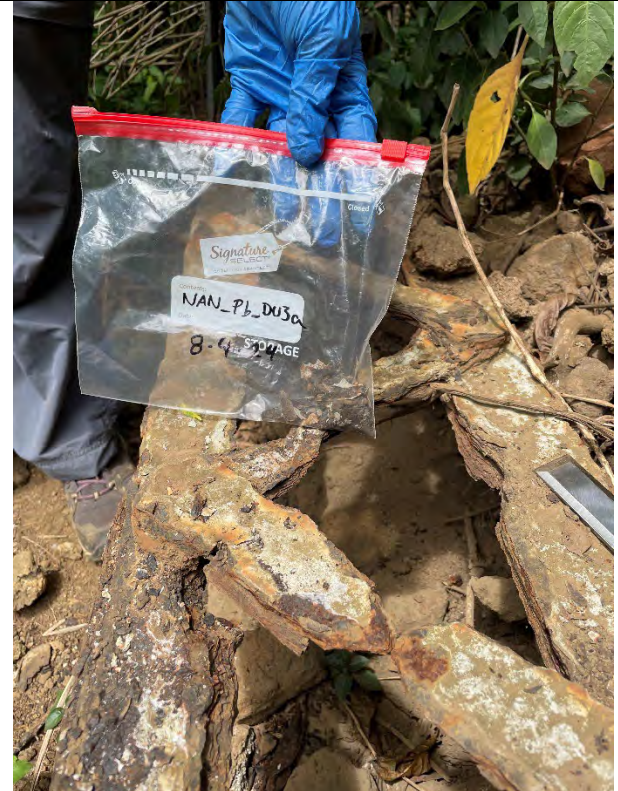
Sample NAN_PB_DU3a

| Sample No. | Sample Location/Description | Result (wt. %) | LBP ₁ (Y/N) | LCP ₂ (Y/N) |
|---|--|---|---|---|
| NAN_Pb_DU3a | N. Embankment, DU3, middle | 0.0087 | N | Y |

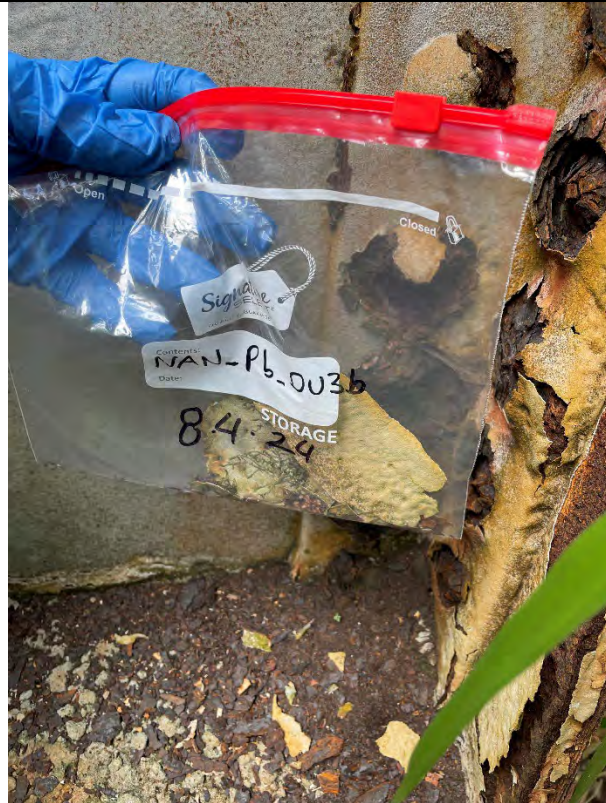
Sample NAN_PB_DU3b

| Sample No. | Sample Location/Description | Result (wt. %) | LBP ₁ (Y/N) | LCP ₂ (Y/N) |
|---|--|---|---|---|
| NAN_Pb_DU3b | N. Embankment, DU3, western beam | 0.066 | N | Y |

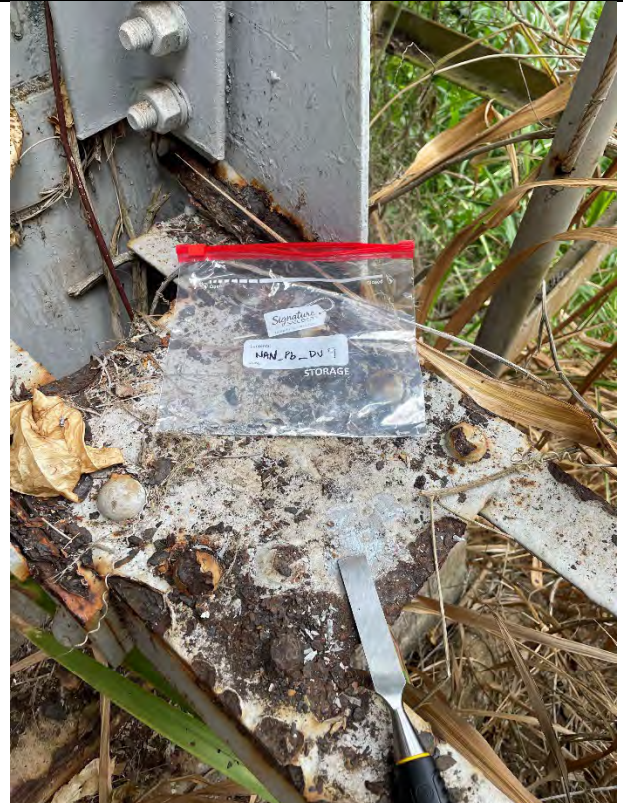
Sample NAN PB DU9a

| Sample No. | Sample Location/Description | Result (wt. %) | LBP ₁ (Y/N) | LCP ₂ (Y/N) |
|---|--|---|---|---|
| NAN_Pb_DU9 | S. Embankment, DU9, southeastern footing | 0.019 | N | Y |

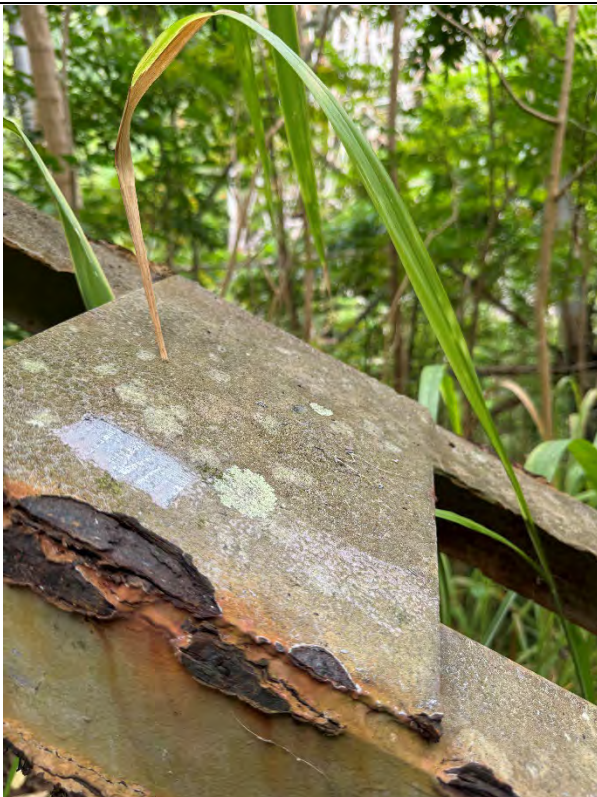
Sample NAN_PB_DU10a

| Sample No. | Sample Location/Description | Result (wt. %) | LBP ₁ (Y/N) | LCP ₂ (Y/N) |
|---|--|---|---|---|
| NAN_Pb_DU10a | S. Embankment, DU10, southeastern footing | 0.094 | N | Y |

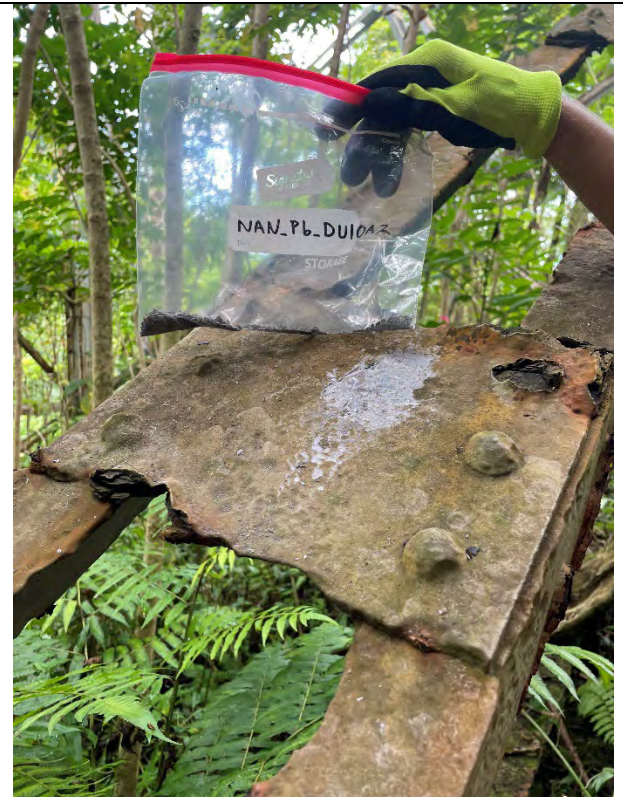
Sample NAN_PB_DU10a2

| Sample No. | Sample Location/Description | Result (wt. %) | LBP ₁ (Y/N) | LCP ₂ (Y/N) |
|---|--|---|---|---|
| NAN_Pb_DU10a2 | S. Embankment, DU10, southwestern footing | 0.047 | N | Y |

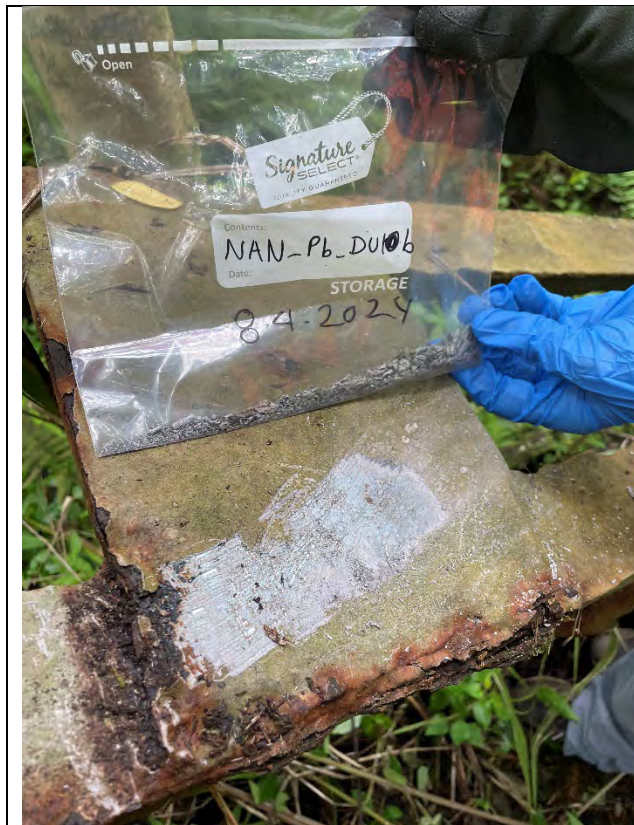
Sample NAN_PB_DU10b

| Sample No. | Sample Location/Description | Result (wt. %) | LBP ₁ (Y/N) | LCP ₂ (Y/N) |
|---|--|---|---|---|
| NAN_Pb_DU10b | S. Embankment, DU10, northeastern footing | 0.055 | N | Y |

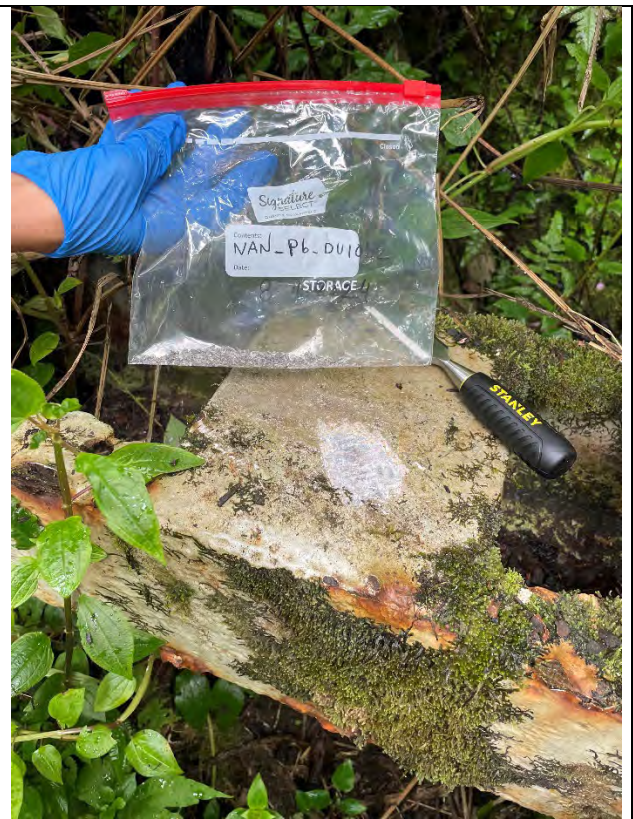
Sample NAN_PB_DU10b2

| Sample No. | Sample Location/Description | Result (wt. %) | LBP ₁ (Y/N) | LCP ₂ (Y/N) |
|---|--|---|---|---|
| NAN_Pb_DU10b2 | S. Embankment, DU10, northwestern footing | 0.031 | N | Y |
