**UNDERGROUND STORAGE TANK
CLOSURE REPORT**
Aircraft Rescue Fire Fighting Training Facility
Lihue Airport
Facility ID 9-702403

ETC Project No. 06-2028

March 2007

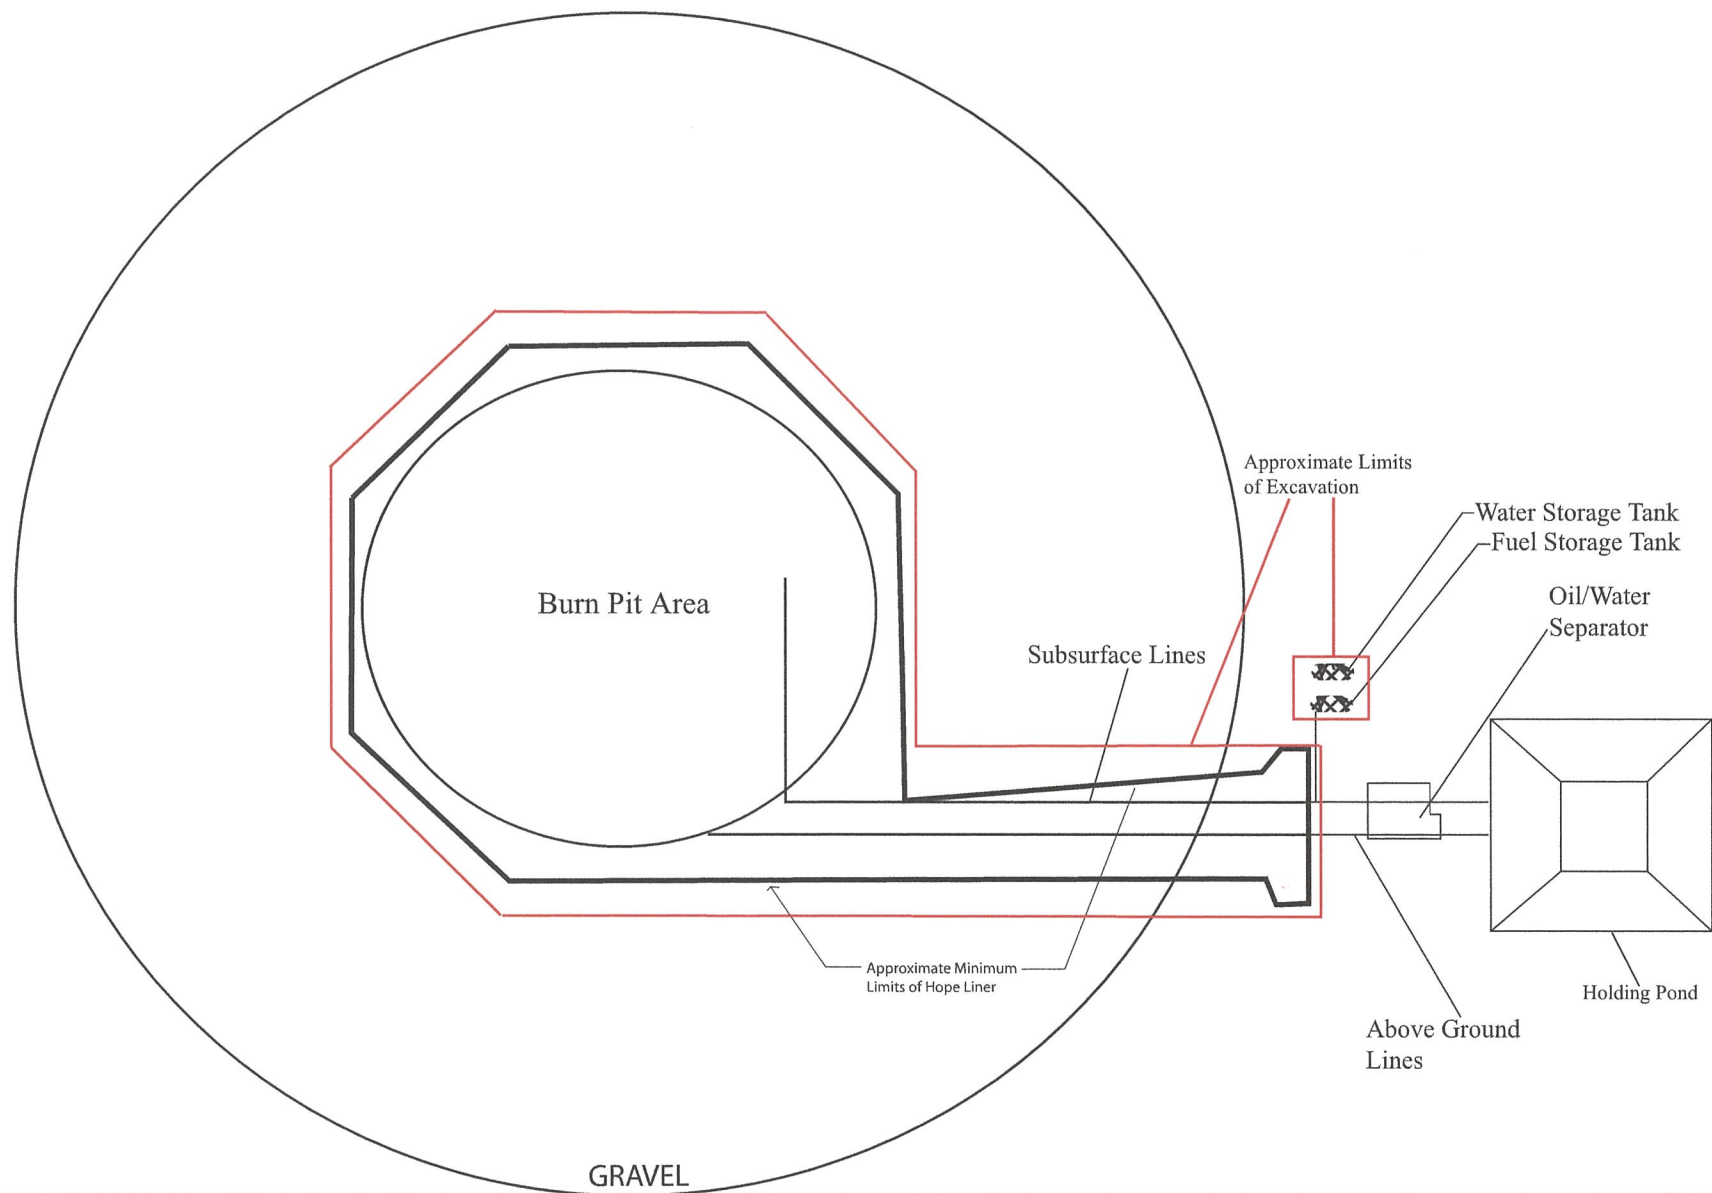
Figure 2-Site Layout Map
ARFF Training Facility
UST Closure
Lihue Airport, Kauai, Hawaii

The project site is the former ARFF, located at the Lihue Airport. The UST was located in the northeastern portion of the site between the Burn Pit and the Holding Pond (Appendix I, Figure 2).

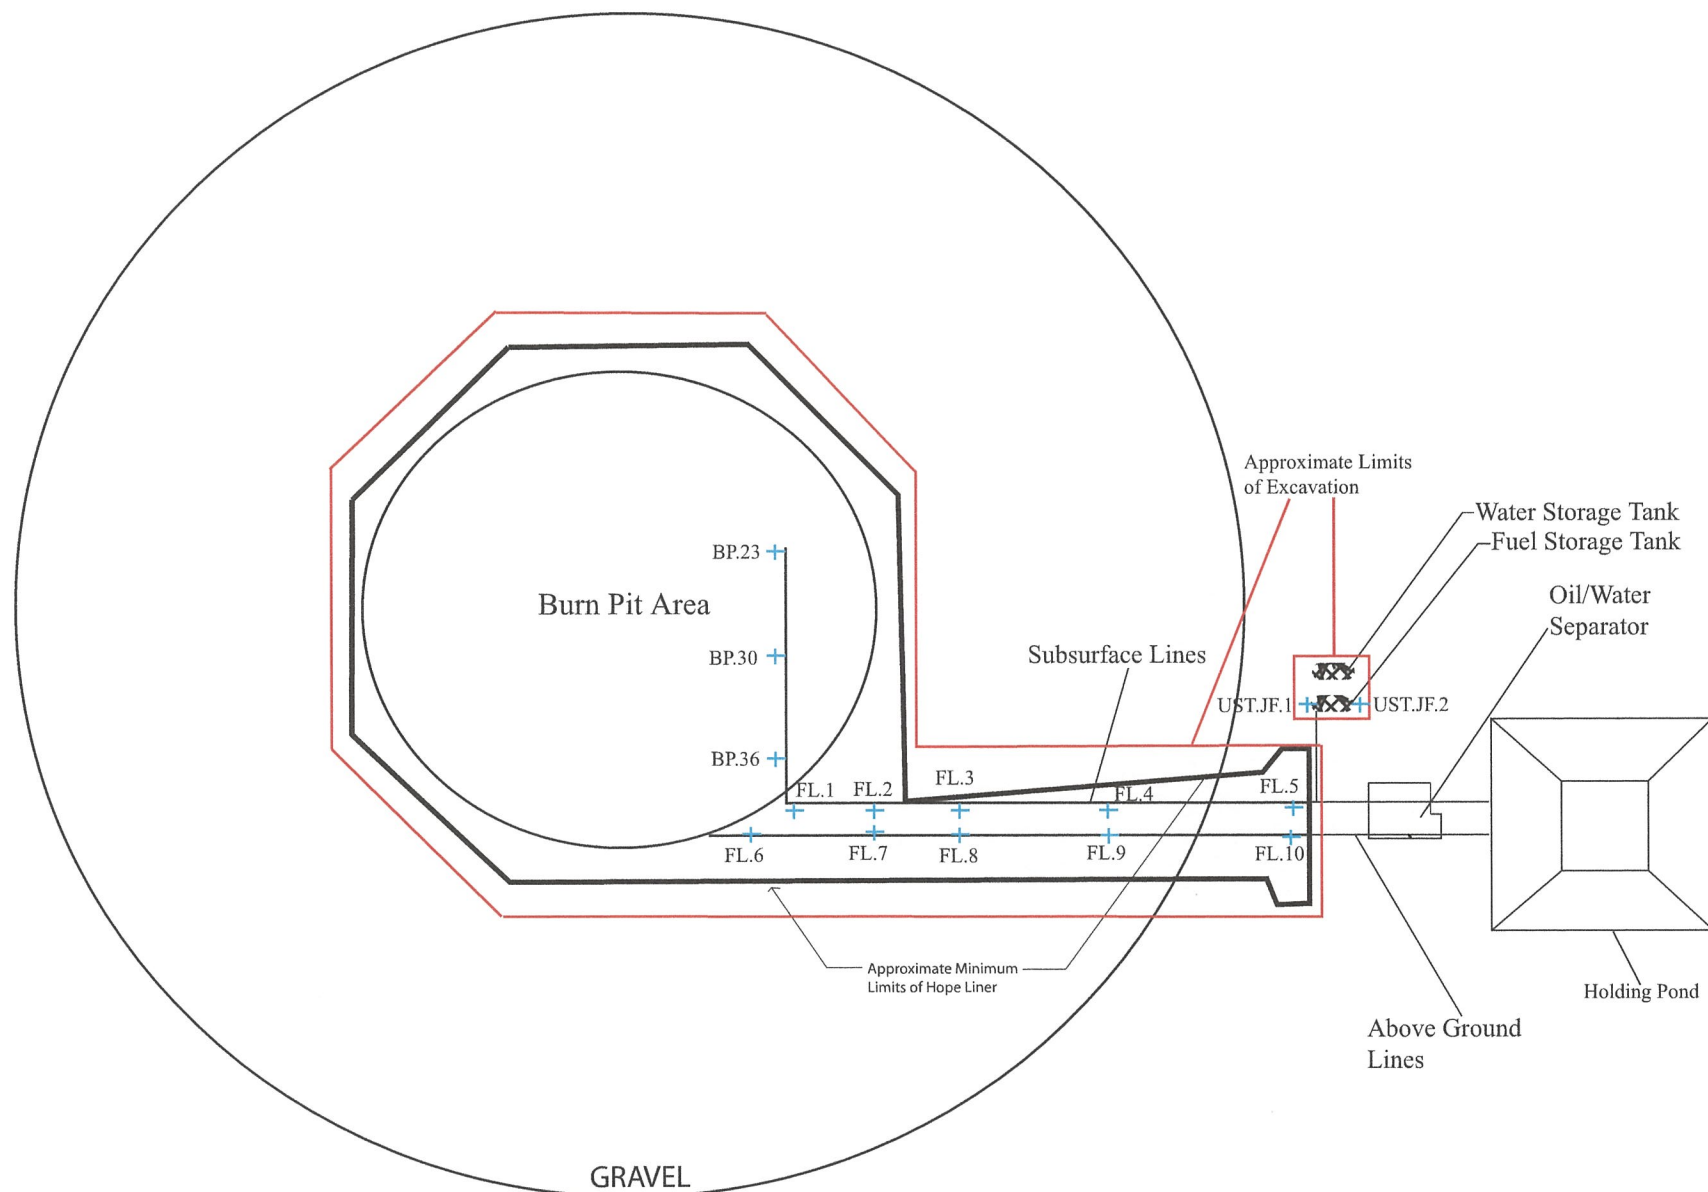
Figure 4 -Soil Sample Location Map
ARFF Training Facility
UST Closure
Lihue Airport, Kauai, Hawaii

A total of thirty two soil samples were collected by ETC personnel during UST closure activities. Line trench samples FL.1 through FL.10, BP.36, BP.30, and BP.23 were collected from soil beneath the high-density polyethylene (HDPE) liner, located approximately 27 feet southwest of the tank, at a depth of 3.5 feet below ground surface. Note that the line trench samples were also taken and used as part of the Burn Pit investigation as the piping was located within the Burn Pit. Sample UST.JF.1 was collected from native soil in the southwest excavation wall, just below the subsurface concrete slab used to anchor the tank, at a depth of 15 feet bgs. Sample UST.JF.2 was collected from native soil in the northeast excavation wall, just below the subsurface concrete slab used to anchor the tank, at a depth of 15 feet bgs. Soil samples SP. 8 through SP. 16 were collected from stockpiled soil from the UST excavation. Soil stockpile samples SP.17 through SP.24 were collected from soil above the HDPE liner that had been stockpiled. Soil sample locations are available in Appendix I, Figure 4.

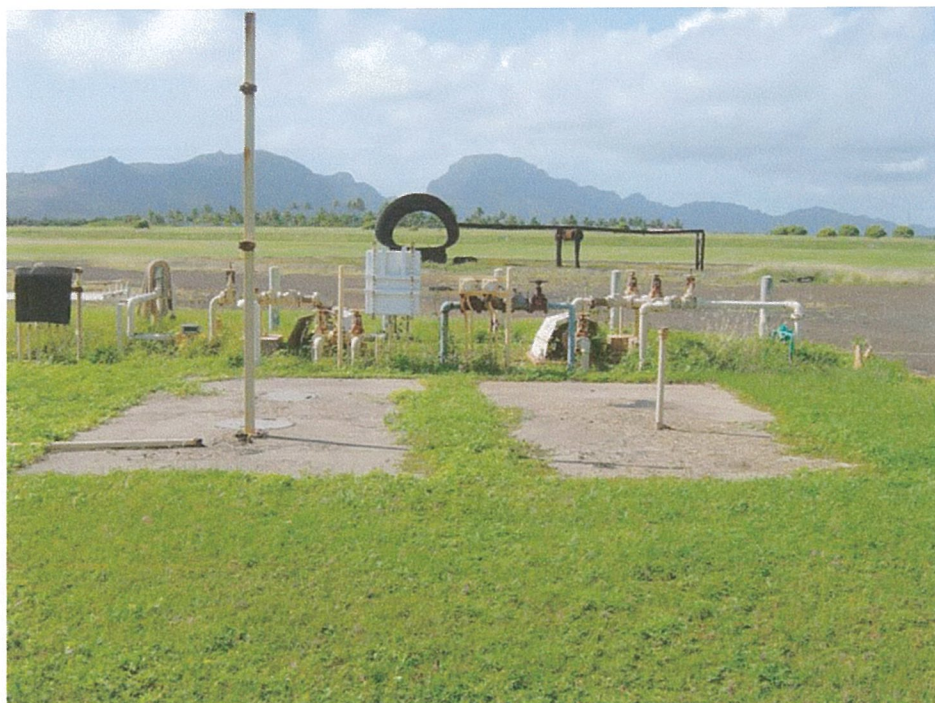
Photograph 1: View of ground cover in the vicinity of the USTs.

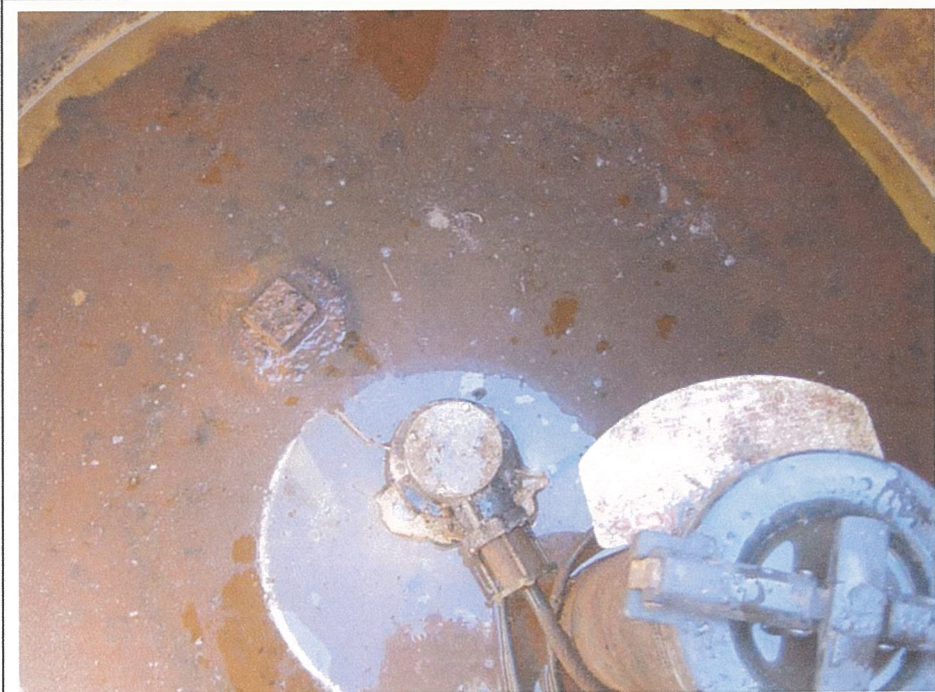
Photograph 2: Manhole accessway for fill pipe.

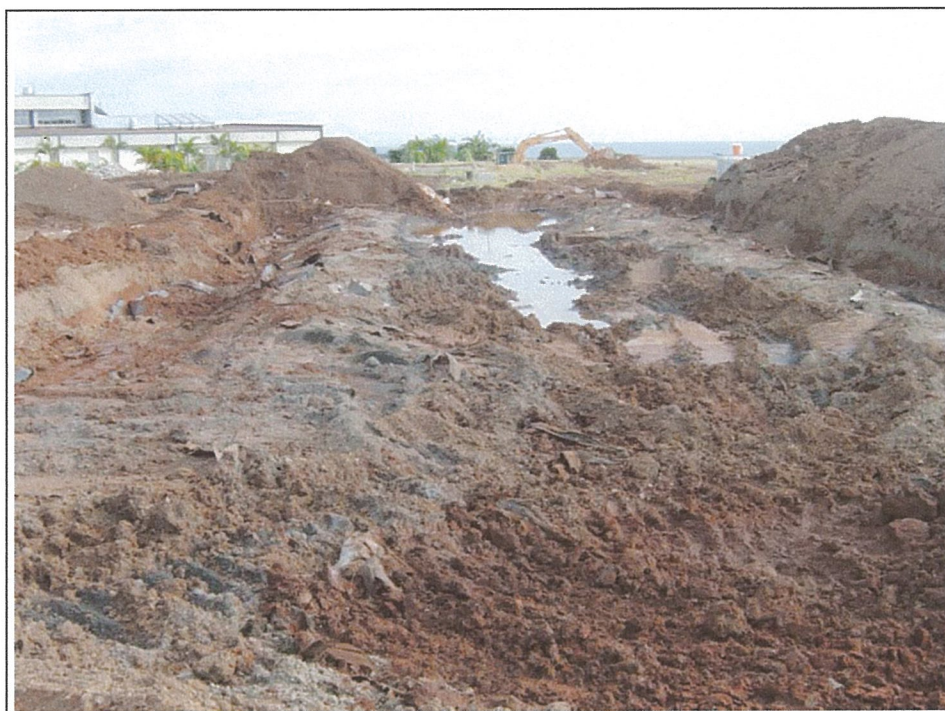
Photograph 3: Trenchline of UST piping to burn pit area.

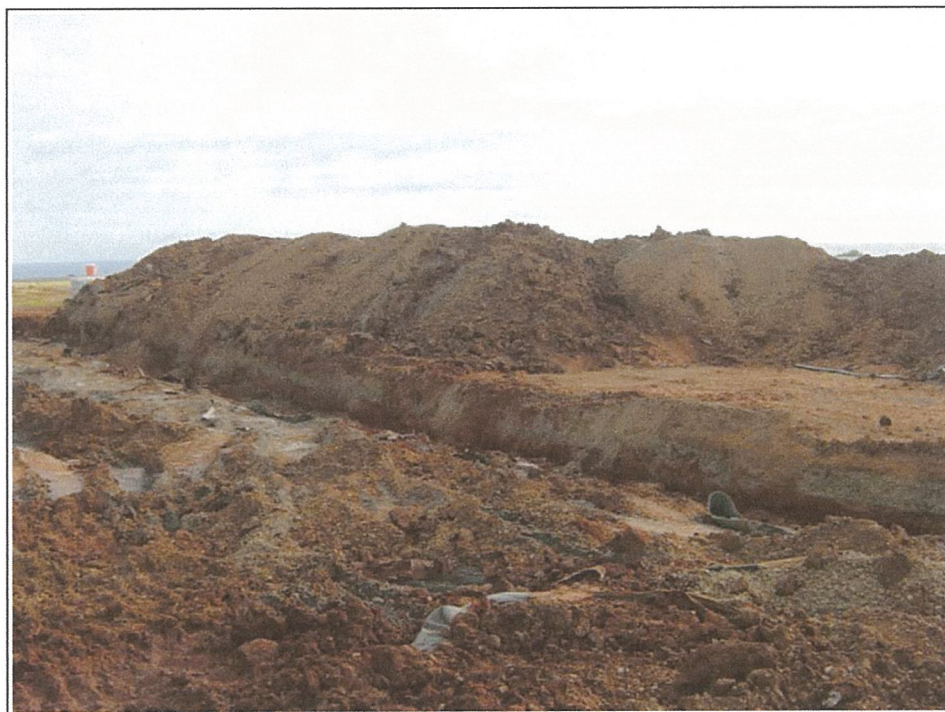
Photograph 4: Trenchline excavation stockpile.
