Biological and water quality surveys of Kaloko Marsh at Kūhio Highway, Wailua, Kauaʻi

May 12, 2009

AECOS No. 1155A

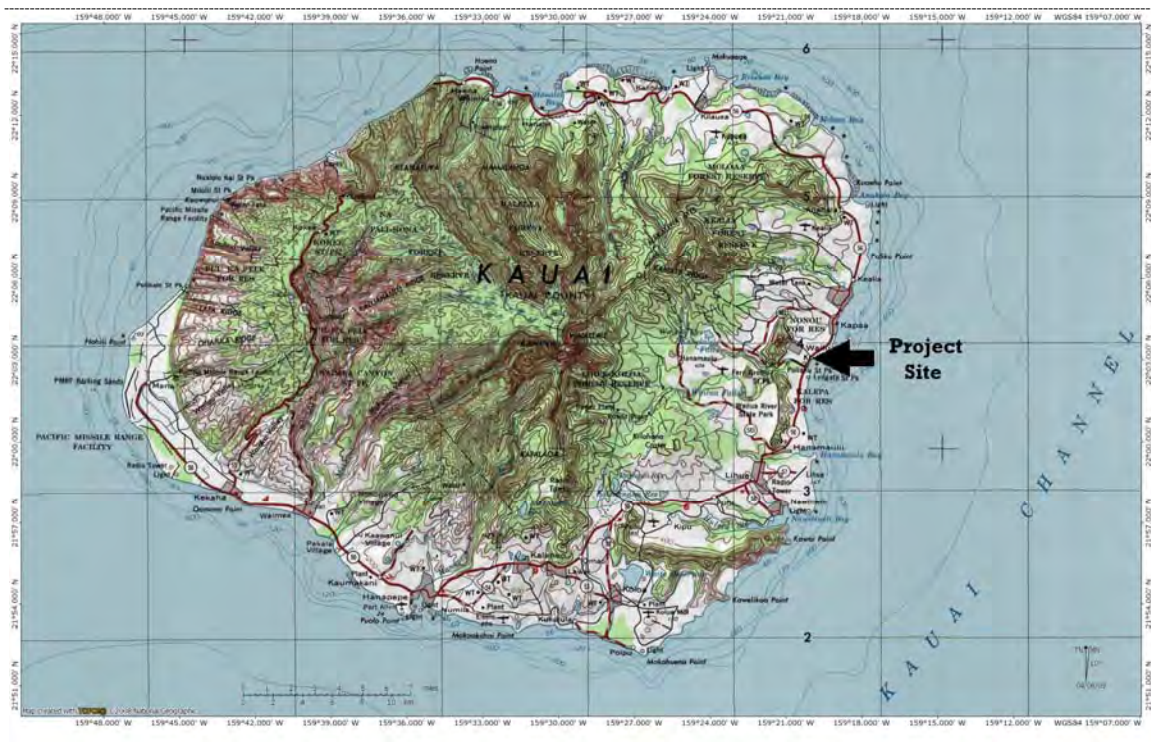
Figure 1. The proposed project location in Wailua, Kauai.

On February 16, March 9, 10, and 11, 2009, AECOS, Inc. biologists conducted water quality and biological reconnaissance surveys of the highway edge of Kaloko Marsh in Wailua, Kauai (Fig. 1). The State Department of Transportation (HDOT) is planning to widen a segment of Kūhio Highway (state Rte. 56) from Kuamoʻo Rd to the Kapaʻa Bypass Road as part of the Kūhio Highway Short Term Improvement Project. This segment of Kūhio Hwy. borders Kaloko Marsh, and connects via culvert under the highway to a drainage swale that originates at nearby Papaloa Road. The culvert crosses under the highway approximately 400 ft (120 m) southwest of the intersection with the Kapaʻa Bypass Road. AECOS, Inc. was contracted by Wilson Okamoto and Associates, Inc. to ascertain biological resources and assess water quality of the waterway for permitting of the construction project. This report details the findings of the surveys.

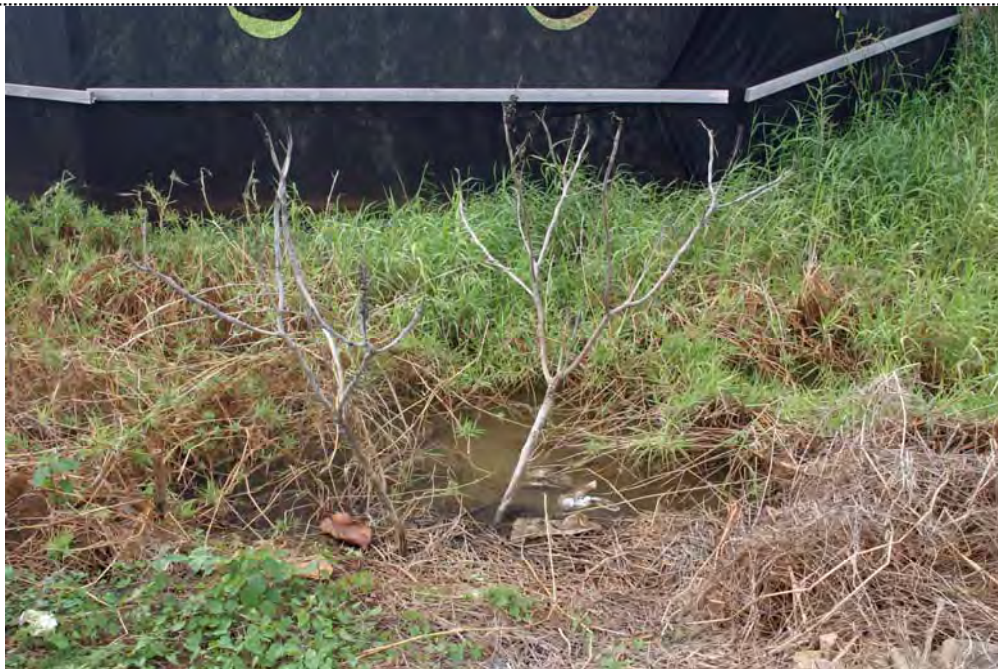
Figure 2. Water quality sampling site (Station Hwy) on makai side of culvert under Kūhio Hwy.

Only isolated pools of water were present in the project waterway during the survey. No actual flow was evident. The largest pool of water was located on the southeast (makai) side of Kūhio Highway approximately 10 ft (3 m) from the culvert. A single water quality station, “Hwy,” was established and sampled from this pool on March 9, 10, and 11, 2009. Results are displayed in Table 1.

Conductivity results indicate fresh water with no influence from brackish groundwater. Dissolved oxygen concentrations in the project waterway were low with saturation averaging 19%. Turbidity levels and total suspended solids (TSS) concentrations were high, reflecting the poor underwater visibility at the time of sampling. Elevated ammonia concentrations, like those found at Sta. Hwy, are typical of waterways with sluggish or stagnant flow due to an accumulation and then decomposition of organic matter. Nitrate-nitrite, total nitrogen and total phosphorus levels were also high here.

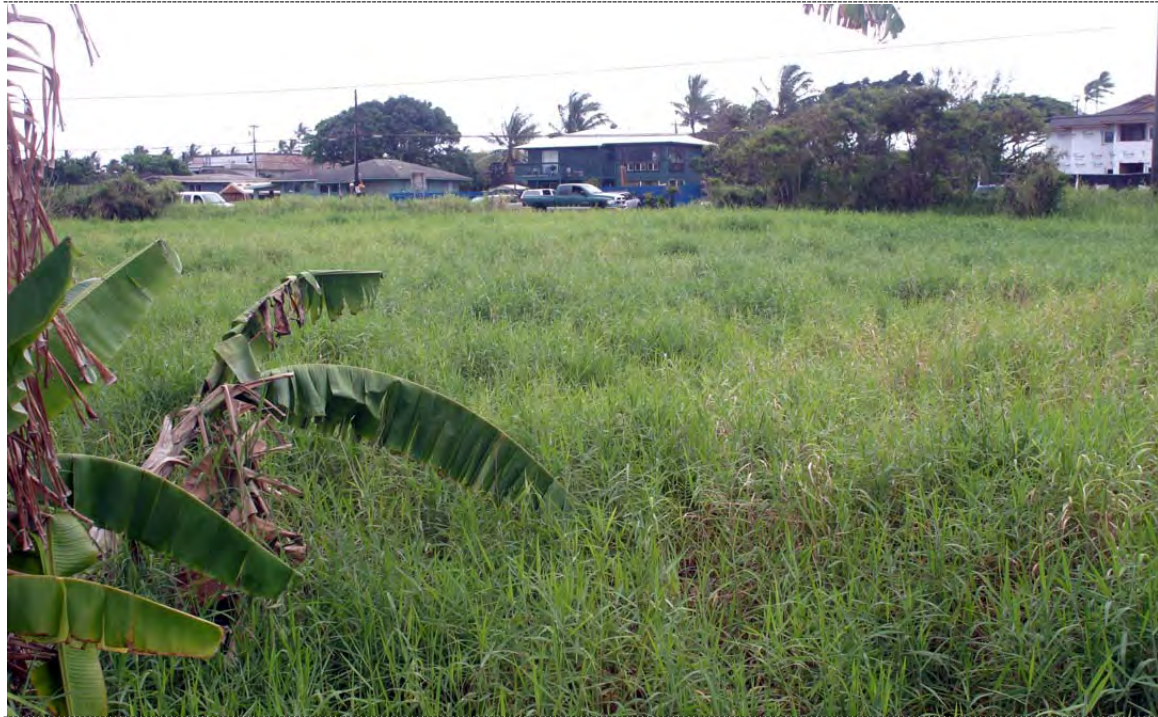
The culvert under Kūhio Hwy. opens (on the mauka side) into Kaloko Marsh, which in this area is a depression completely covered by the aggressive, introduced grass known as para or California grass (*Urochloa mutica*; see Fig. 3). The marsh itself shows no open water areas other than at the culvert under the highway and the culvert under the old cane haul road.

Figure 3. Kaloko Marsh showing the makai portion overgrown with California grass. Houses in background are along the makai side of Kūhio Highway.

Given the highly overgrown state of the makai portion of this wetland feature, it is unlikely that it is currently usable by native wetland avian species. The inland section may provide resources that are used by three listed waterbird species, Hawaiian Coot, (*Fulica alai*), Common Moorhen (*Gallinula chloropus sandvicensis*), and occasionally Hawaiian Duck (*Anas wyvilliana*), on a seasonal
