In Reply Refer To:  
2022-0064915-S7-001

March 10, 2023

Subject: Biological Opinion for the Proposed Kūhiō Highway Emergency Shoreline Mitigation Project, Wailuā Beach, Kaua'i, Federal-aid Project No. ER-24(004)

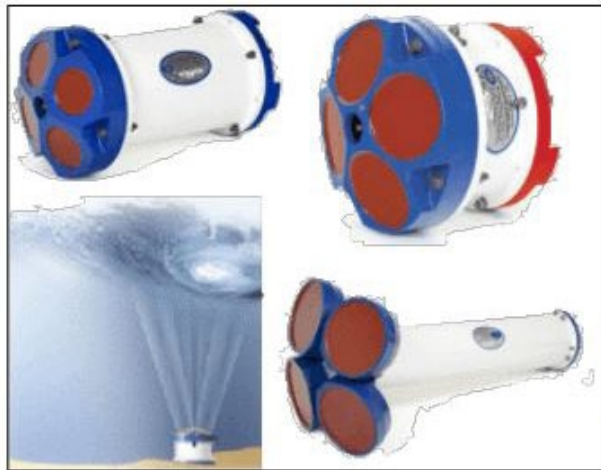
Each ADCP unit is enclosed in a plastic casing and measures about 7 inches (in) (18 centimeters (cm)) in diameter (Figure 1). Each ADCP will be installed on corrosion resistant aluminum DeepWater Buoyancy's BTM-AL50 tripod bottom mounts holding the equipment in place (Figure 2). The tripod mount will also be encased in plastic, the same material encasing the ADCP. The total size of the tripod that the ADCPs will be on in the water will be 3 ft x 3 ft x 3 ft (3 m x 3 m x 3 m).

Figure 1. Acoustic Doppler Current Profilers in plastic casing.

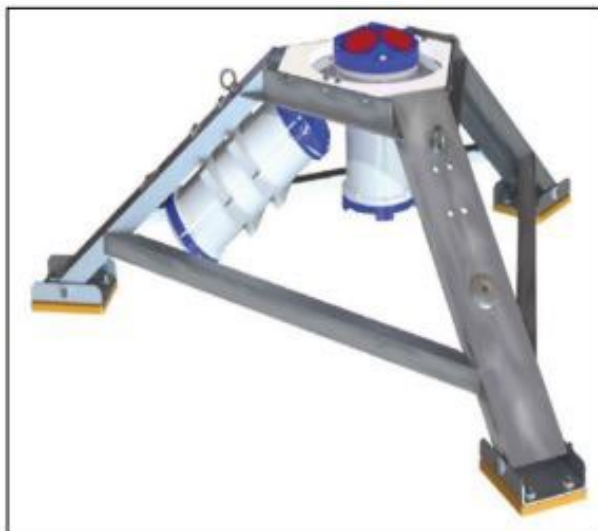
Figure 2. Acoustic Doppler Current Profilers installed on corrosion resistant aluminum Deepwater Buoyancy's BTM-AL50 bottom mounts holding the equipment in place.

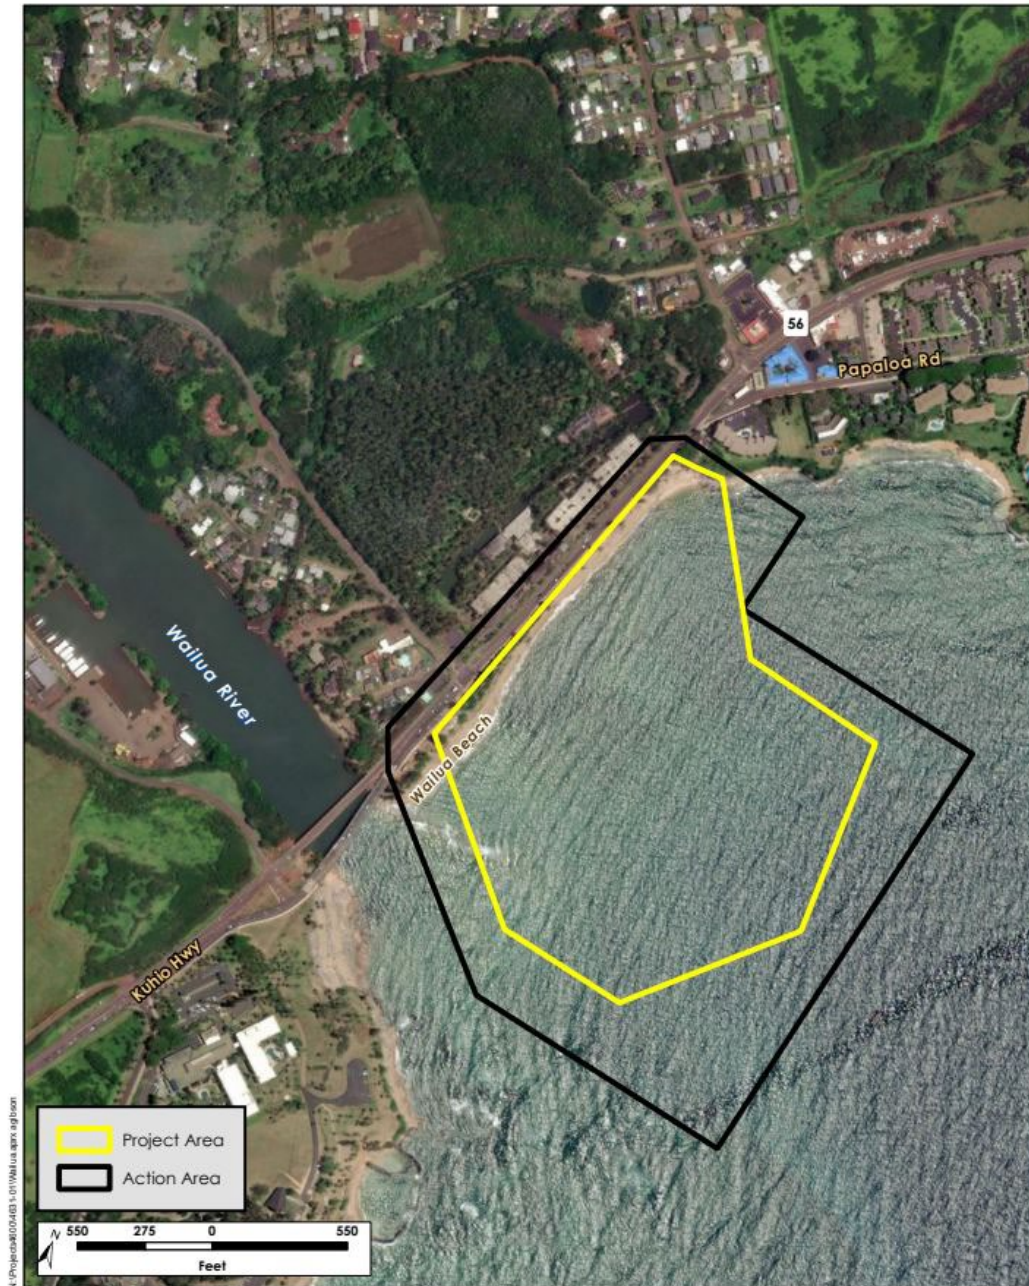
largely be composed of the project area (52.7 acres or 21.3 hectares) plus some additional land area surrounding the project area; totaling 88.3 acres (35.7 hectares) (Figure 6).

Figure 6. Project area and action area.
