HANA HIGHWAY  
IMPROVEMENTS

STATE PROJ. NO. AM-1061-12  
AIP PROJ. NO. 3-15-0006-11

TYP. ARRANGEMENT  
OF TOP REINF.,  
PILE PLACEMENT  
AT ABUTMENT.

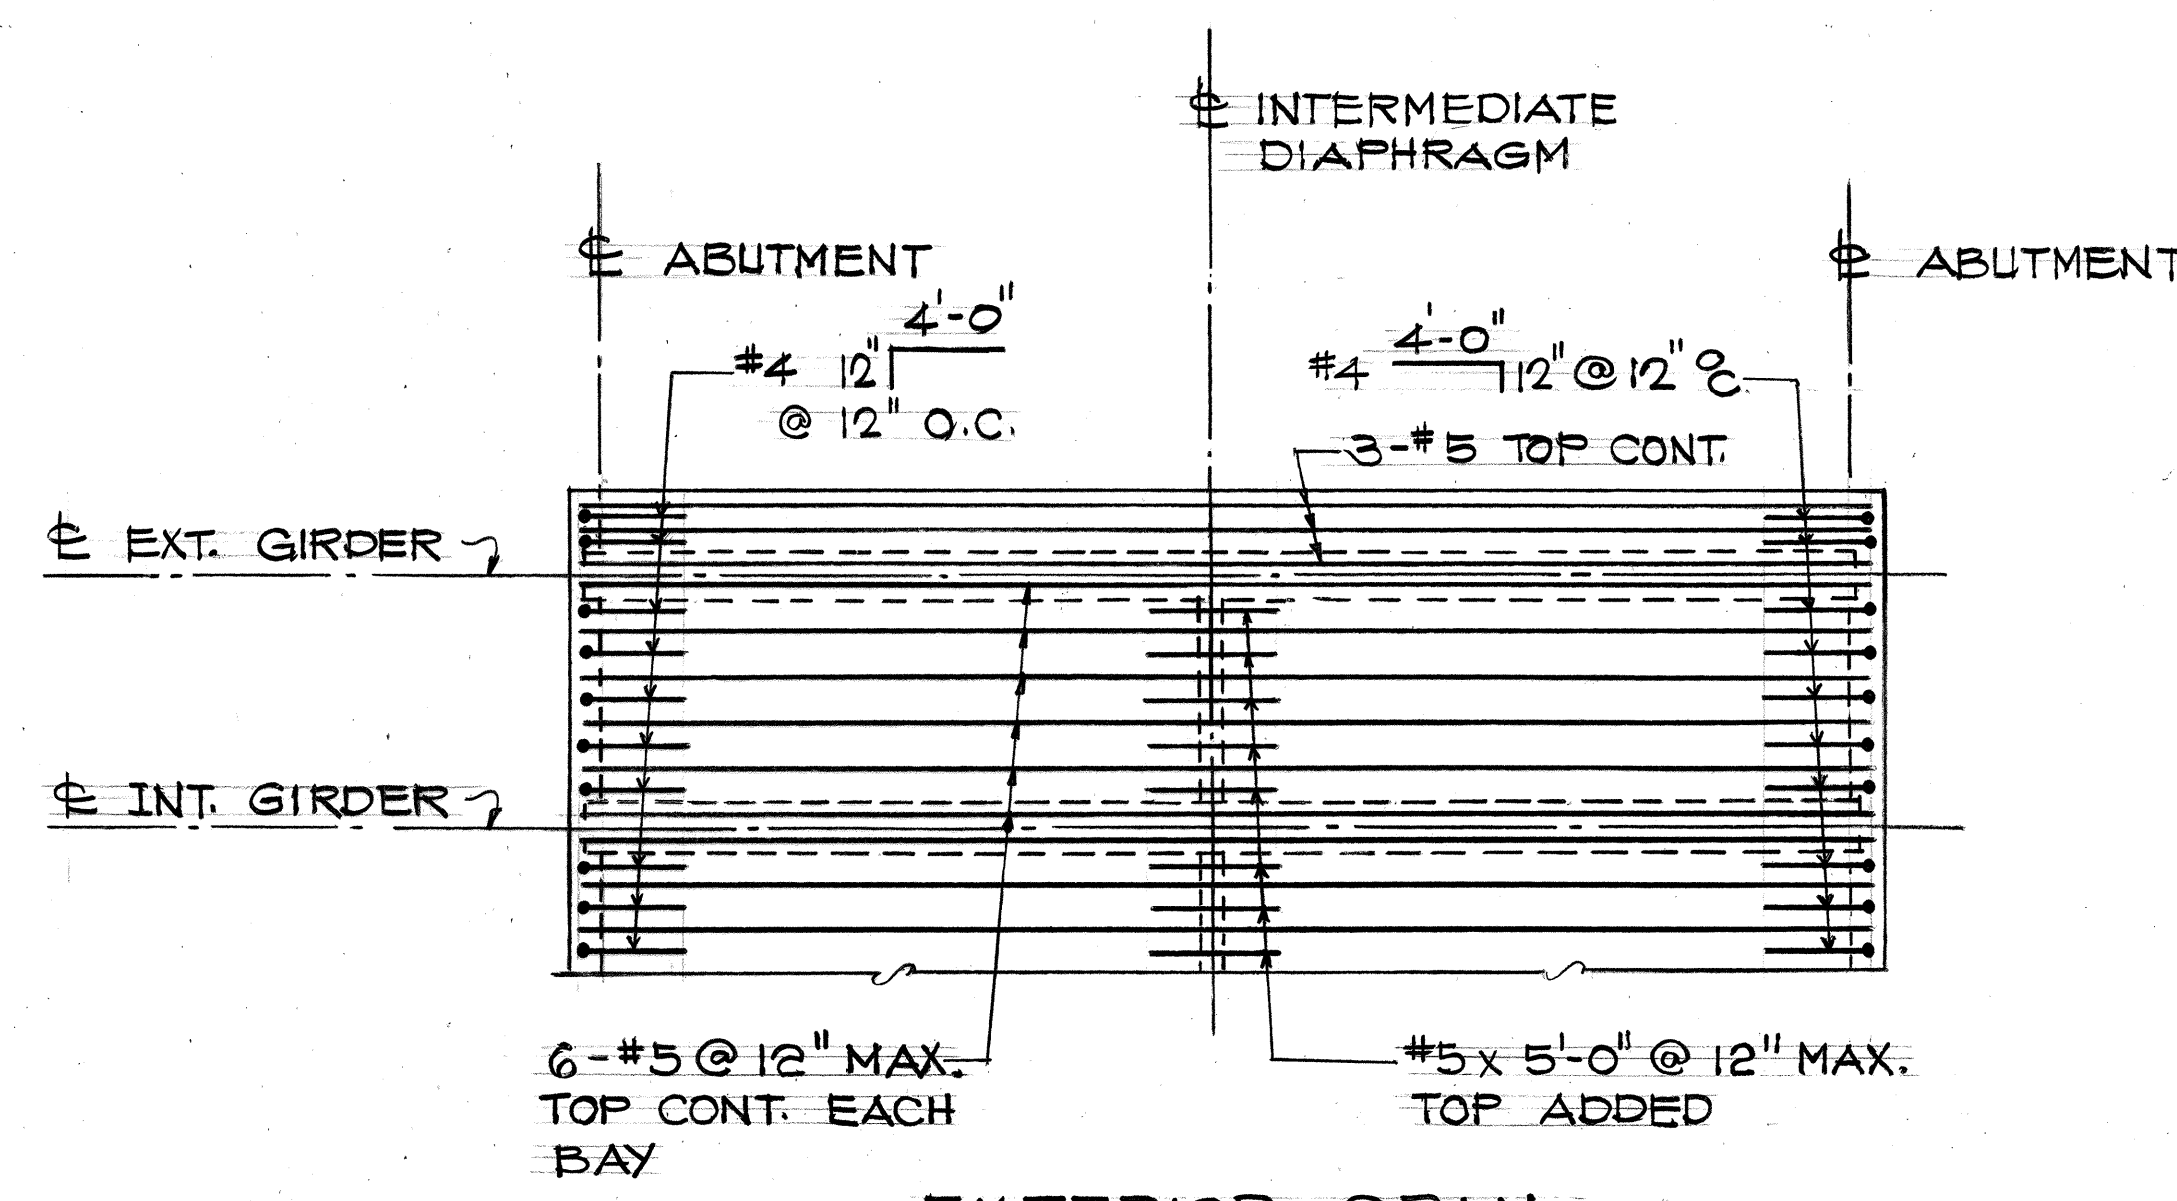
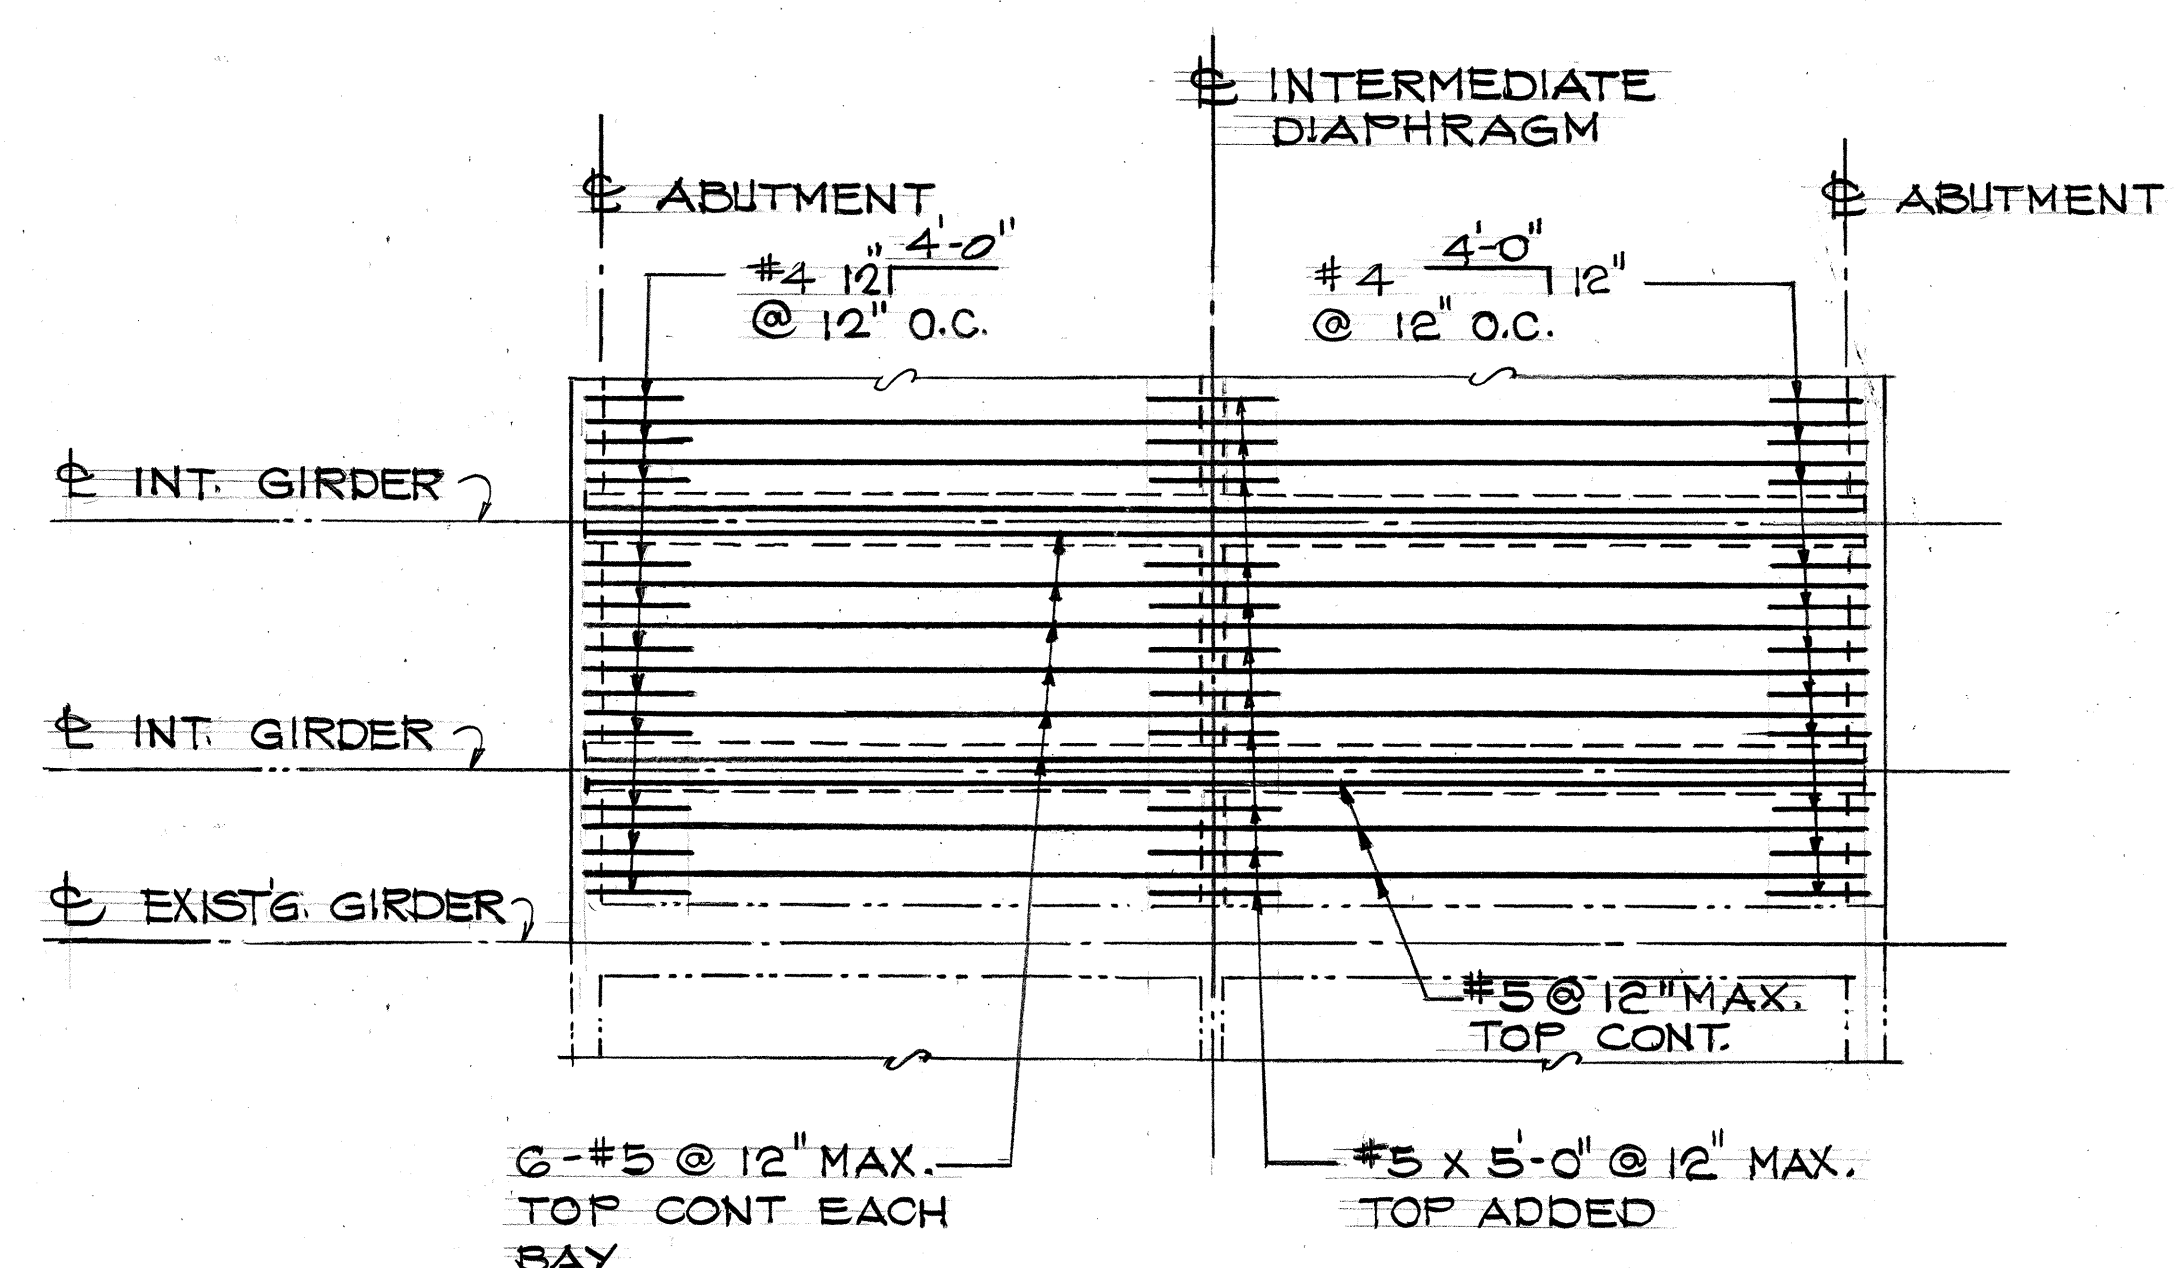
TYPICAL ARRANGEMENT OF TOP REINF.

EXTERIOR SPAN

INTERIOR SPAN

NOTE:  
REINFORCEMENT NOT SHOWN  
FOR CLARITY

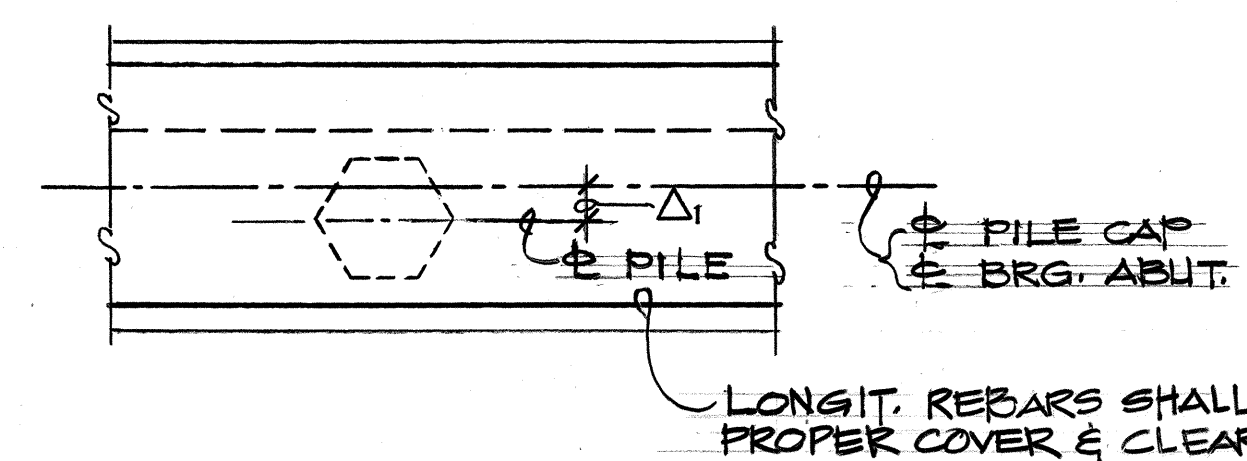
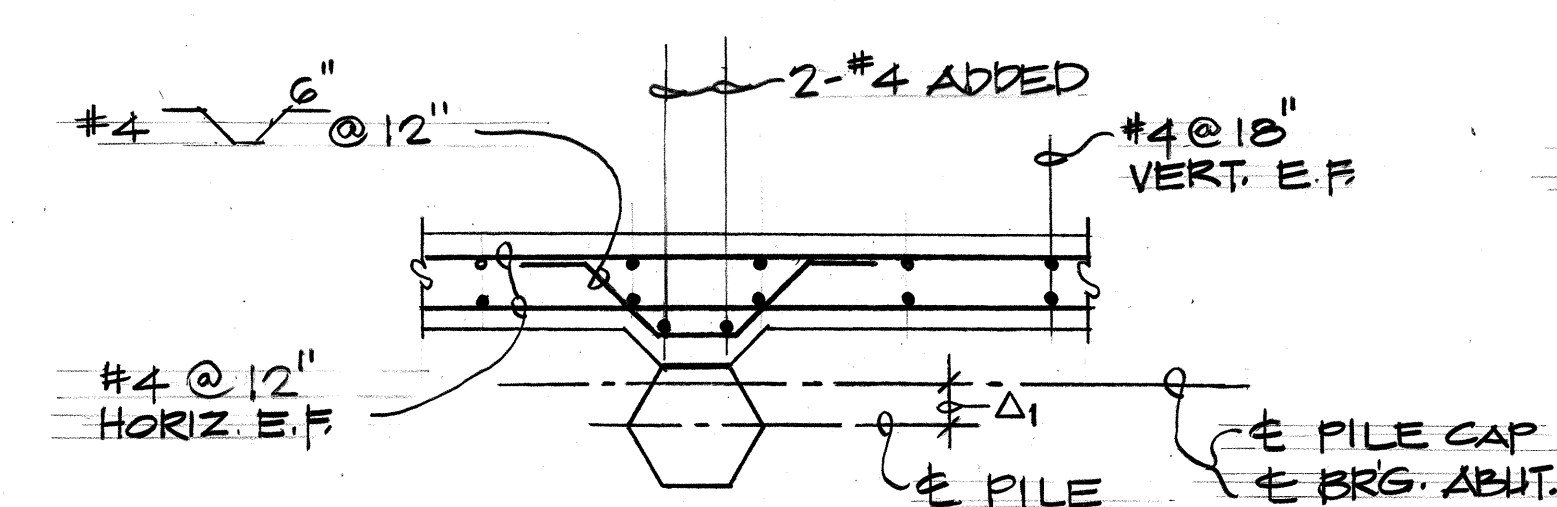
PLAN-SECTION THRU PILE CAP

PLAN-SECTION THRU WALL

PILE PLACEMENT ERROR CONDITION ( $\Delta_1 = 5\frac{1}{2}"$  MAX.)  
AT ABUTMENT No. 1  
PILES NO. 6, 8, 9, 10

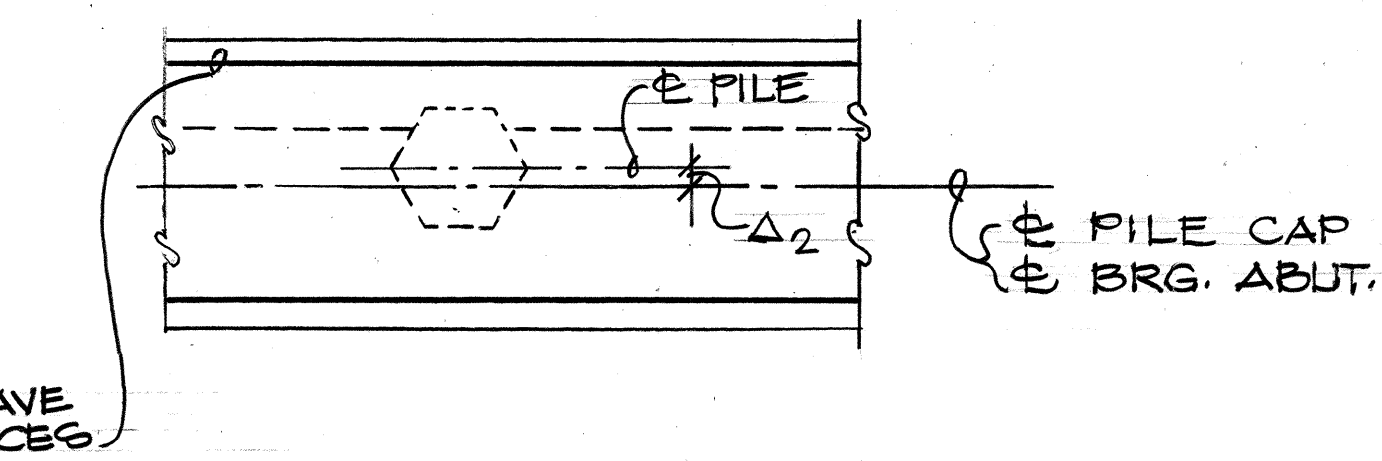
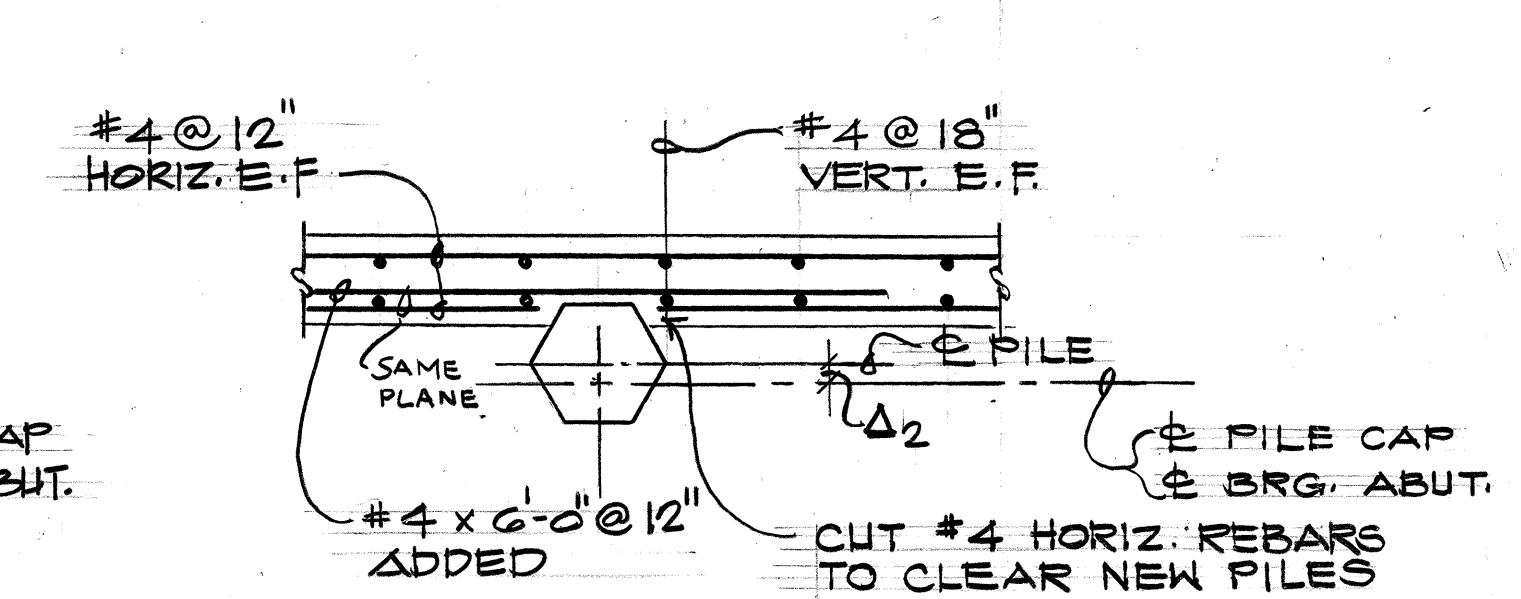
PLAN-SECTION THRU PILE CAP

PLAN-SECTION THRU WALL

PILE PLACEMENT ERROR CONDITION ( $\Delta_2 = 2"$  MAX.)  
AT ABUTMENT No. 2  
PILES NO. 11, 12, 13, 14, 15
