HONOLULU HARBOR, OAHU, HAWAII

PILE CAP AND FENDER REPAIR DETAILS

S-4

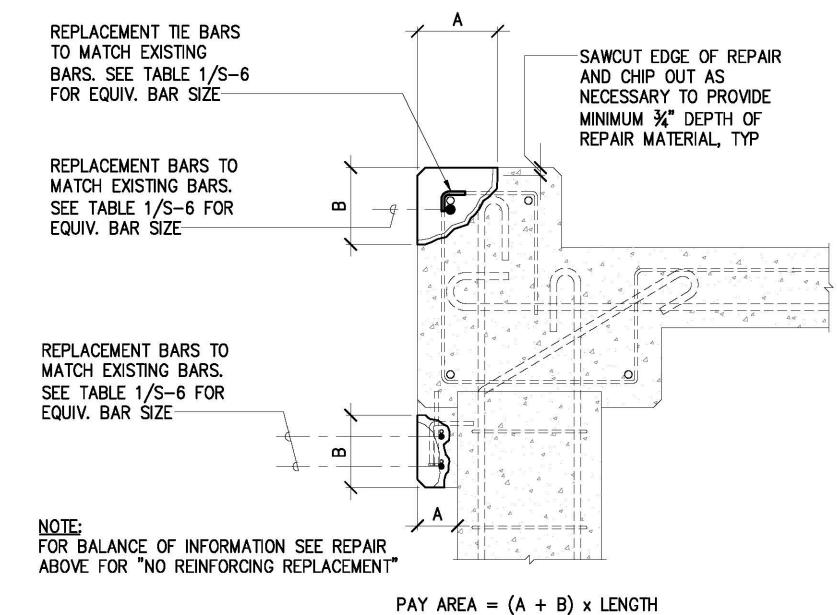
S-4 SCALE: 1" = 1'-0"

PILE CAP SECTION
(WITH REINFORCING REPLACEMENT)

NOTE: FENDER NOT SHOWN FOR CLARITY

PILE CAP SPALL REPAIR (TYPE TL AND BL)
