FINAL ENVIRONMENTAL ASSESSMENT

CASTLE HILLS ACCESS ROAD DRAINAGE IMPROVEMENTS

**District of Koolaupoko, Island of Oahu
Project No. HWY-O-04-98**

**State Of Hawaii Department Of Transportation
Highways Division**

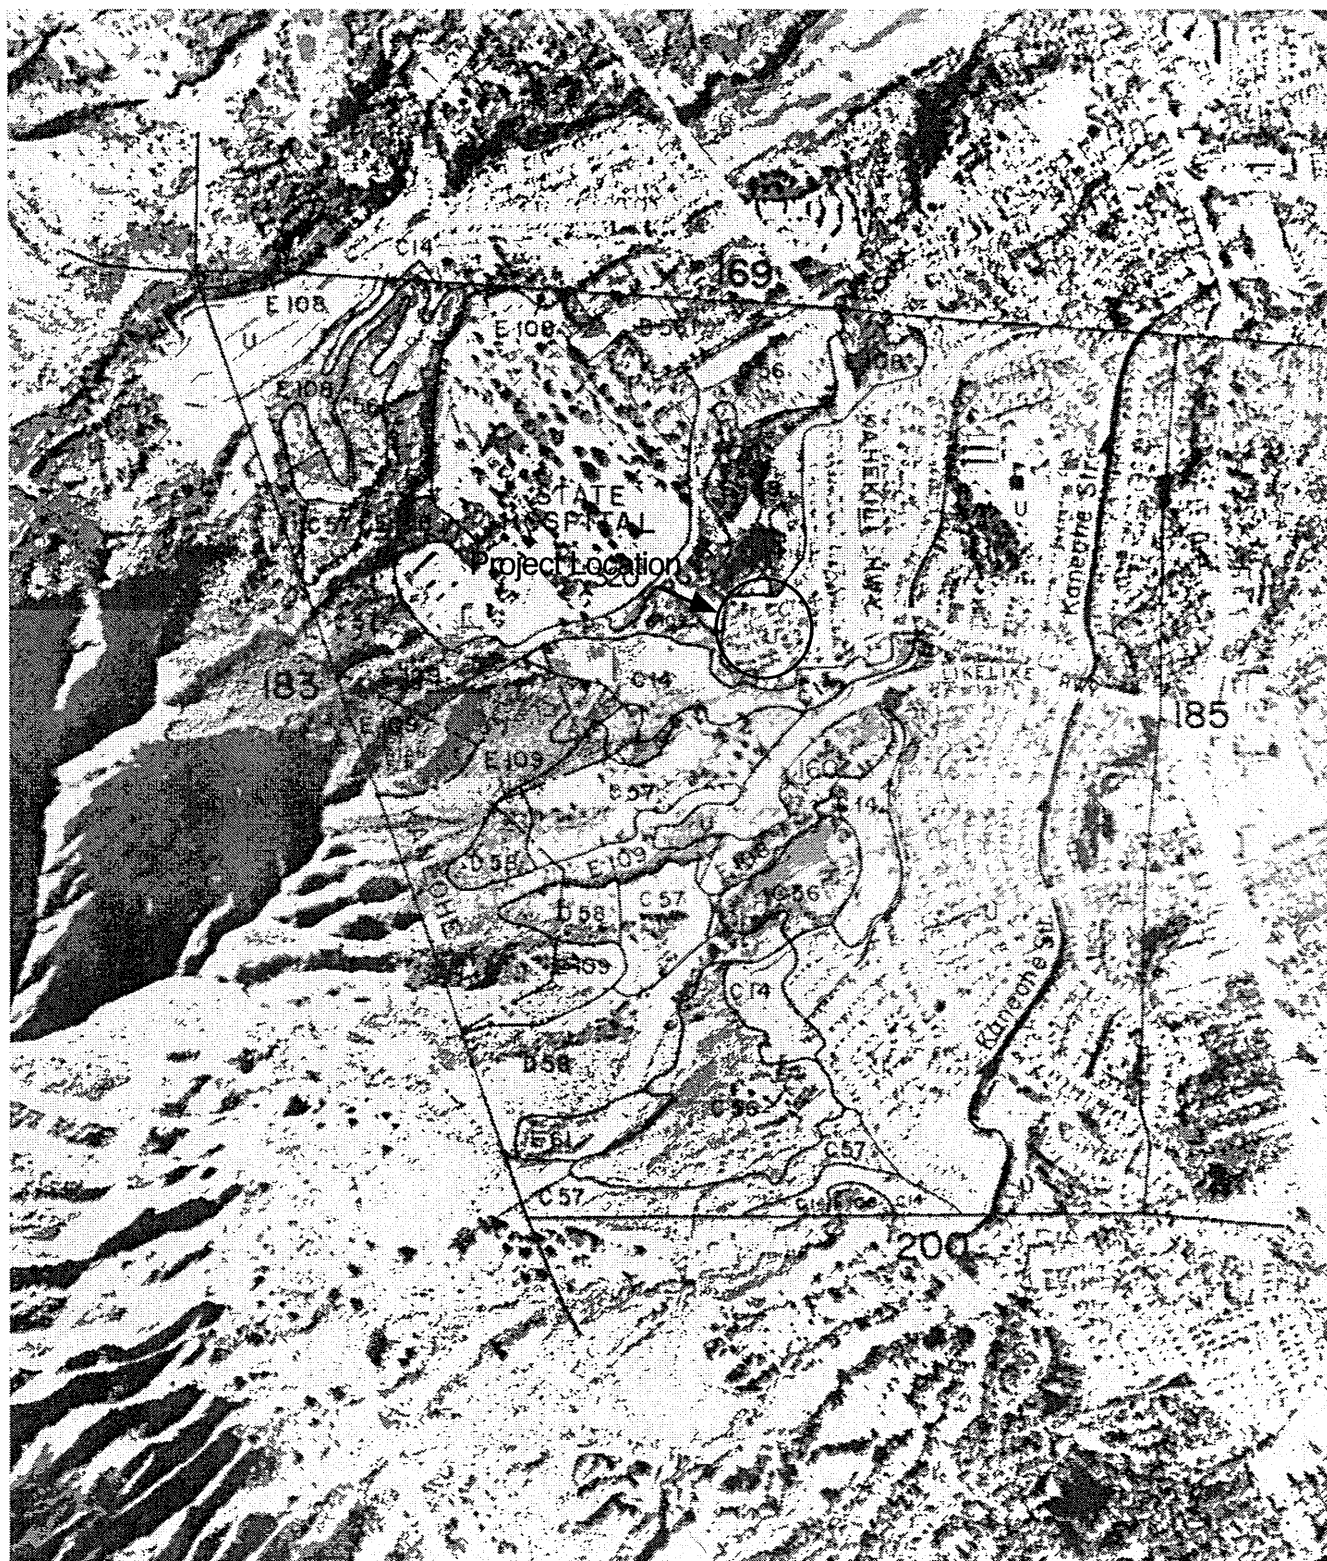
Figure 8
Page 3-3

According Sheet Number 60 of the Soil Survey of Islands of Kauai, Oahu, Maui, Molokai, and Lanai, State of Hawaii by the US Department of Agriculture Soil Conservation Service, the project site is located on soils classified as HnB Hanalei silty clay, 2 to 6 percent slopes (Figure 8).

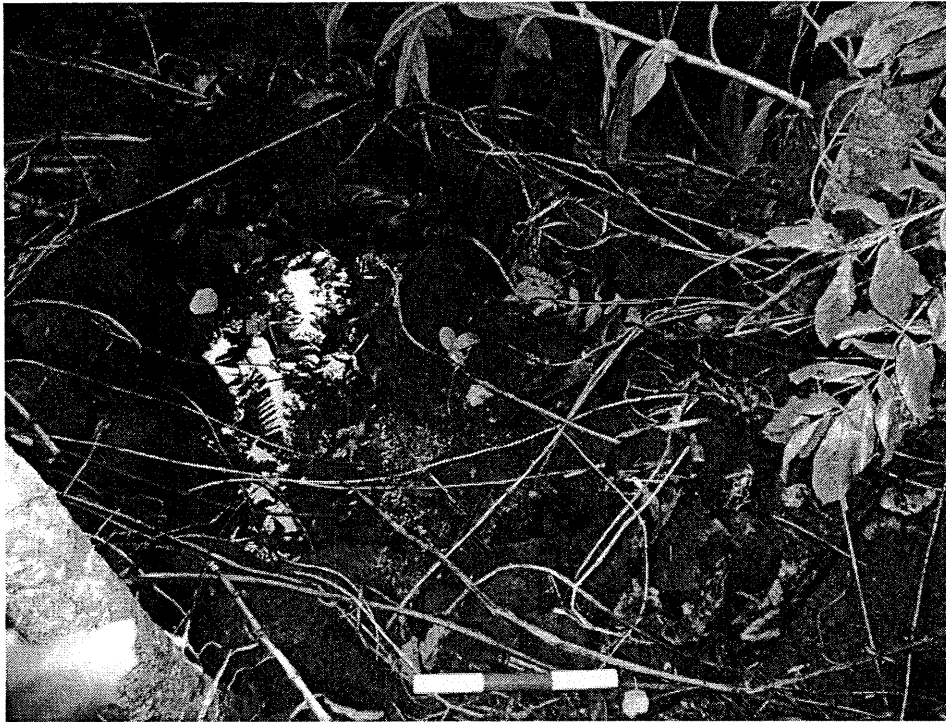
Figure 3: Modern pit feature, showing plastic lining. The scale is marked in 10 cm increments.

Modern structural remnants were found along the north bank of Kapunahala Stream. This consisted of a stone circular pit, approximately 45 m from the east end of the project area. Concrete was observed beneath the structure and a plastic liner was visible within the pit, indicating recent construction (Figure 3). The pit appears to be a modern landscaping feature, such as a small pond, and is not archaeologically significant.

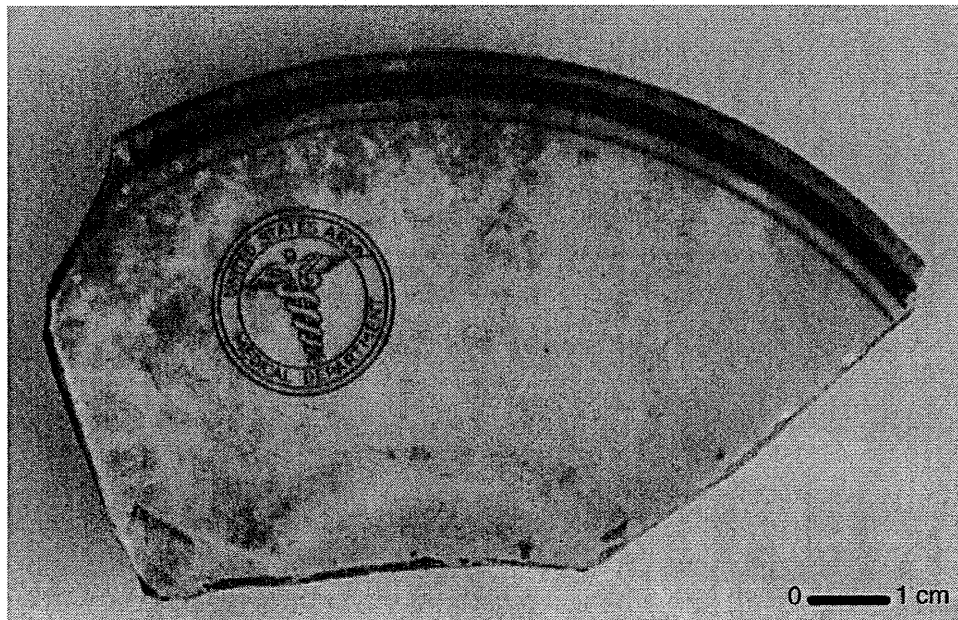
One surface artifact was collected during the survey. This was a ceramic sherd found on the north bank of Kapunahala Stream, approximately 40 m from the east end of the project area, just east of the circular pit. The sherd is a saucer fragment with a red double-line rim band and a "UNITED STATES ARMY MEDICAL DEPARTMENT" crest on the front surface (Figure 4). The underside of the saucer fragment bears a faint green image, possibly part of a maker's mark, although no text is visible. It is not clear if the sherd was associated with the circular pit or washed down the stream. Recent episodes of heavy rain render it likely that the sherd was deposited secondarily during flooding.

Figure 4. Ceramic sherd found on the north bank of Kapunahala Stream.
