# TEMPORARY STABILIZED CONSTRUCTION INGRESS/EGRESS AND WASHDOWN CONTAINMENT AREA

# EROSION CONTROL DETAILS

CASTLE HILLS ACCESS ROAD Drainage Improvements, Phase 1 Project No. HWY-0-04-98

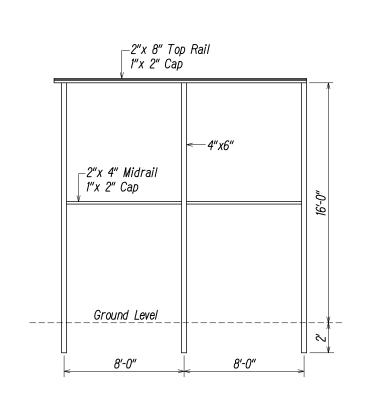
Elevation

**DUST SCREEN DETAIL** Not to Scale

- 2. Cloth barrier not shown in elevation view for clarity.
- 3. Cloth barrier shall be a "geotextile" or "nursery shade". Burlap is not an acceptable cloth barrier material.

- 5. Bury base of cloth barrier to indicated dimension, as shown.
- 6. 1x2 cloth barrier caps to be nailed 12" o.c.
- 7. Cloth to have no horizontal seams.
