BOLLARD AND FENDER REPAIRS AT PIER 60, HONOLULU HARBOR, OAHU, HAWAII

RAMP FENDER REPAIRS

Sheet No. SKS-1

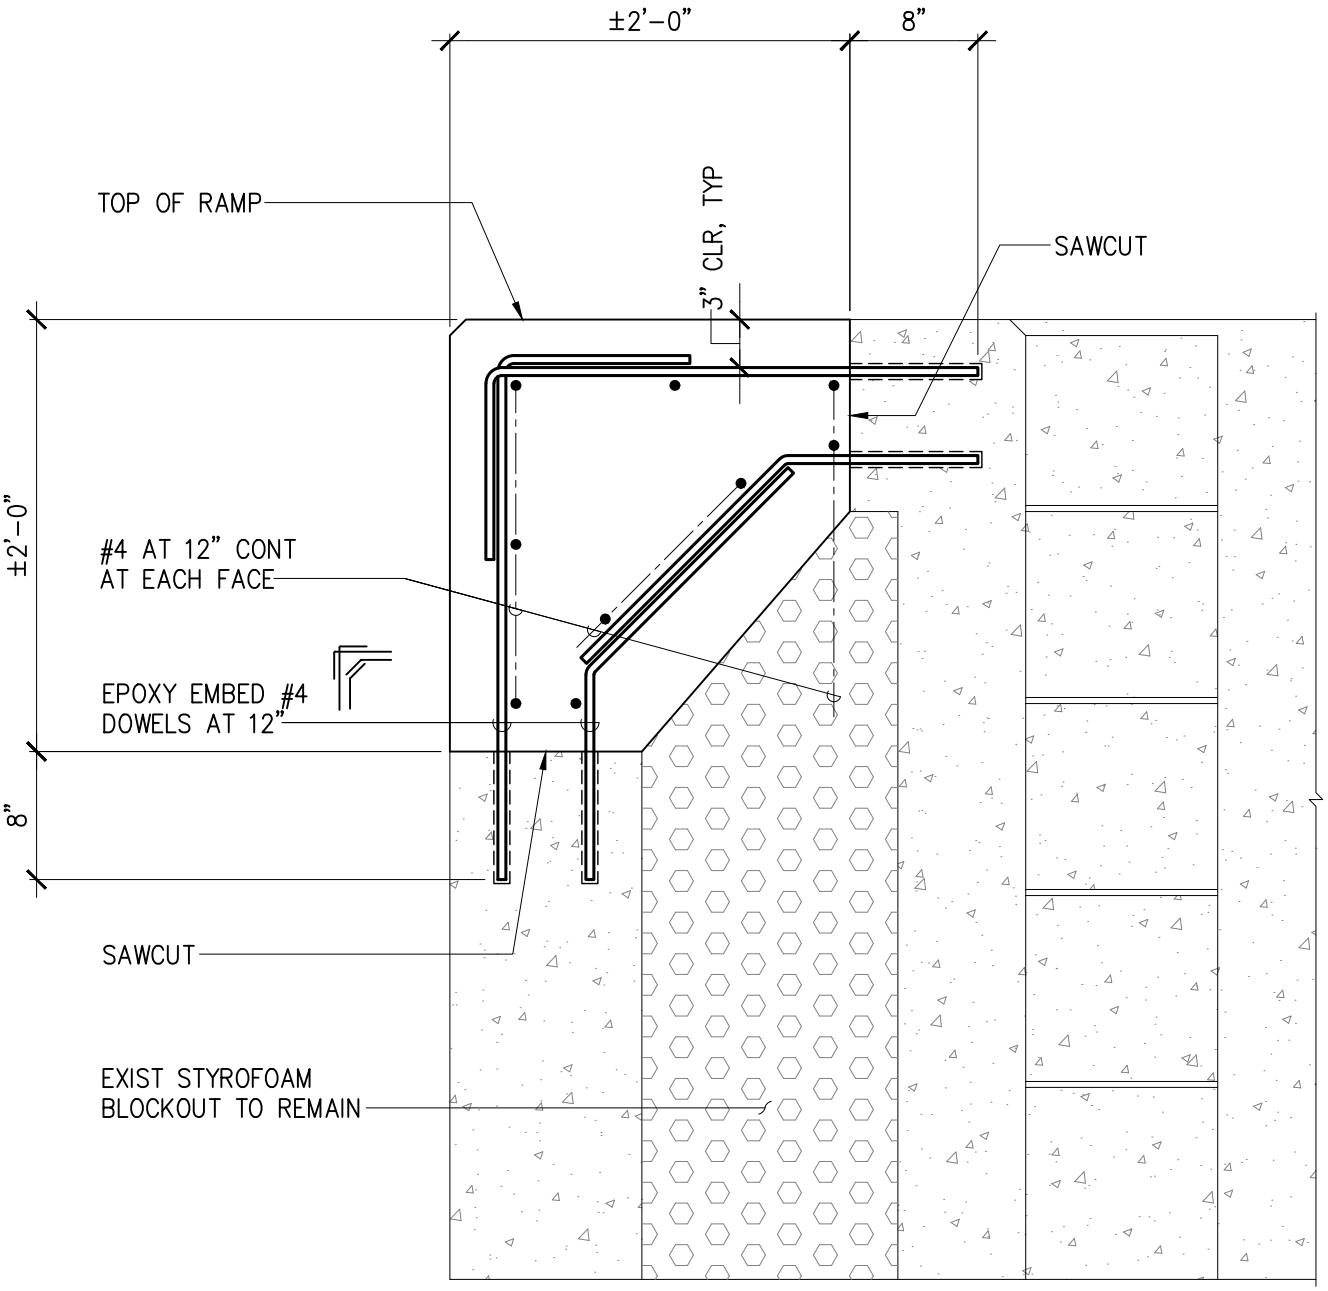
1 / SKS-1 SECTION

1. EXIST REINFORCING BARS ARE GFRP AND MAY BE SAWCUT AT EXTENTS OF DEMOLISHED AREAS.
