Modified
Phase I Environmental Site Assessment

**Lihue Airport (LIH)
3901 Mokulele Loop
Lihue, Hawaii 96766**

**Engineering Branch – AIR-EM
State of Hawaii Department of Transportation Airports Division
400 Rodgers Boulevard, Suite 700
Honolulu, Hawaii 96819-1880**

Project No. 117019:DO-36/120037:DO-15

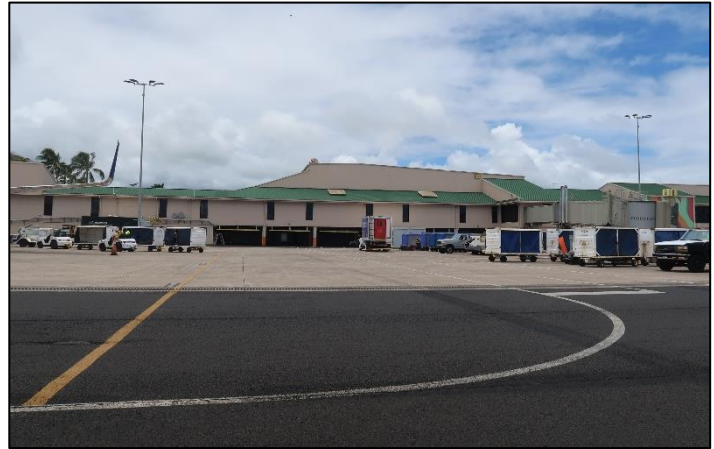
At the time of the inspection, the Main Terminal (Photograph 04; Appendix C) consisted of airline gates 3-10, holdrooms, ticketing and security entry areas, baggage claim, administrative offices, and aircraft parking apron. Containers, roll-off dumpsters, and a puddle of water without signs of contamination were observed southwest of the Main Terminal building (Photograph 05; Appendix C). A 2,000-gallon diesel UST (Photograph 06 and 07; Appendix C) is located on the western side of the terminal generator building along with two pad-mounted electrical transformers (Photograph 08; Appendix C).

Photo 04: Main Terminal.
