ROUTINE (PERIODIC) BRIDGE INSPECTION REPORT

NUAAILUA STREAM BRIDGE
BRIDGE NO. 009003600501540
MAUI, HAWAII

State of Hawaii
Department of Transportation
Highways Division

Nagamine Okawa Engineers Inc.
1003 Bishop Street
Suite 2025
Honolulu, Hawaii 96813
Telephone: (808) 536-2626

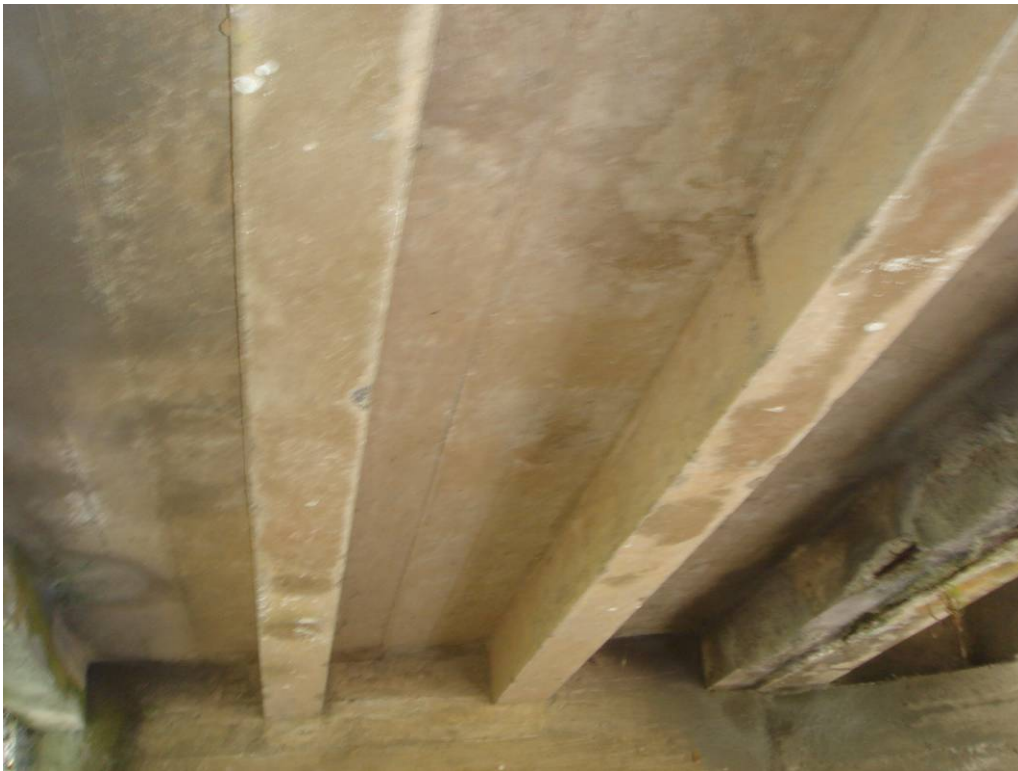
PHOTO 15 JOINT IN SOFFIT
