REVISION DATE DESCRIPTION BY APPROVED	
STATE OF HAWAII DEPARTMENT OF TRANSPORTATION HARBORS DIVISION			
JOB TITLE SUBSTRUCTURE AND FENDER REPAIRS AT PIERS 13-14 HONOLULU HARBOR, OAHU, HAWAII			
SHEET TITLE BEAM SPALL REPAIR DETAILS			
DESIGNED BY: GO DRAWN BY: DL CHECKED BY: BK DATE: 04/2023 SCALE: AS SHOWN	JOB NUMBER H.C. 10826	SHEET S-6 8 of 12 SHTS.

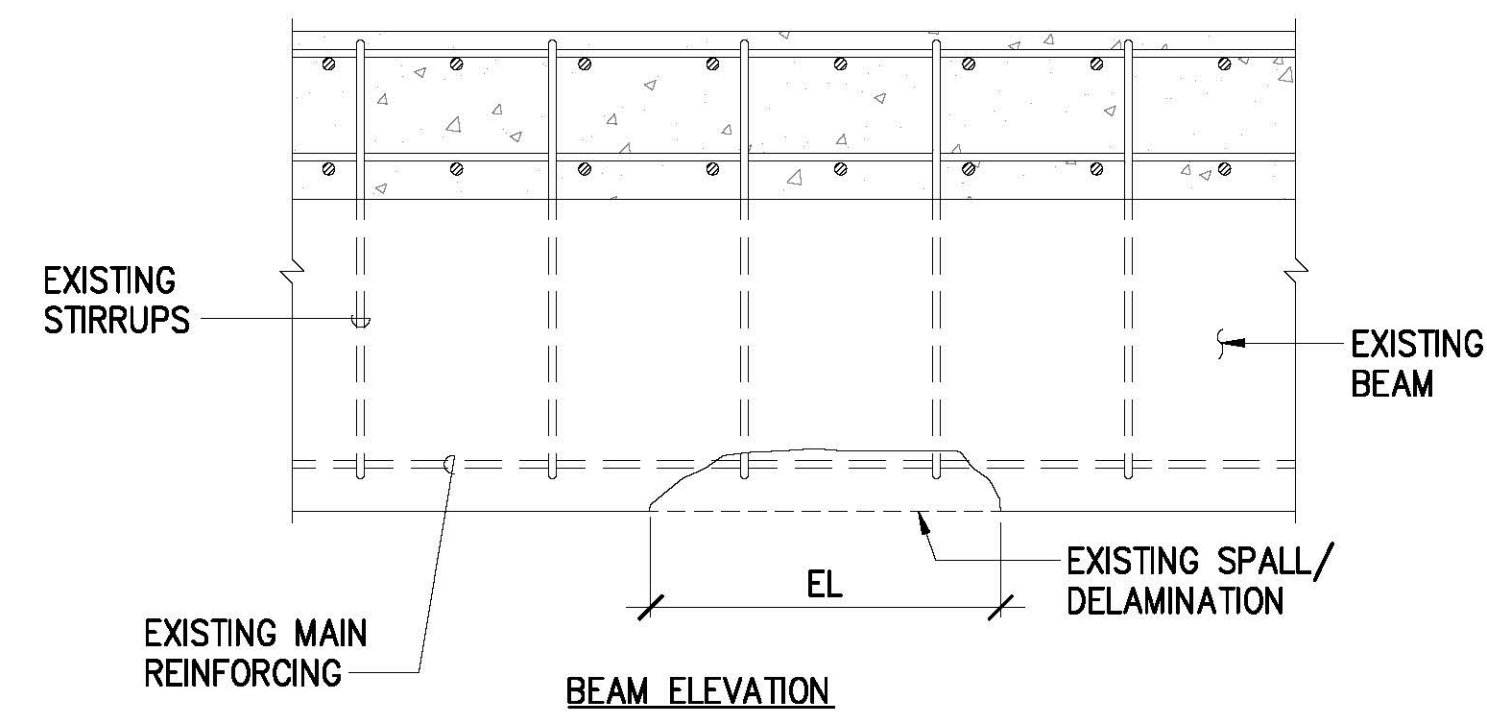
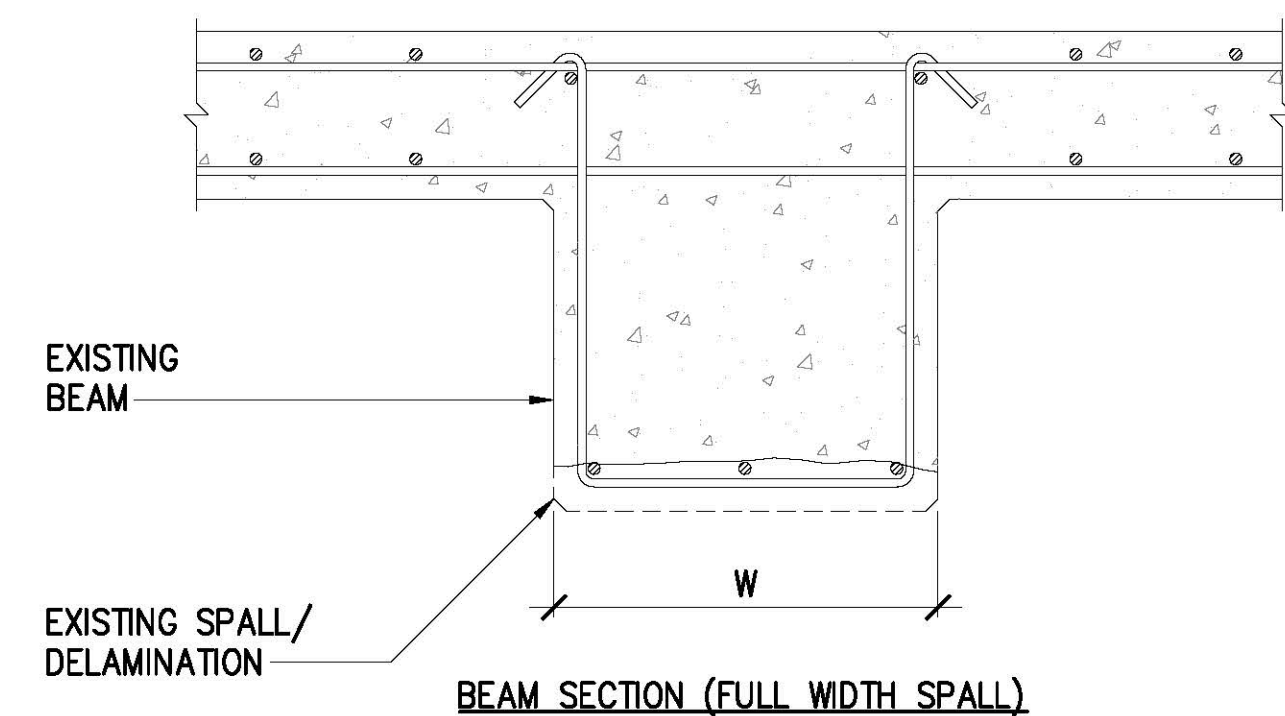
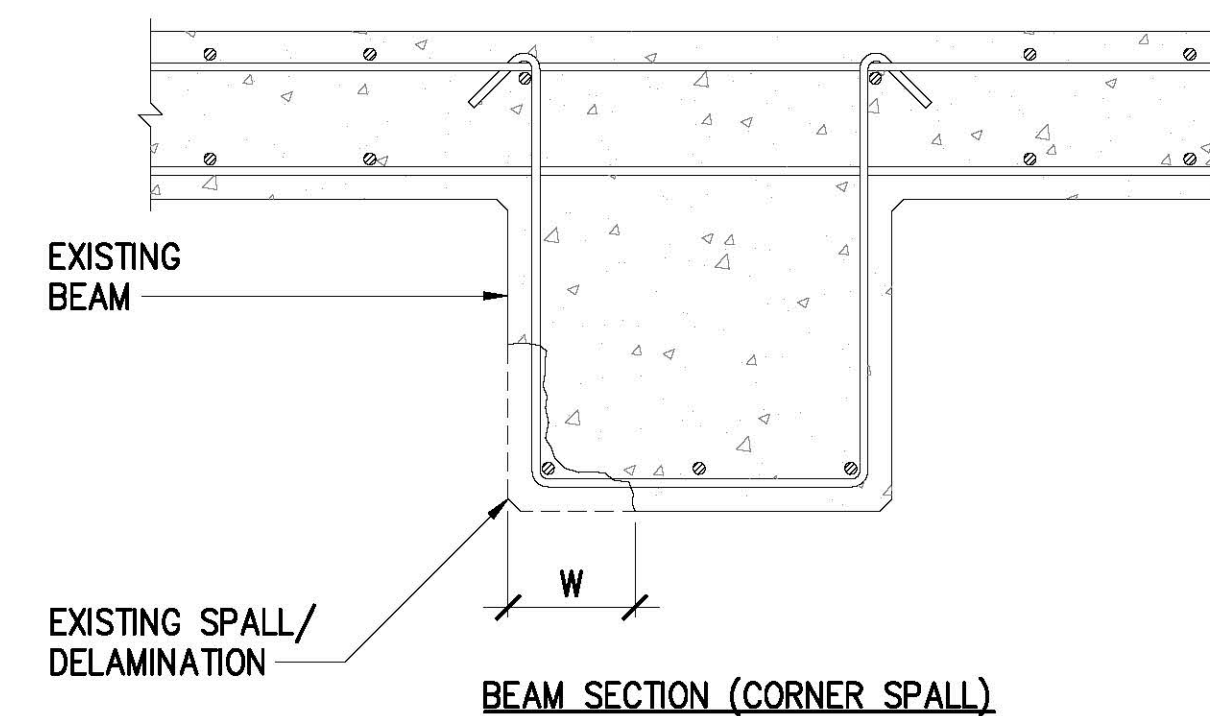
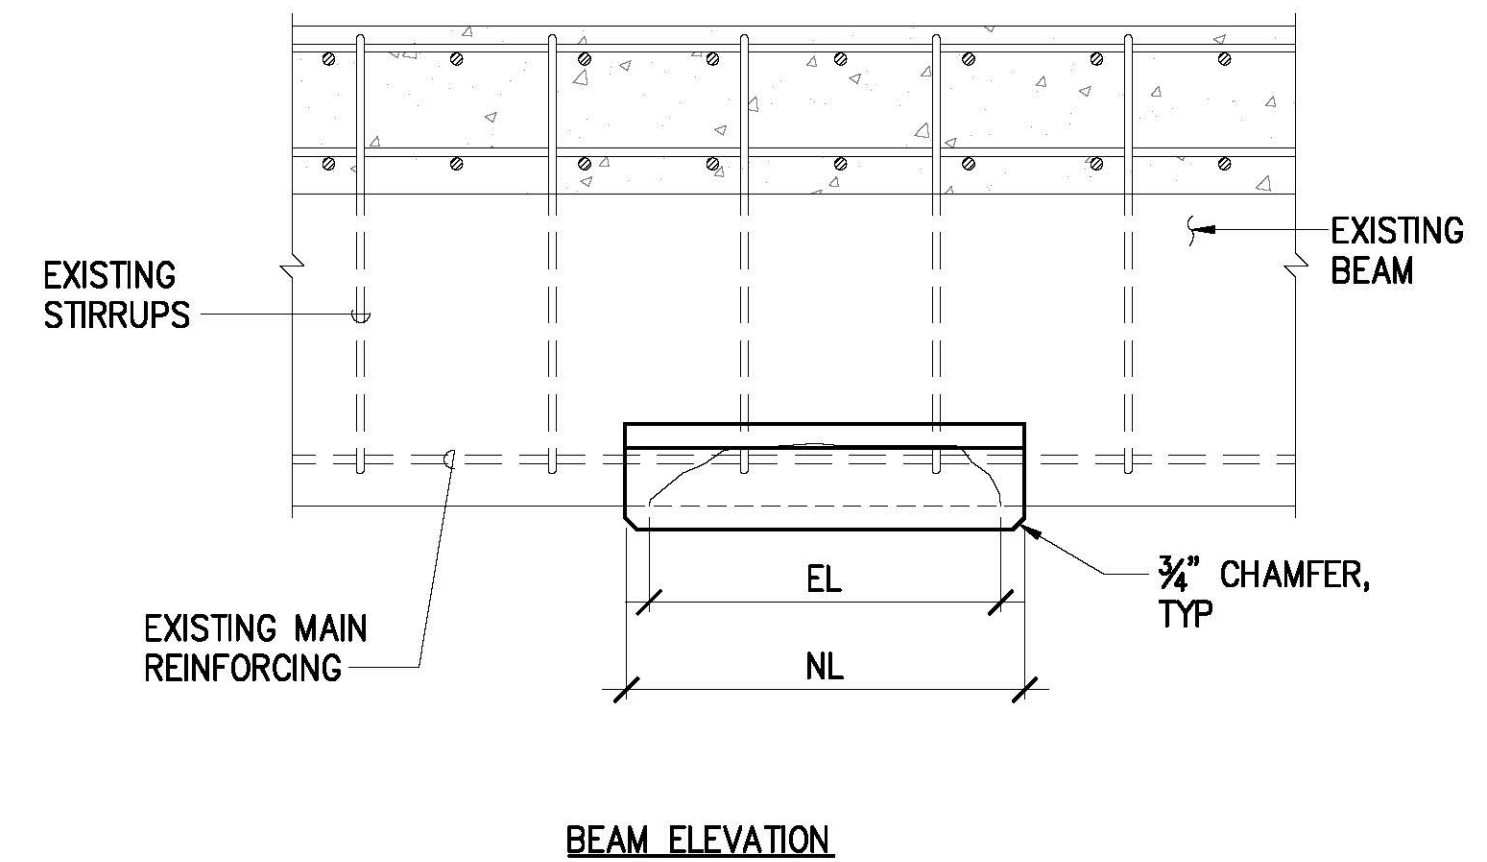
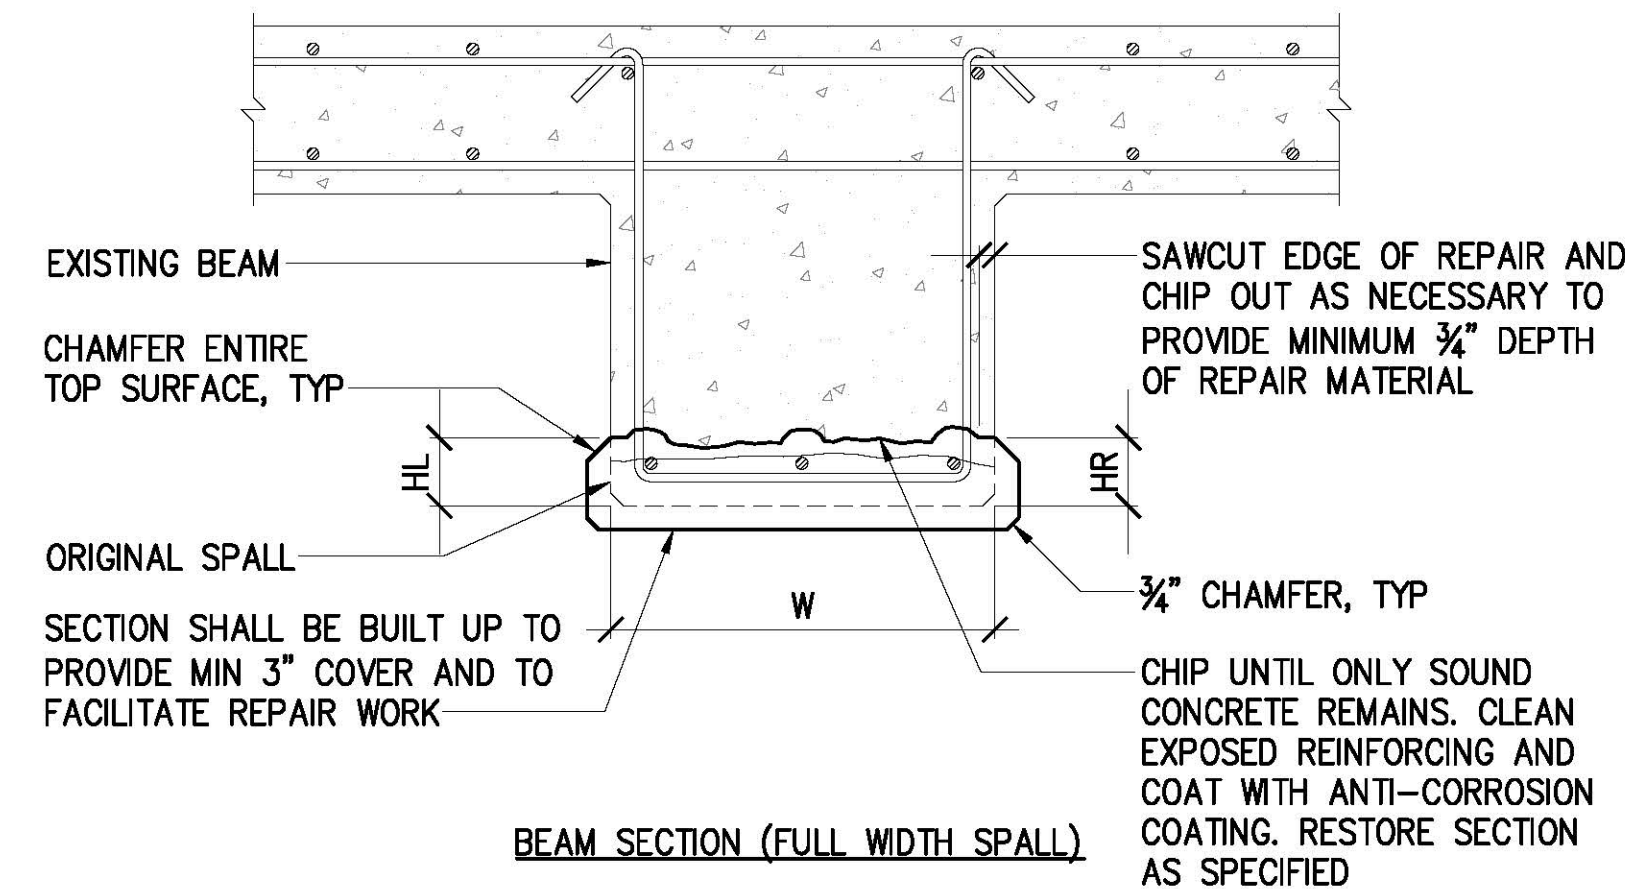
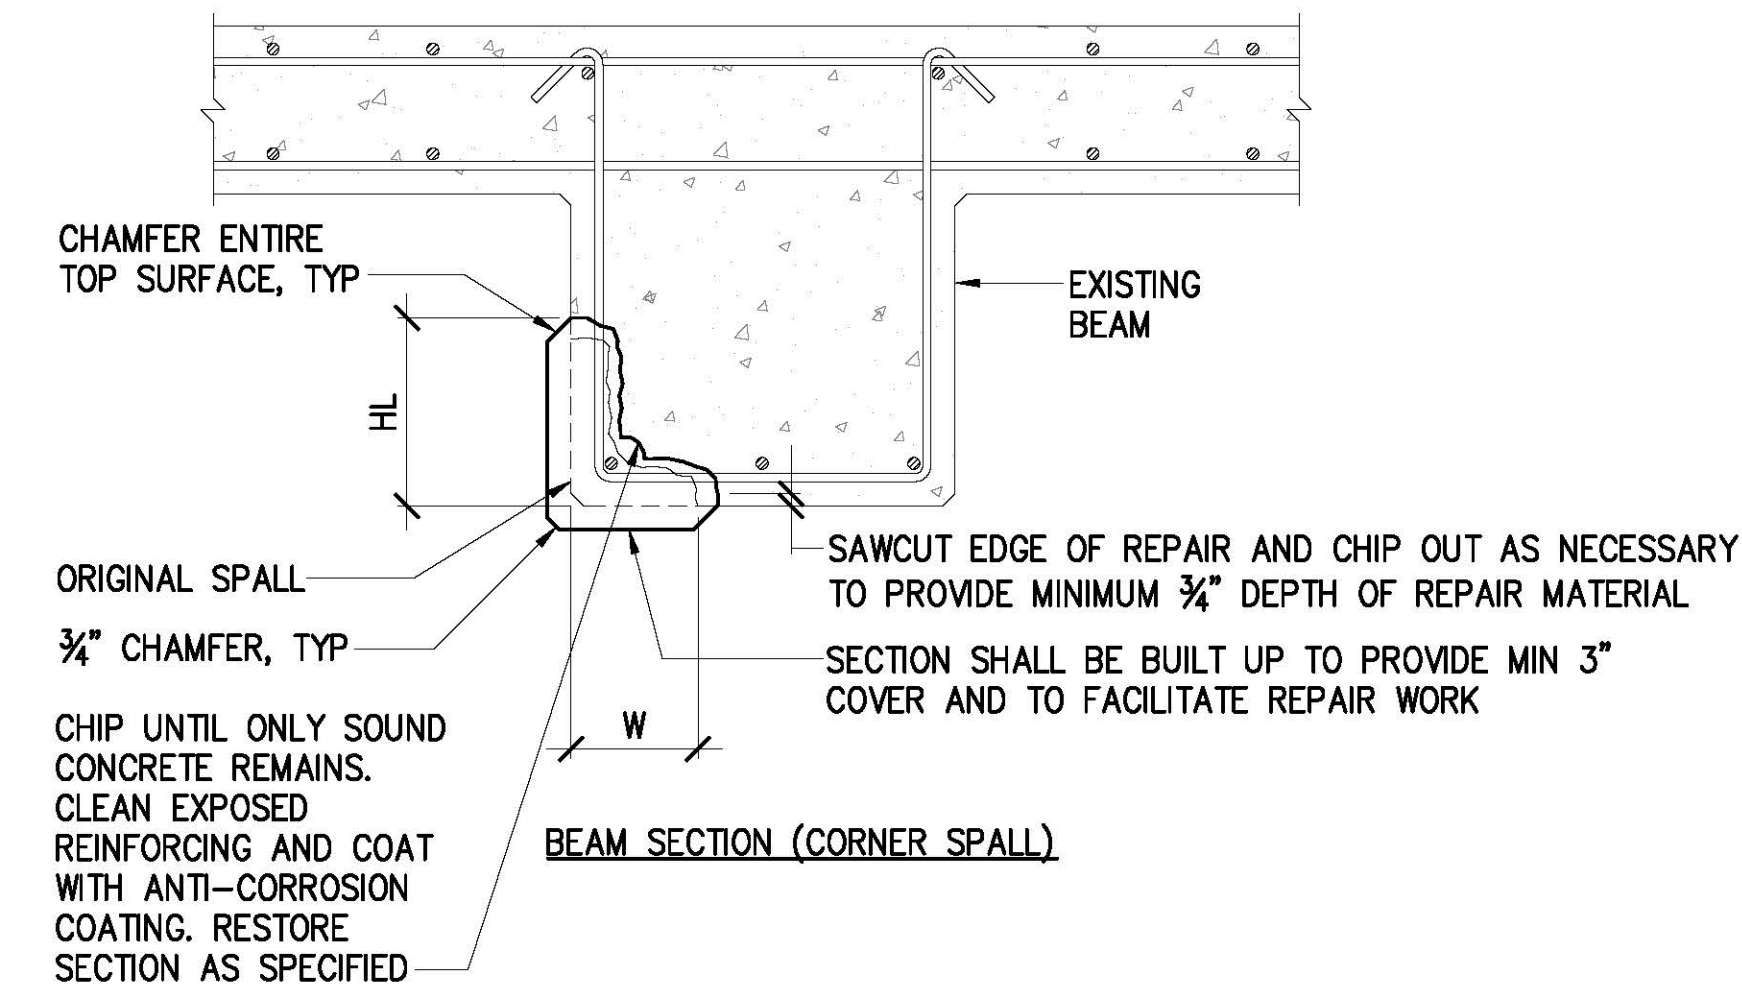
1 BEAM SPALL REPAIR (TYPE B)
 S-6 NOT TO SCALE

PAY AREA:
 HL = HEIGHT OF REPAIR (LEFT SIDE)
 HR = HEIGHT OF REPAIR (RIGHT SIDE)
 W = ORIGINAL WIDTH OF BEAM/GIRDER
 EL = EXISTING LENGTH OF SPALL
 NL = LENGTH OF REPAIR

$$\text{PAY AREA} = (\text{HL} + \text{HR} + \text{W})\text{NL}$$

1. PAY AREA SHALL BE THE TOTAL REPAIRED AREA ON ALL BEAM FACES. IF HL, HR OR W VARY ALONG THE LENGTH OF REPAIR, PAY AREA SHALL BE CALCULATED INDIVIDUALLY FOR EACH BEAM FACE.

EXISTING CONDITION

REPAIRED CONDITION

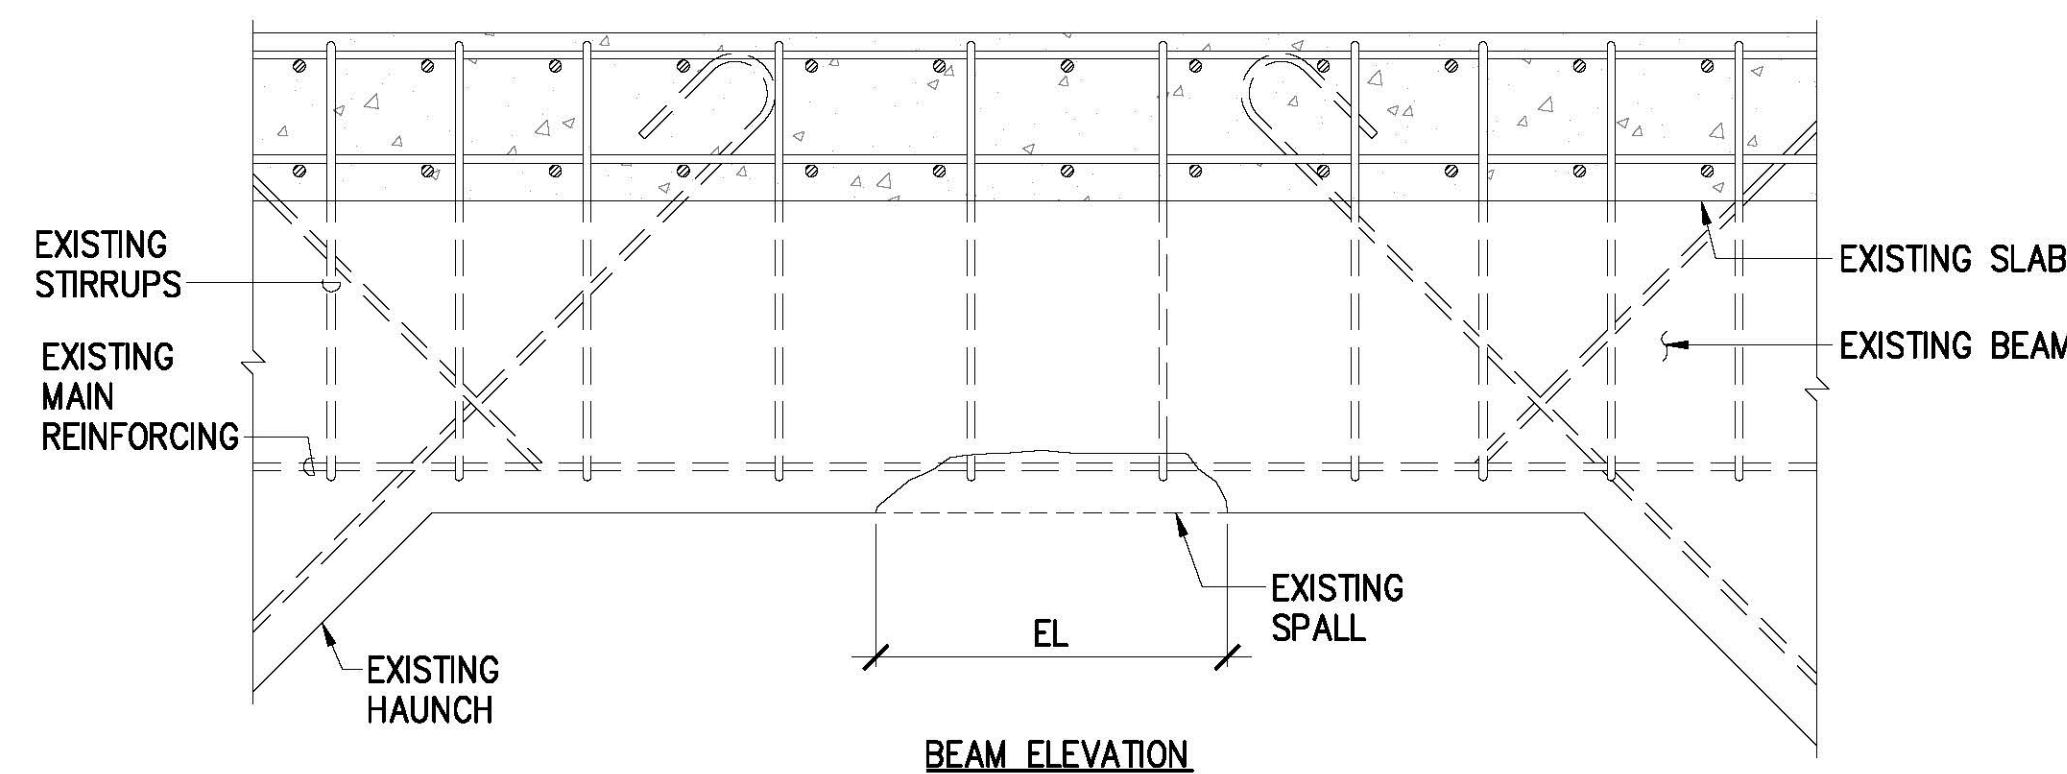
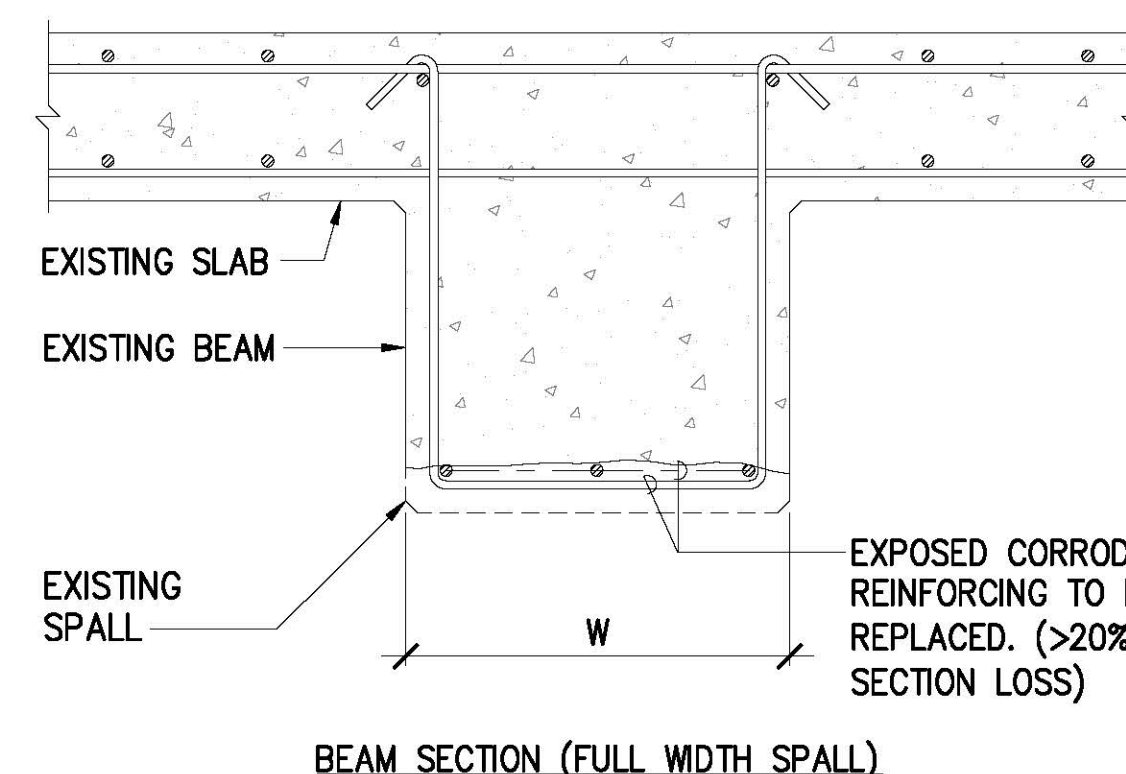
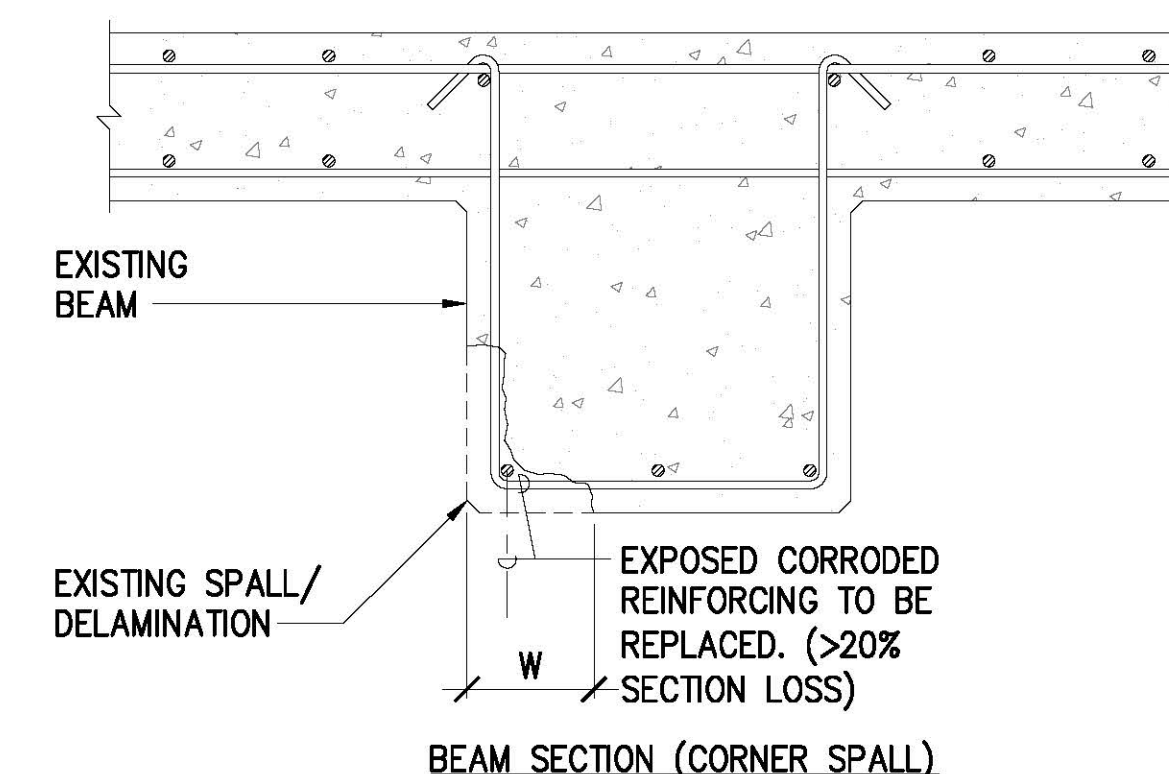
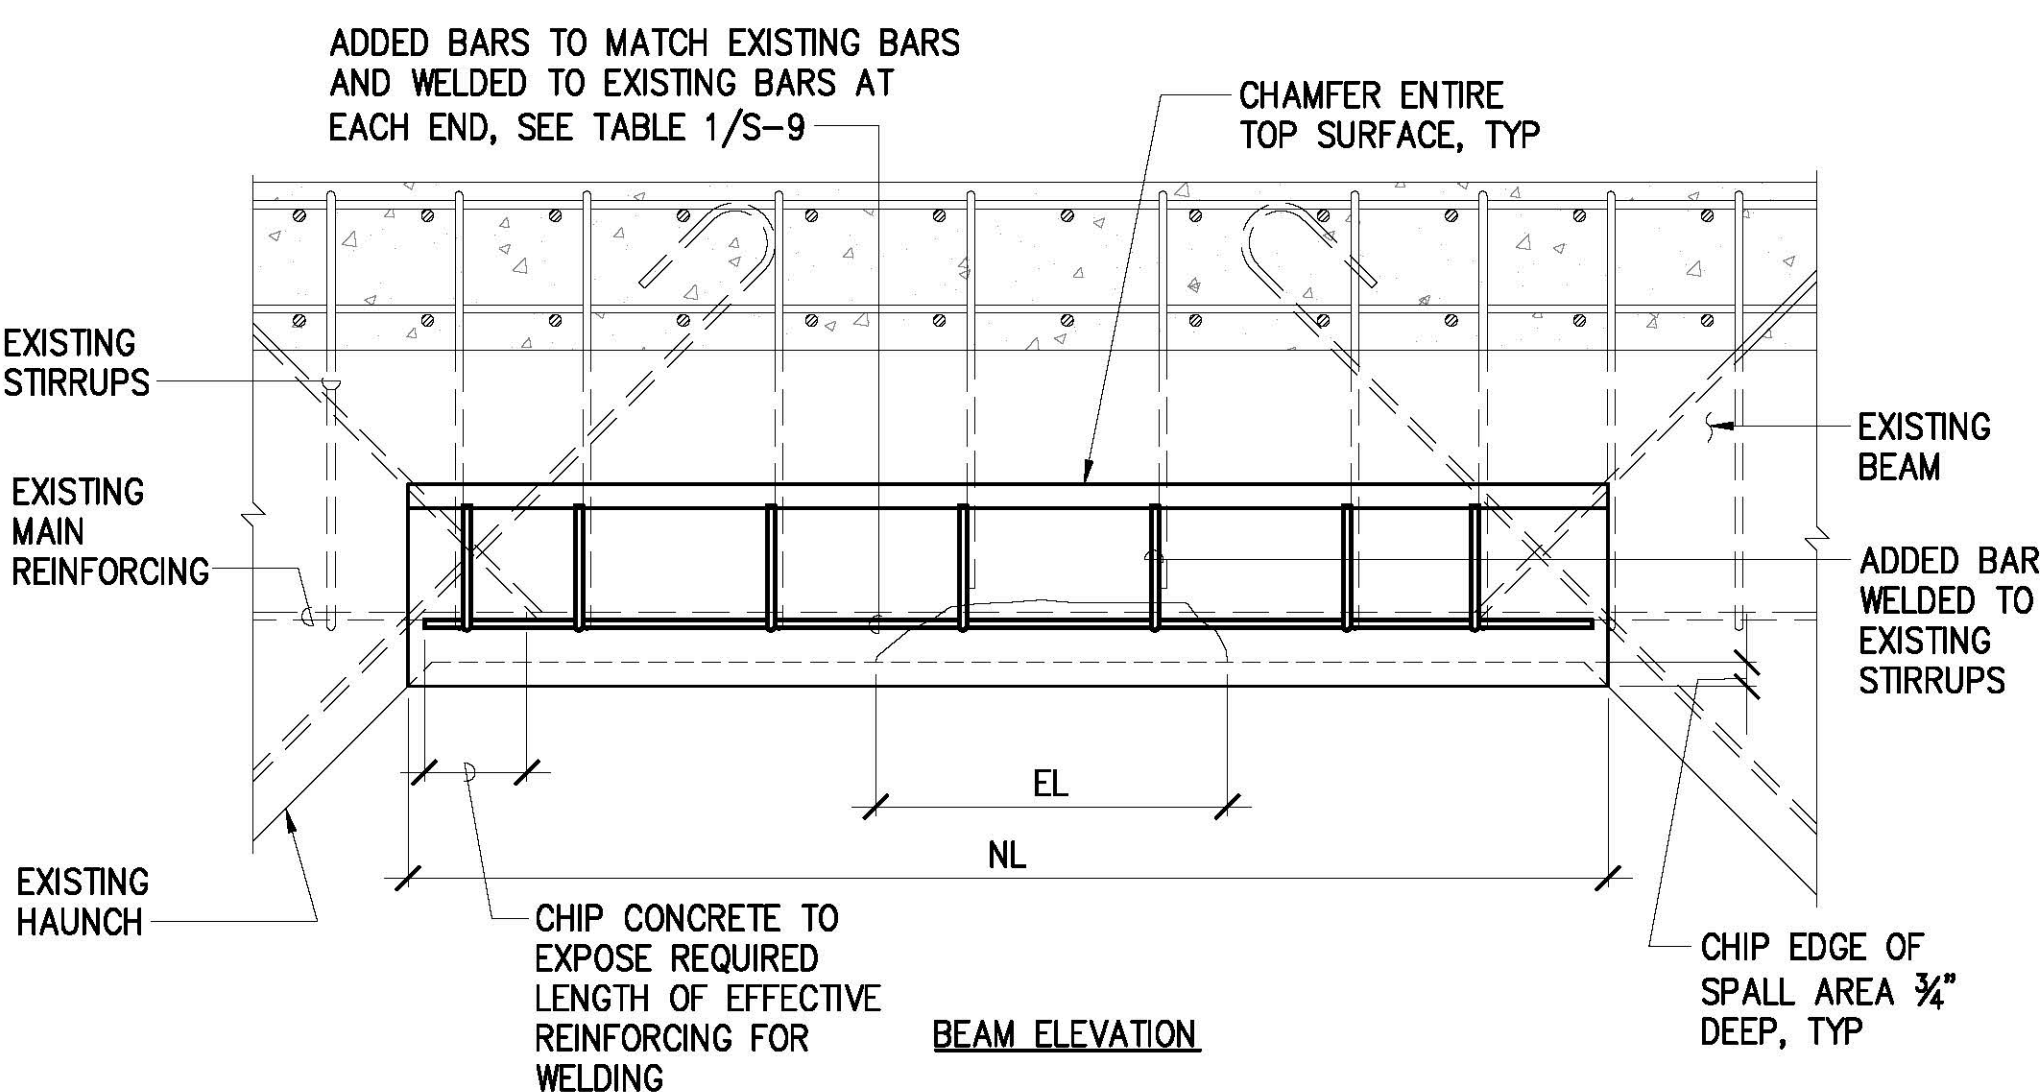
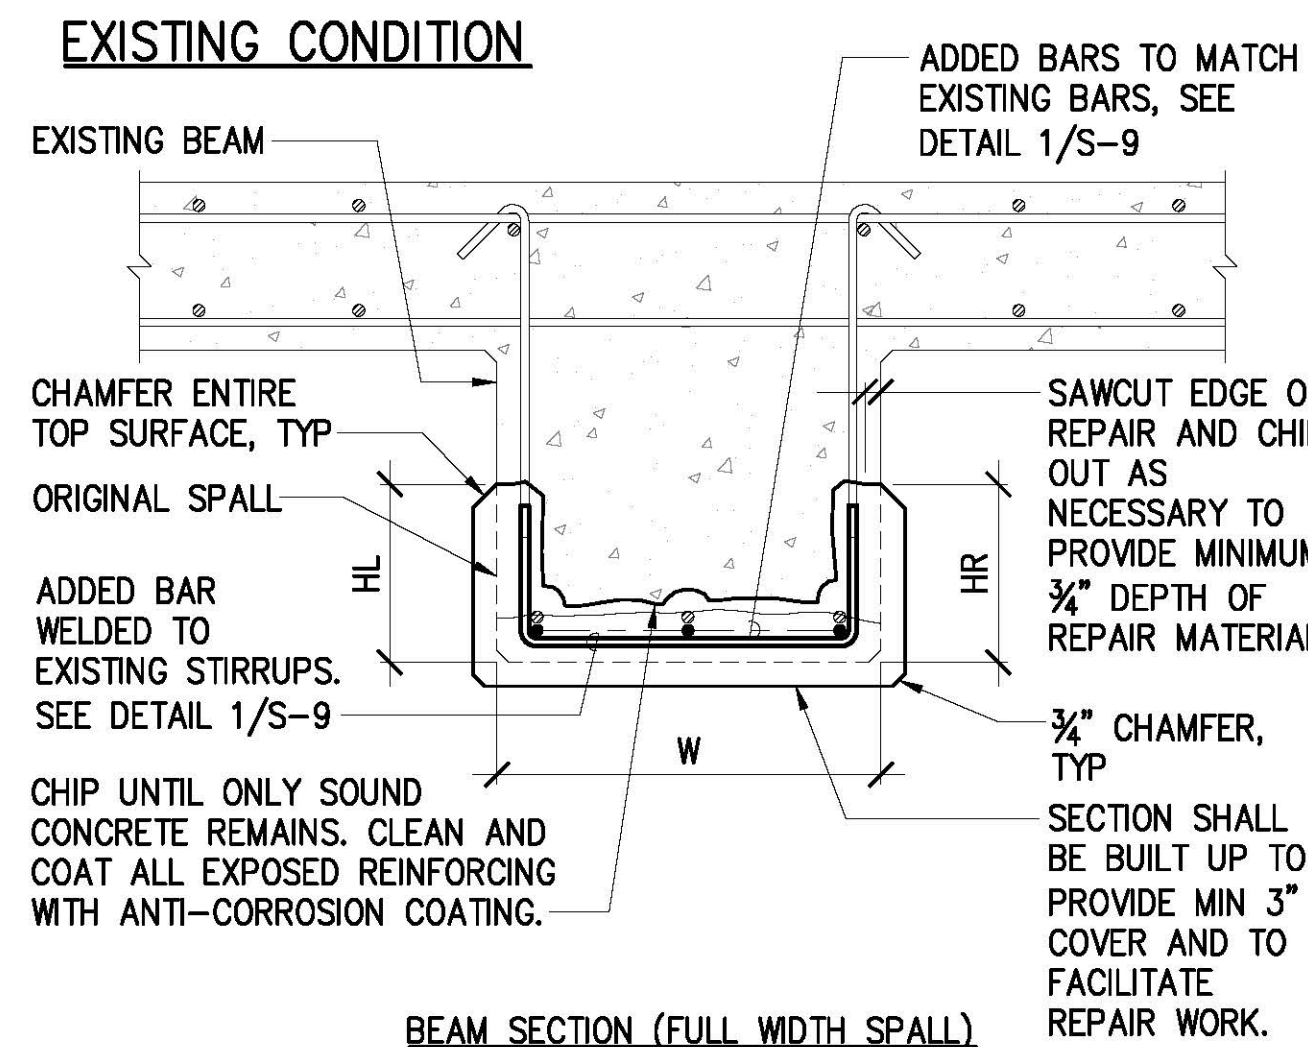
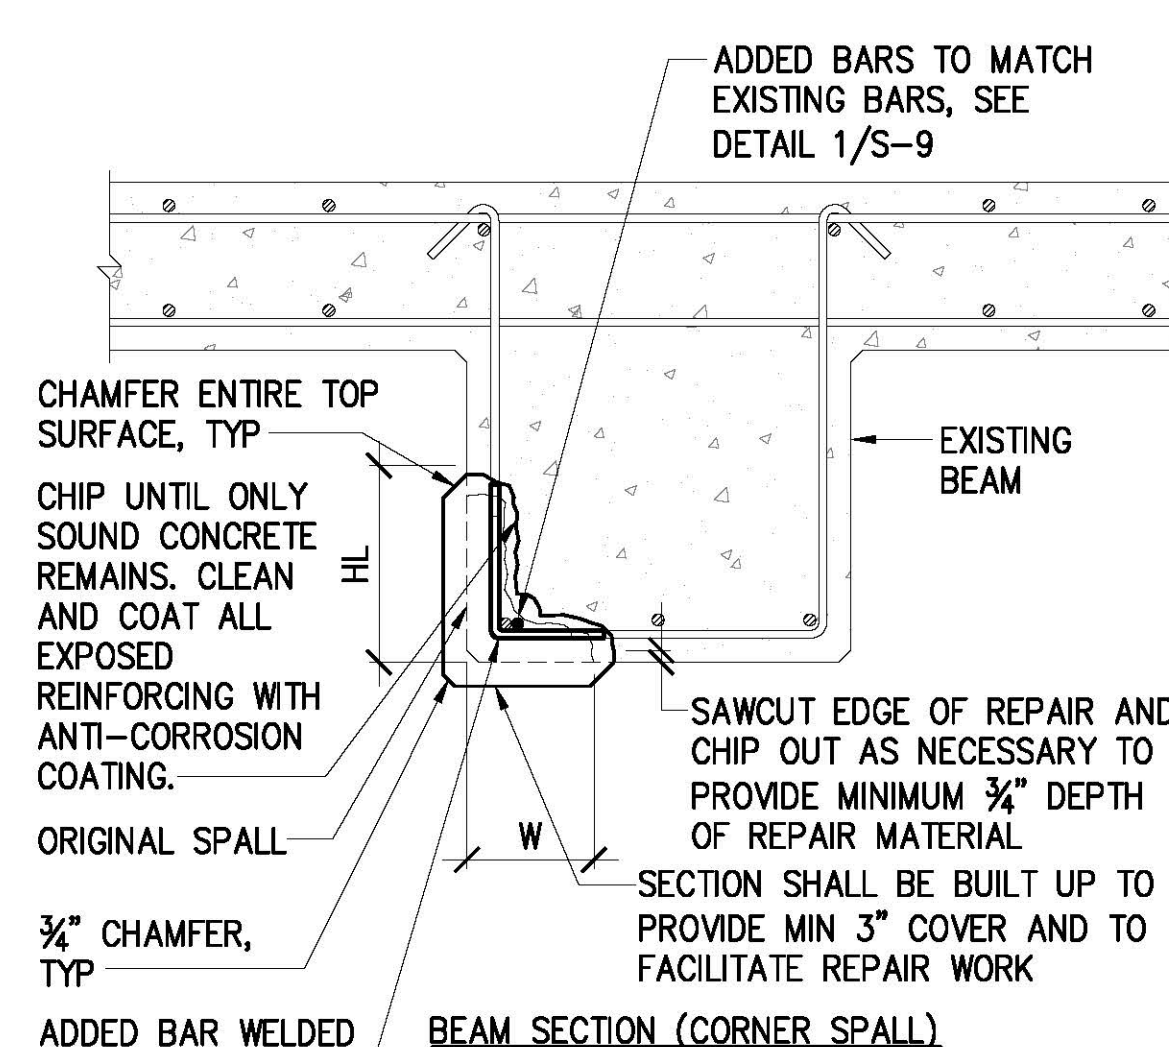
2 BEAM SPALL REPAIR WITH REINFORCING STEEL REPLACEMENT (TYPE BR)
 S-6 NOT TO SCALE

PAY AREA:
 HL = HEIGHT OF REPAIR (LEFT SIDE)
 HR = HEIGHT OF REPAIR (RIGHT SIDE)
 W = ORIGINAL WIDTH OF BEAM/GIRDER SPALL
 EL = EXISTING LENGTH OF SPALL
 NL = LENGTH OF REPAIR

$$\text{PAY AREA} = (\text{HL} + \text{HR} + \text{W})\text{NL}$$

1. PAY AREA SHALL BE THE TOTAL REPAIRED AREA ON ALL BEAM FACES. IF HL, HR OR W VARY ALONG THE LENGTH OF REPAIR, PAY AREA SHALL BE CALCULATED INDIVIDUALLY FOR EACH BEAM FACE.

EXISTING CONDITION

REPAIRED CONDITION
