HARBORS DIVISION SHEET PILE AND BOLLARD REPAIRS AT PIER 39 HONOLULU HARBOR, OAHU, HAWAII

TYPICAL PIER SECTION AND SHEET

PILE SPALL REPAIR DETAILS DESIGNED BY: A J DRAWN BY: DL S-3 CHECKED BY: GO JOB NUMBER 03/2023 DATE: S10848

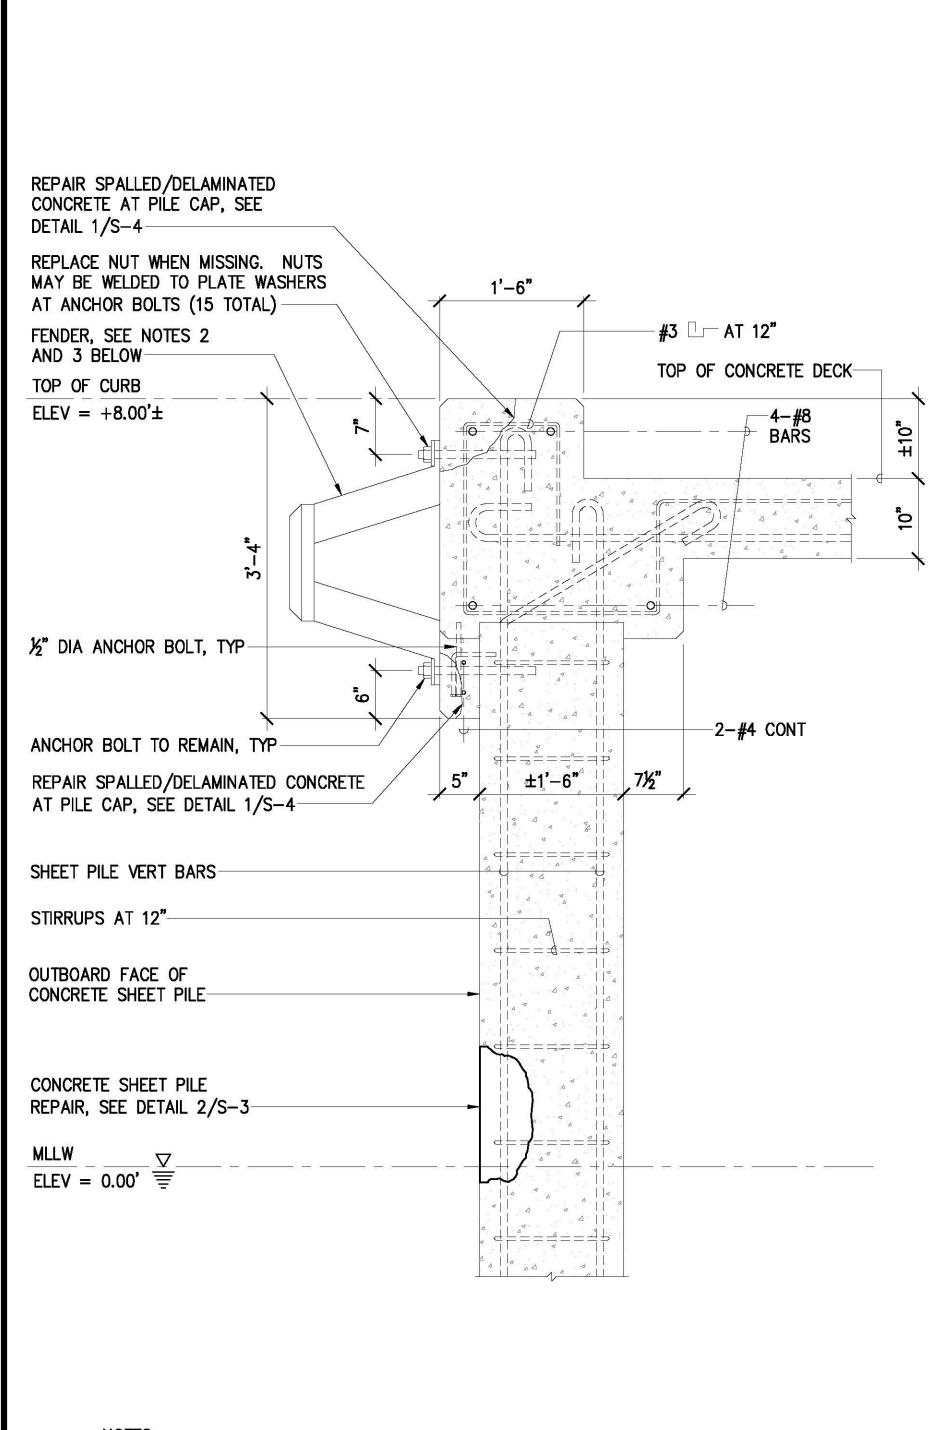
TYPICAL EXISTING PIER SECTION S-3 / SCALE: = 1" = 1'-0"

- 1. EXISTING DRAWING REPRESENT THE ENGINEER'S BEST KNOWLEDGE OF THE REPAIR AREA. CONTRACTOR SHALL VERIFY FIELD CONDITIONS AND REPORT ANY DISCREPANCIES TO THE CONSTRUCTION ENGINEER BEFORE STARTING THE WORK.
- 2. CONTRACTOR SHALL REMOVE EXISTING FENDERS AS NECESSARY TO PERFORM THE WORK AND REINSTALL TO MATCH EXISTING CONDITION UPON COMPLETION OF THE WORK.
- 3. PIER 39C SECTION IS SIMILAR EXCEPT FENDER SYSTEM CONSISTS OF TIRE FENDERS.

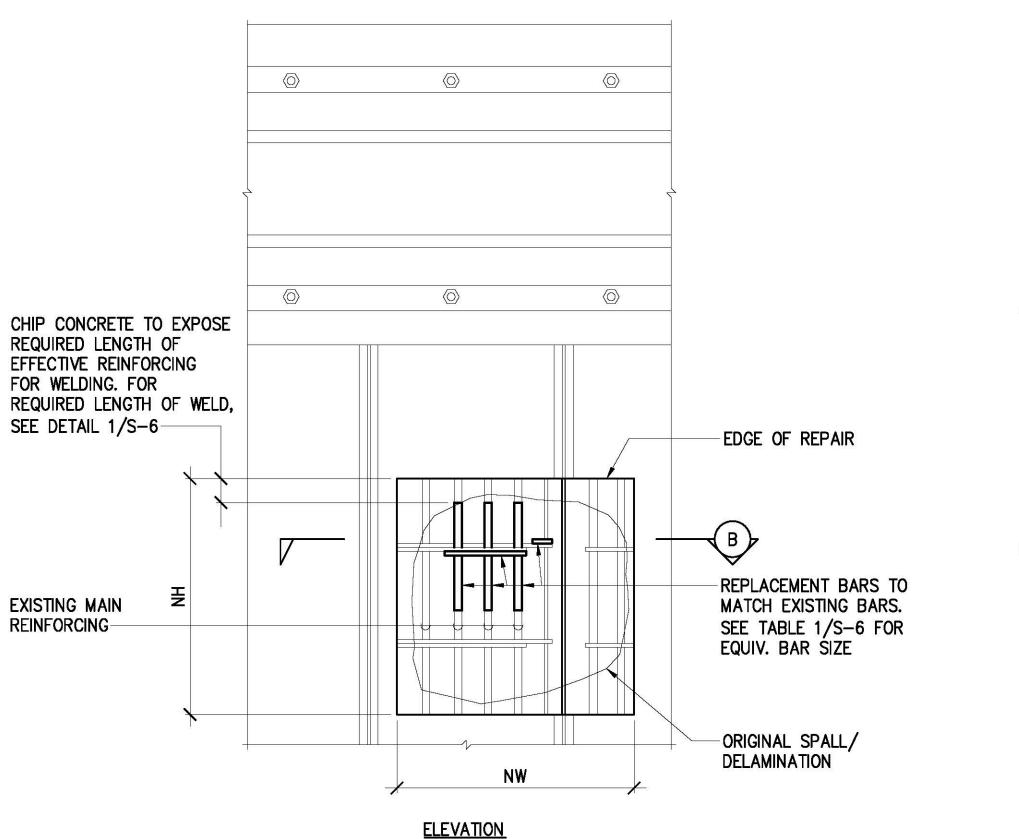
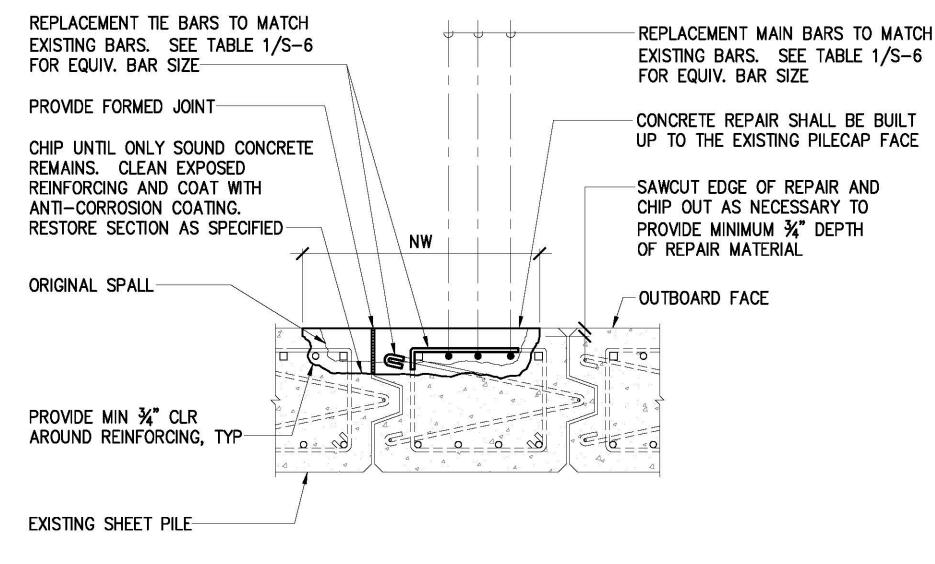
SHEET PILE SPALL REPAIRS (TYPE SPR)

### SHEET PILE SECTION B

## REPAIRED CONDITION

1. SHEET PILE SPALL REPAIRS GENERALLY OCCUR ABOVE MLLW, HOWEVER SOME SPALLS AND DELAMINATIONS MAY OCCUR AT OR JUST BELOW THE WATERLINE. THE CONTRACTOR SHALL TAKE NECESSARY PRECAUTIONS TO PREVENT CONSTRUCTION DEBRIS FROM ENTERING THE WATER.

W = ORIGINAL WIDTH OF SPALL H = ORIGINAL HEIGHT OF SPALL NW = WIDTH OF REPAIRNH = HEIGHT OF REPAIR

$PAY AREA = NW \times NH$
