STATE OF HAWAII DEPARTMENT OF TRANSPORTATION HIGHWAYS DIVISION

BORING LOGS

EROSION CONTROL AND BEST MANAGEMENT PRACTICES FOR STORM WATER PERMIT COMPLIANCE PHASE 2

SHEET No. EC-14 OF 14 SHEETS

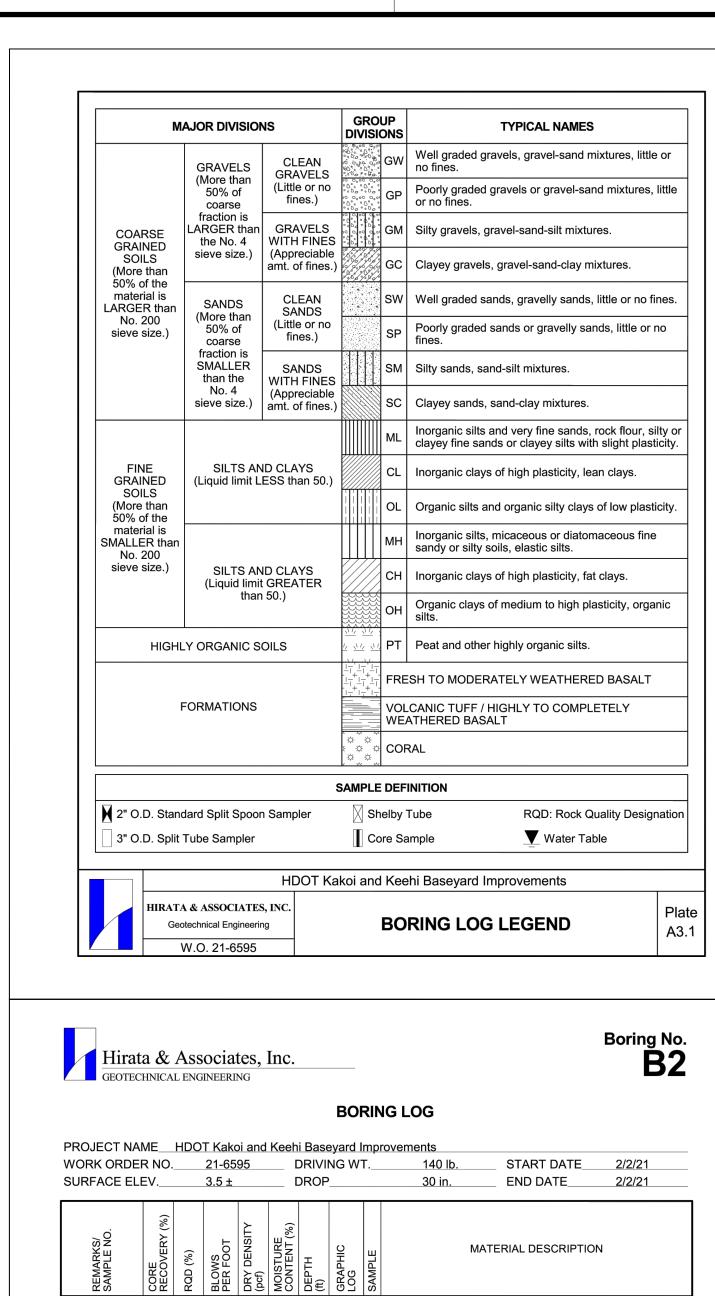
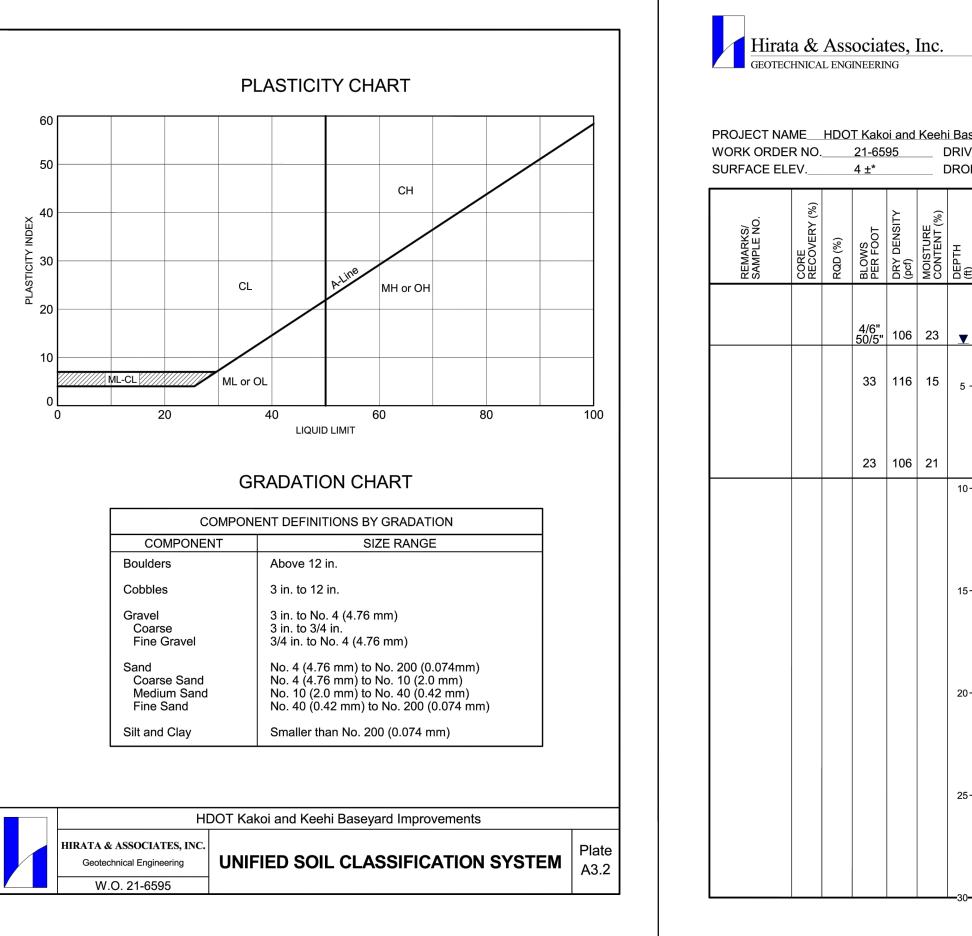
SURFACE ELEV			3.5 ±		DROP				30 in. END DATE 2/2/21
REMARKS/ SAMPLE NO.	CORE RECOVERY (%)	RQD (%)	BLOWS PER FOOT	DRY DENSITY (pcf)	MOISTURE CONTENT (%)	DEPTH (ft)	GRAPHIC LOG	SAMPLE	MATERIAL DESCRIPTION
Lost Recovery			33 50/4"	103	20	- - <u>¥</u> -			Silty GRAVEL (GM) - Dark brown, moist, medium dense, with sand. (Fill) Covered by 2 inches of AC over 3.5 inches of base material. Metal shards at 1 foot.
		40	110	16	5	Cobble at 3 feet. Silty Coralline GRAVEL (GM) - Tan, medium dense to dense, with sand. Groundwater encountered at 3.2 feet on 2/2/21 at 11:00 am.			
			54	94	38	10-			End boring at 10.5 feet.
						- - 15— -			
						20-			
						25— -			
						-			Plate A4.

OJECT NAME <u>HDOT Kakoi an</u> ORK ORDER NO. <u>21-6595</u> RFACE ELEV. <u>4</u> ±			95	DRIVING WT				140 lb.					
REMARKS/ SAMPLE NO.	CORE RECOVERY (%)	RQD (%)	BLOWS PER FOOT	DRY DENSITY (pcf)	MOISTURE CONTENT (%)	DEPTH (ft)	GRAPHIC LOG	SAMPLE	MA	TERIAL DESCRIPTIOI	N		
			104/8"		14	-	20 \$ 00 0 0 0 0 0 0 0 0 0 0 0 0 0 0 0 0		with sand. (Fill)	GC) - Dark brown, m nches of AC over 3 ir			
			23	105	21	<u>▼</u> 5 –			Groundwater encountered at 4.6 feet on 2/1/21 at 9:20 am.				
			24	100	25	- - 10-			Silty Coralline GRA with sand.	AVEL (GM) - Tan, me	edium dense		
						-	bold⊾obb,		End boring at 10.5	feet.			
						_							
						15-							
						-							
						20-							
						- - 25—							
						-
