**EXPLORATORY BORING REPORT
LILIHA STREET REHABILITATION
NORTH KING STREET TO SCHOOL STREET
HONOLULU, HAWAII
PROJECT NO.: 7413A-01-04M**

**STATE OF HAWAII
DEPARTMENT OF TRANSPORTATION**

**HIRATA & ASSOCIATES, INC.
W.O. 12-5333
December 12, 2012**

**FOUNDATION INVESTIGATION
LILIHA STREET REHABILITATION
NORTH KING STREET TO SCHOOL STREET
HONOLULU, HAWAII
PROJECT NO.: 7413A-01-04M**

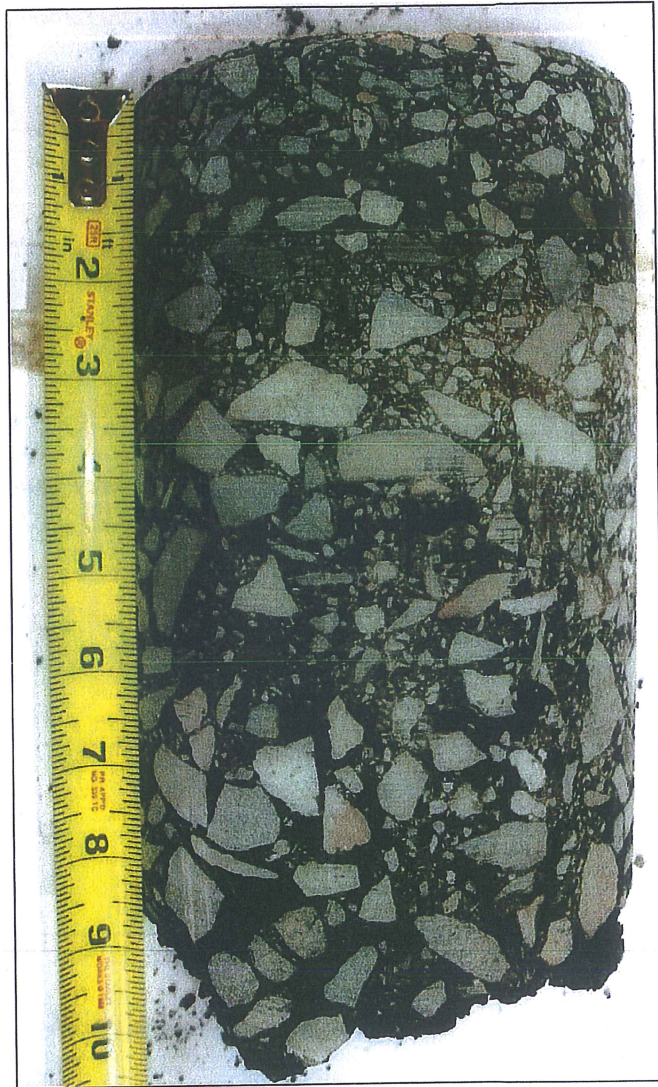
Boring B1

W.O. 12-5333	Liliha Street Rehabilitation
Hirata & Associates, Inc.	PAVEMENT CORE
