TYPICAL TRENCH RESTORATION AND DUCT ENCASEMENT DETAILS

VOLCANO ROAD INTERSECTION
IMPROVEMENTS AT HUINA ROAD
State Project No. 11M-01-00

SCALE: AS NOTED DATE: AUGUST, 2001
SHEET No. E-7 OF 7 SHEETS

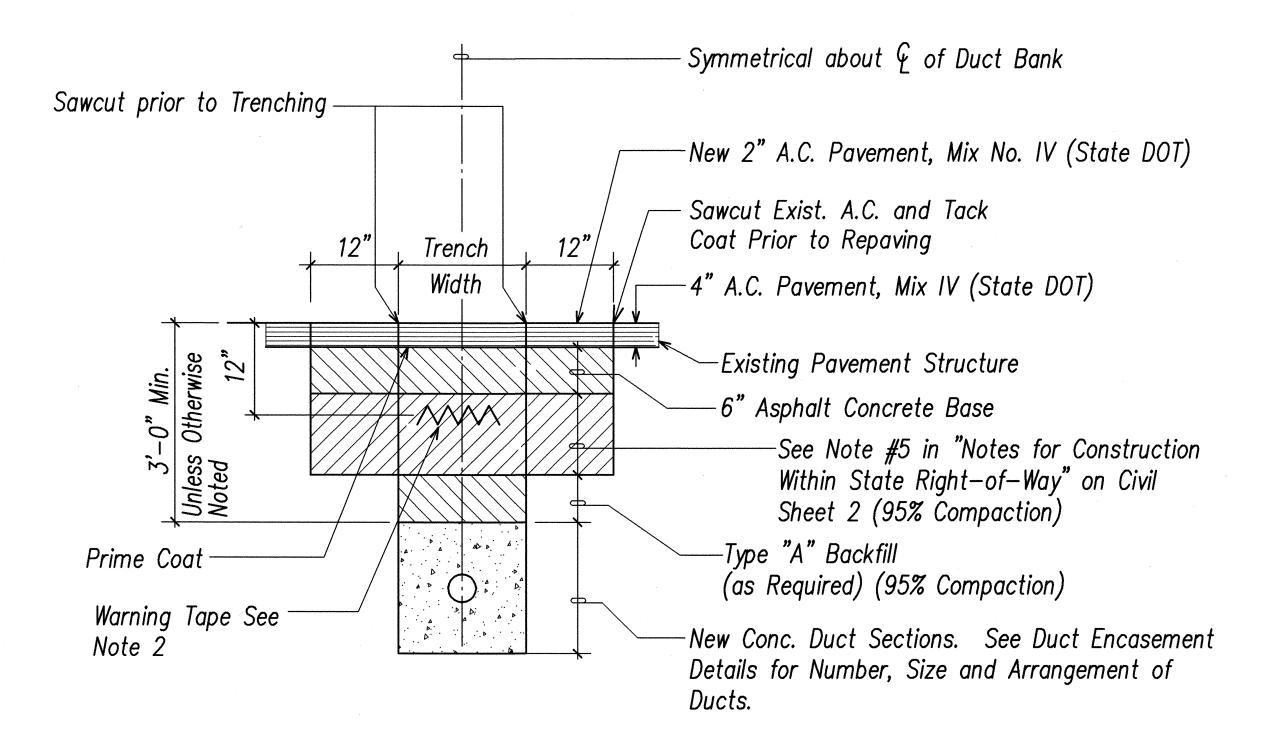
TYPICAL TRENCH RESTORATION DETAIL NOT TO SCALE

- 1. Provide Pavement Structure as Shown or Match Existing Pavement Structure, Whichever is Greater.
- 2. Install 8 Mil. Thick Orange Color Warning Tape 4" Wide, Entire Length.
  Tape should read "Warning Stop Digging Call Verizon Hawaii.
  Communications Cable Below. Failure to Comply could result in Legal Action".

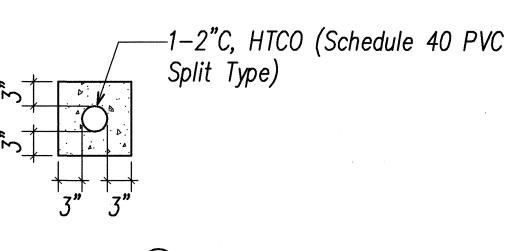
DUCT ENCASEMENT DETAILS NOT TO SCALE

SECTION (A)
