# R-VALUE TEST REPORT

## Resistance R-Value and Expansion Pressure - ASTM D2844

| Test Results | Material Description |
|---|---|
| <p><b>Project No.:</b> 27909</p> <p><b>Project:</b> Kaaau-Pahoa Road Improvements - Route 130</p> <p><b>Location:</b> B-6</p> <p><b>Sample Number:</b> 8948-1</p> <p><b>Date:</b> 10/19/2018</p> | <p><b>Tested by:</b> D. Nisbeth</p> <p><b>Checked by:</b> O. El-Fiky</p> <p><b>Remarks:</b><br/>W.O. 18-6213</p> |

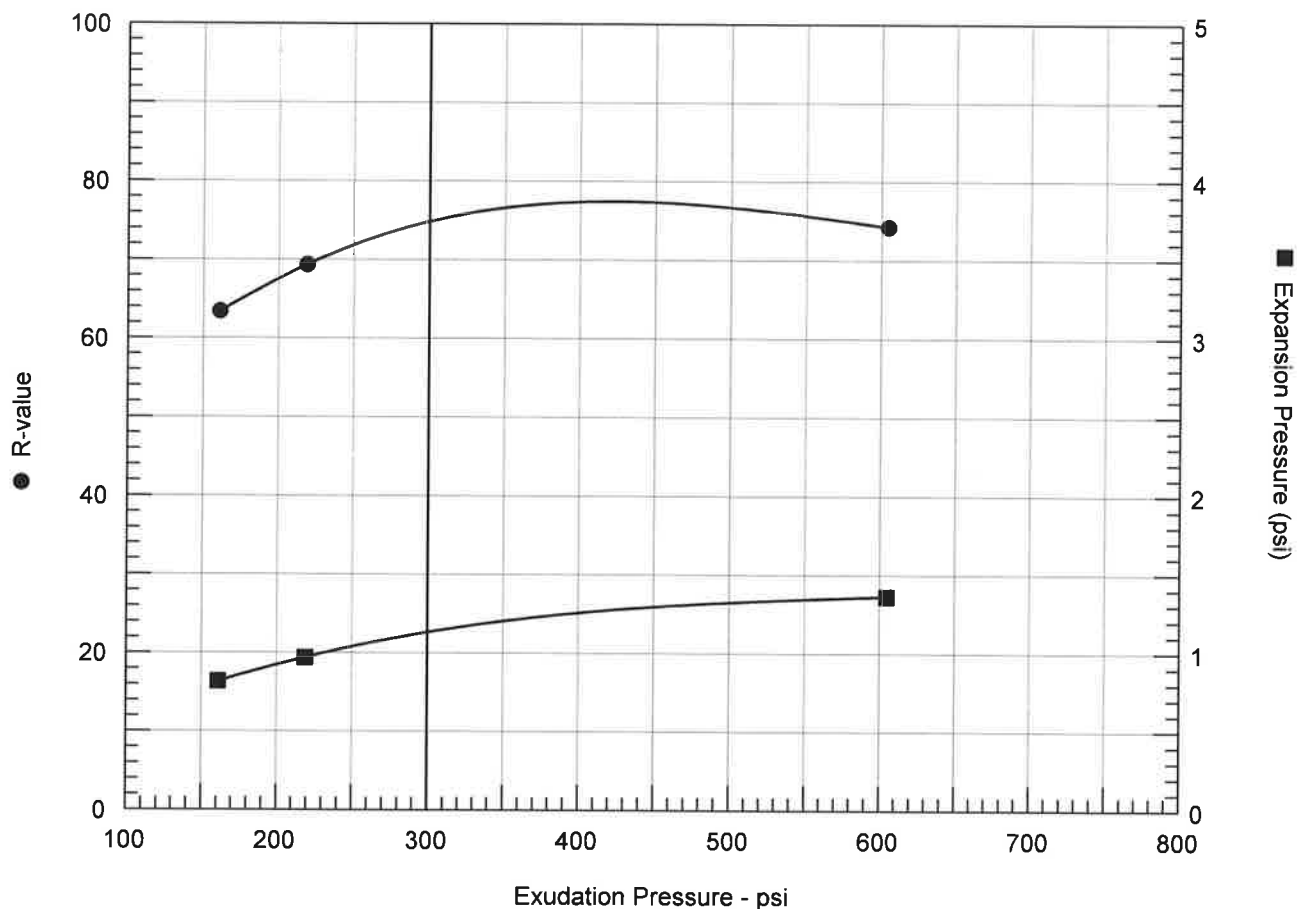
| Test Results | Material Description |
|---|---|
| | <p>Plate B6.1</p> |

| Test Results | Material Description |
|---|---|
| <p><b>R-value at 300 psi exudation pressure = 74.8</b></p> <p><b>Exp. pressure at 300 psi exudation pressure = 1.13 psi</b></p> | <p>Very Dark Brown Sandy Silt some Gravel &amp; Clay</p> |

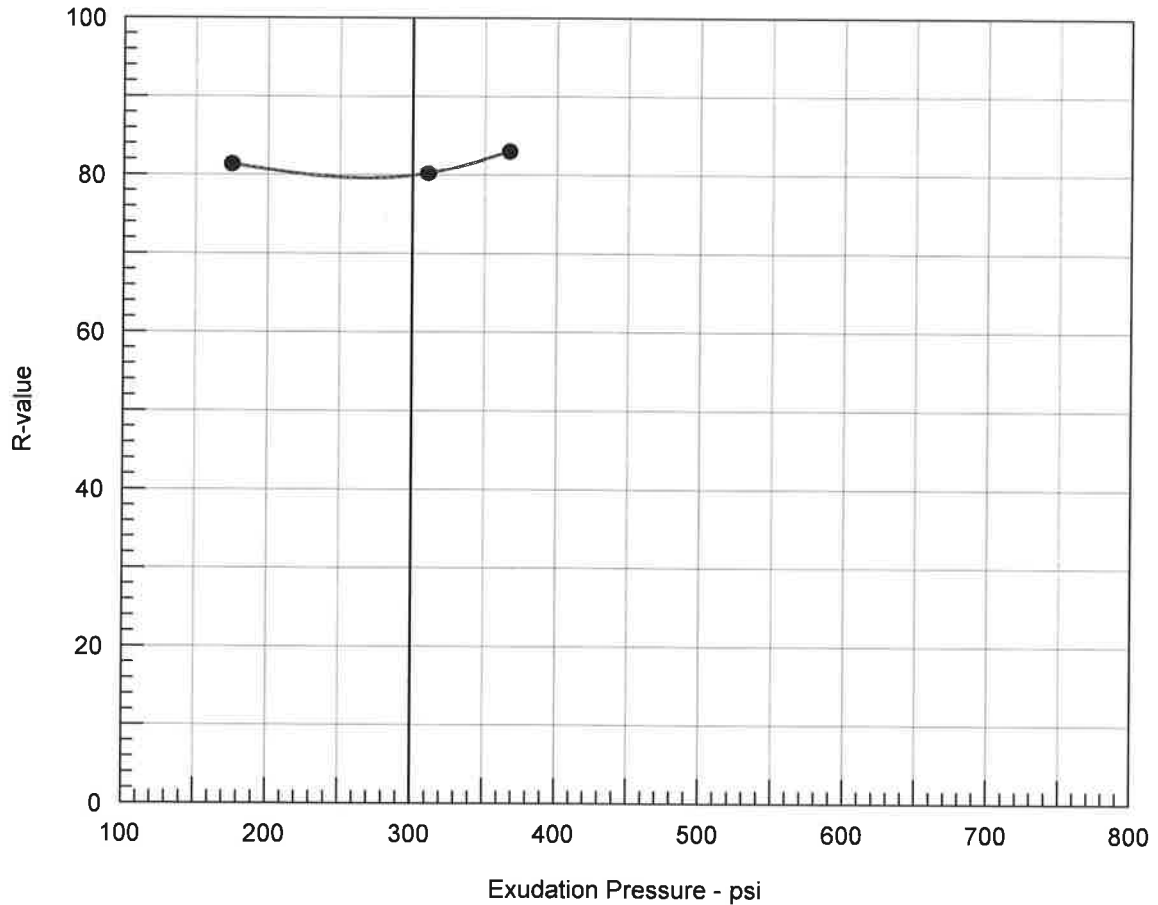
| Test Results | Material Description |
|---|---|
| | Plate B6.2 |

| Test Results | Material Description |
|---|---|
| R-value at 300 psi exudation pressure = 79.9 | Dar Brown Gravelly (Lava Rock) Sand some Silt |

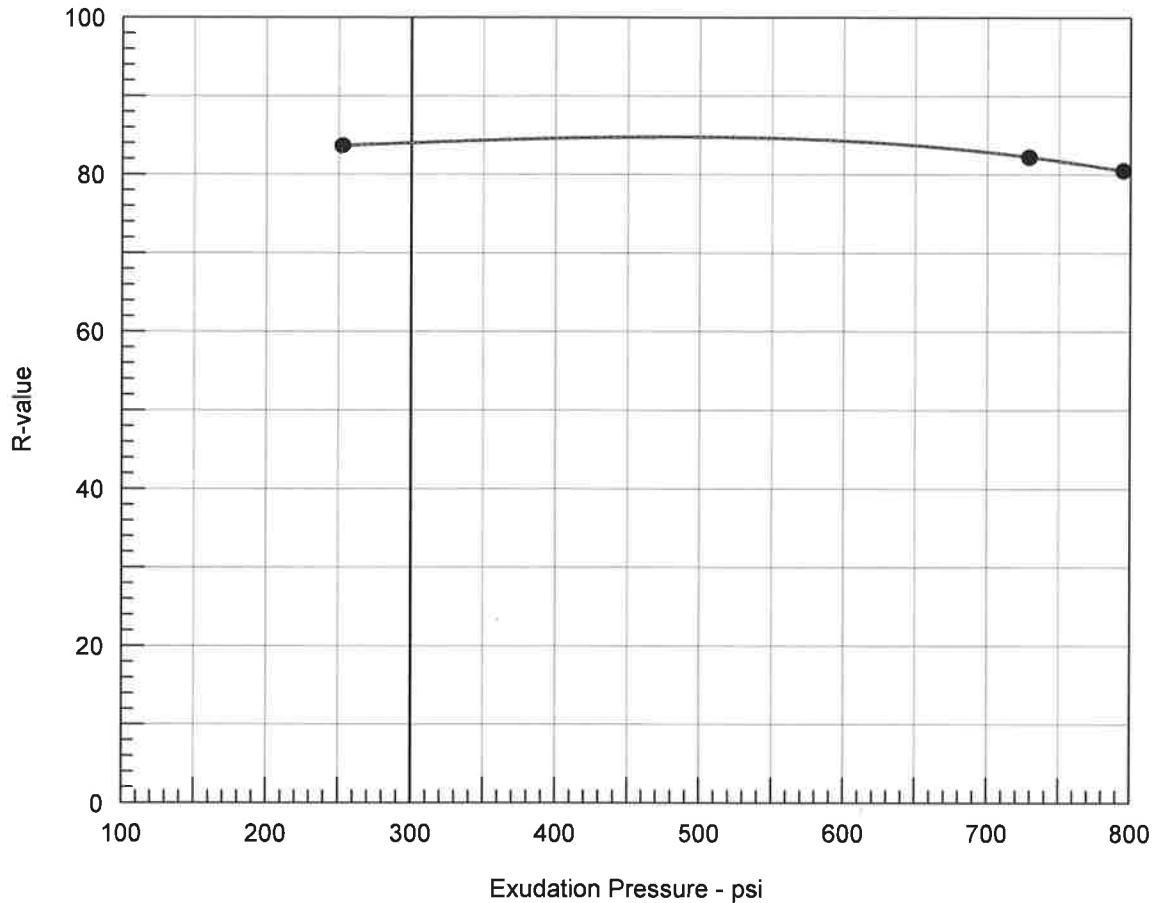
| Test Results | Material Description |
|---|---|
| | Plate B6.3 |

| Test Results | Material Description |
|---|---|
| R-value at 300 psi exudation pressure = 84.0 | Dark Brown Gravelly (Lava Rock) Sand some Silt |
