Subject: Addendum
Updated 50-foot Mast Arm Traffic Signal Pole Foundation
Recommendations
Traffic Signal Modernization Project
Kahuapaani Street & Ulune Street Intersection
Halawa, Oahu, Hawaii

TRAFFIC SIGNAL MODERNIZATION PROJECT
KAHUAPAANI STREET &
ULUNE STREET INTERSECTION
HALAWA, OAHU, HAWAII

GEOTECHNICAL ENGINEERING EXPLORATION
TRAFFIC SIGNAL MODERNIZATION PROJECT
KALANIANA'OLE HIGHWAY & KALANIIKI STREET INTERSECTION
HONOLULU, OAHU, HAWAII

PROJECT LOCATION MAP
TRAFFIC SIGNAL MODERNIZATION PROJECT
FARRINGTON HIGHWAY & NANAKEOLA STREET INTERSECTION
WAIANAE, OAHU, HAWAII

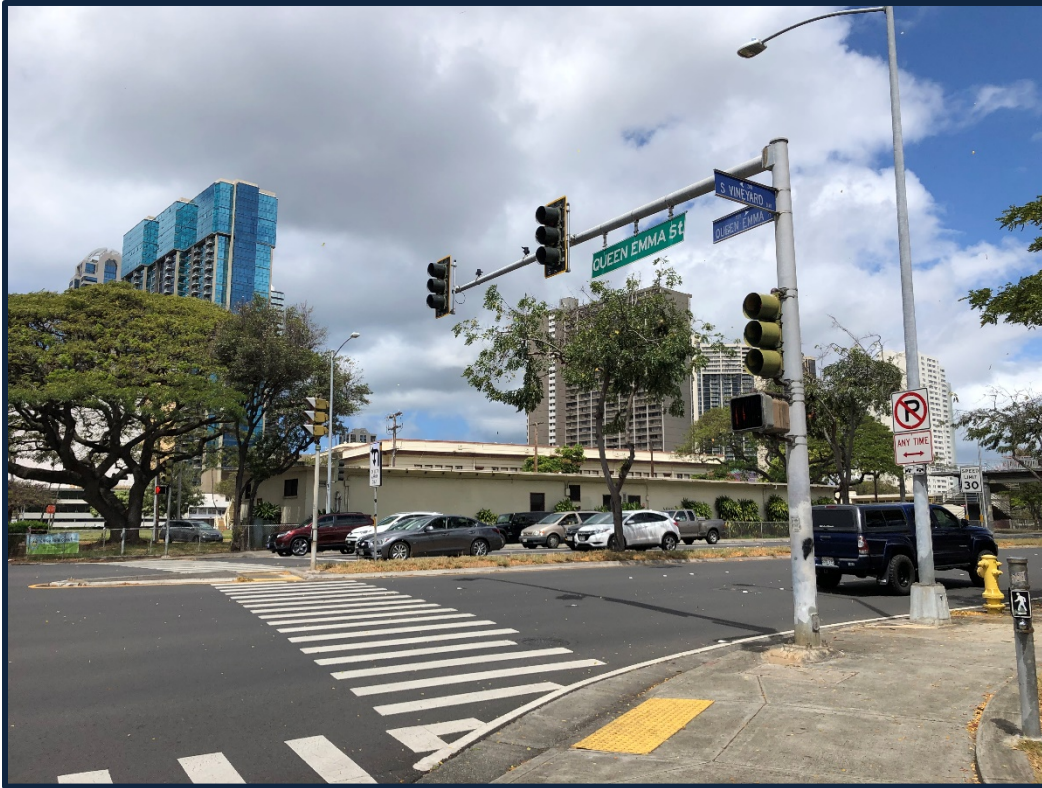
Photograph No. 1 – Existing traffic signal pole on the northern corner of the intersection (view facing southwest).

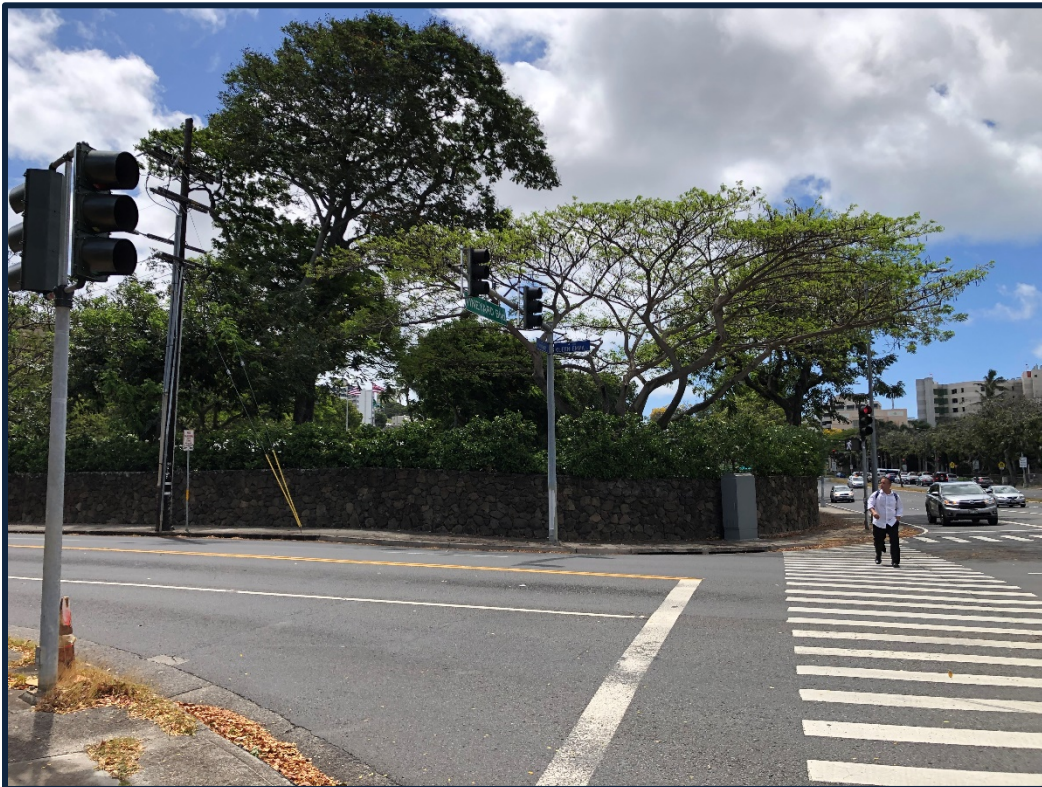
Photograph No. 2 – Existing traffic signal pole on the eastern corner of the intersection (view facing southeast).

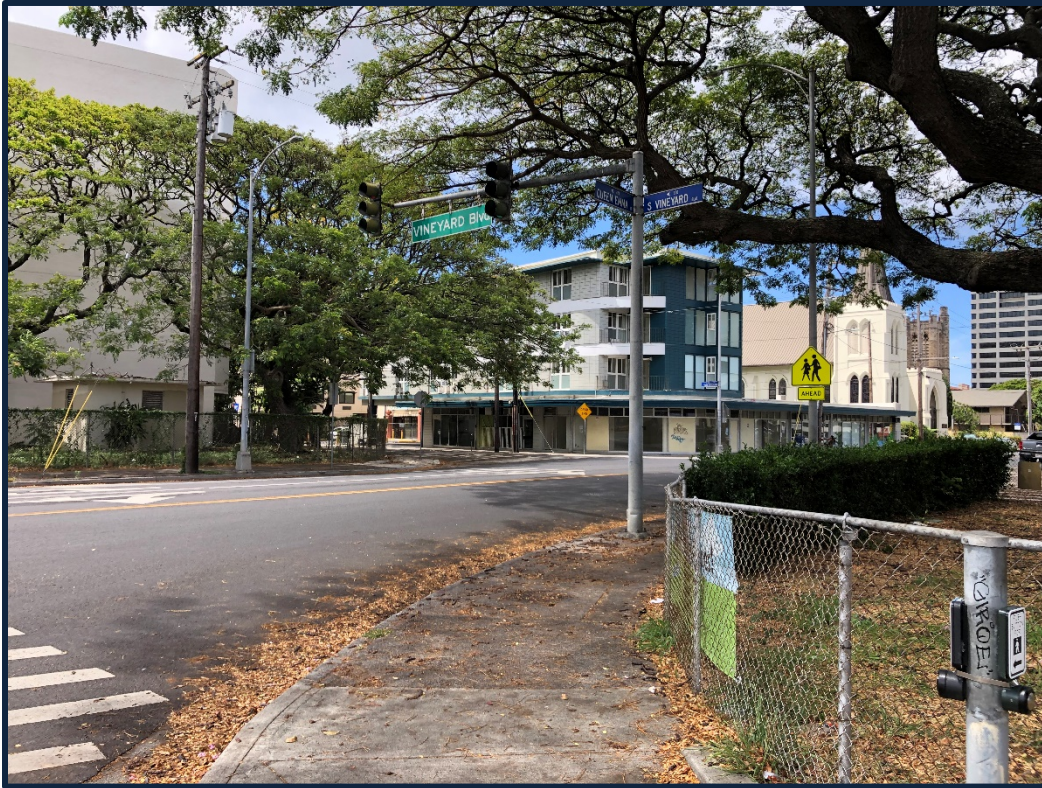
Photograph No. 3 – Existing traffic signal pole on the western corner of the intersection (view facing southwest).

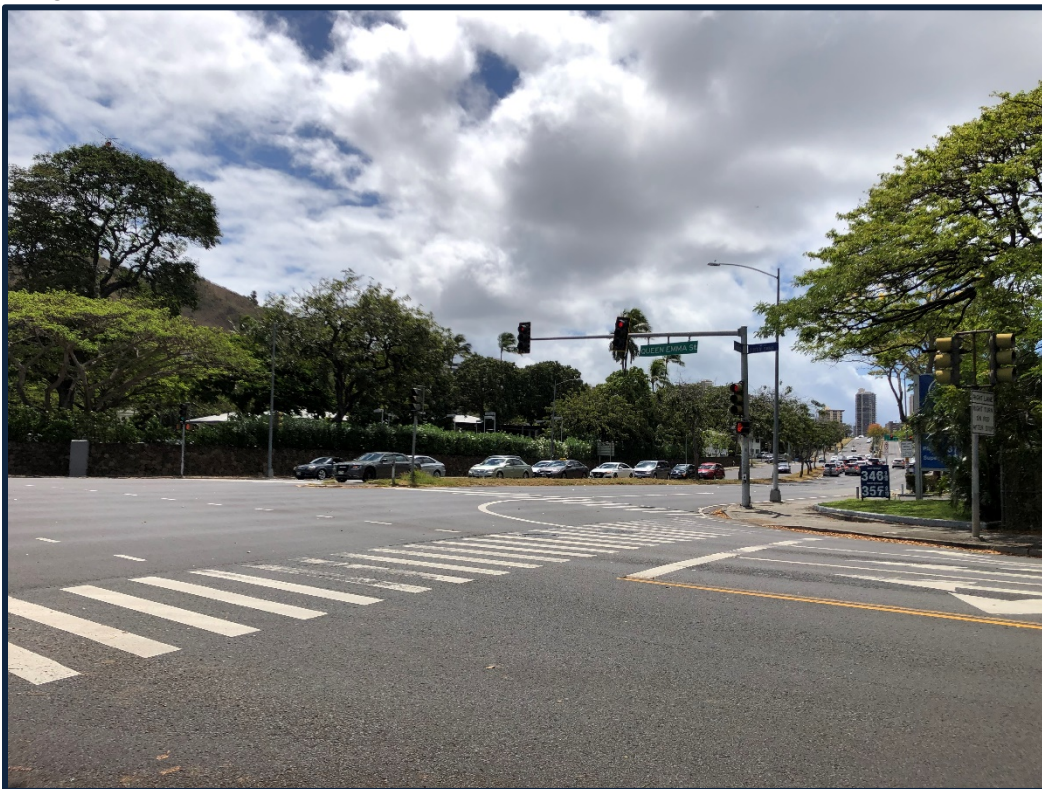
Photograph No. 4 – Existing traffic signal pole on the southern corner of the intersection (view facing southeast).

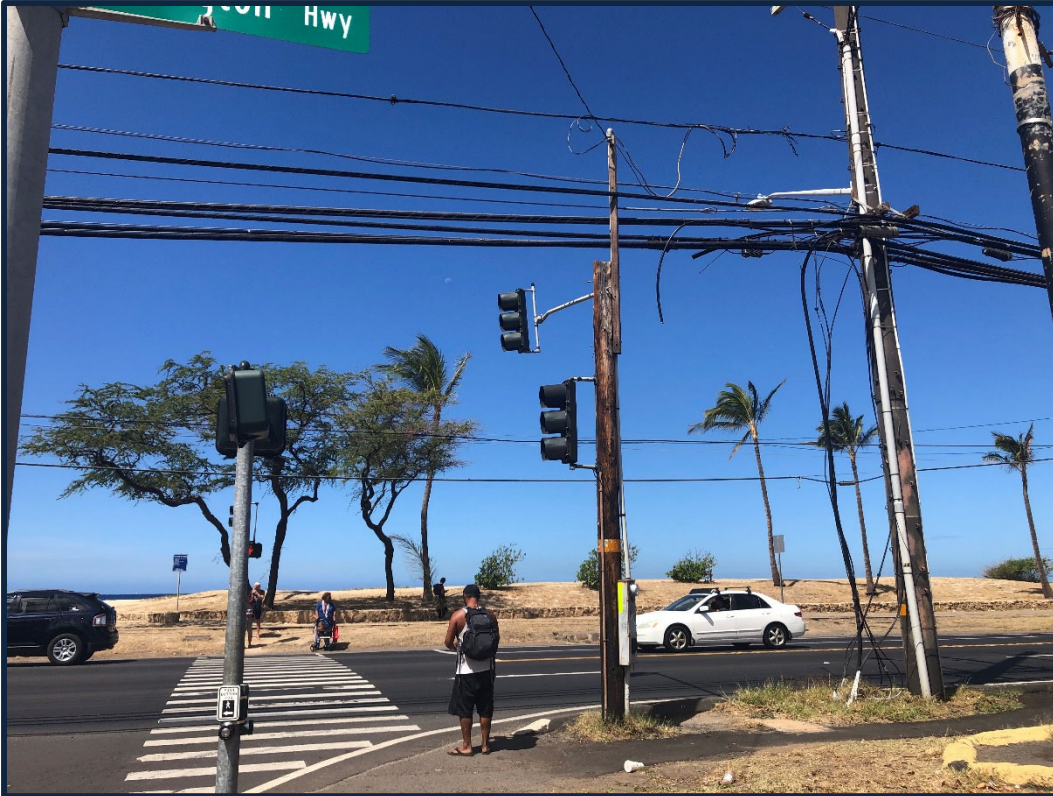
Photograph No. 1 – Existing traffic signal pole on the northern corner of the intersection (view facing southwest).

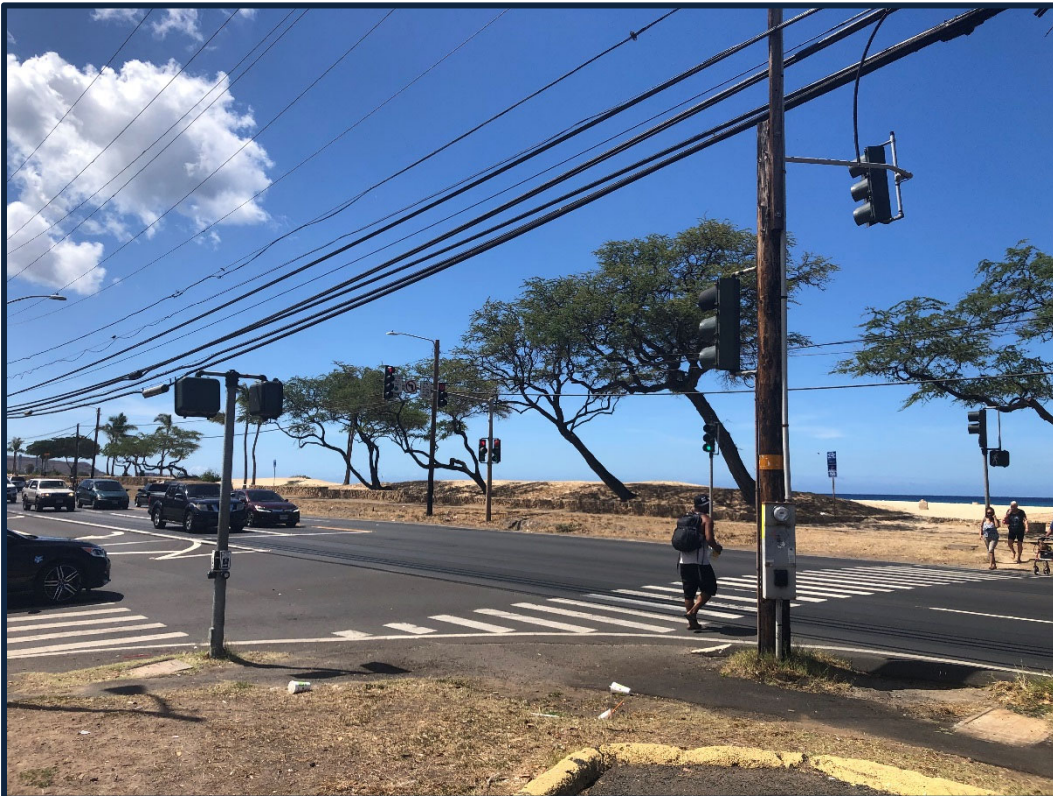
Photograph No. 2 – Existing traffic signal pole on the northern corner of the intersection (view facing).

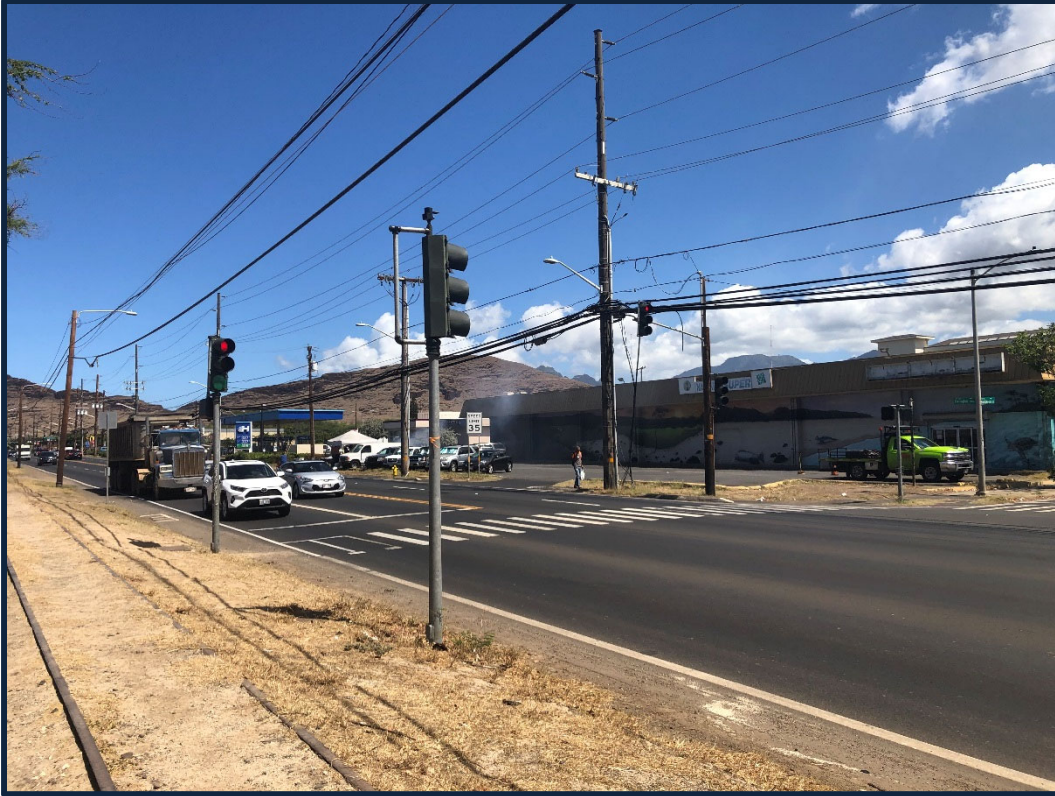
Photograph No. 3 – Existing single pole traffic signal (left) signaling the outbound traffic on Farrington Highway (view facing north).
