ROUTINE (PERIODIC) BRIDGE INSPECTION REPORT

NUAAILUA STREAM BRIDGE
BRIDGE NO. 009003600501540
MAUI, HAWAII

State of Hawaii
Department of Transportation
Highways Division

Nagamine Okawa Engineers Inc.
1003 Bishop Street
Suite 2025
Honolulu, Hawaii 96813
Telephone: (808) 536-2626

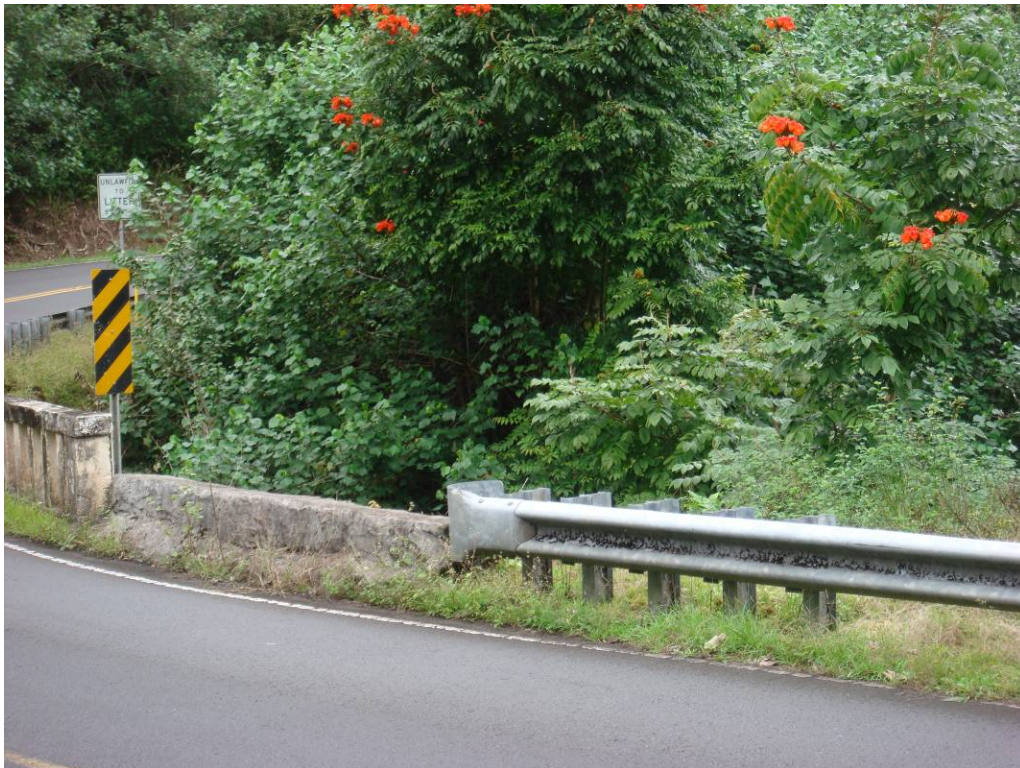
PHOTO 6 DOWNSTREAM / HANA GUARDRAIL END TREATMENT AND CRM WALL. NOTE: GUARDRAIL END TREATMENT HT = 26"

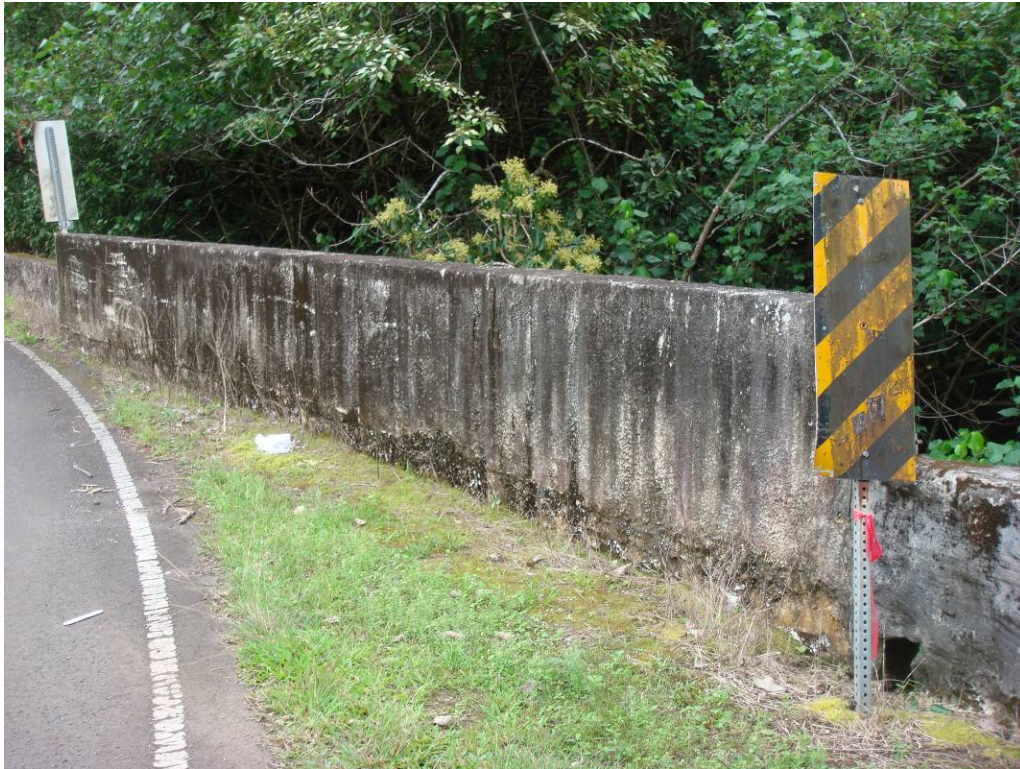
PHOTO 7 UPSTREAM PARAPET ELEVATION. NOTE: PARAPET HT = 42"

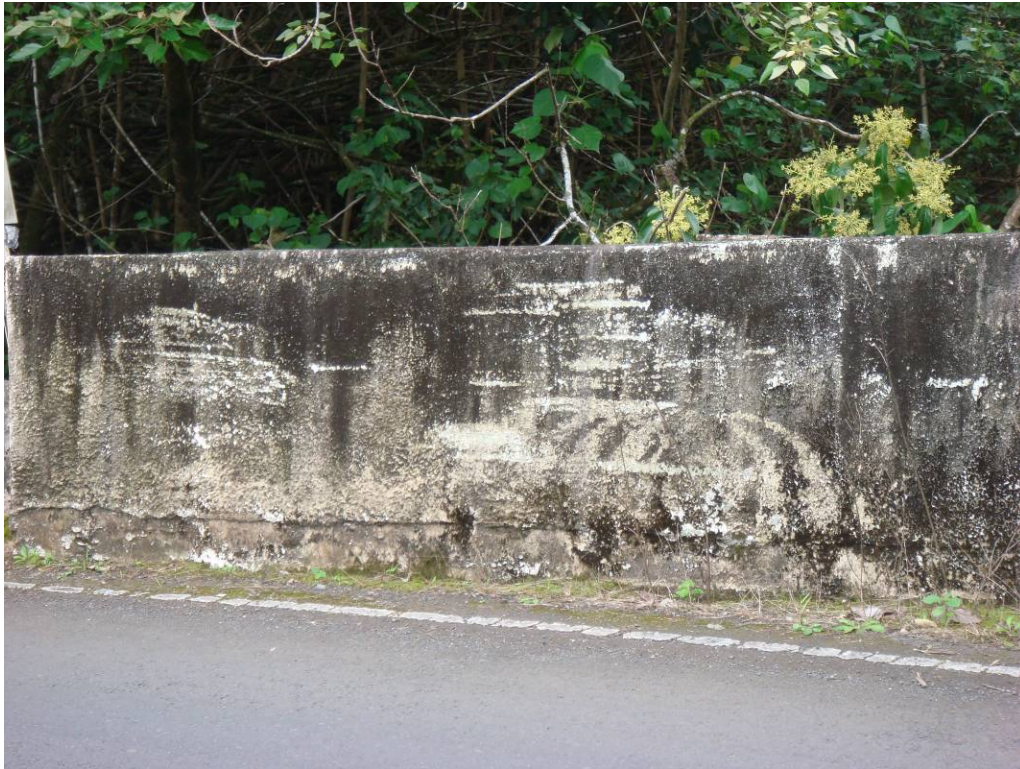
PHOTO 9 CLOSE UP OF SCRAPES ON UPSTREAM PARAPET NEAR HANA SIDE

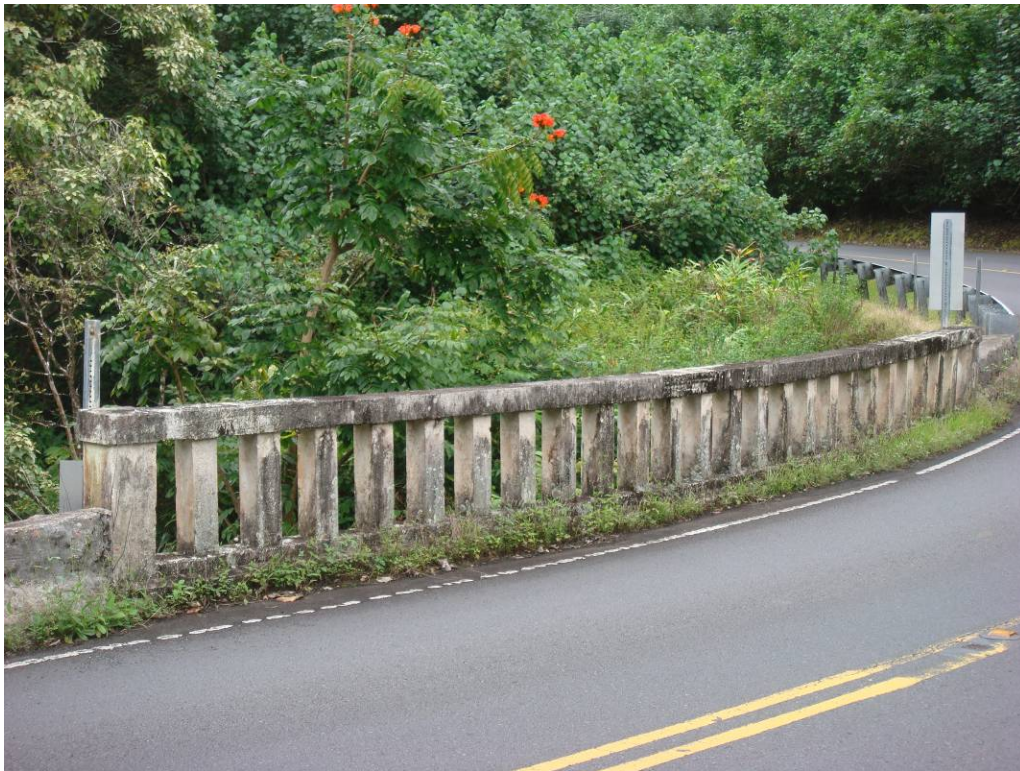
PHOTO 10 DOWNSTREAM RAILING ELEVATION. NOTE: RAILING HT = 40"

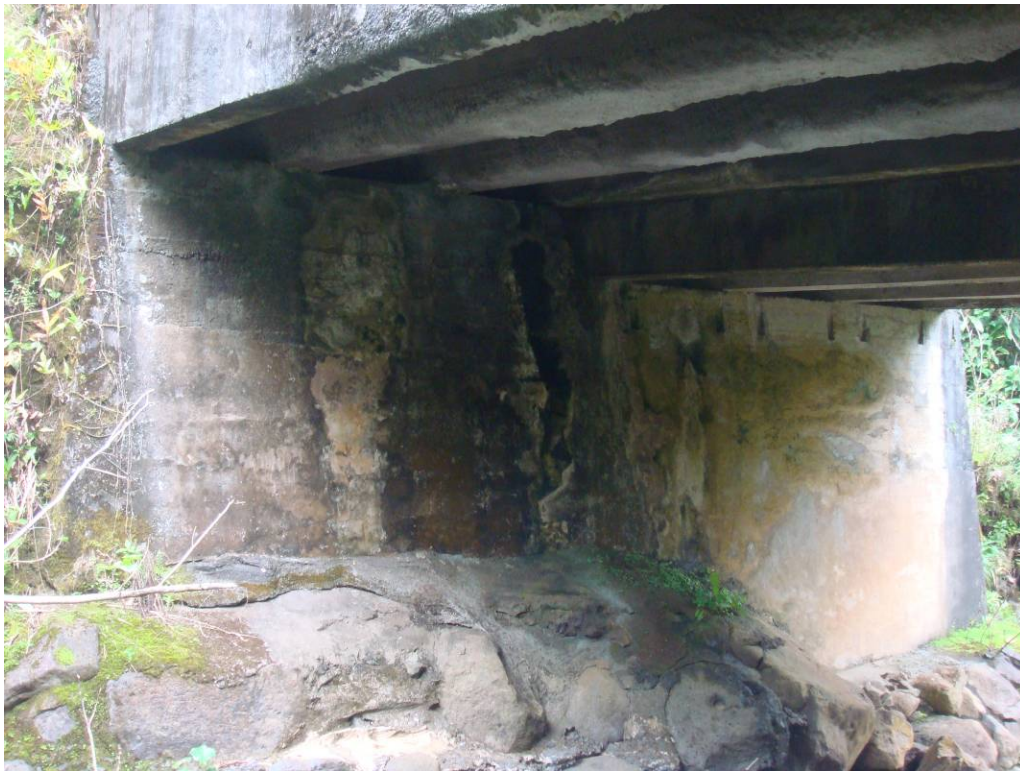
PHOTO 18 KAHULUI ABUTMENT WITH DARK WATER STAINS

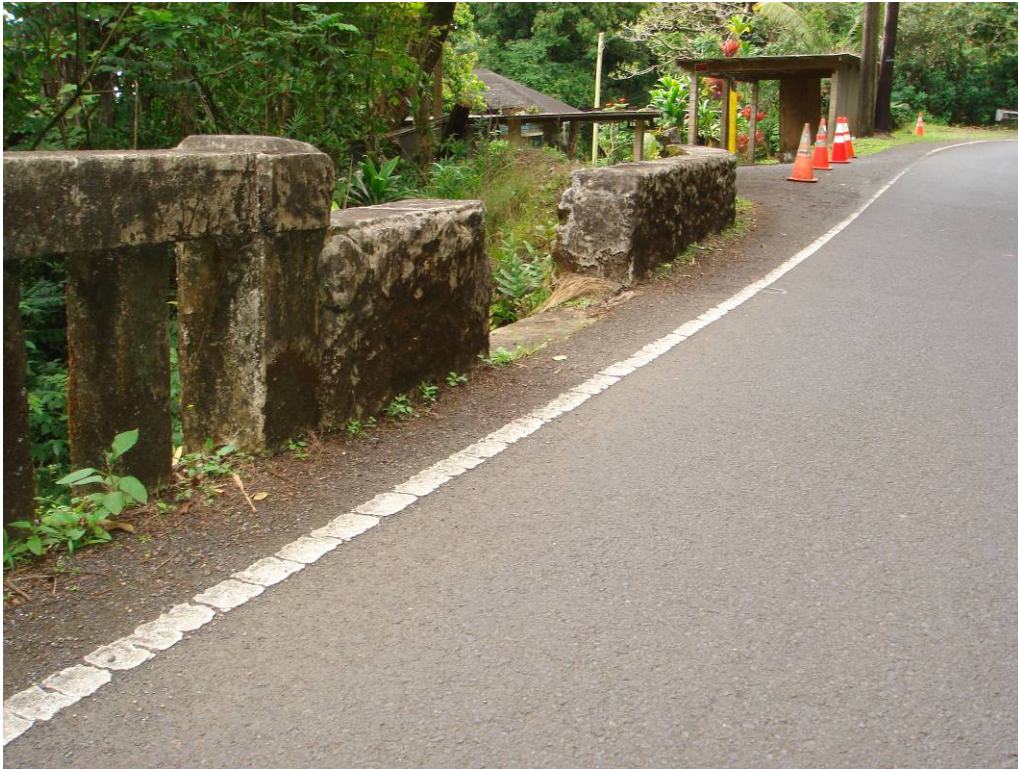
PHOTO 7 OPENING IN DOWNSTREAM HANA CRM WALL

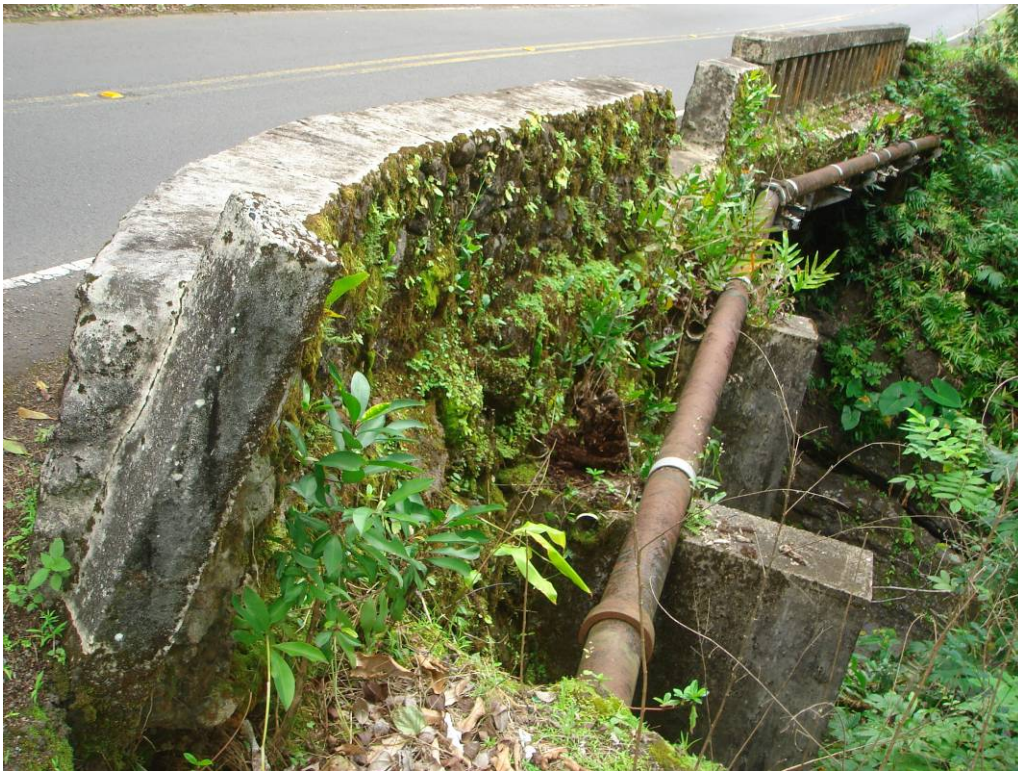
PHOTO 8 BACK SIDE VIEW OF DOWNSTREAM END WITH UTILITIES

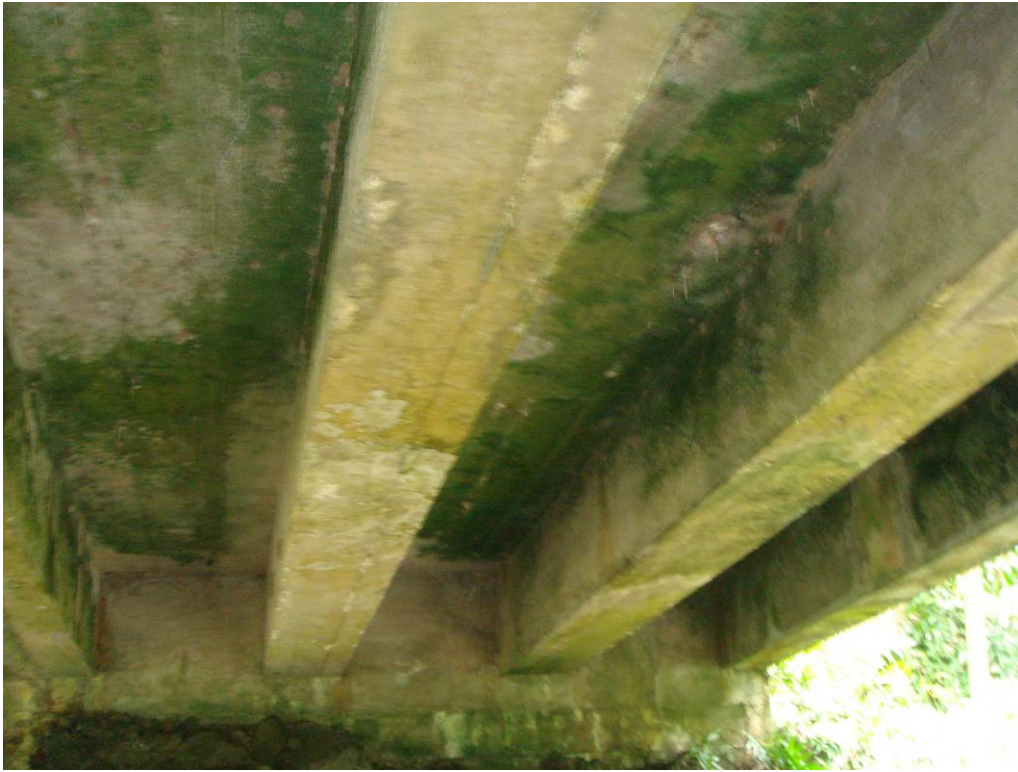
PHOTO 15 DOWNSTREAM HALF OF SOFFIT LOOKING TOWARD KAHULUI WITH EFFLORESCENCE AND MOSS. DELAMINATION IN GIRDER G6 DOWNSTREAM FACE NEAR KAHULUI ABUTMENT.

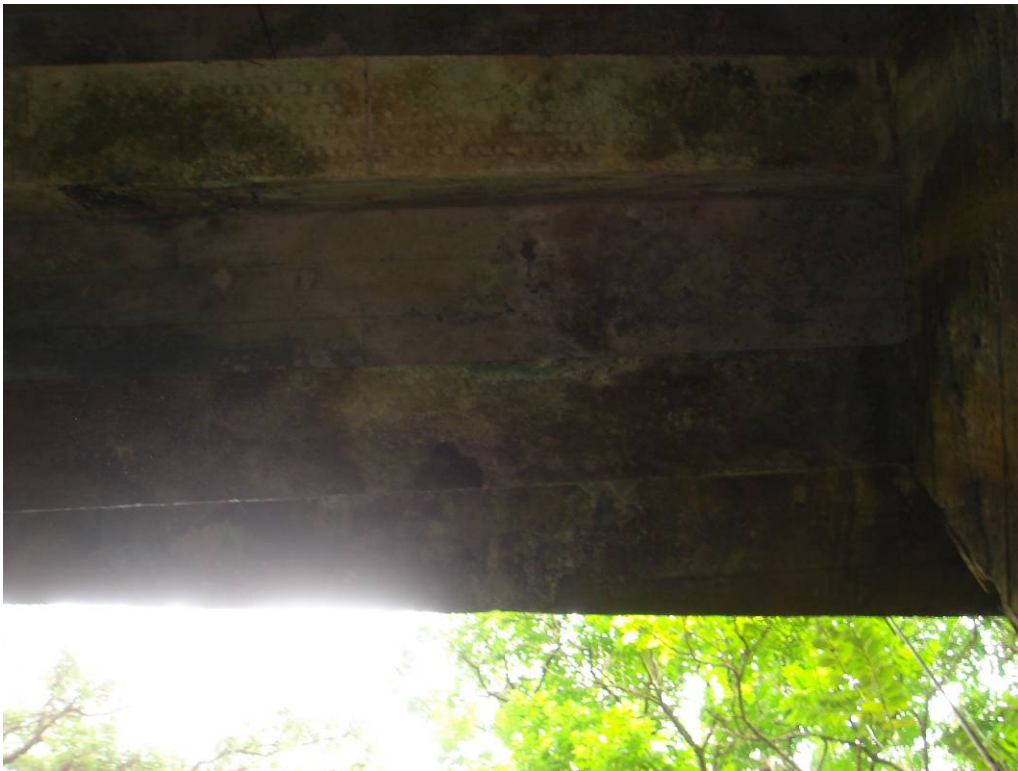
PHOTO 16 HONEYCOMBING IN CANTELEIVERED SOFFIT UPSTREAM END

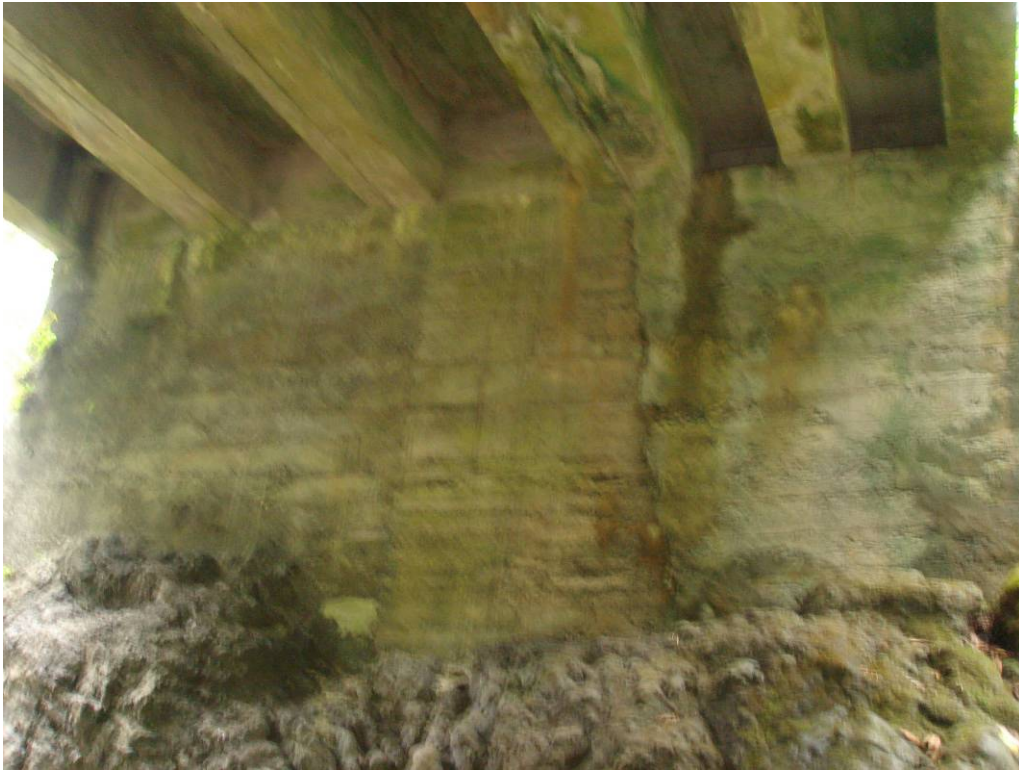
PHOTO 18 KAHULUI ABUTMENT

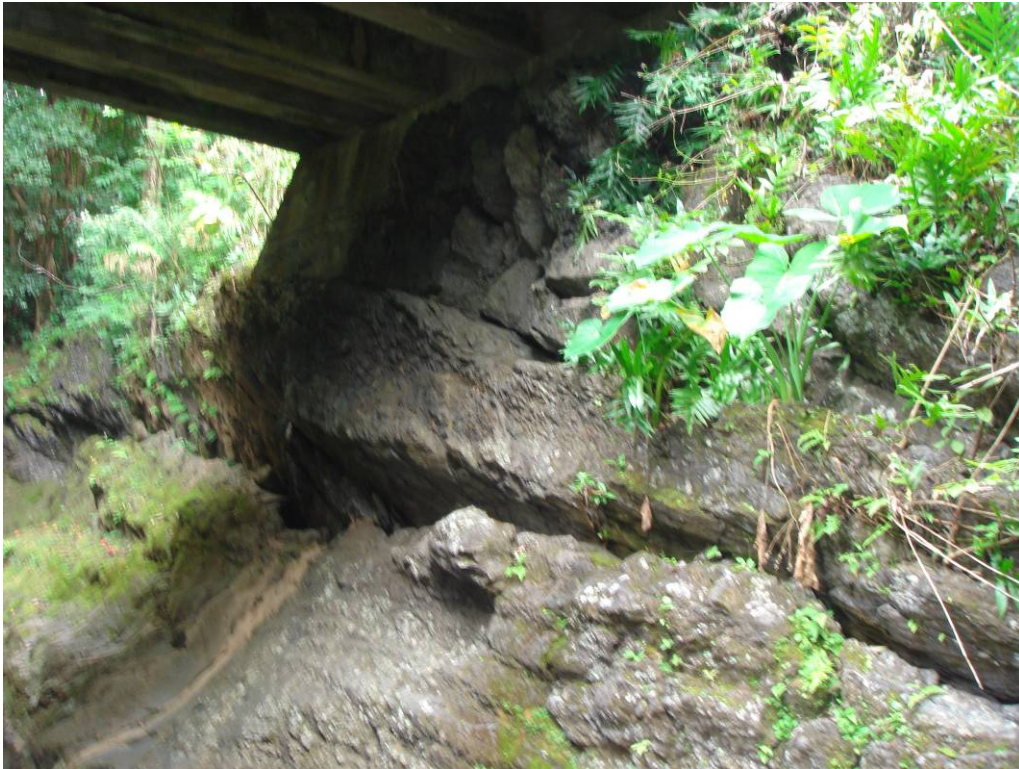
PHOTO 19 SOLID ROCK STREAM CHANNEL FRONTING KAHULUI ABUTMENT

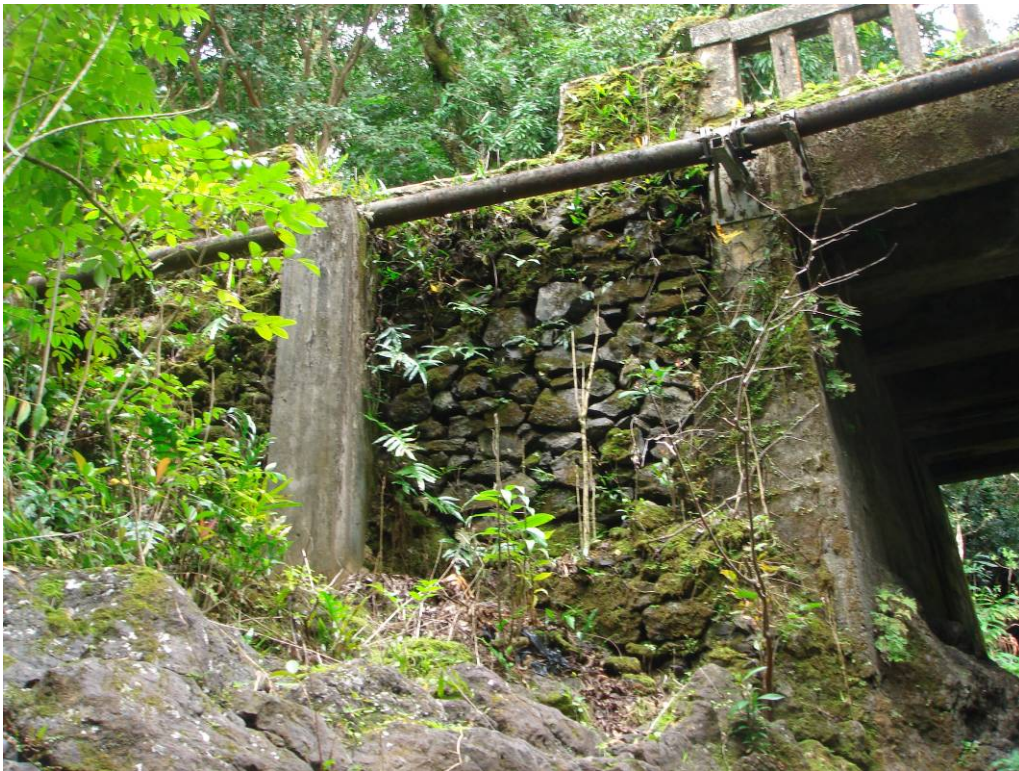
PHOTO 20 DOWNSTREAM HANA CRM WINGWALL AND UTILITY PIPE

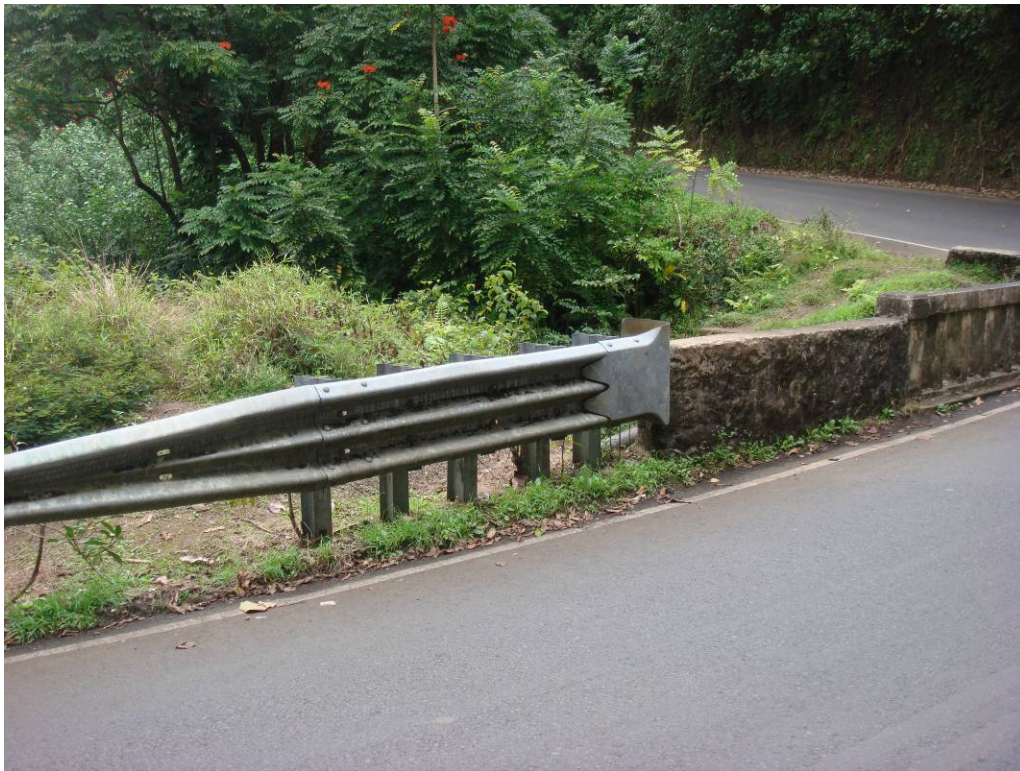
**PHOTO 4 DOWNSTREAM / KAHULUI GUARDRAIL END TREATMENT AND CRM WALL.
NOTE: GUARDRAIL END TREATMENT HT = 36"**

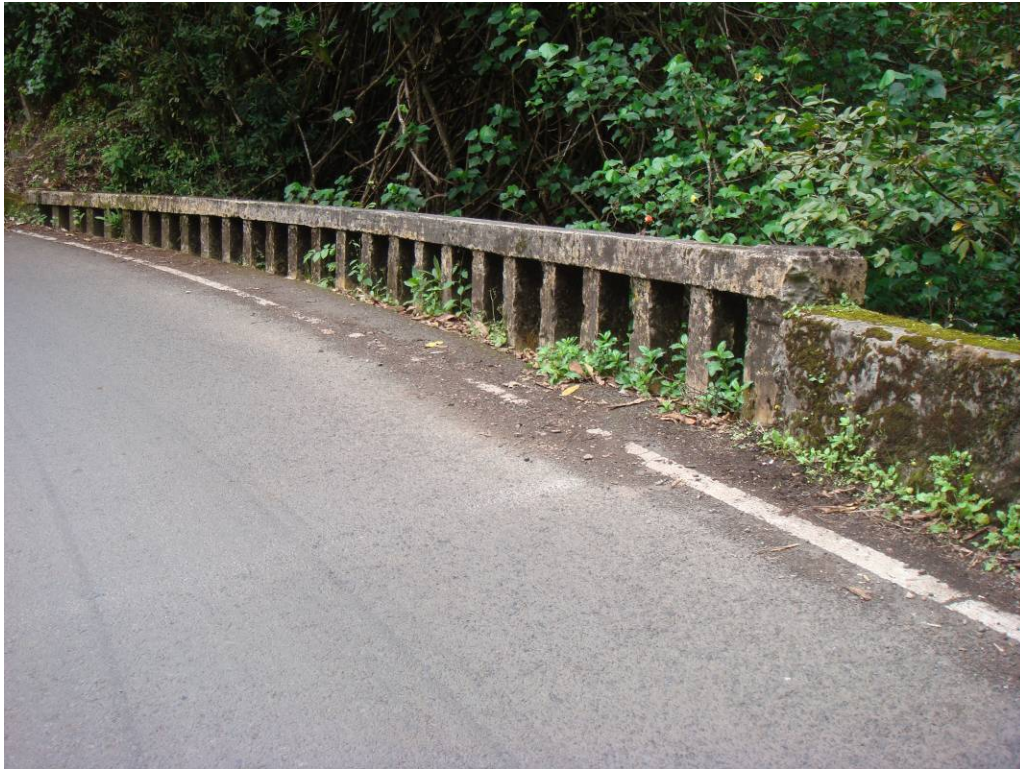
PHOTO 7 UPSTREAM BRIDGE RAILING. NOTE: RAILING HT = 24"

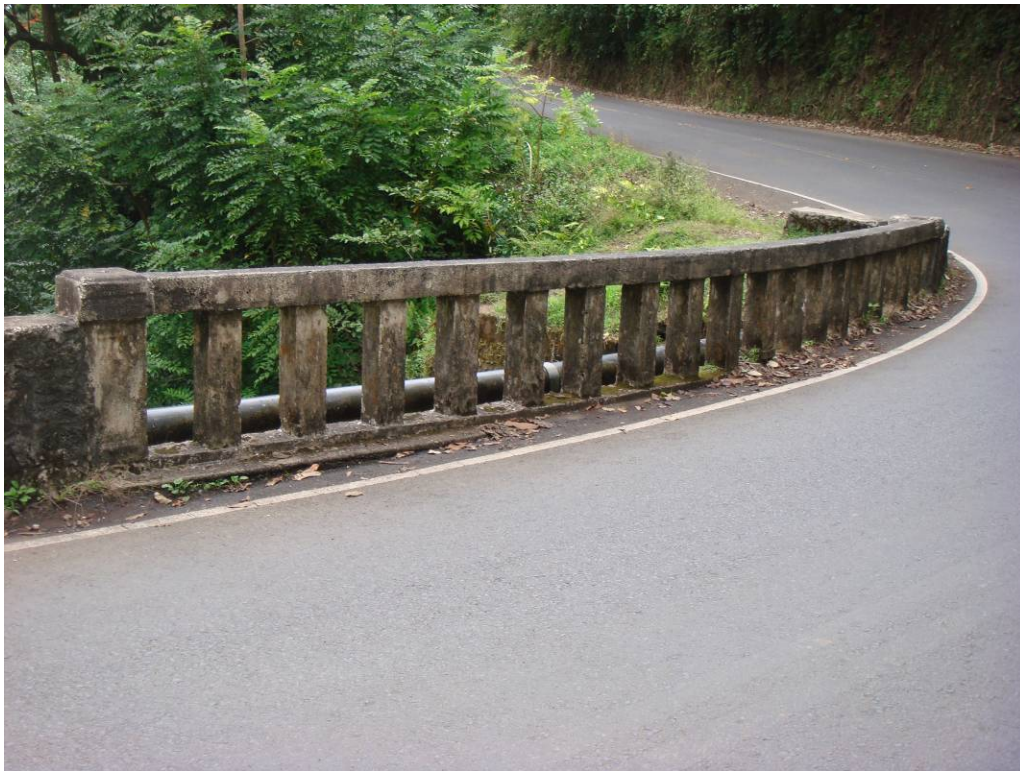
PHOTO 10 DOWNSTREAM BRIDGE RAILING. NOTE: RAILING HT = 33"

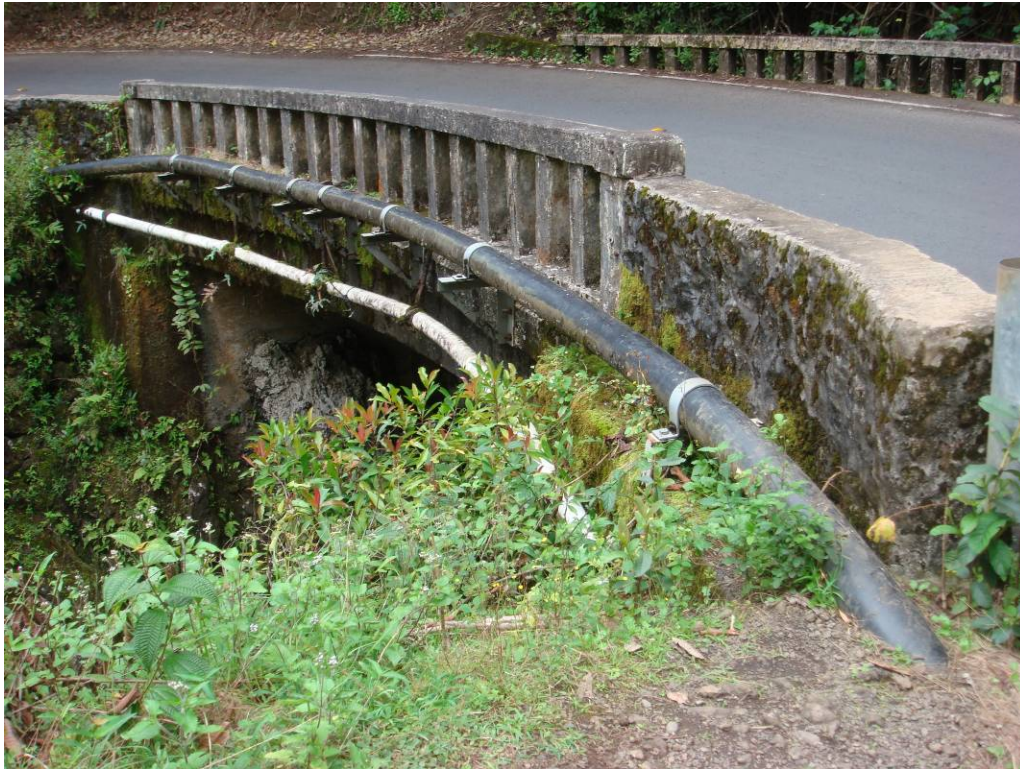
PHOTO 13 DOWNSTREAM BRIDGE ELEVATION, BACKSIDE OF DOWNSTREAM BRIDGE RAILING AND CRM WALLS, AND UTILITY LINES ATTACHED TO SIDE OF BRIDGE

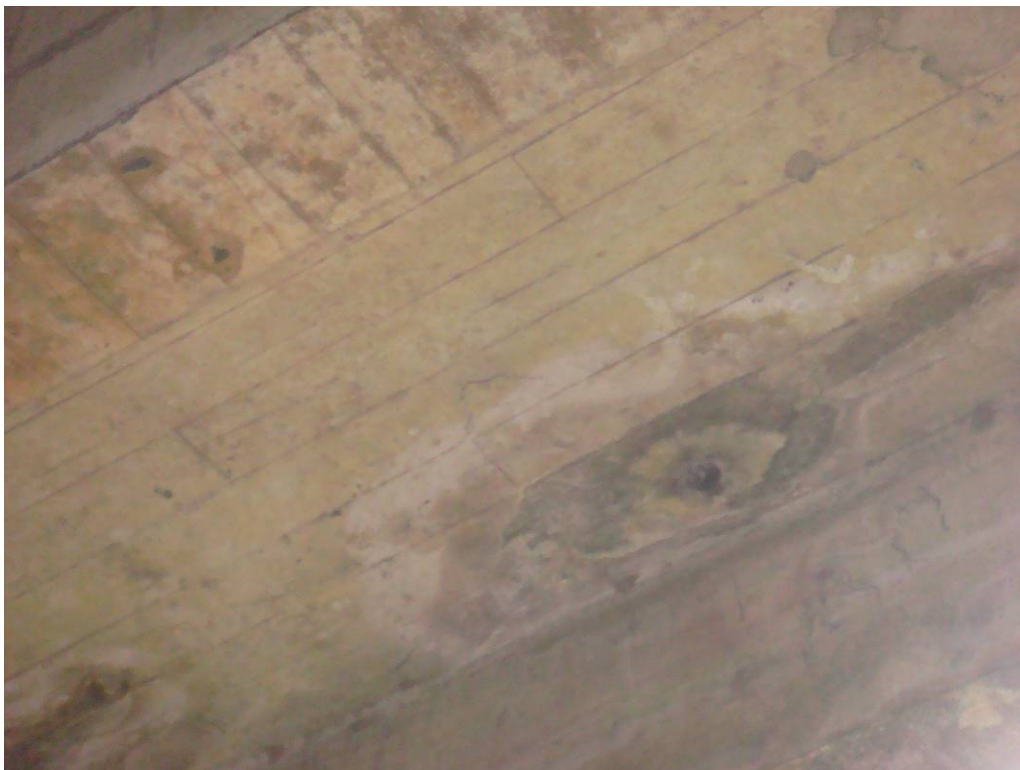
PHOTO 16 DELAMINATION IN DECK SOFFIT BETWEEN GIRDERS G3 AND G4 NEAR MID-SPAN

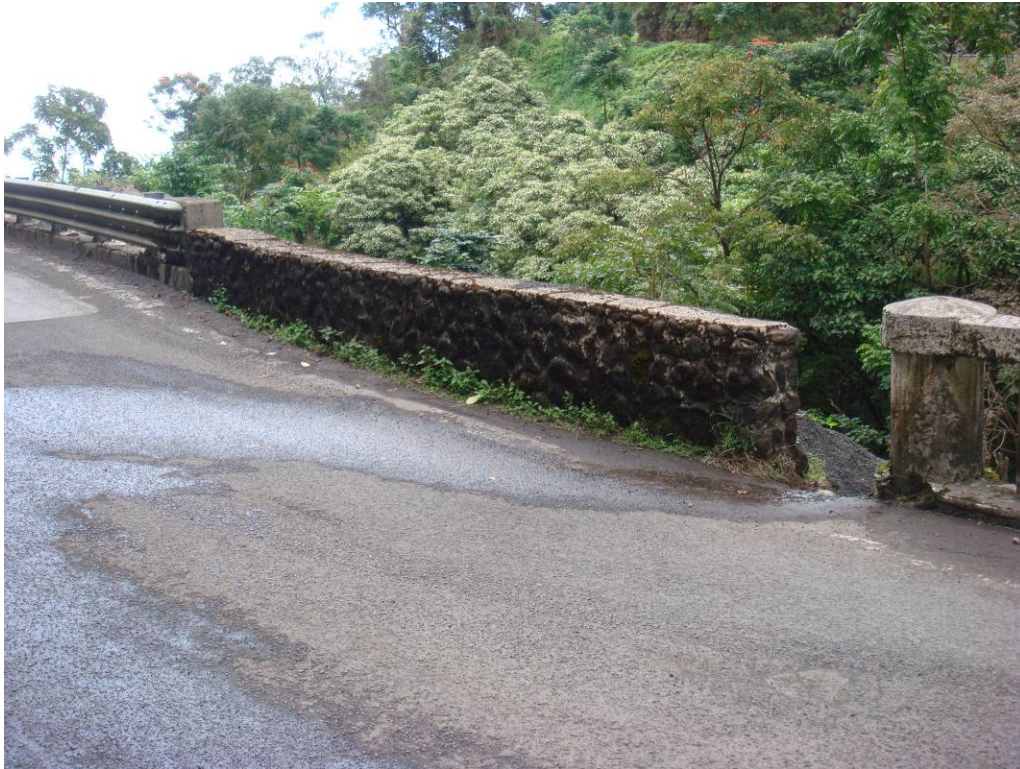
PHOTO 5 DOWNSTREAM / KAHULUI GUARDRAIL TRANSITION AND CRM WALL. NOTE: GUARDRAIL TRANSITION HT = 34"

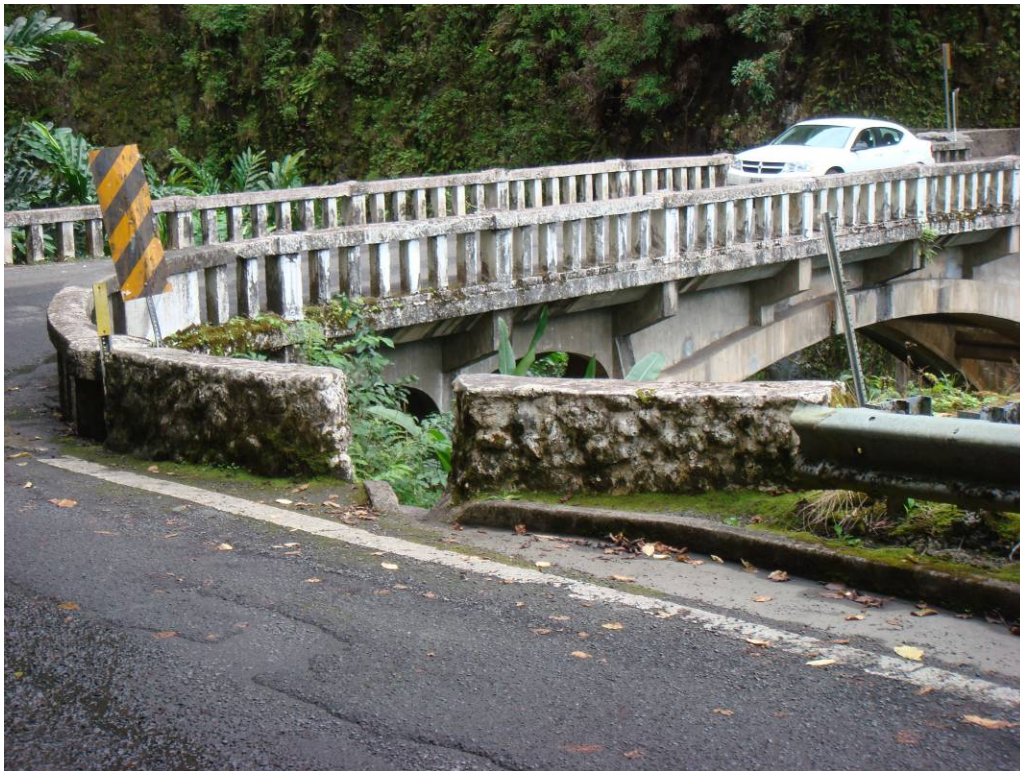
PHOTO 8 DOWNSTREAM / HANA GUARDRAIL AND CRM WALL. NOTE: GUARDRAIL HT = 27"

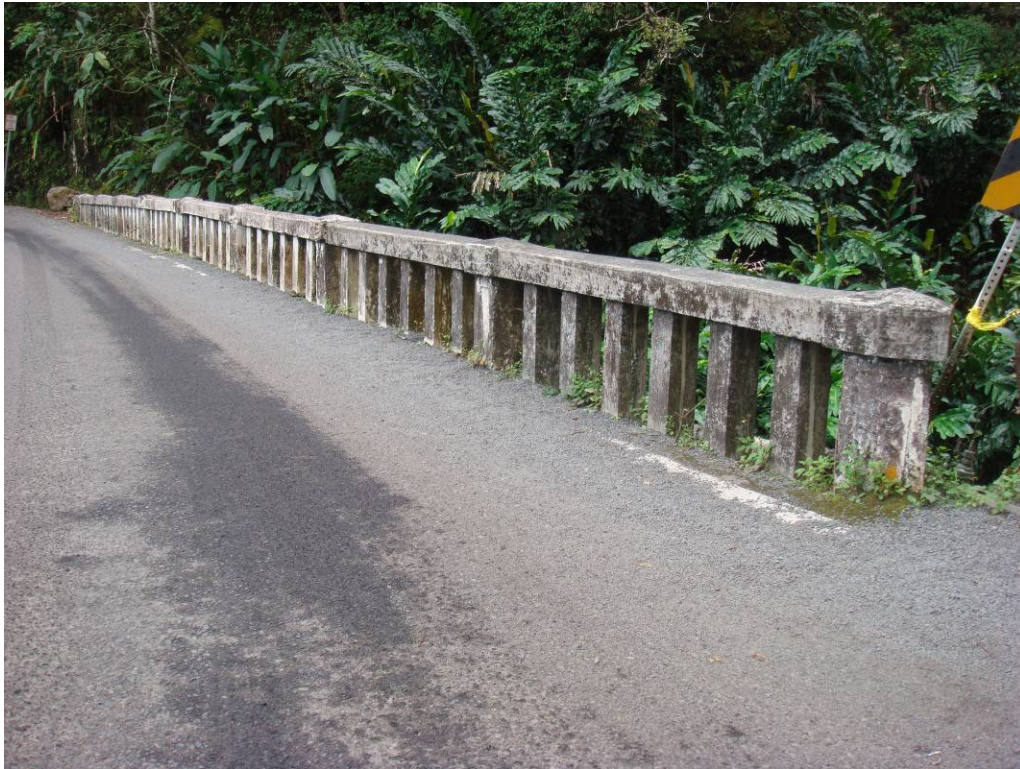
PHOTO 9 UPSTREAM RAILING ELEVATION. NOTE: RAILING HT = 29"

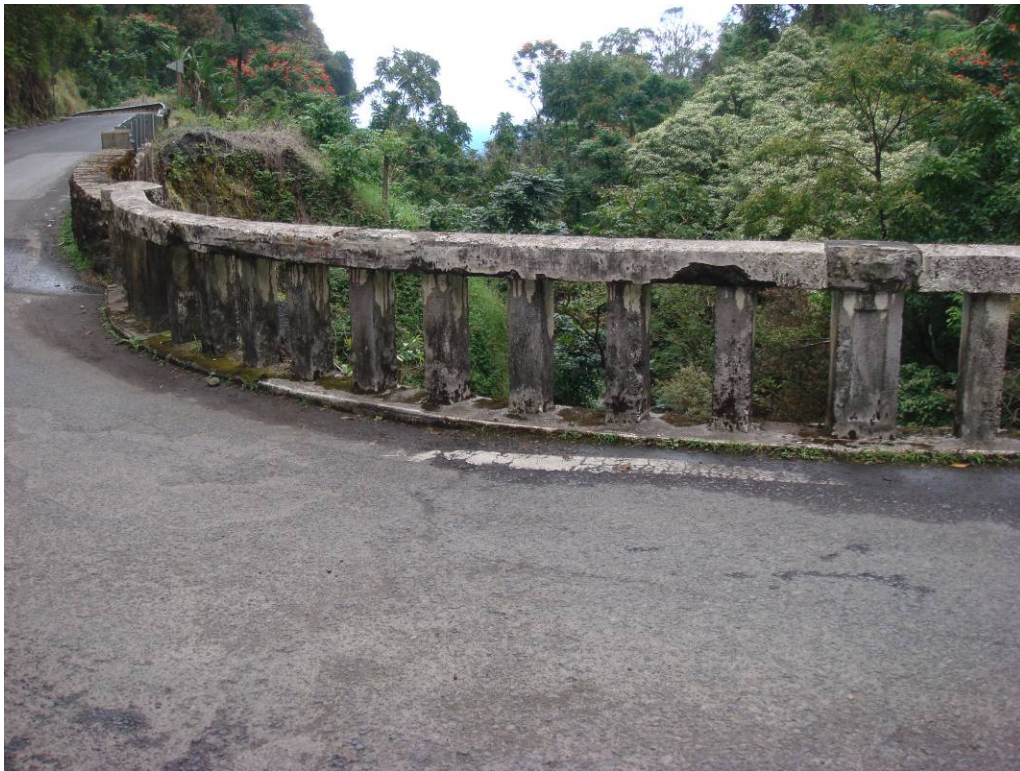
PHOTO 10 PARTIAL VIEW OF DOWNSTREAM RAILING ELEVATION NEAR KAHULUI.
NOTE: RAILING HT = 33"

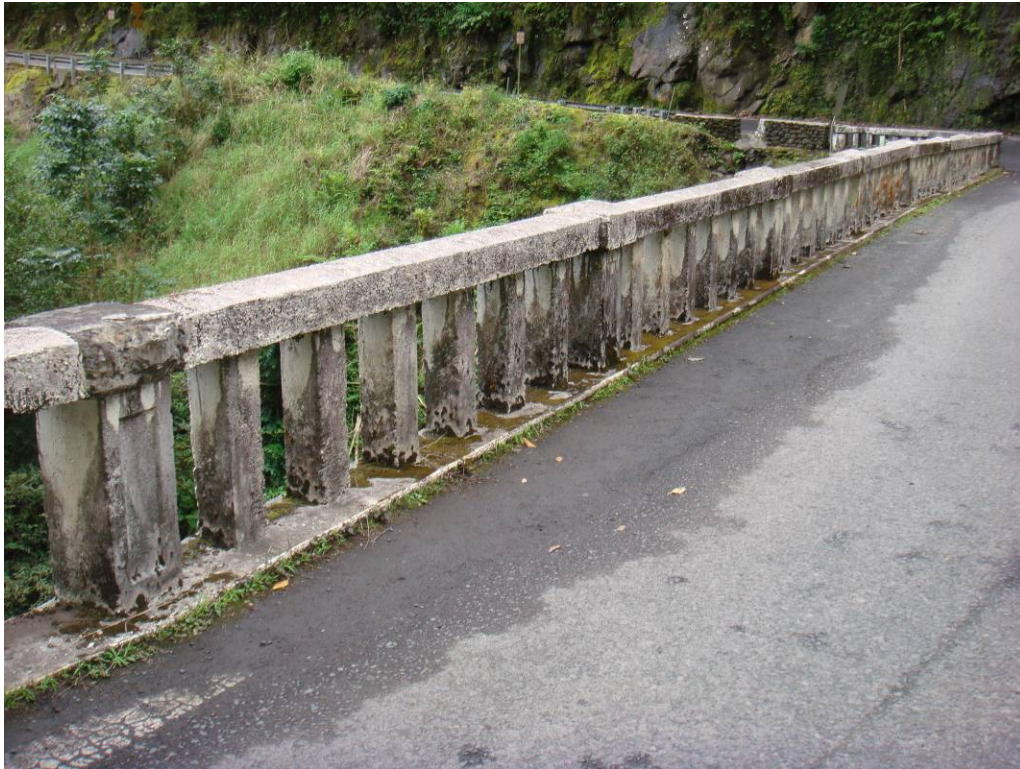
PHOTO 11 PARTIAL VIEW OF DOWNSTREAM RAILING ELEVATION LOOKING TOWARD HANA

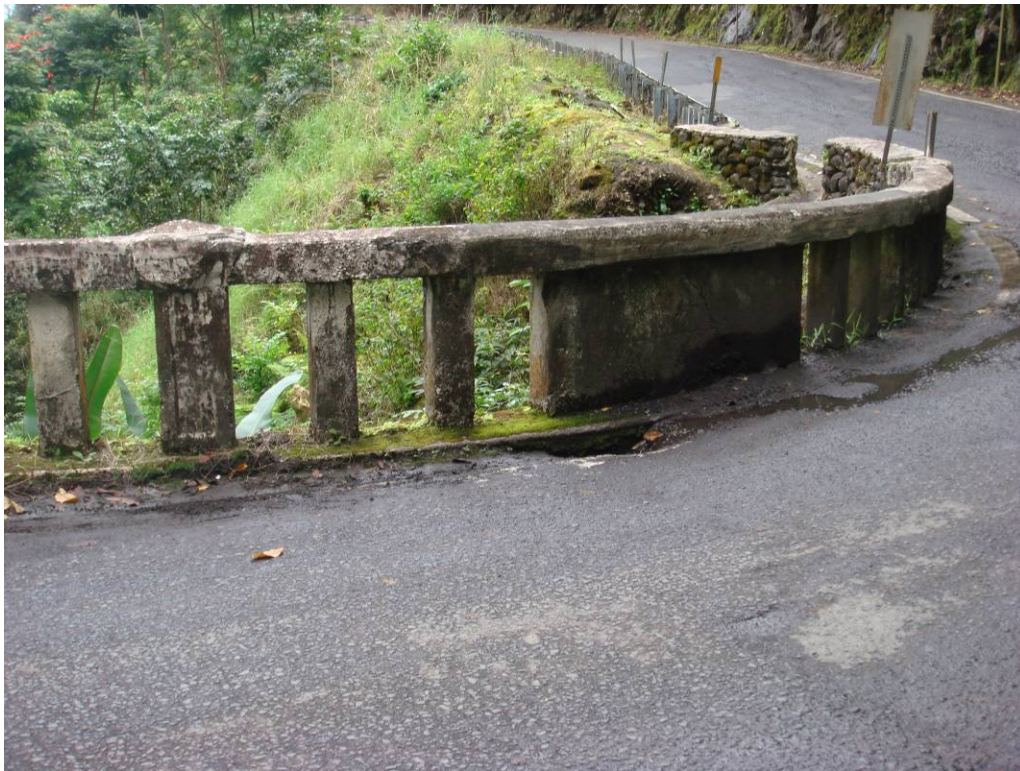
PHOTO 12 PARTIAL VIEW OF DOWNSTREAM RAILING ELEVATION NEAR HANA

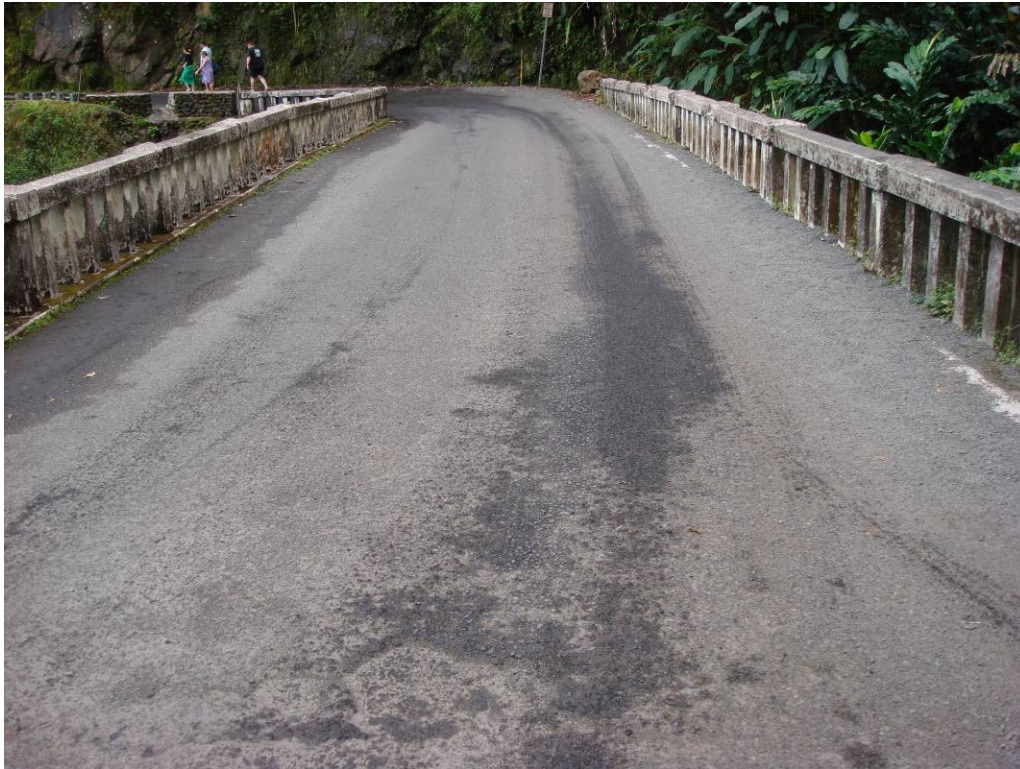
PHOTO 15 OVERALL A.C. PAVEMENT LOOKING TOWARD HANA

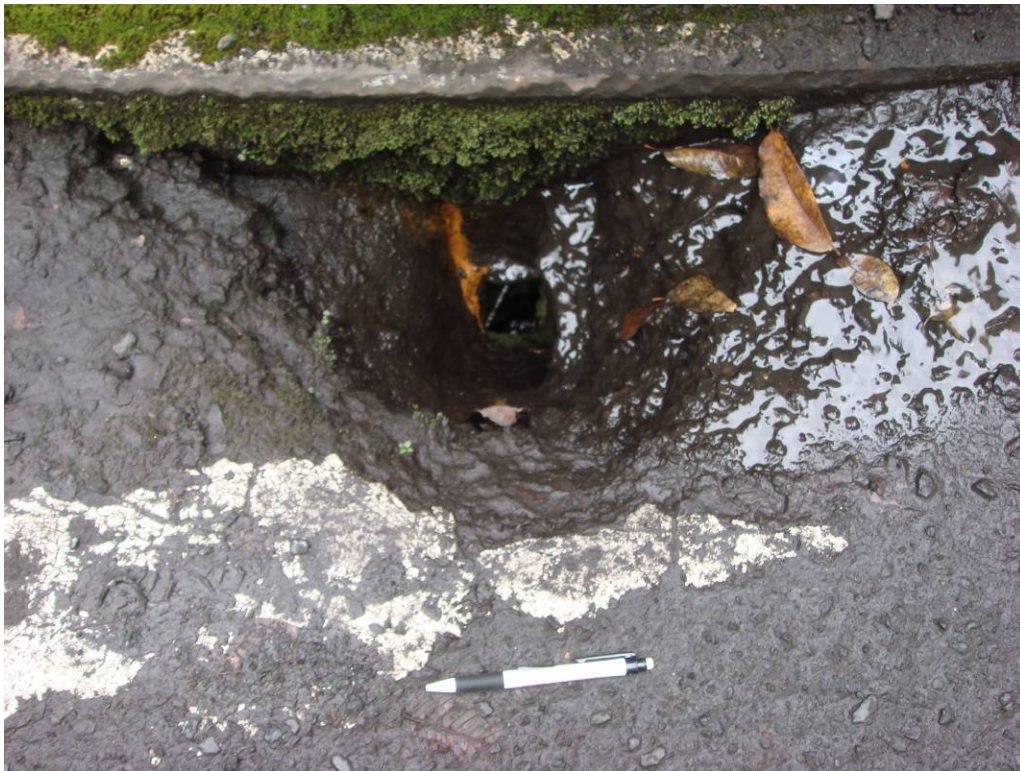
PHOTO 16 DECK DRAIN ALONG DOWNSTREAM RAILING

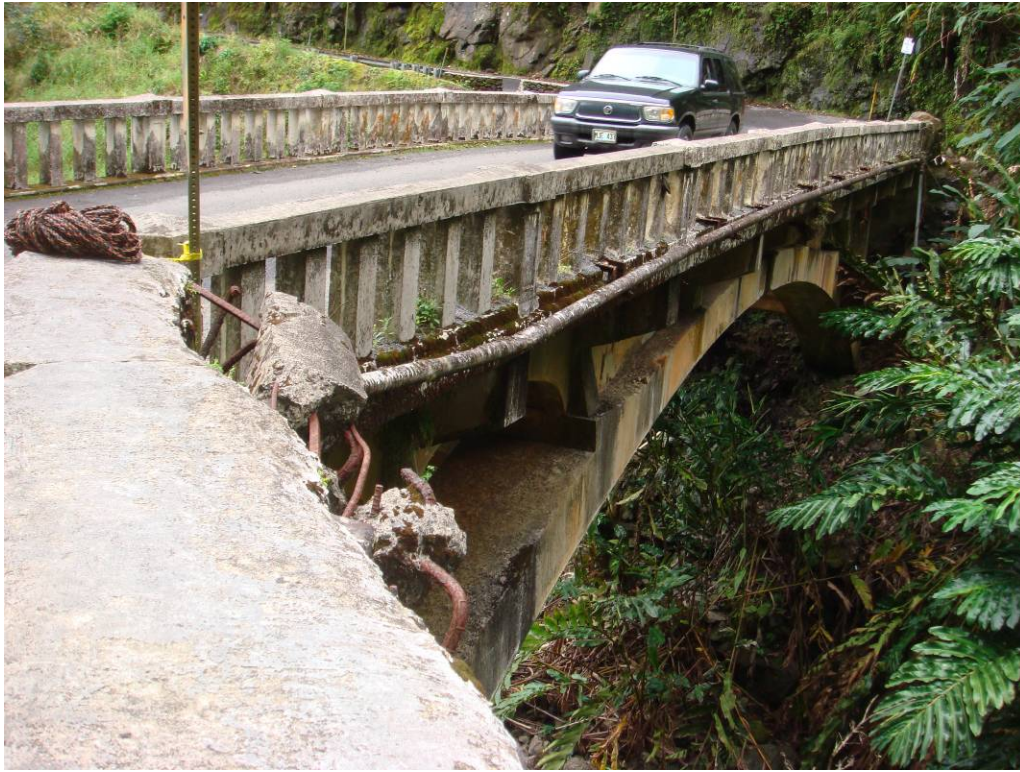
PHOTO 17 UPSTREAM ELEVATION AND UTILITY LINE ALONG BASE OF RAILING

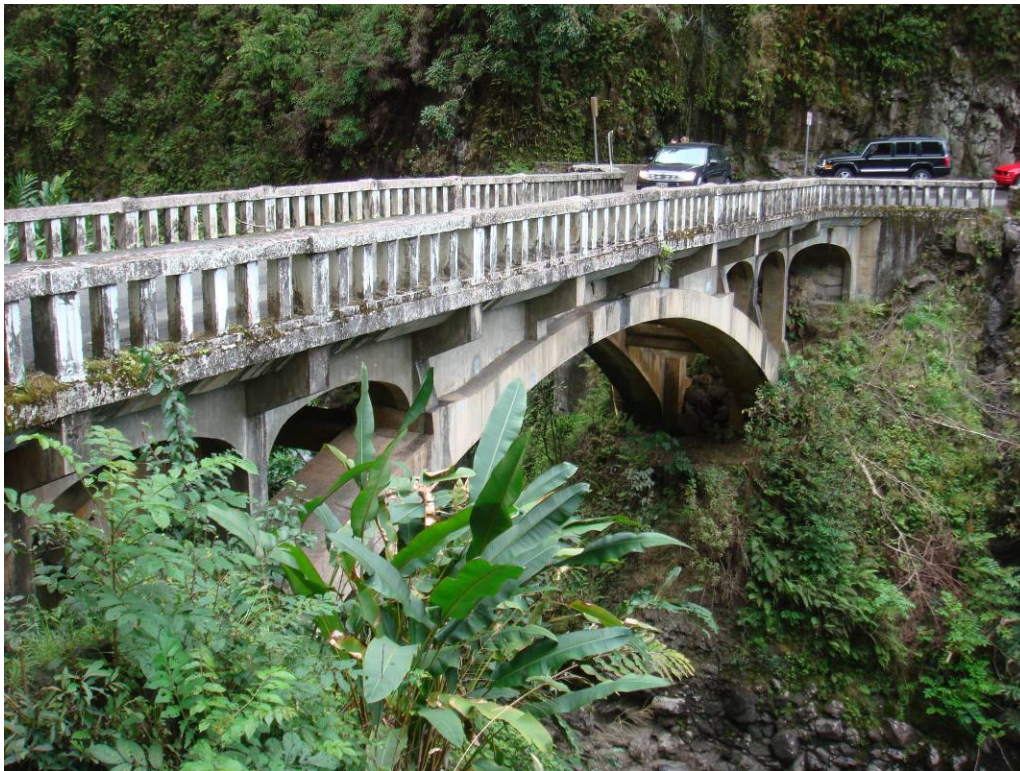
PHOTO 18 DOWNSTREAM ELEVATION

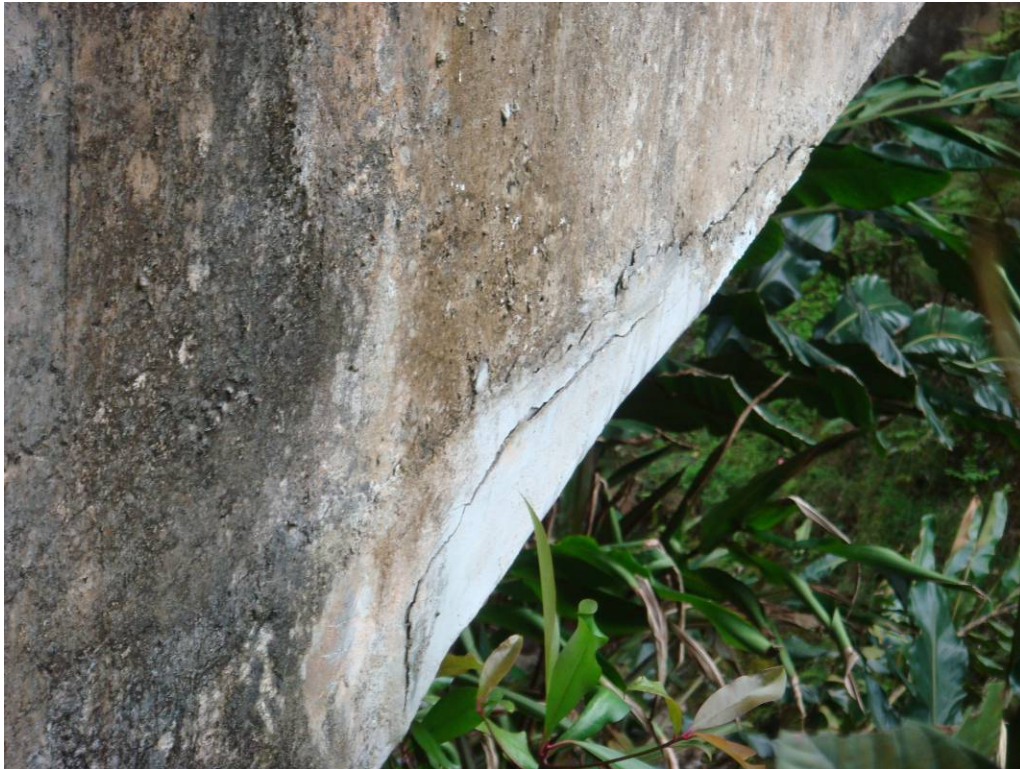
**PHOTO 19 DELAMINATION (1' (H) X 3' (W)) IN DOWNSTREAM FACE OF ARCH RIB UNDER
DOWNSTREAM / HANA SPANDREL COLUMN**
