ROUTINE (PERIODIC) BRIDGE INSPECTION REPORT

NUAAILUA STREAM BRIDGE
BRIDGE NO. 009003600501540
MAUI, HAWAII

State of Hawaii
Department of Transportation
Highways Division

Nagamine Okawa Engineers Inc.
1003 Bishop Street
Suite 2025
Honolulu, Hawaii 96813
Telephone: (808) 536-2626

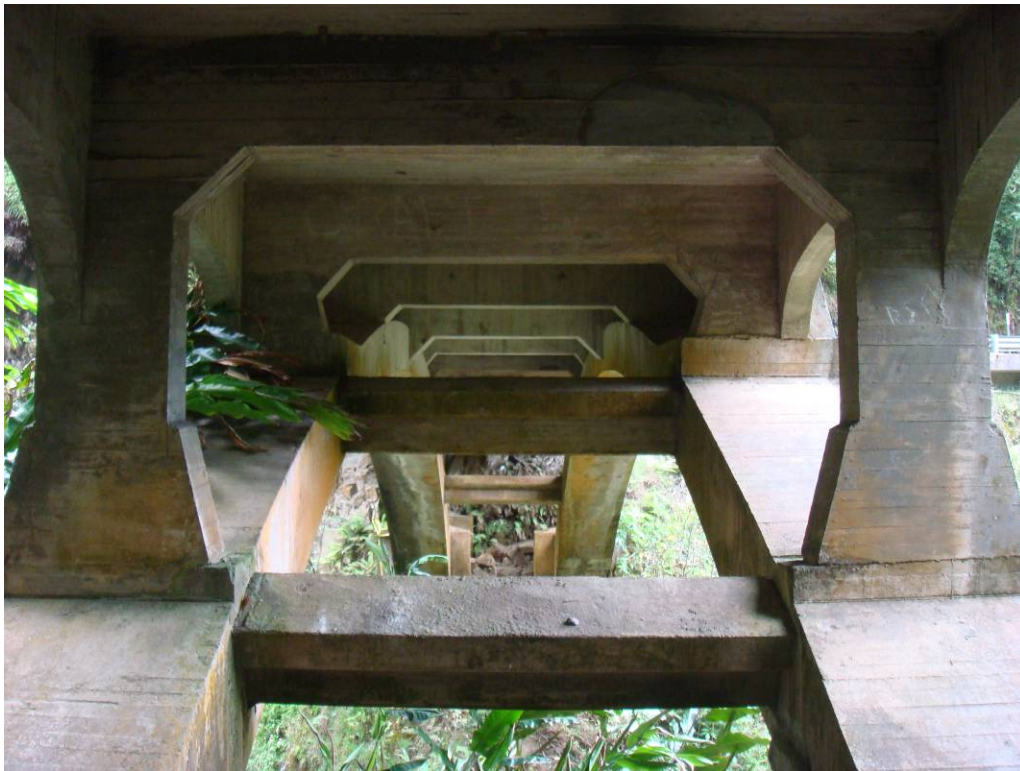
PHOTO 20 OVERALL SOFFIT VIEW LOOKING TOWARD KAHULUI

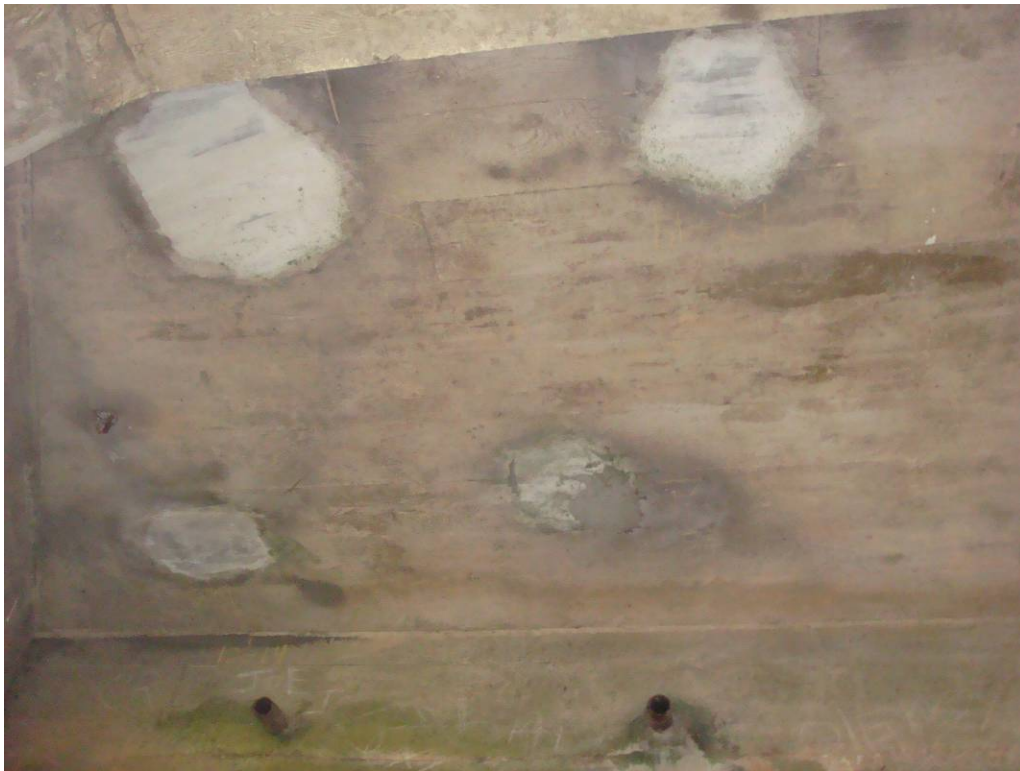
PHOTO 24 PATCHES IN SOFFIT NEAR HANA END

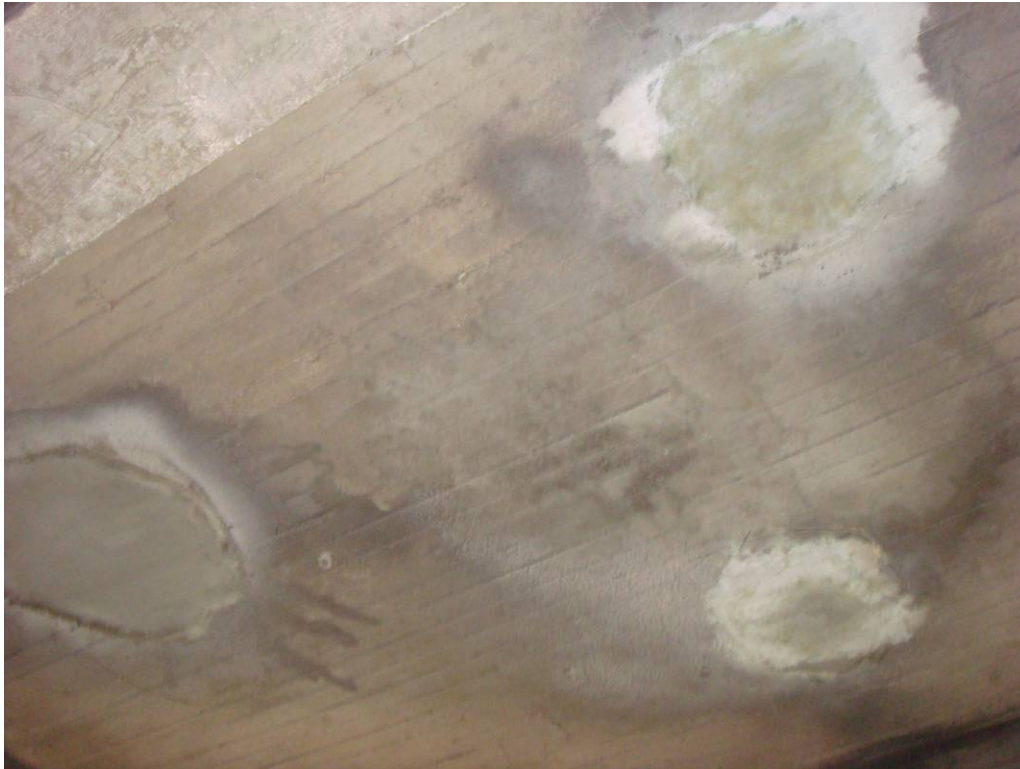
PHOTO 25 PATCHES IN SOFFIT BETWEEN SPANDREL BENT 1 AND 2. NOTE: SPANDREL COUNT STARTS FROM HANA ABUTMENT.

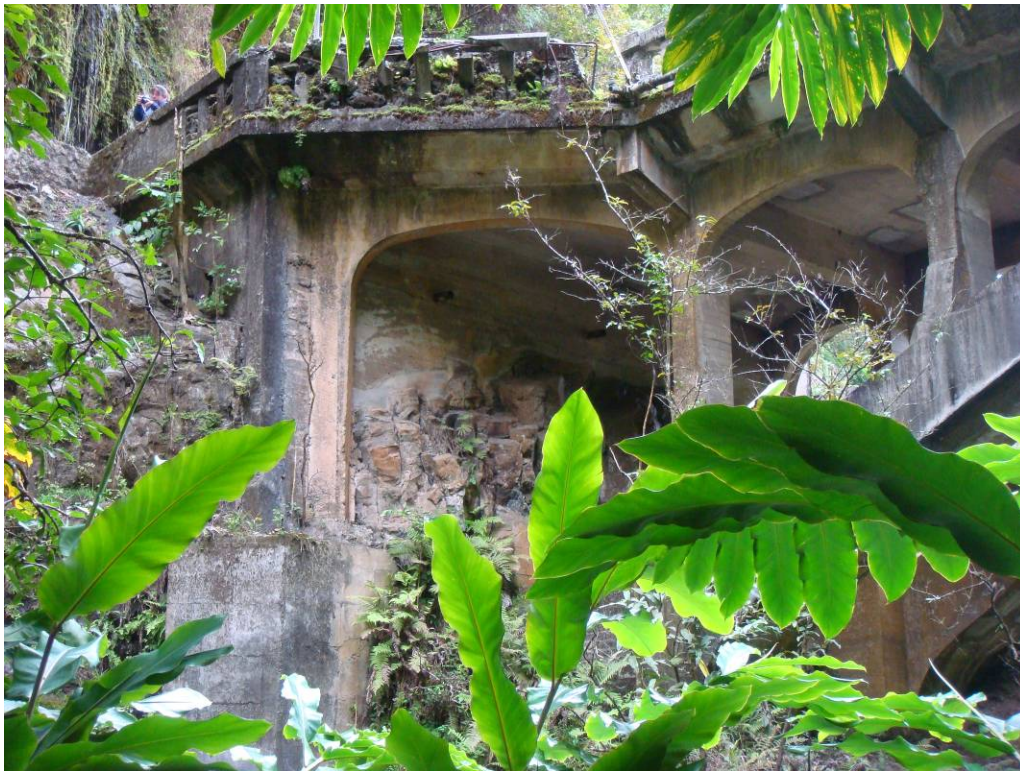
PHOTO 26 KAHULUI ABUTMENT

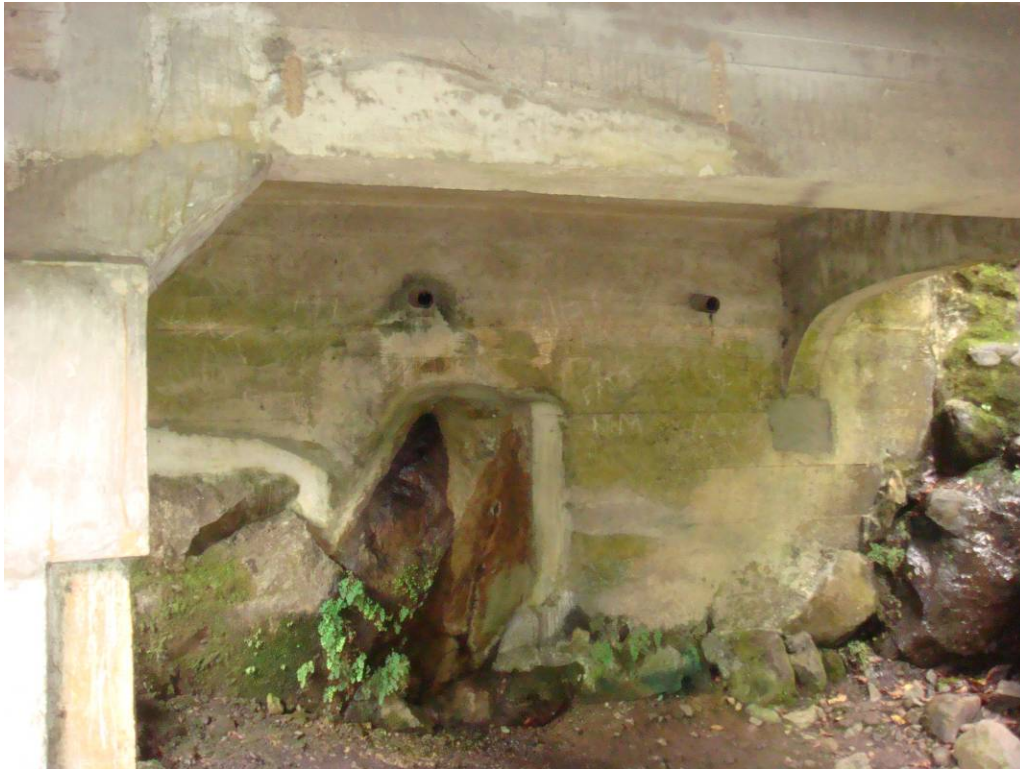
PHOTO 27 HANA ABUTMENT

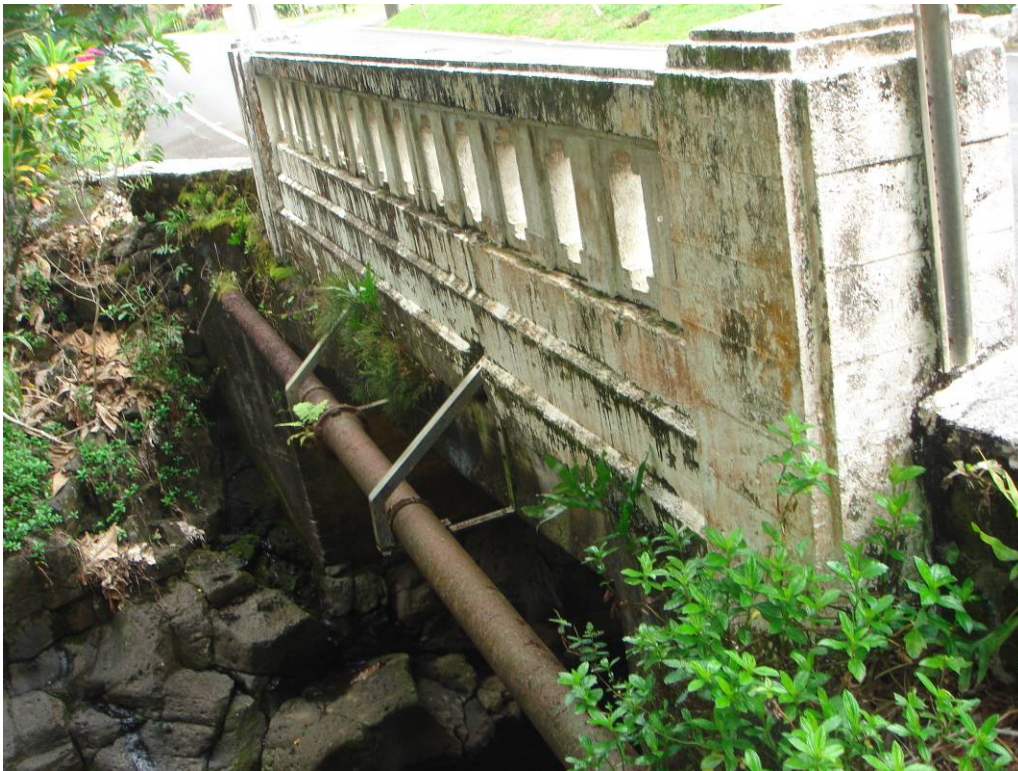
PHOTO 10 BACKSIDE OF UPSTREAM RAILING AND UTILITY PIPE

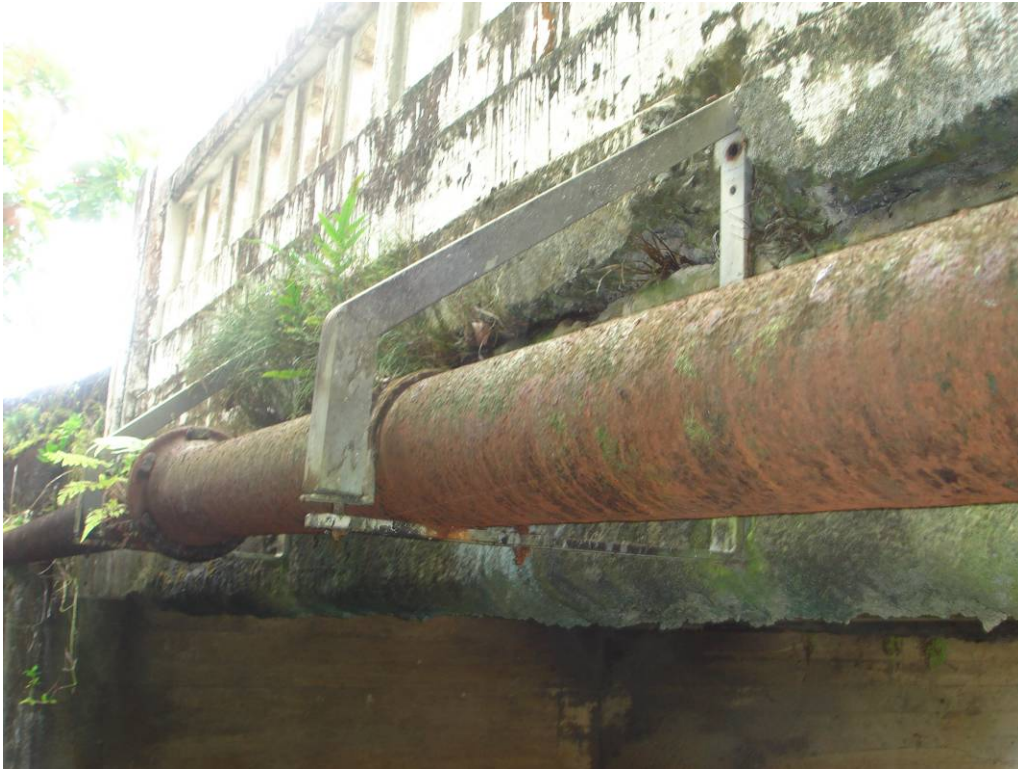
PHOTO 11 CLOSE UP OF UTILITY PIPE AND HANGERS ON UPSTREAM SIDE OF BRIDGE

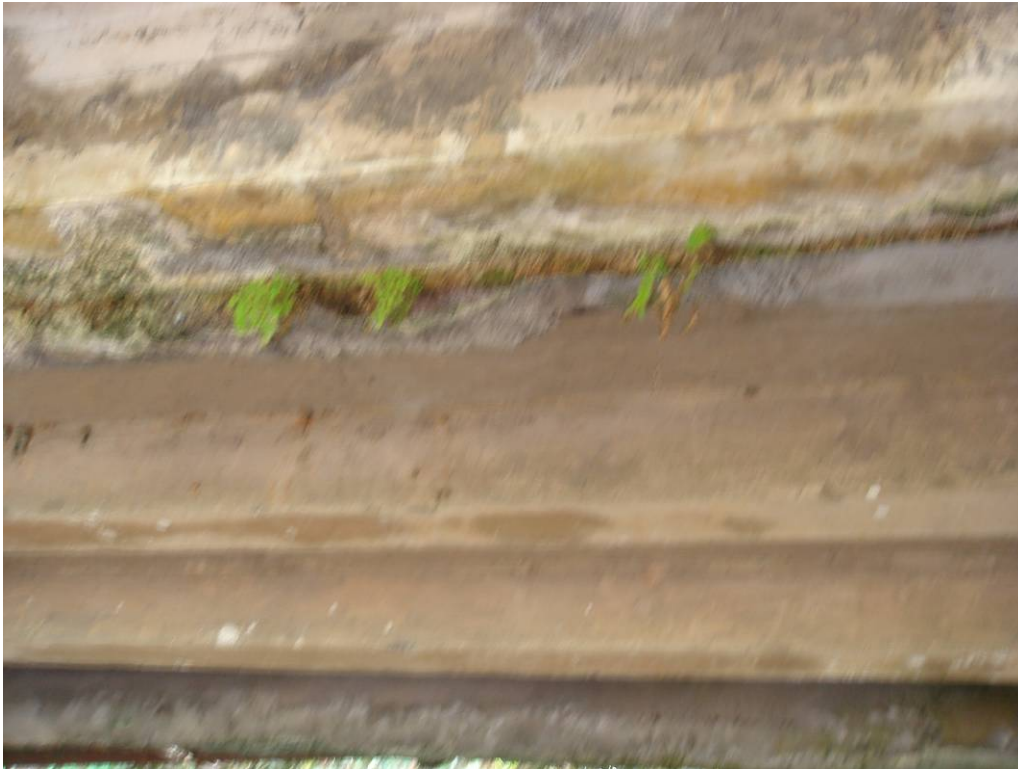
PHOTO 15 JOINT IN SOFFIT

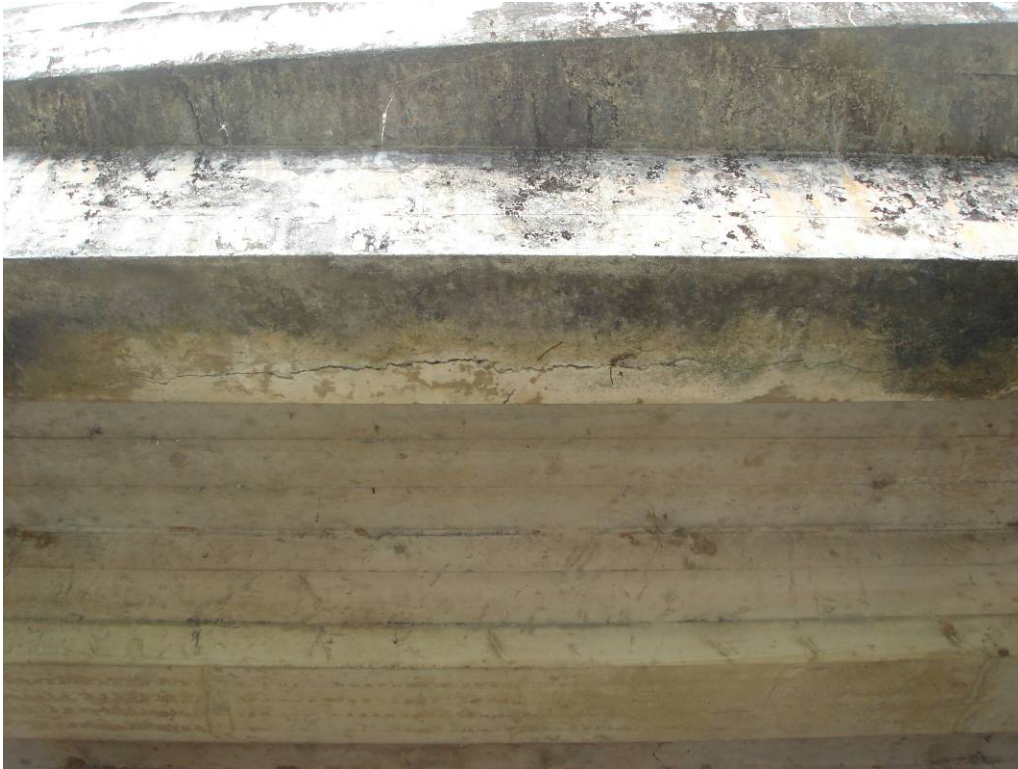
PHOTO 16 UPSTREAM HALF OF SOFFIT LOOKING TOWARD KAHULUI

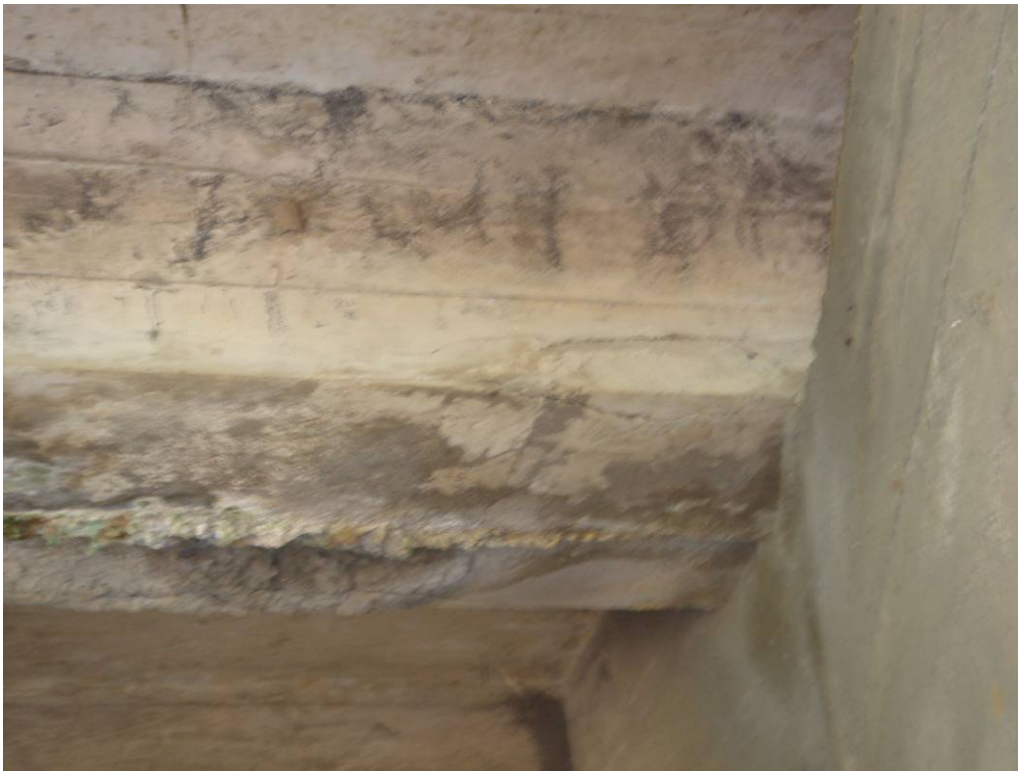
PHOTO 17 6' DELAMINATION IN GIRDER G8

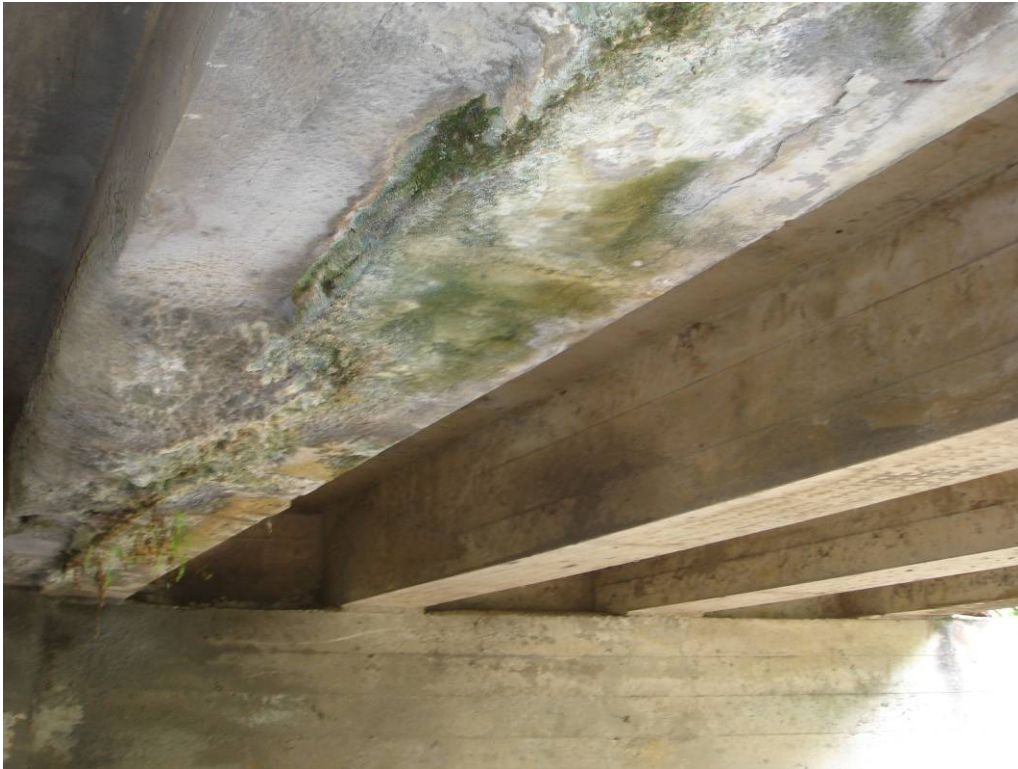
PHOTO 20 DELAMINATION AND VEGETATION GROWING IN GIRDERS G4 AND G5

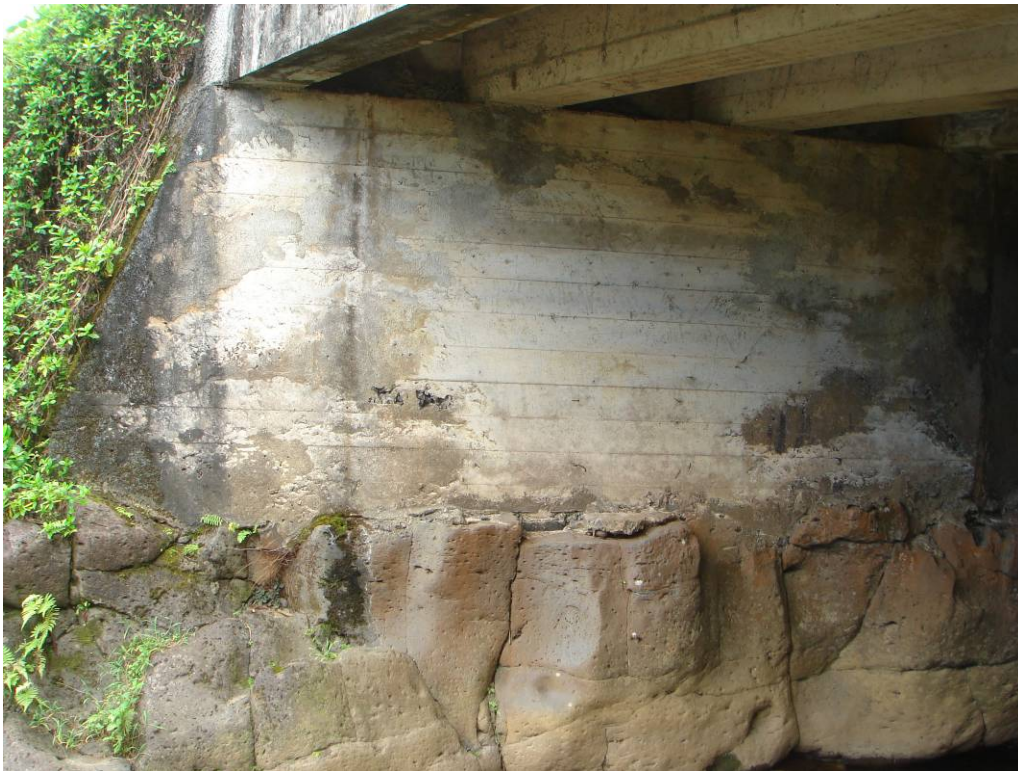
PHOTO 21 DOWNSTREAM HALF OF KAHULUI ABUTMENT GIRDER SEAT

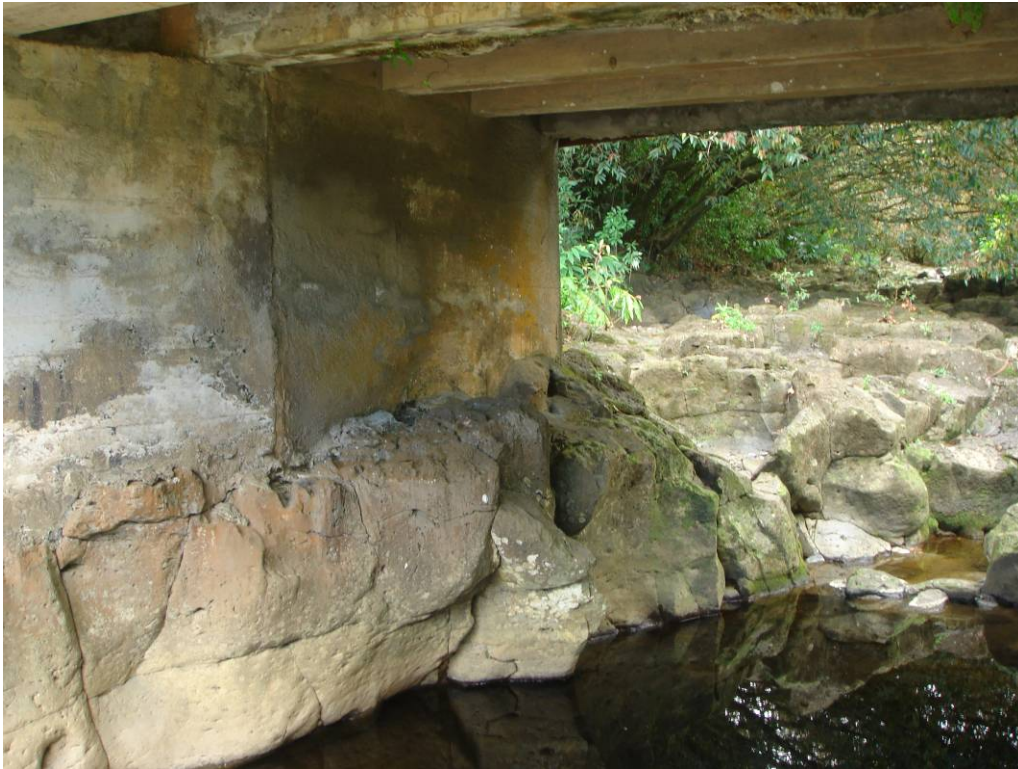
PHOTO 22 DOWNSTREAM HALF OF HANA ABUTMENT

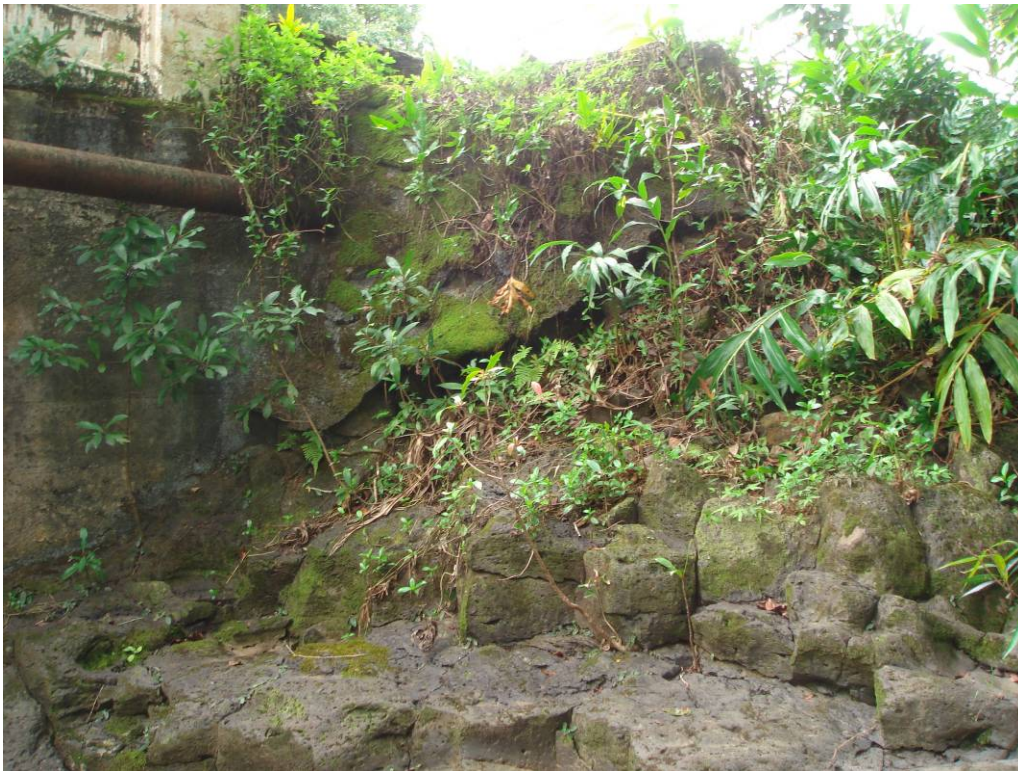
PHOTO 23 UPSTREAM HALF OF HANA ABUTMENT

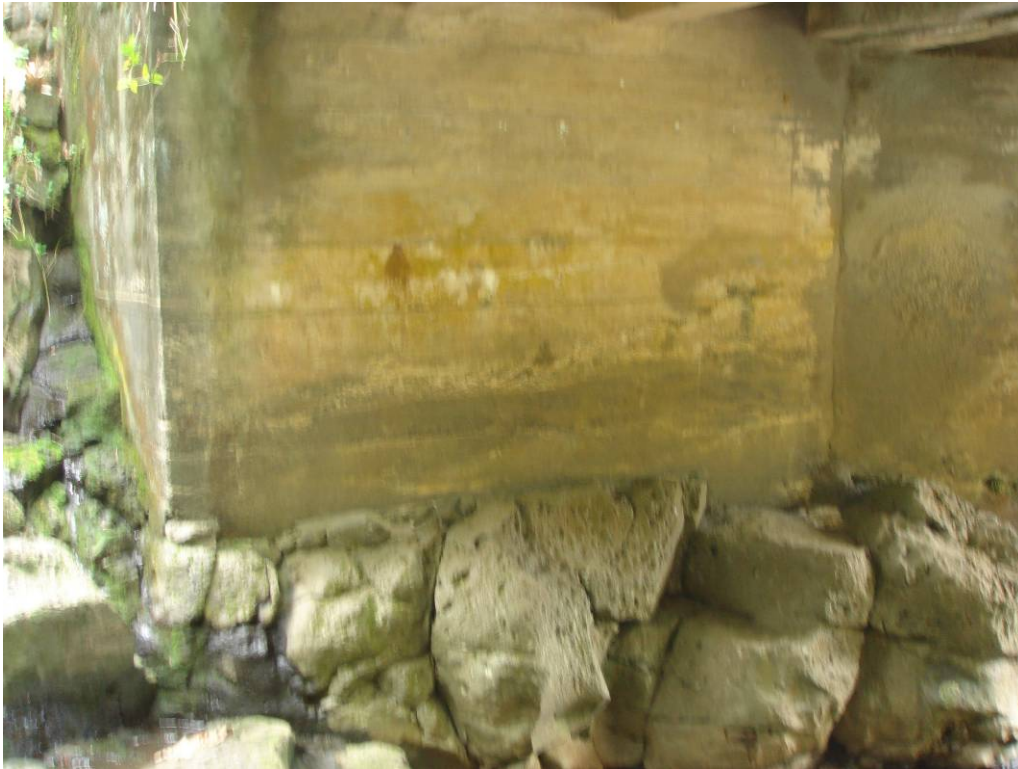
PHOTO 26 LOOSE ROCKS IN UPSTREAM KAHULUI CRM WALL

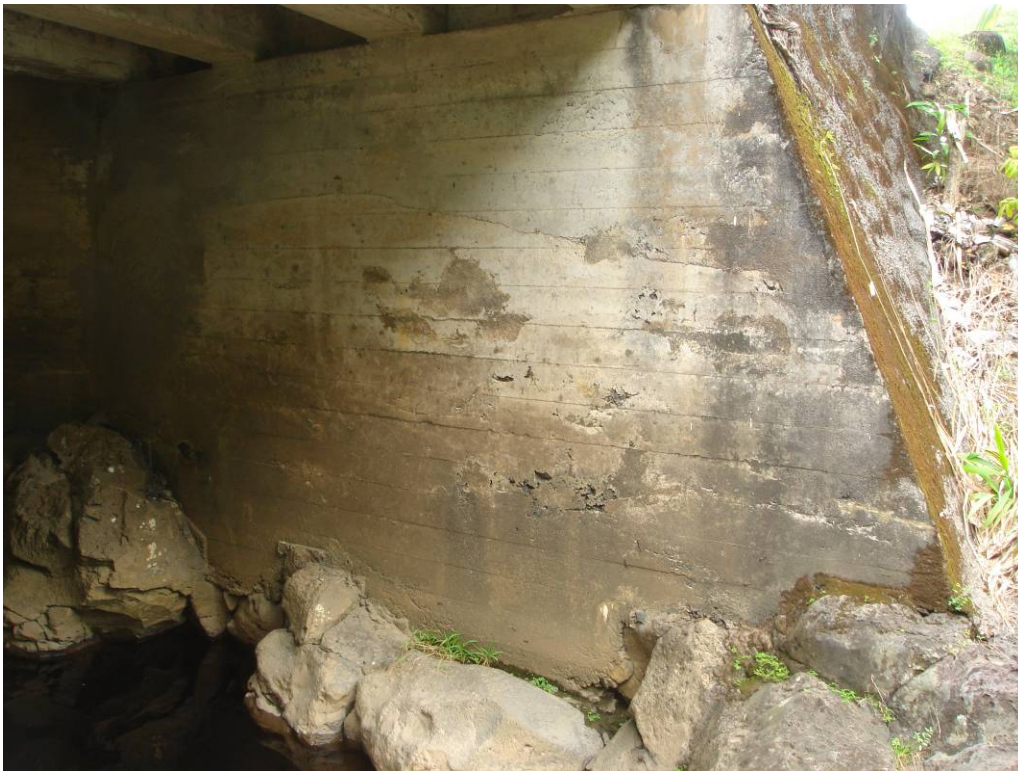
PHOTO 27 UPSTREAM HALF OF KAHULUI ABUTMENT

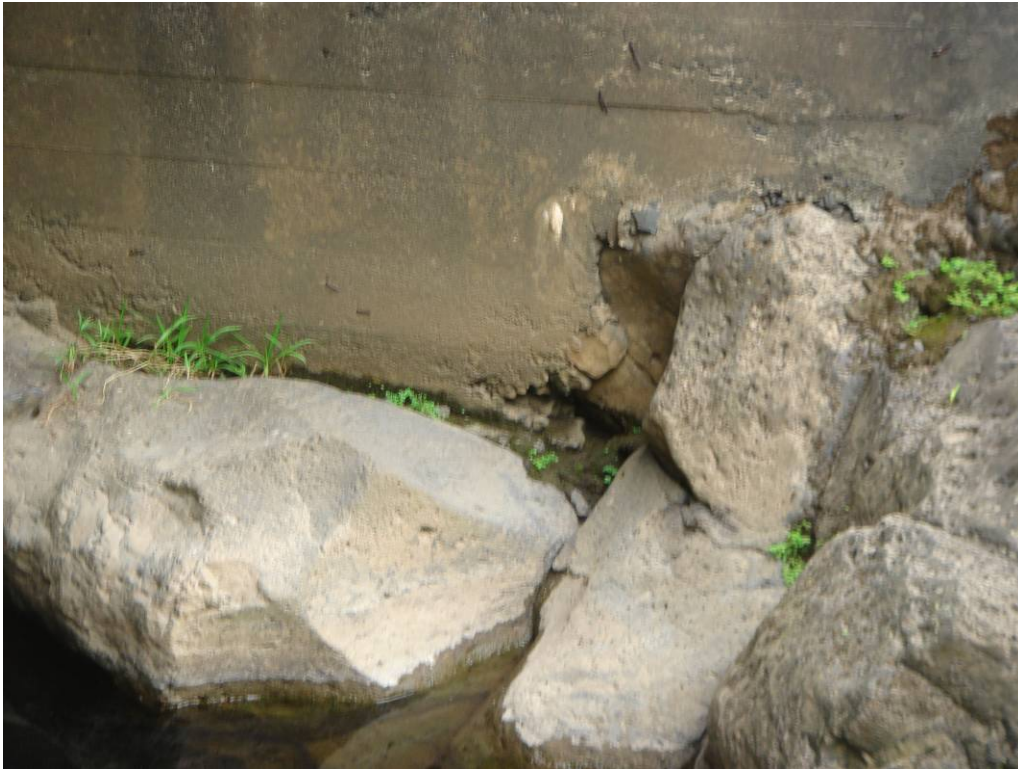
PHOTO 28 DOWNSTREAM HALF OF KAHULUI ABUTMENT
